ENGINEERING INVESTIGATIONS AT INACTIVE HAZARDOUS WASTE SITES

PHASE II INVESTIGATION

C & D Batteries
Site No. 336001
Huguenot, Orange County
Final - March, 1990

Prepared by:
Gibbs & Hill, Inc.
New York, New York

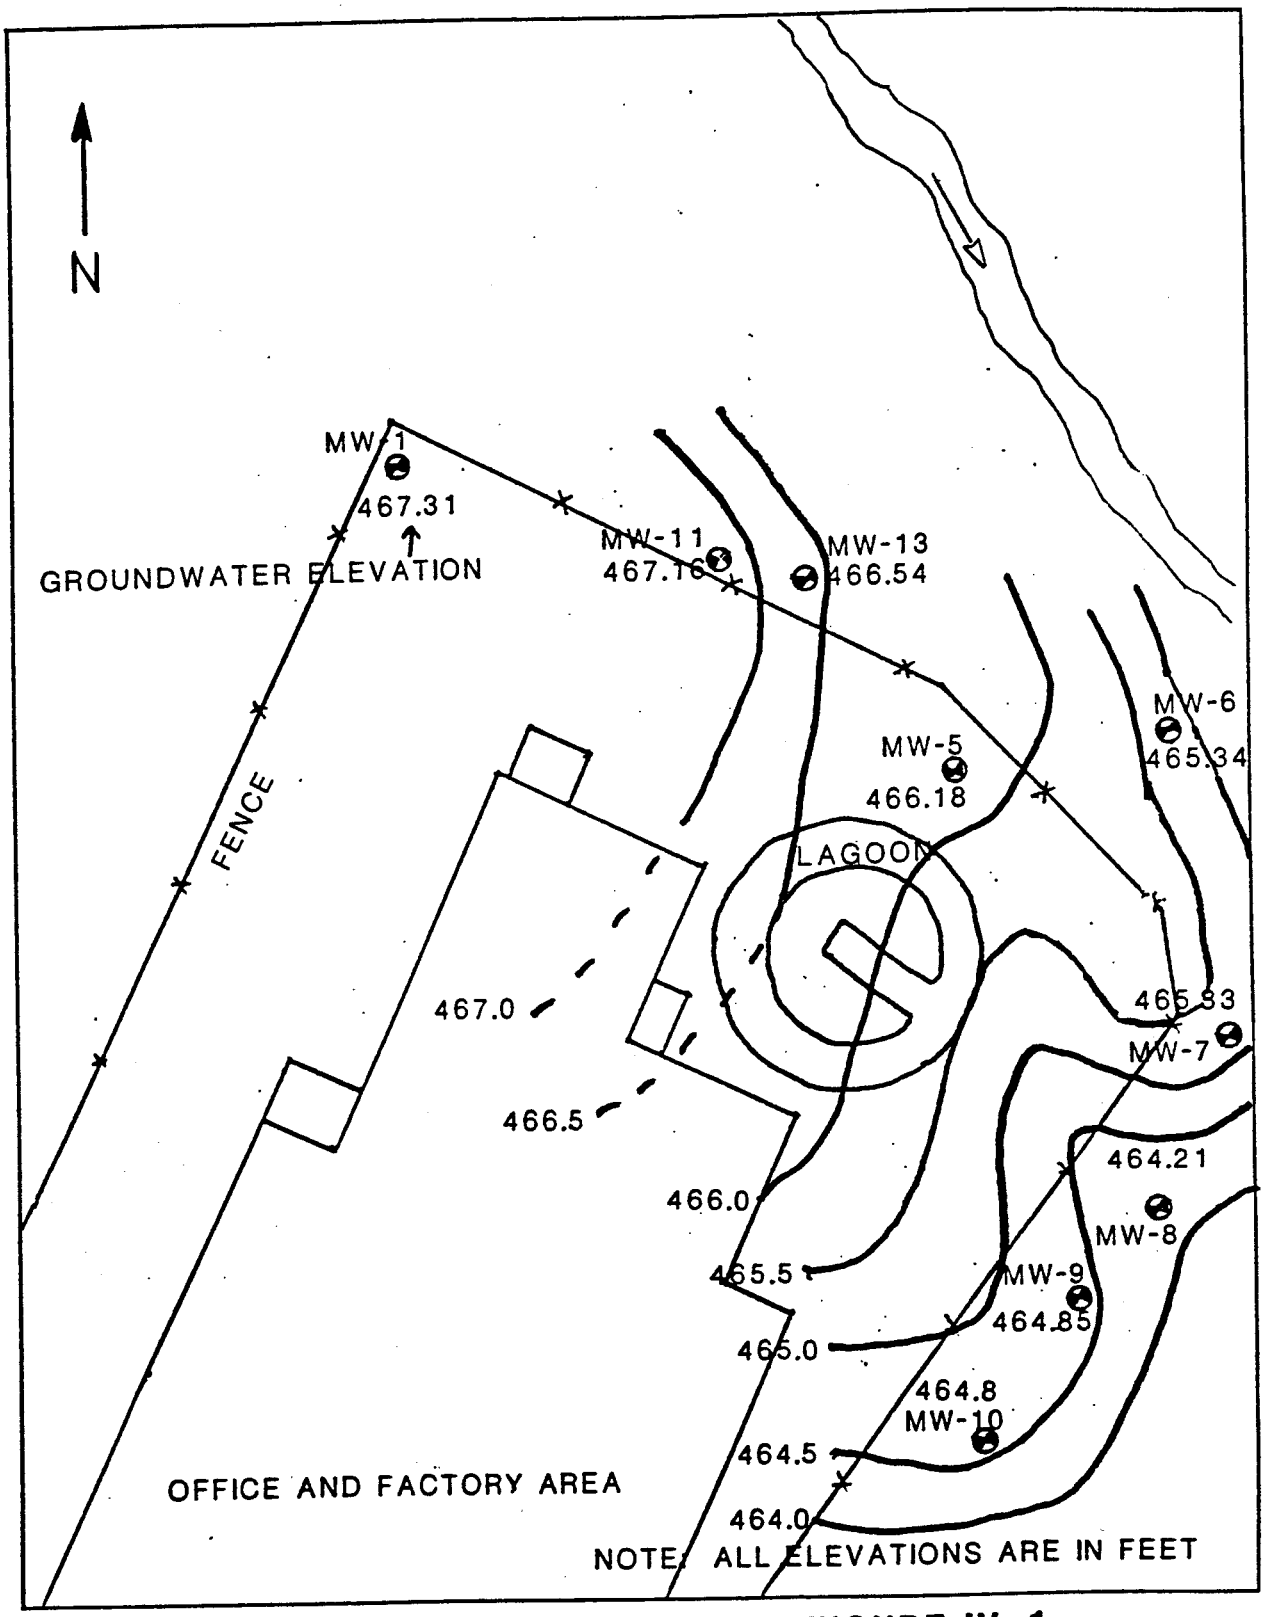
FIGURE IV-1
GIBBS & HILL INC.

The flow condition of the groundwater at the site was reconstructed from measurements performed at all existing wells. The local configuration of groundwater flow at the site is shown in Figure IV-1. Groundwater flow is approximately southeast at a gradient of less than 1 percent, which agrees with the groundwater contour map prepared by ERM [D.17]. The groundwater flows toward the nearby brook, which is a tributary to the Neversink River.
