Site Inspection Report for Malta Test Station

DERP FUDS Project No. **C02NY089802**

September 2007

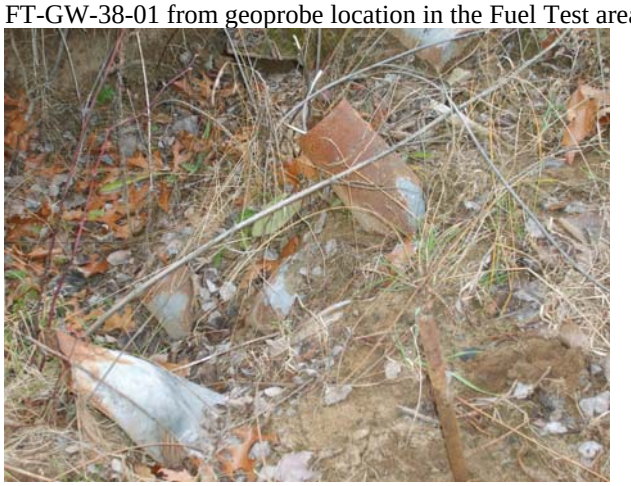
Photo E.3 – 155 mm and various other casings found in a sand pit in the Range Pond area.
