ADDITIONS/CHANGES TO REGISTRY: SUMMARY OF APPROVALS

SITE NAME: SPEEDY'S CLEANERS DEC I.D. NUMBER 828109

FIGURE 3-2
SURFACE WATER AND SEDIMENT SAMPLE LOCATIONS
PRELIMINARY SITE ASSESSMENT REPORT
SPEEDY'S CLEANERS SITE
PITTSFORD, NEW YORK
Harding Lawson Associates

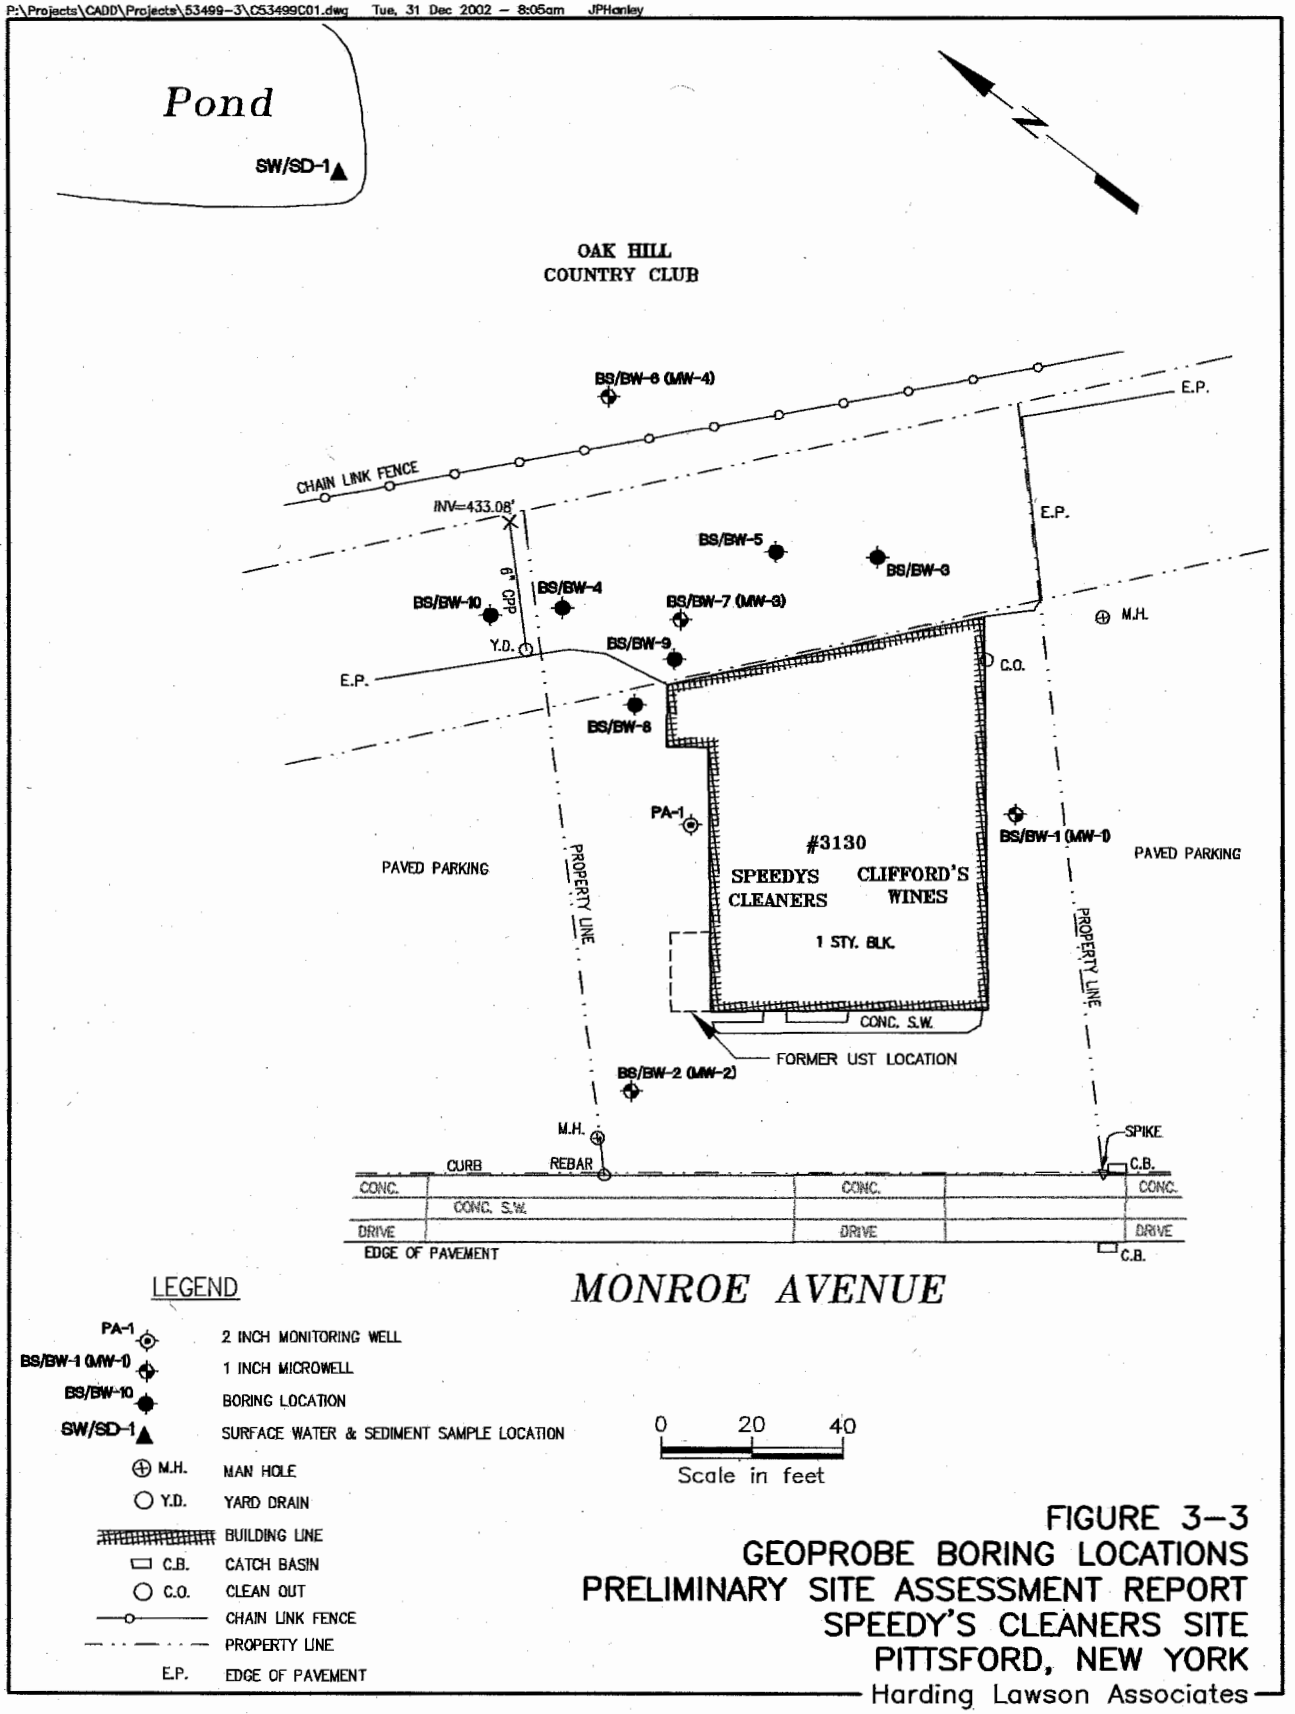
FIGURE 3-3
GEOPROBE BORING LOCATIONS
PRELIMINARY SITE ASSESSMENT REPORT
SPEEDY'S CLEANERS SITE
PITTSFORD, NEW YORK
Harding Lawson Associates

PCE was detected in five samples from four borings (BS-4, BS-7, BS-8, and BS-9) at concentrations above the NYSDEC Soil Cleanup Objectives. Concentrations ranged from 4,200 µg/Kg (BS-8) to 110,000 µg/Kg (BS-9); the Soil Cleanup Objective for PCE is 1,400 µg/Kg. These borings are located north and east of the northern corner of the Site building. Relatively low concentrations of fuel related compounds were also detected in soil samples from two of the borings (BS-5 and BS-7).

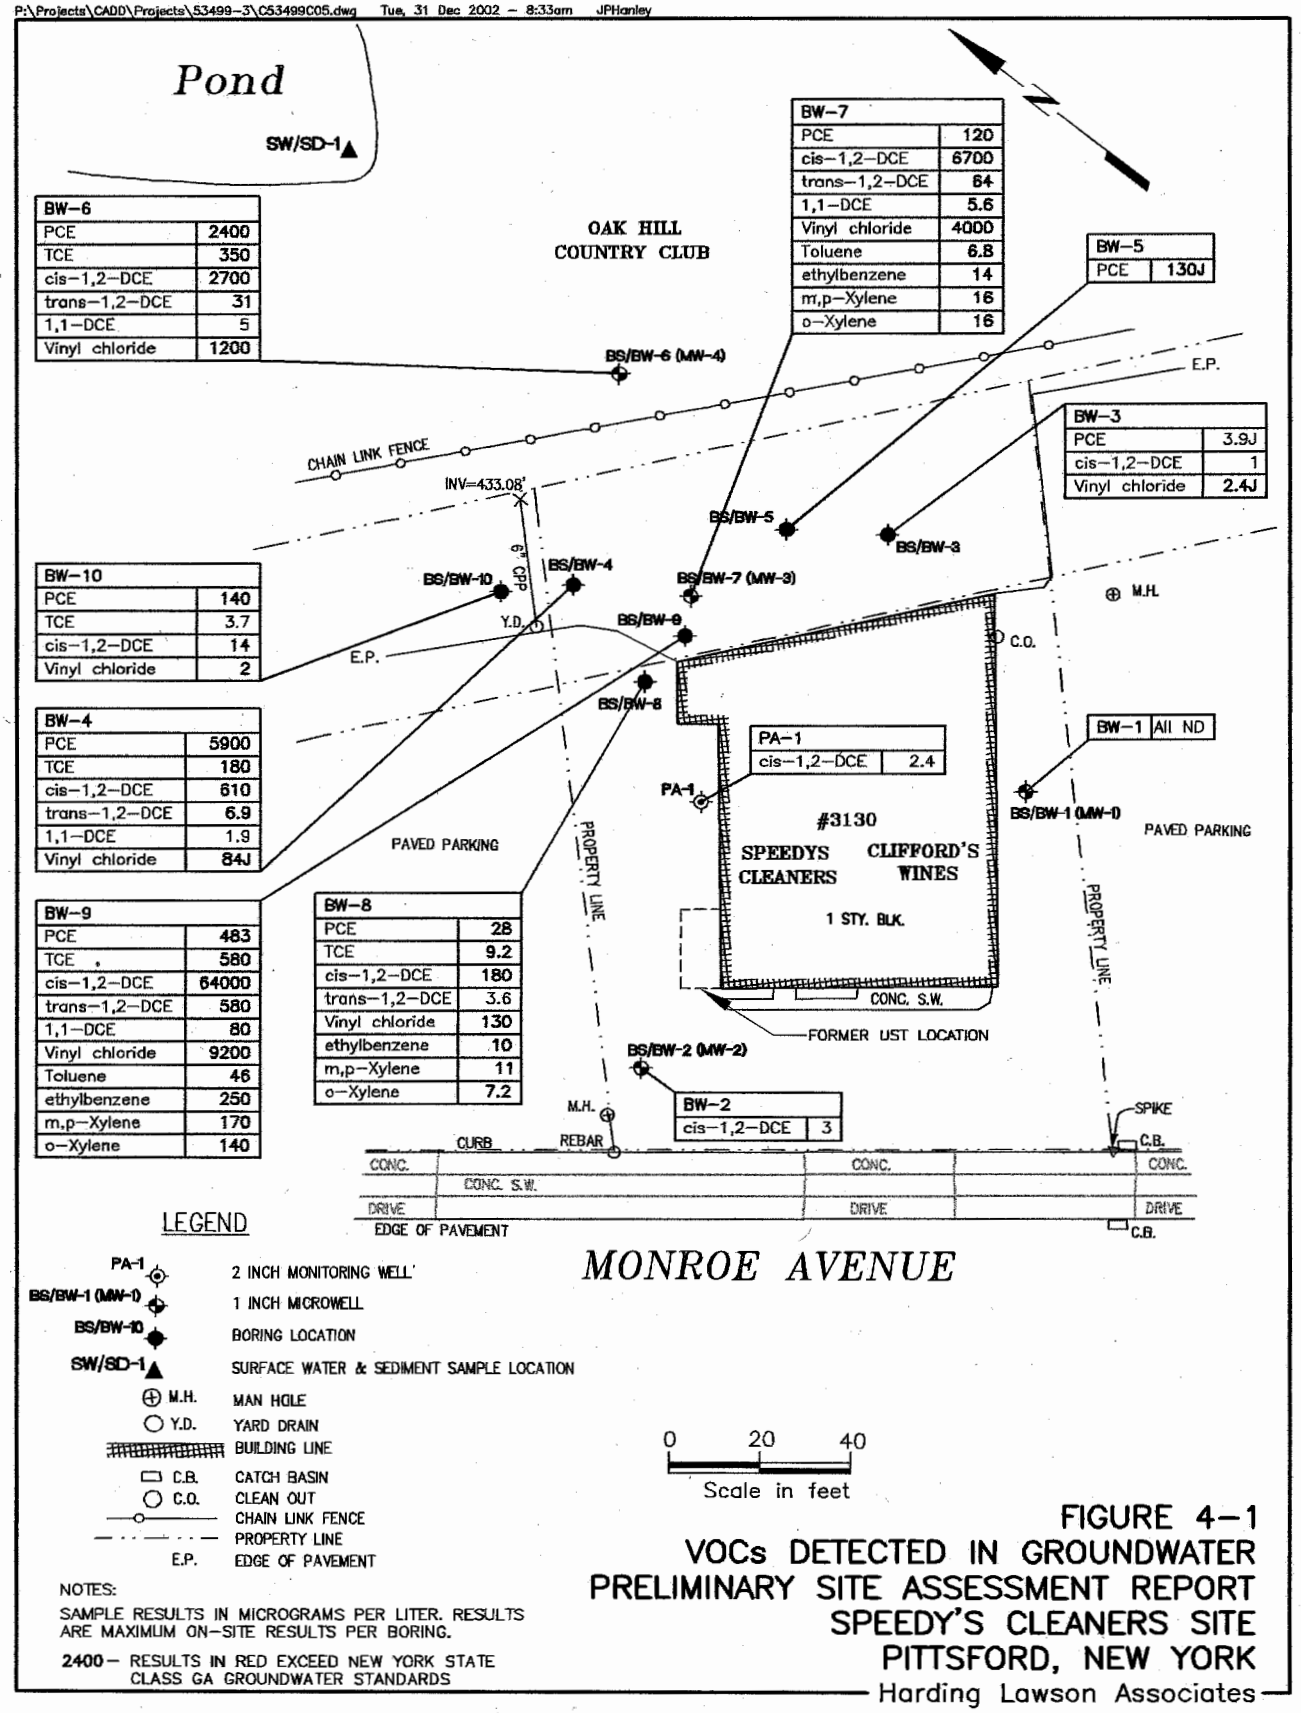
FIGURE 4-1
VOCs DETECTED IN GROUNDWATER
PRELIMINARY SITE ASSESSMENT REPORT
SPEEDY'S CLEANERS SITE
PITTSFORD, NEW YORK

A summary of target VOCs detected in groundwater samples is presented in Table 4-2 and on Figure 4-1. Table 4-2 presents hits only on-site and off-site analytical laboratory results.

PCE was detected in groundwater samples collected from eight of the 10 borings. Concentrations ranged from 3.9 J µg/L (BW-3) to 5900 µg/L (BW-4). Concentrations in samples collected from seven of the borings (BW-4 through BW-10), exceeded the NYS Class GA groundwater standard of 5 µg/L (Figure 4-1).

The highest concentrations of VOCs detected in shallow groundwater occur near the northern corner of the Site building. Contamination in groundwater appears to be migrating off the Site. Six of the analytes detected in the sample collected from boring BW-6, located on the Oak Hill Country Club property, exceeded the NYS Class GA groundwater standards. Results for this sample are listed below:

SAMPLE RESULTS IN MICROGRAMS PER LITER. RESULTS ARE MAXIMUM ON-SITE RESULTS PER BORING.

2400 – RESULTS IN RED EXCEED NEW YORK STATE CLASS GA GROUNDWATER STANDARDS

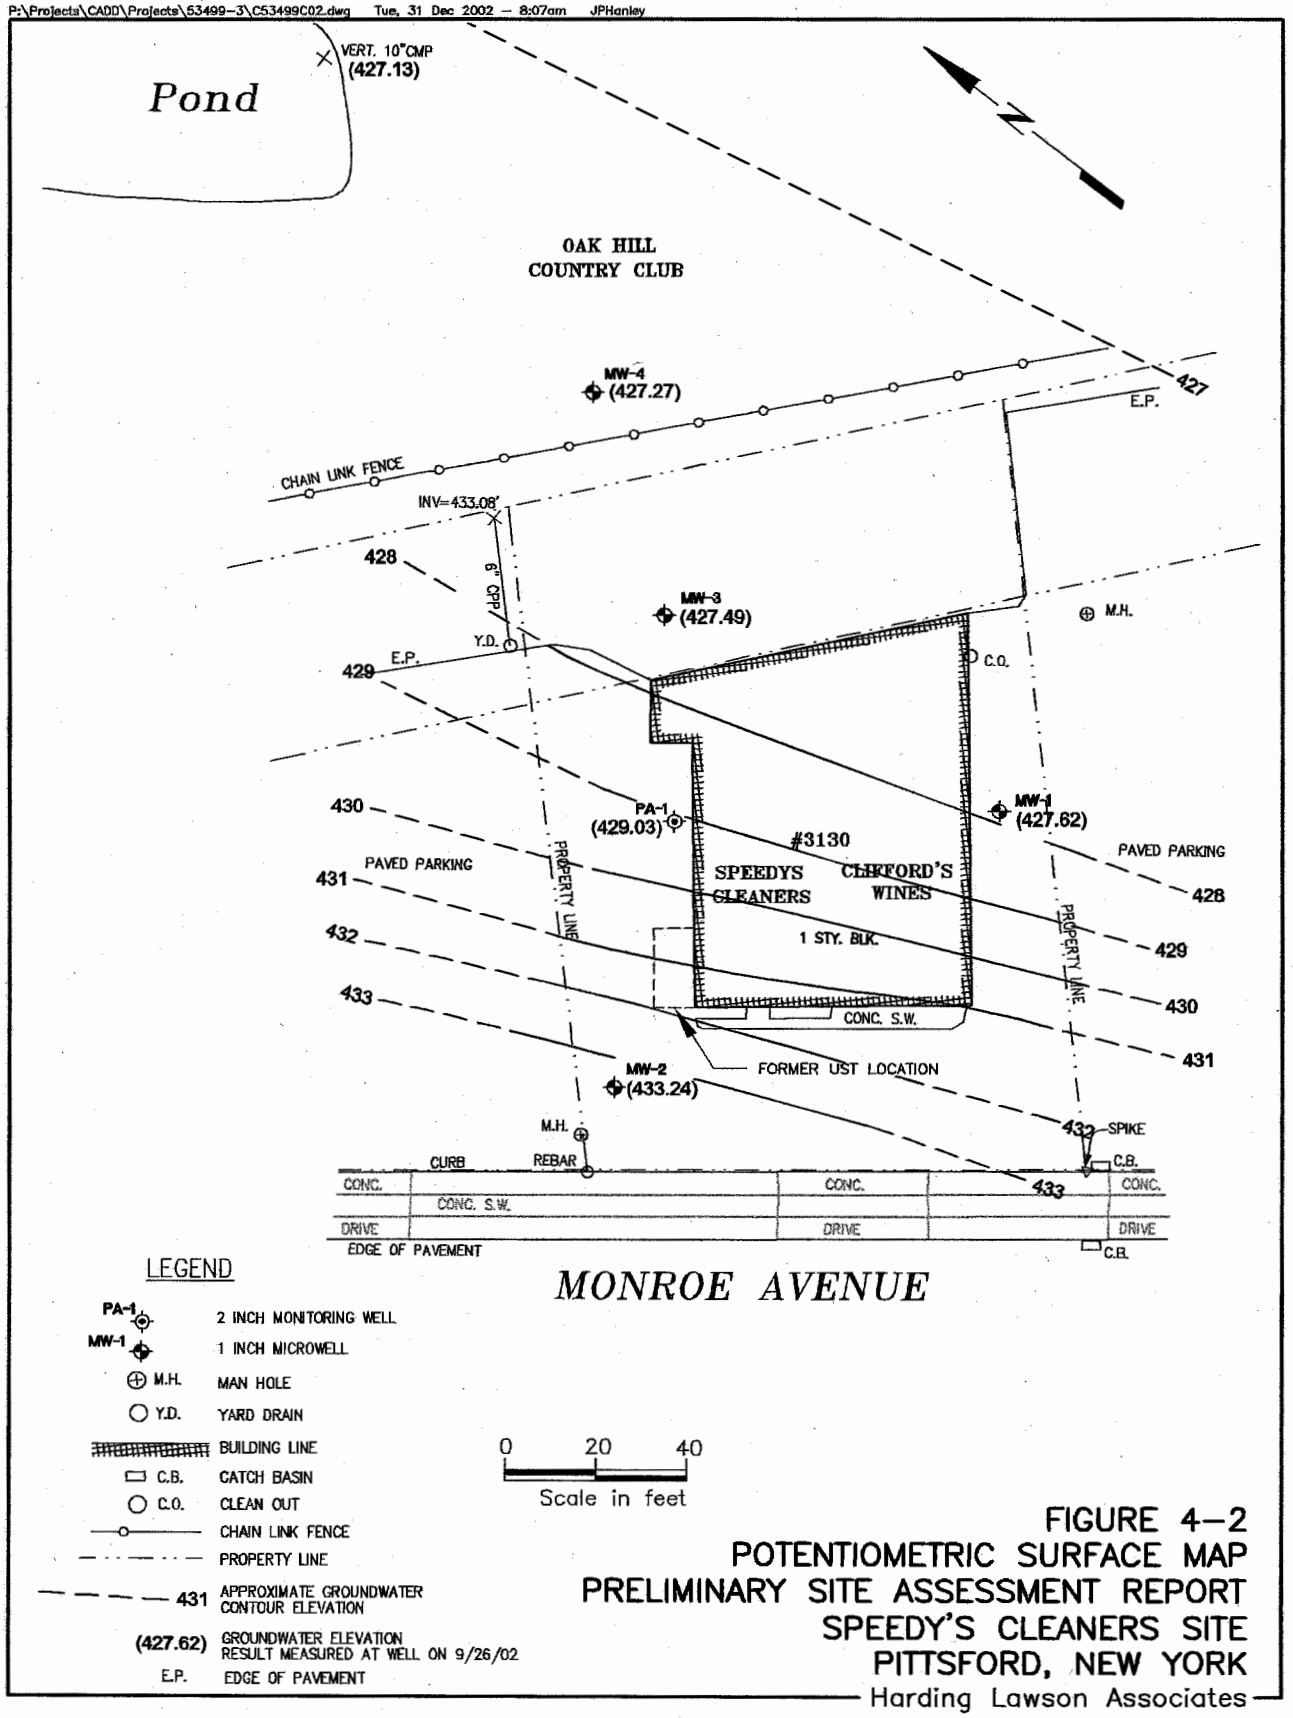
FIGURE 4-2
POTENTIOMETRIC SURFACE MAP
PRELIMINARY SITE ASSESSMENT REPORT
SPEEDY'S CLEANERS SITE
PITTSFORD, NEW YORK
Harding Lawson Associates

Well and pond survey and depth to water measurements from September 26, 2002 were used to create a potentiometric surface map (Figure 4-2). Microwell survey and water elevation data are presented in Table 4-3. To preclude introduction of possibly false high water levels caused by heavy rains during the evening of September 26 and day of September 27, groundwater measurements collected on September 27, 2002 were not used for contouring groundwater data. Measured groundwater elevations on September 26 varied from a high of 433.24 feet above msl southwest of the Site buildings, to a low of 427.13 feet above msl at the golf course pond. Interpreted groundwater surface contours indicate that groundwater flows to the northeast. Because MW-7 was located adjacent to the public sewer lines, groundwater levels in MW-2 may be artificially high due to the presence of localized drainage in the gravel trenches of the utility lines.

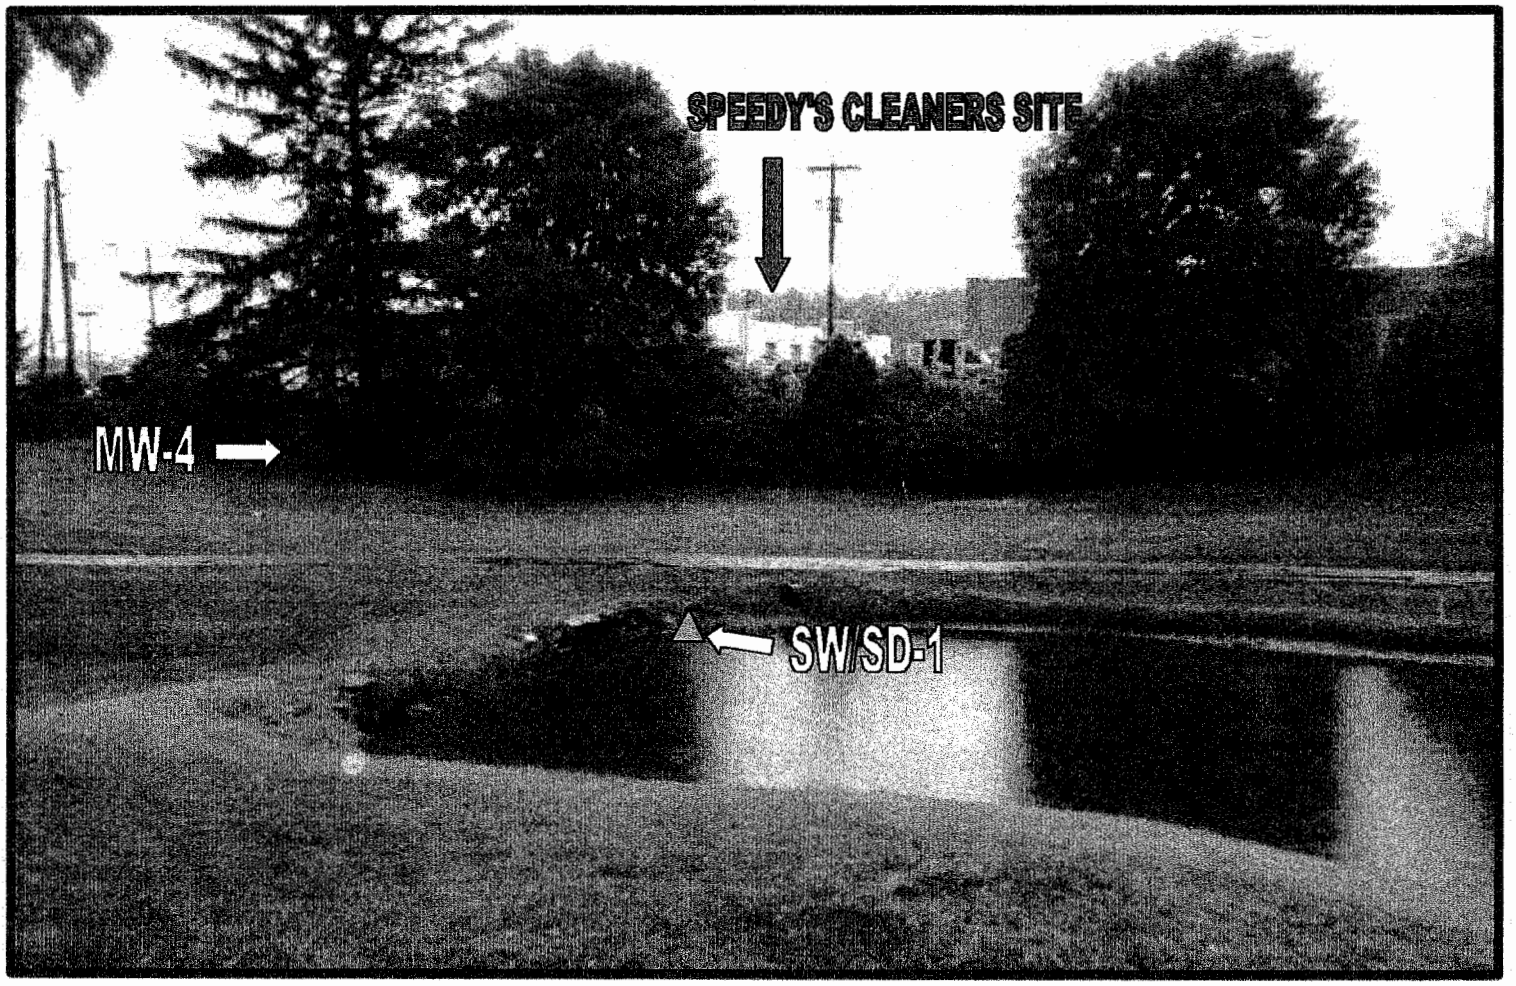
Looking south from small pond on Oak Hill Country Club fairway #13 to Site

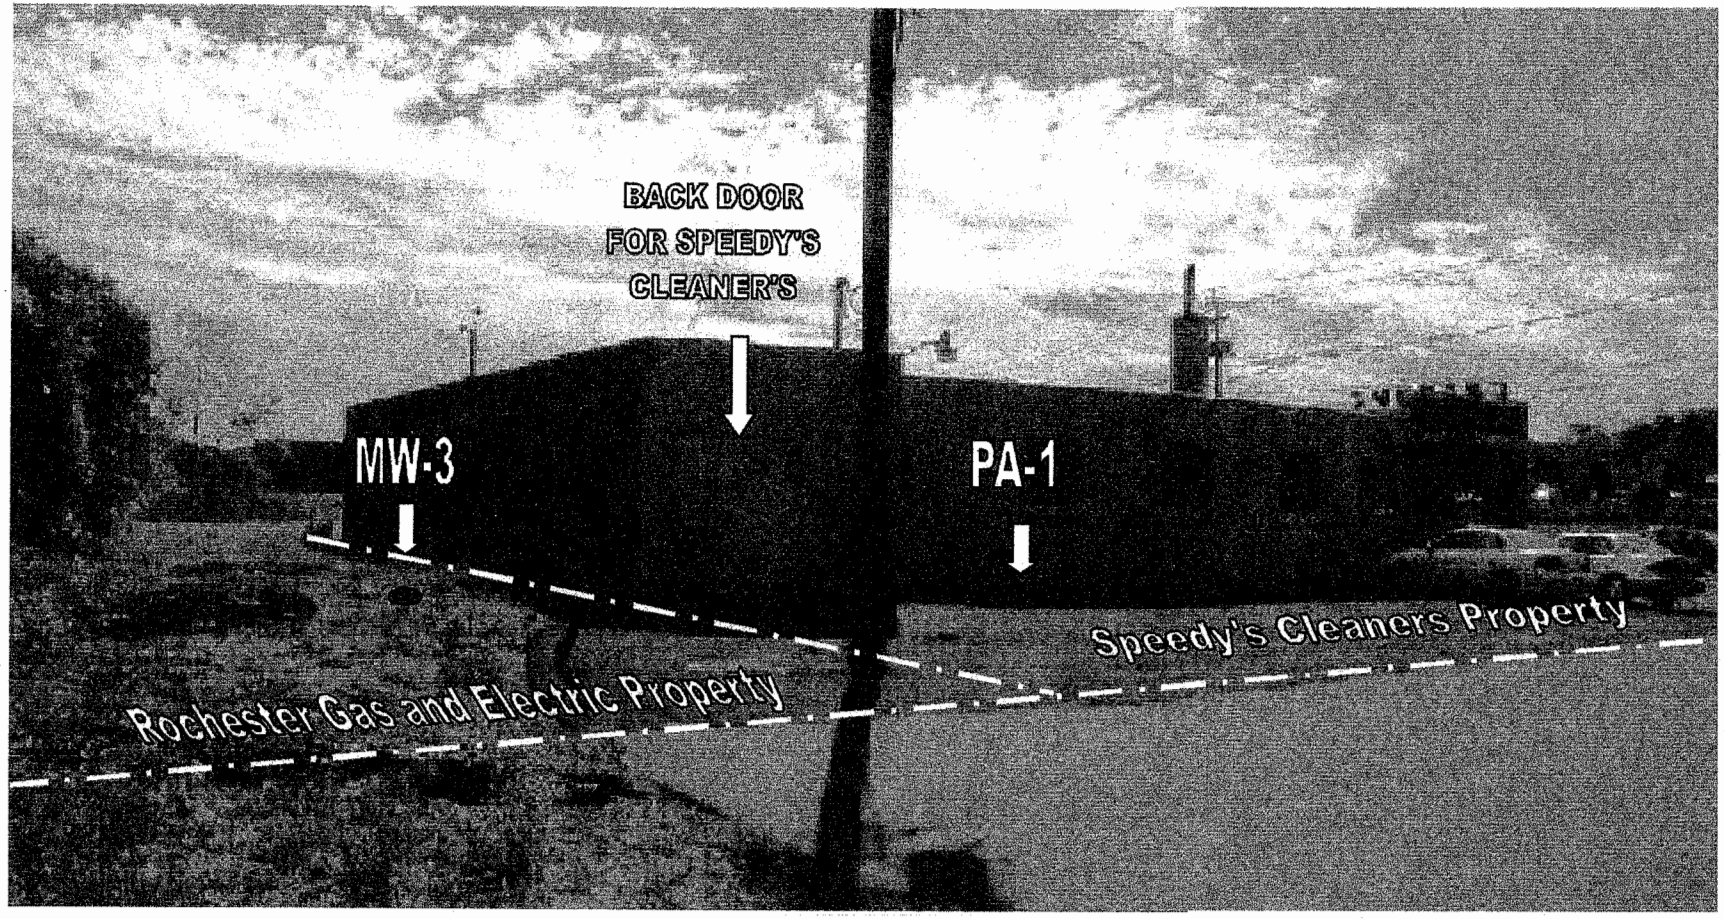
View looking southwest at Site

Approximate property line location
