ACTIVE INDUSTRIAL
UNIFORM SITE
GROUNDWATER
EXTRACTION AND
TREATMENT SYSTEM

Site Management Quarterly Report No. 49

January 1, 2017 through March 31, 2017

D&B Engineers and Architects, P.C.

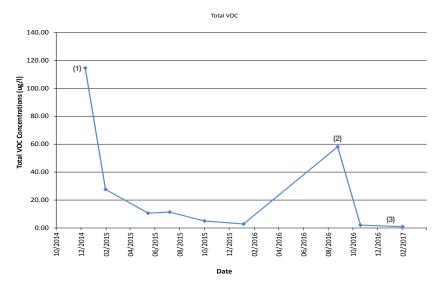
#### **Extraction Well RW-1 Total VOC Concentration Trend Line**

- 1. As previously discussed, the GWE&TS was manually shut down on April 30, 2014 and remained off until November 3, 2014, when it was restarted, as per NYSDEC direction. The GWE&TS remained off during this time due to anomalous elevated contaminant concentrations in aqueous-phase effluent samples, for inspection of a partially blocked discharge pipe and in an effort to achieve static aquifer conditions for the MIP Investigation program.

- 2. The GWE&TS was operating for a brief amount of time throughout the July to September reporting period, as such only one aqueous-phase influent sample was collected from RW-1 for VOC analysis only, in August 2016.

- 3. The GWE&TS was not operating throughout the majority of this reporting period and through the duration of the previous reporting period. As such, aqueous-phase influent samples were not collected throughout these reporting periods. It should be noted that a groundwater sample was collected from extraction well RW-1 for VOC analysis only, as part of the quarterly groundwater sampling conducted on January 31, 2017.
