Re: SSDS Vacuum Monitoring Summary Second Quarter 2020 Bulova Watch Factory Site No. 152139 15 Church Street, Village of Sag Harbor, New York

On behalf of the Watchcase Factory Condominium, Roux Environmental Engineering and Geology, D.P.C. (Roux), is submitting this letter report summarizing the results of the sub-slab depressurization system (SSDS) monitoring activities performed at the Bulova Watch Factory Site No. 152139, 15 Church Street, Village of Sag Harbor, New York (Site) during the Second Quarter of 2020. SSDS monitoring activities were conducted to confirm the system is performing as designed in accordance with the January 27, 2009 Site Management Plan (SMP); the May 7, 2012 SMP Addendum No. 1; the October 2017 SMP Addendum No. 2; and the January 20, 2015 Operation, Maintenance and Monitoring (OM&M) Plan submitted to the New York State Department of Environmental Conservation (NYSDEC). A brief description of SSDS operations and monitoring results during the Second Quarter 2020 reporting period are provided below.

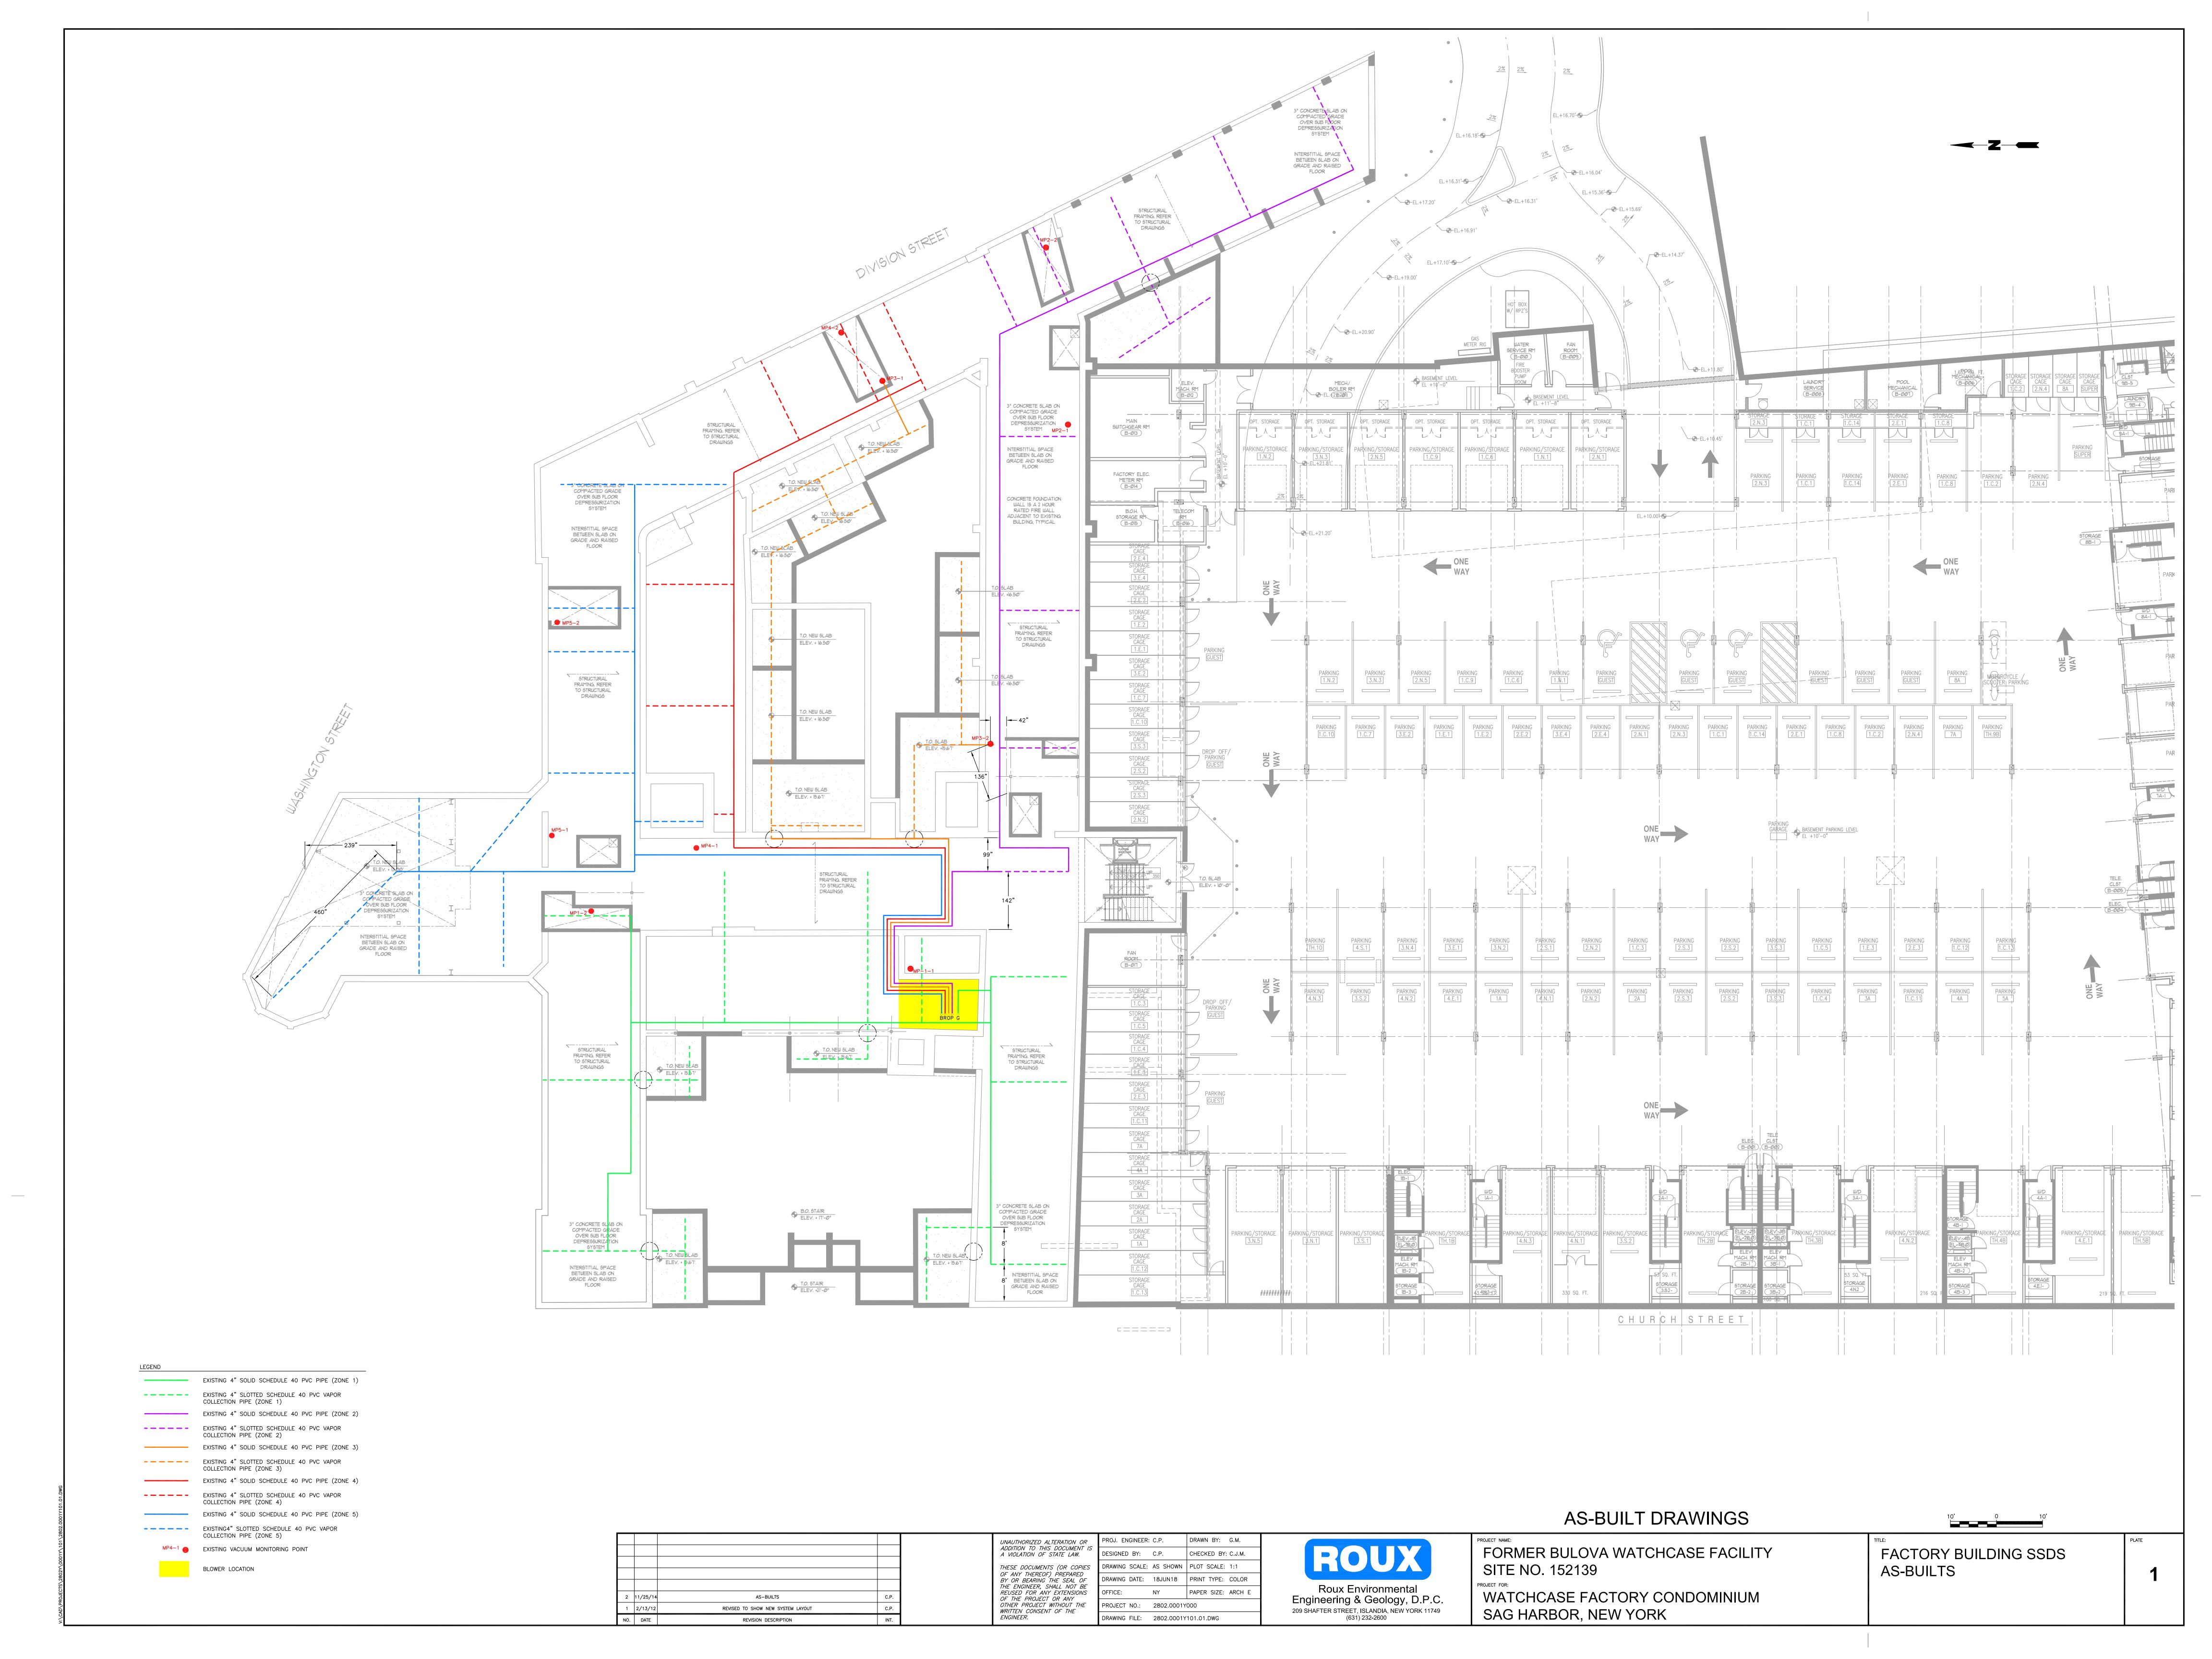
Factory Building SSDS As-Builts

The SSDS consists of a two-blower system in the former factory building (Factory Building SSDS) and a separate one-blower system beneath the garage (Garage SSDS). The Factory Building SSDS consists of five vapor-collection piping legs (zones 1 through 5) beneath the former factory building and two monitoring points associated with each vapor-collection piping leg (MP1-1 through MP5-2). The locations of each piping leg and monitoring point for the Factory Building SSDS are depicted on the asbuilt drawing attached as Plate 1. The Garage SSDS consists of one vapor-collection piping leg beneath the garage with three monitoring points (MP6-1 through MP6-3) and one vapor-collection piping leg around the perimeter of the garage with one monitoring point (MP7-1). The locations of each piping leg and monitoring point for the Garage SSDS are depicted on the as-built drawing attached as Plate 2. Vacuum readings for each piping leg were collected at the SSDS monitoring points.
