ENVIRONMENTAL PRODUCTS & SERVICES OF VERMONT, INC.
SYRACUSE NY DIVISION

November 19, 2008

RE: Tank Closure Report and Environmental Sampling Results
Underground Gasoline and Kerosene Storage Tanks
Store #132
343 West Pulteney Street
Corning, Steuben County, NY 14830
EPSVT Project No. N7208
NYSDEC Spill # 08-08882

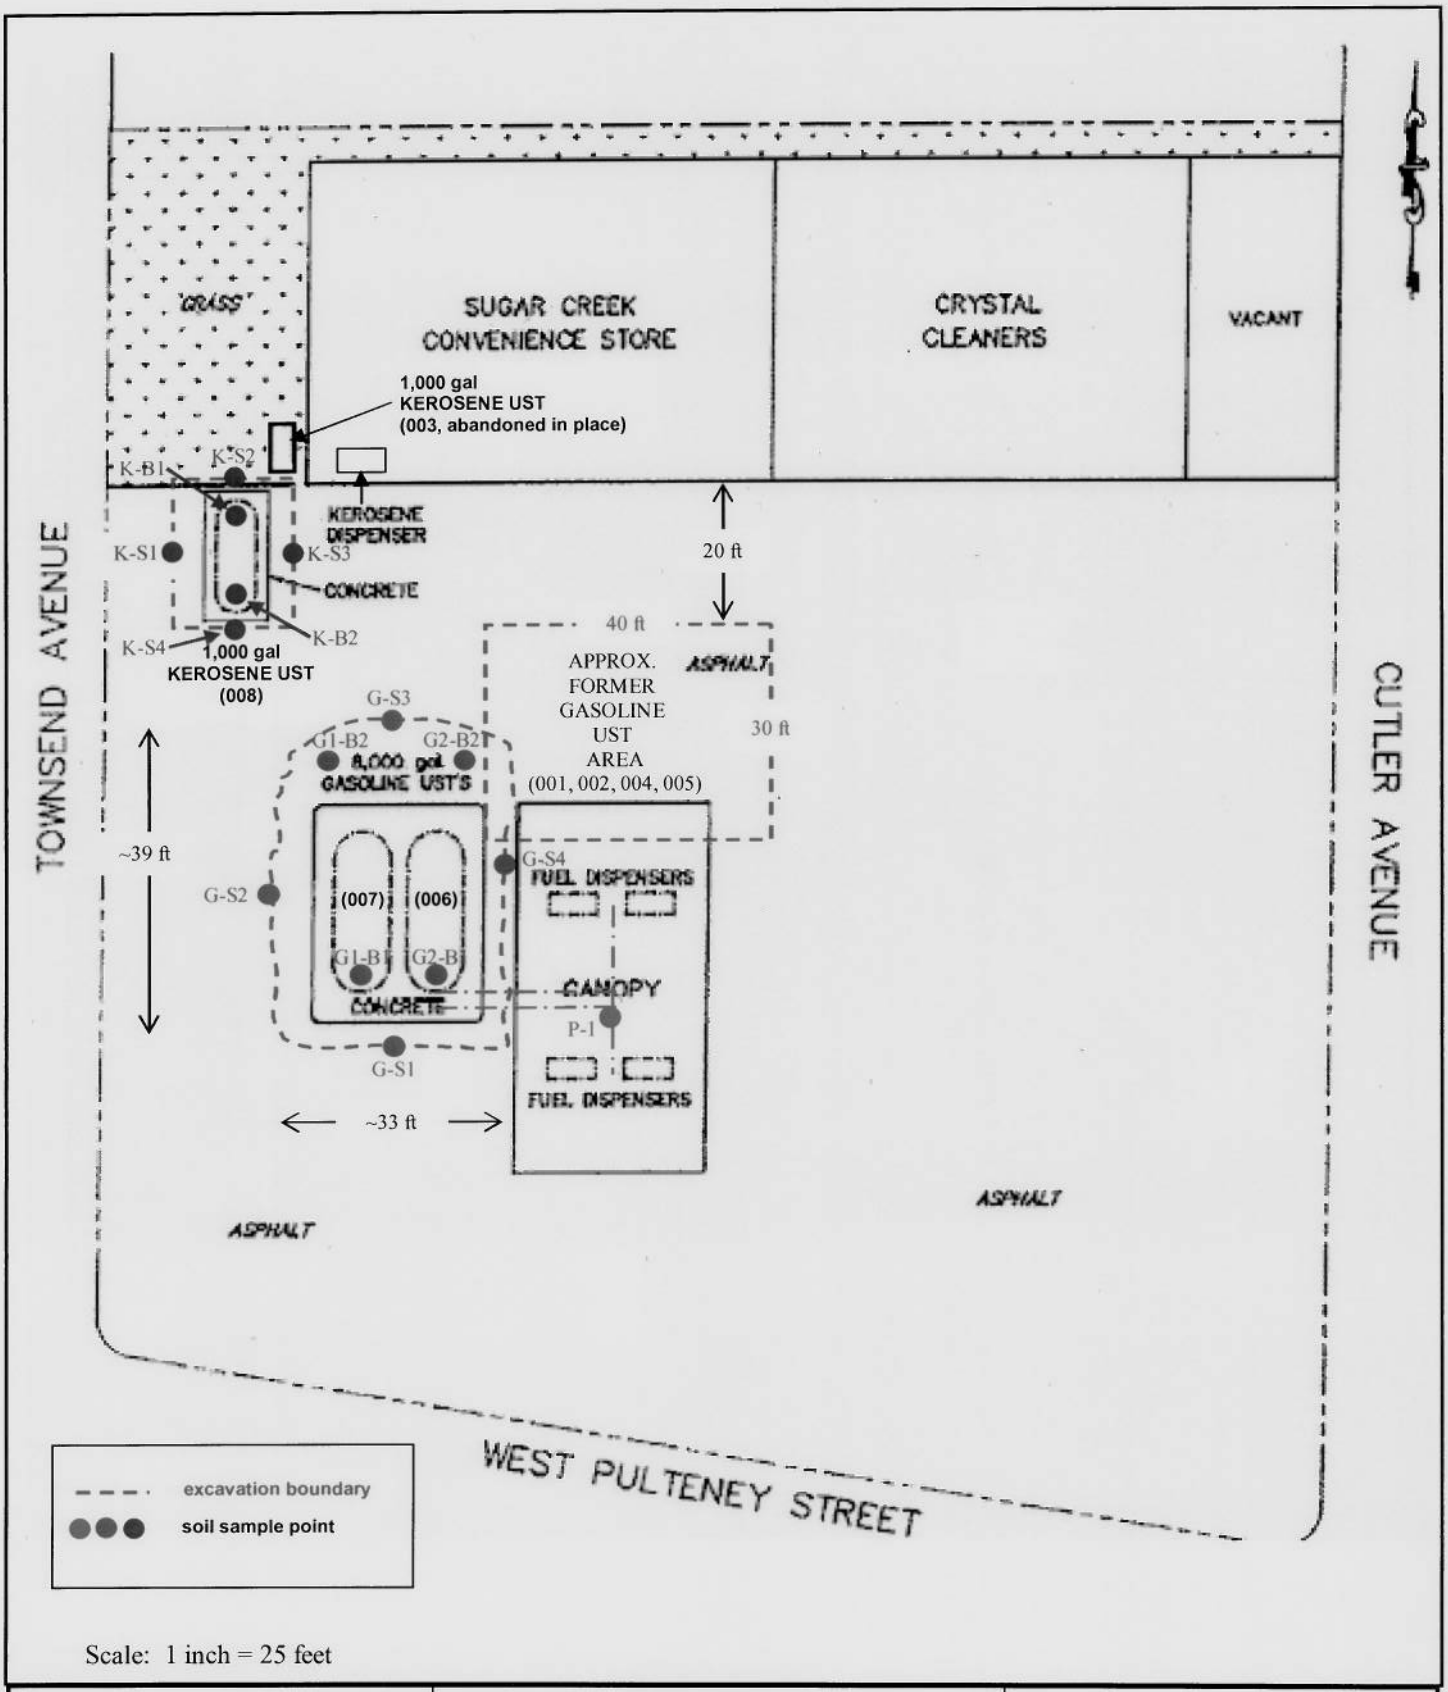
ENVIRONMENTAL PRODUCTS & SERVICES OF VERMONT, INC	**SITE PLAN** **Wilson Farms – Sugar Creek Store #32** **343 West Pulteney** **Corning, Steuben Co., NY**	Project No. N7208 Date: November 2008 Figure No.: 2

In accordance with NYSDEC PBS tank closure requirements, soil samples were collected for laboratory analyses. In the vicinity of the kerosene tank, soil was collected from each sidewall and from the bottom of the excavation at each end of the former tank location. Since the PID readings from the sidewall grab samples were all minimal, NYSDEC allowed the submittal of one composite sample from the grab samples from the four sidewalls. Therefore, one sidewall composite, K-SW, and two bottom samples, K-B1 and K-B2, were submitted for analyses. The samples were transported in a cooler with ice and a proper chain-of-custody to Environmental Laboratory Services in North Syracuse, NY for analyses of volatile organic compounds ("VOCs") and semi-volatile organic compounds ("SVOCs") using EPA Methods 8260 and 8270, respectively. NYSDEC STARS List compounds will be reported from the 8270 analysis. In the case of the VOC analysis, NYSDEC requested the full 8260 list compounds be reported rather than just the STARS List compounds. The approximate sampling locations are shown on **Figure 2**.

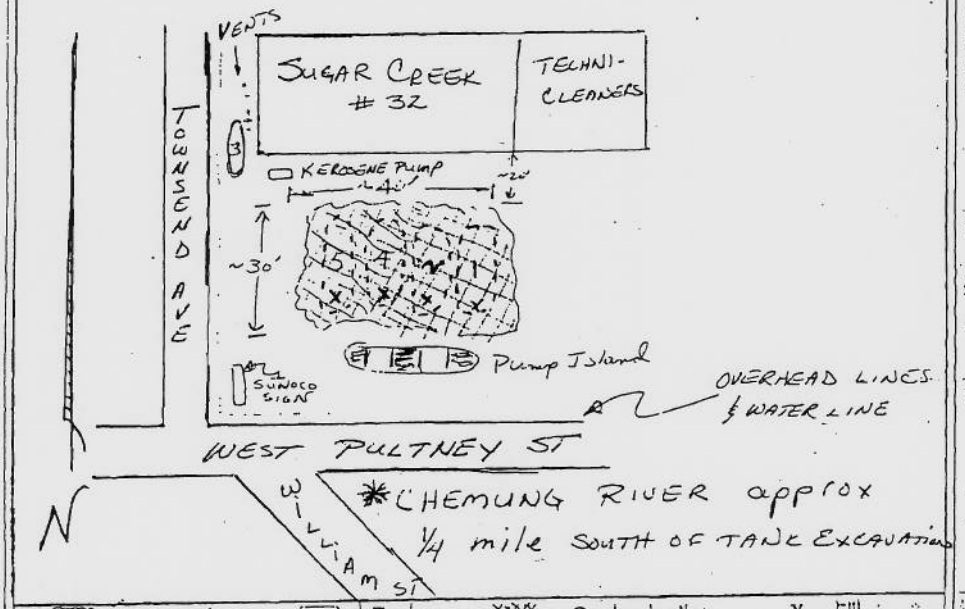
Site Sketch (Diagram not to scale)

Report/Observation : 1245 - Arrive site. Tanks 5 & 4 were already removed. Tanks generally in fair to poor condition. Dug to approximately 12 ft below grade under fill area of tanks. Heavy contamination noted in soil. DTW at 12-13', sheen noted on water. Dug to approx 8 ft below grade at south end of excavation. Grey layer of contaminated soil found to approx 1 ft thick. Further action is needed

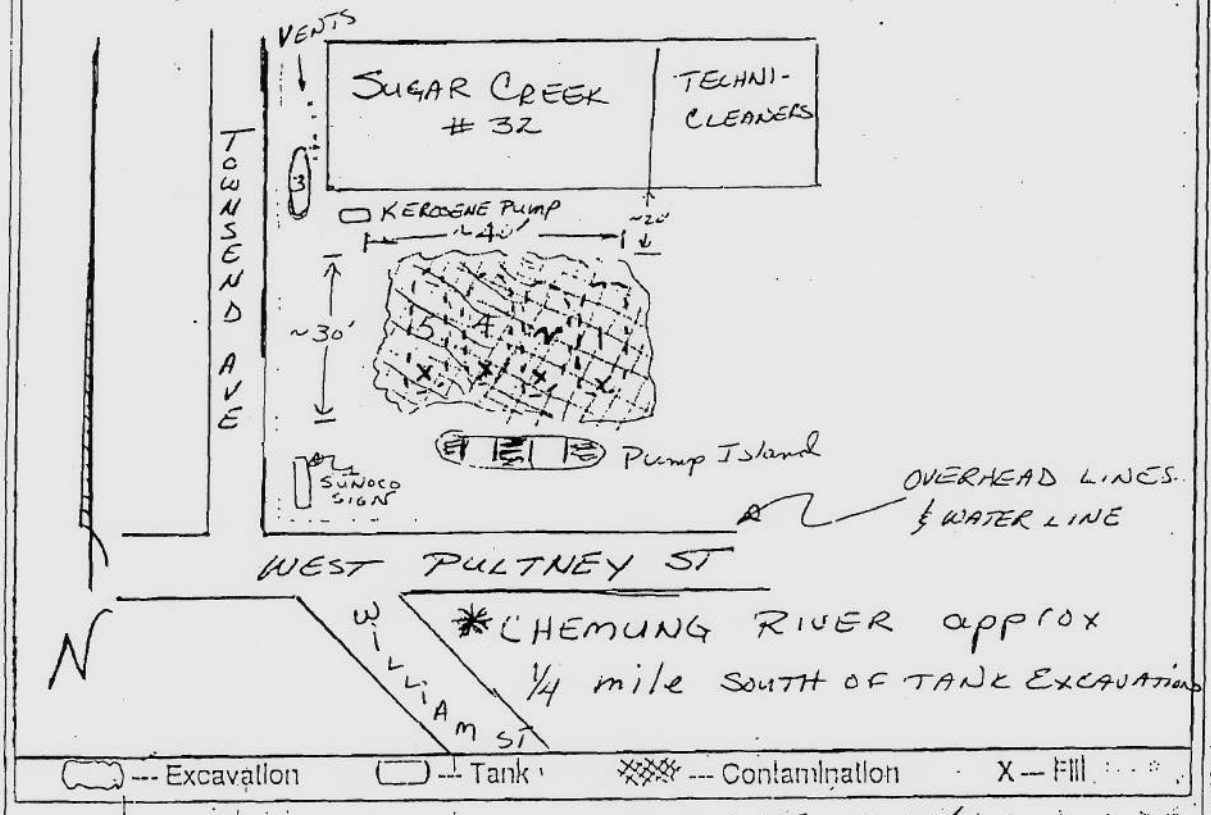
Site Sketch (Diagram not to scale)

Report/Observation : 1245 - Walk on site. Tanks 5 & 4 were already removed. Tanks generally in fair to poor condition. Dug to approximately 12 ft below grade under fill and at tanks. Heavy contamination noted in soil DTW at 12-13', sheen noted on water. Dug to approx 8 ft below grade at south end of excavation. Grey layer of contaminated soil found (approx 1 ft thick) Further action is needed

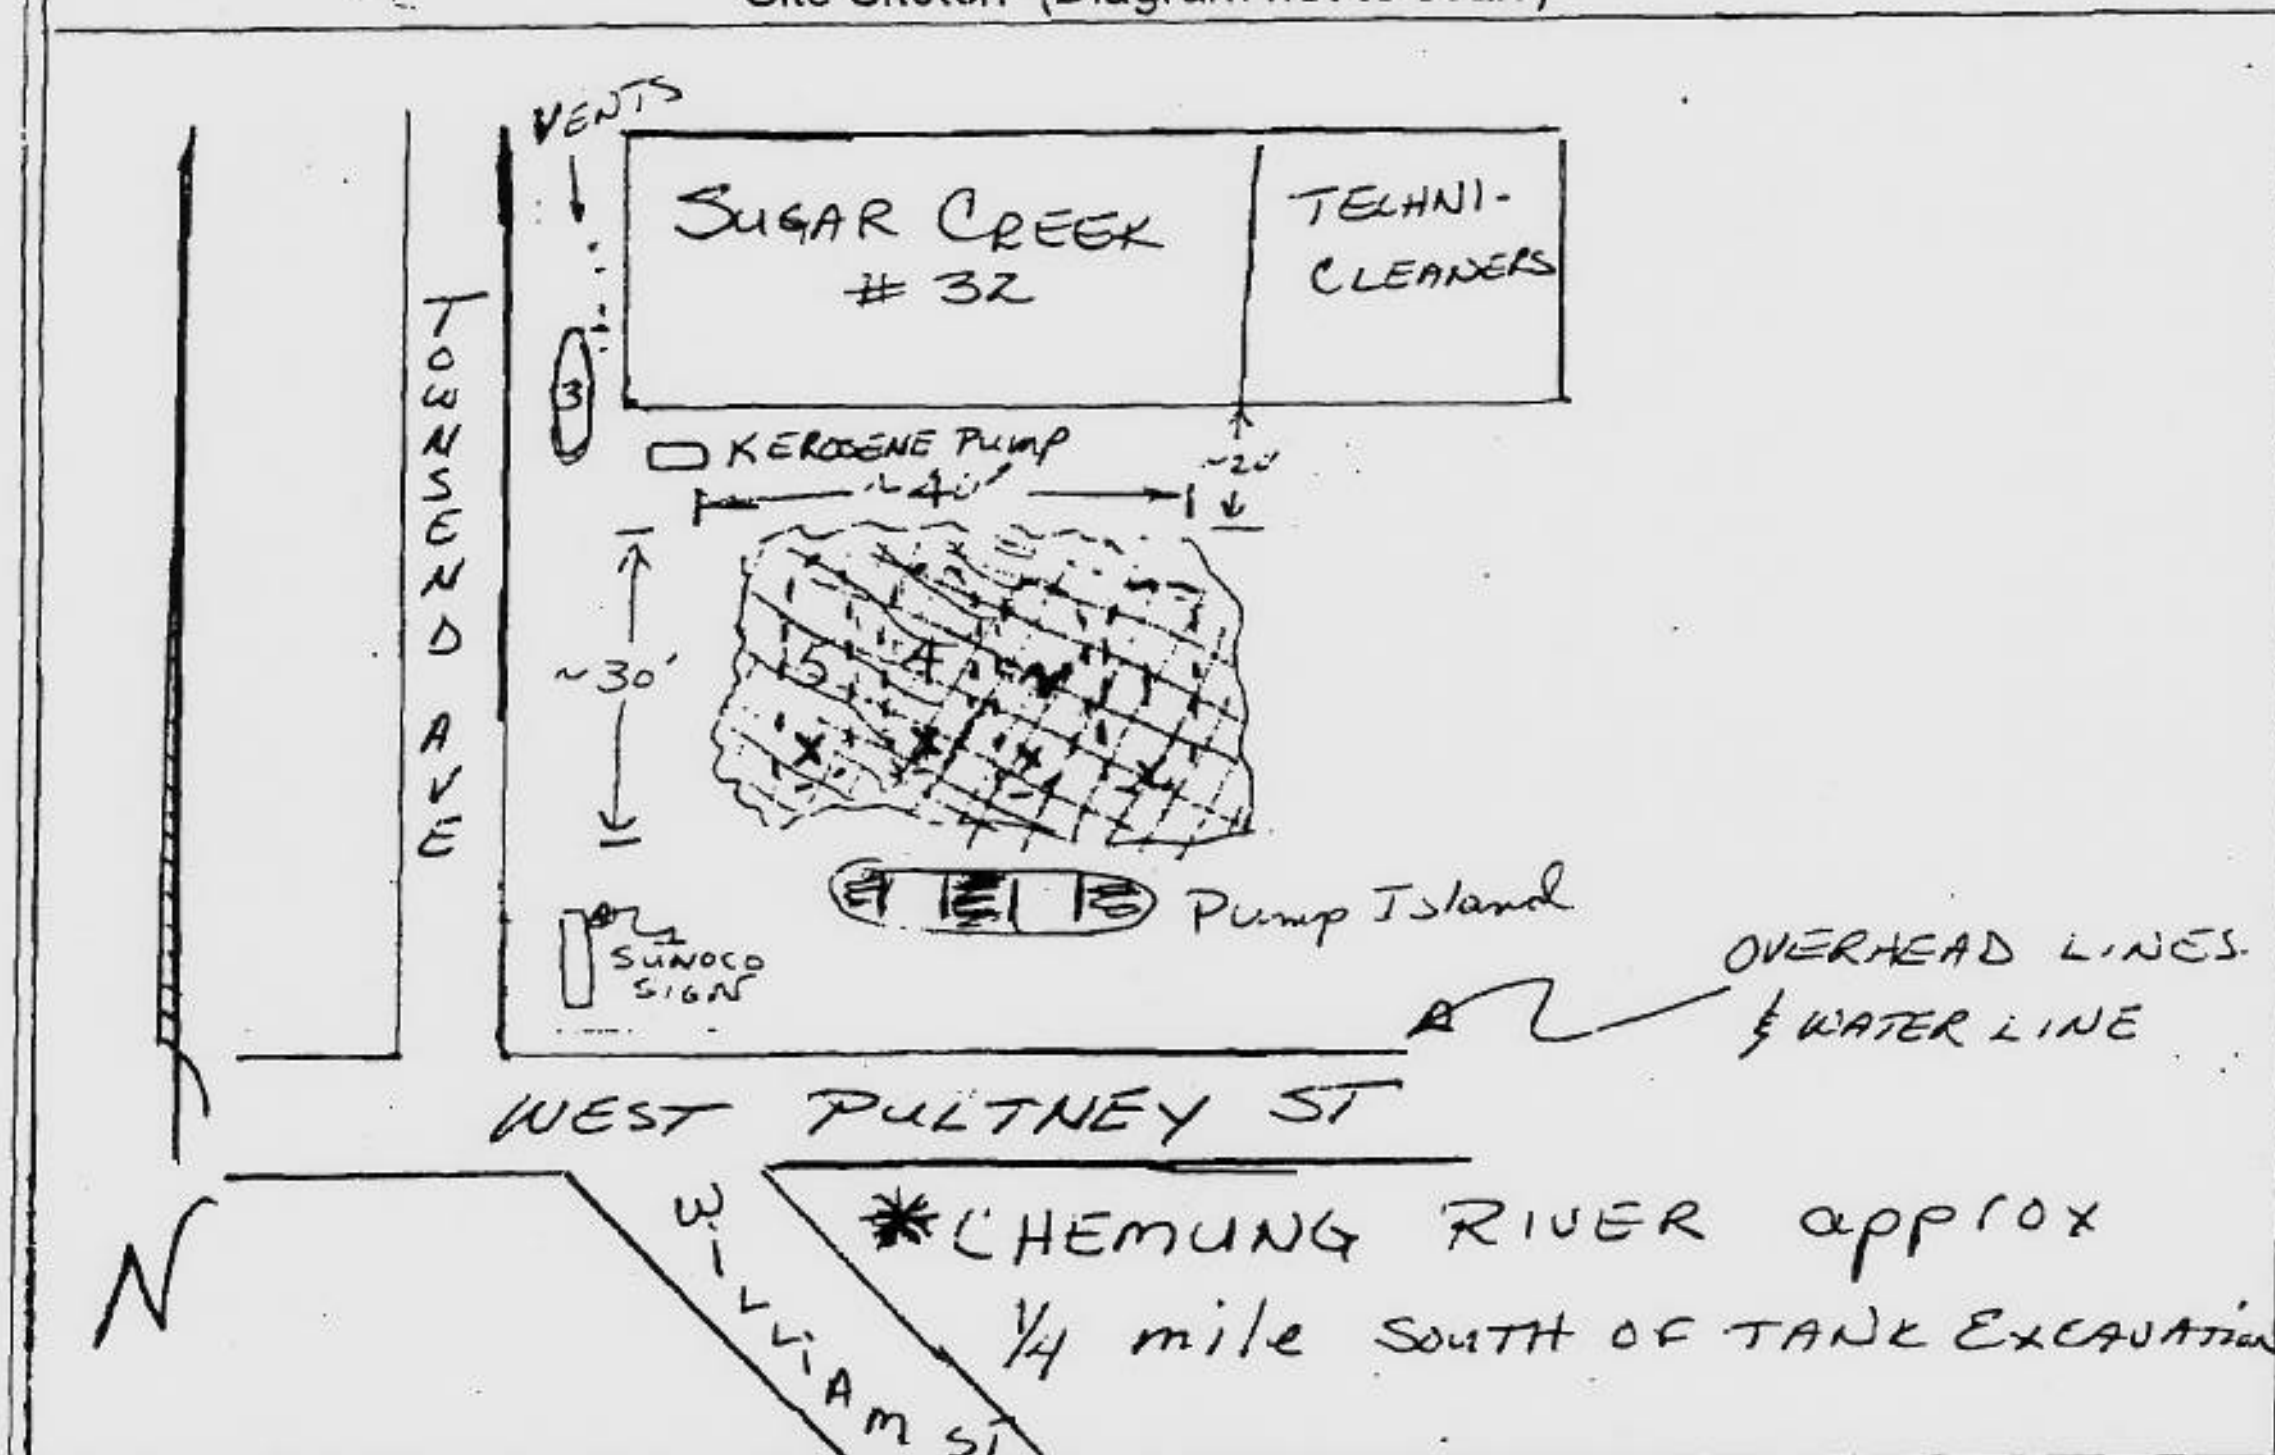
Site Sketch (Diagram not to scale)

Report/Observation: 1245 - Walsh on site. Tanks 5 & 4 were already removed. Tanks generally in fair to poor condition. Dug to approximately 12 ft below grade [illegible]

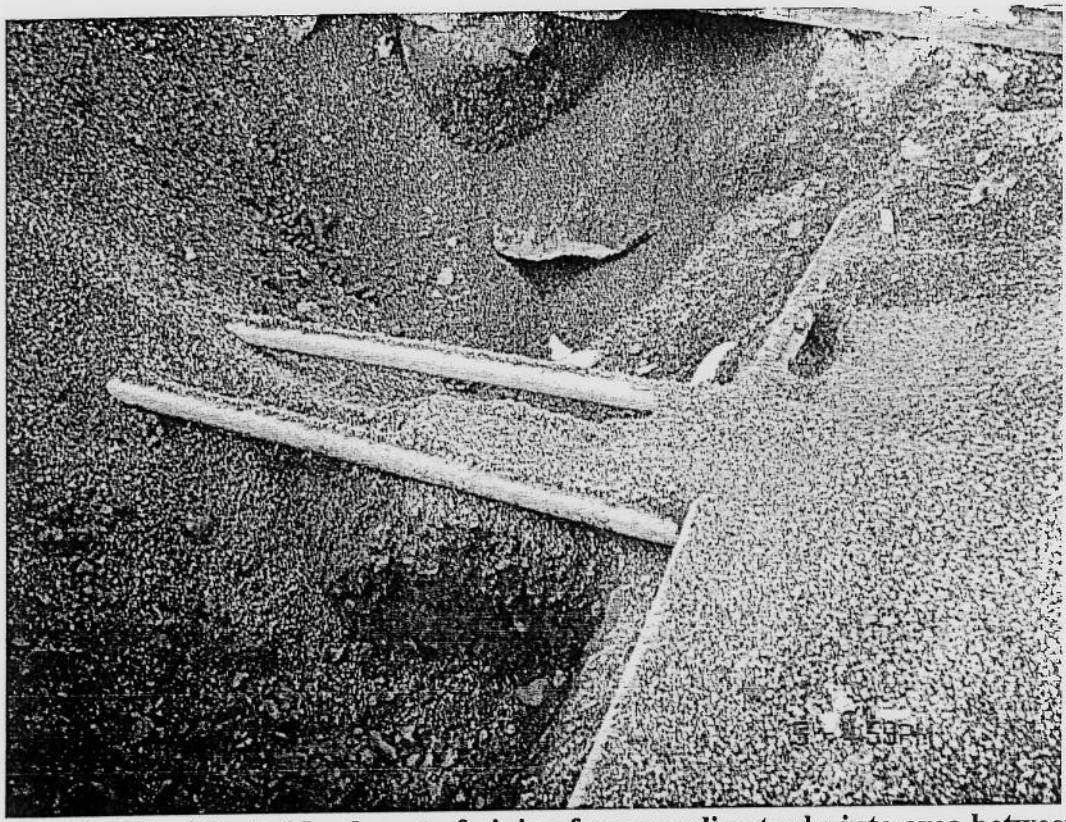
Photo 8: View Northwest of north wall of kerosene tank excavation (south end of abandoned-in-place steel kerosene tank visible).

Photo 9: View North-Northwest of piping from gasoline tanks into area between dispensers. No evidence of contamination along piping.
