CONSTRUCTION COMPLETION REPORT FOR THE INTERIM MEASURE

MINMILT REMEDIAL SITE

EAST FARMINGDALE, NEW YORK

Prepared By: P.W. Grosser Consulting Engineer & Hydrogeologist, P.C.

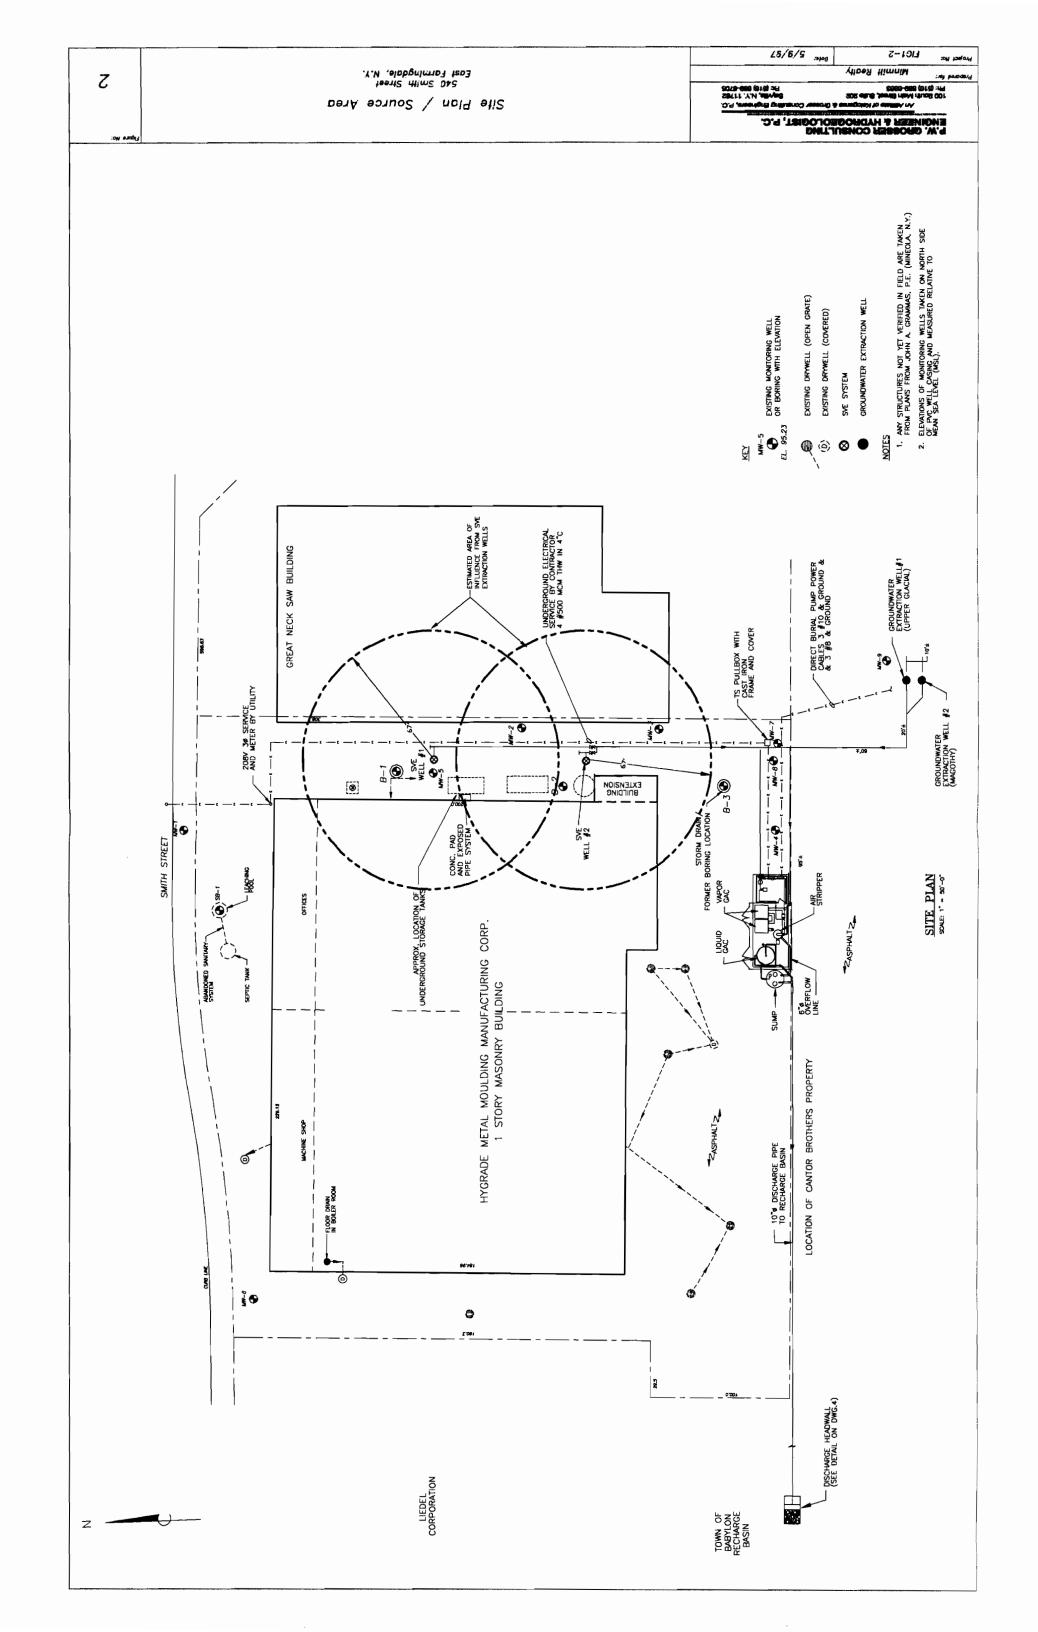
The SVE treatment system consists of two vapor extraction wells set in the source area located on the east side of the building (Figure 2). The contaminated air stream is extracted from the source area and passed through an air/water separator to remove moisture with a vacuum blower. The discharge from the SVE blower combines with the off gas from the air stripper prior to passing through a duct heater. The duct heater reduces the relative humidity of the air stream to less than 50% before it enters the first of two 3,000-pound vapor phase GAC vessels (in series) that remove contaminants prior to discharge to the atmosphere. A process flow diagram detailing the SVE treatment system is depicted in Figure 3.

The groundwater remedial system includes two recovery wells. The shallow recovery well is screened in the Upper Glacial Aquifer and the deep recovery well is screened in the Magothy Aquifer. Groundwater extracted from these recovery wells is pumped to the top of a packed column air stripper tower (influent), allowing it to flow downward through the packing media while air is forced upward through the column. The treated water (effluent) then flows by gravity to a sump, and then pumped through a 14,000-pound liquid phase GAC polishing unit. The effluent is then discharged to the Town of Babylon recharge basin located adjacent to the site. A process flow diagram detailing the flow path of the groundwater recovery treatment system is depicted in Figure 3.
