PEROIDIC REVIEW REPORT
FEBRUARY 1, 2015 THROUGH JANUARY 31, 2016

STRIPPIT, INC.
AKRON, NEW YORK
NYSDEC SITE NUMBER: 915053

Prepared by:	Day Environmental, Inc. 1563 Lyell Avenue Rochester, New York 14606
Prepared for:	Strippit, Inc. 12975 Clarence Center Road Akron, New York 14001
Date:	February 2016
Project No.:	5204R-16

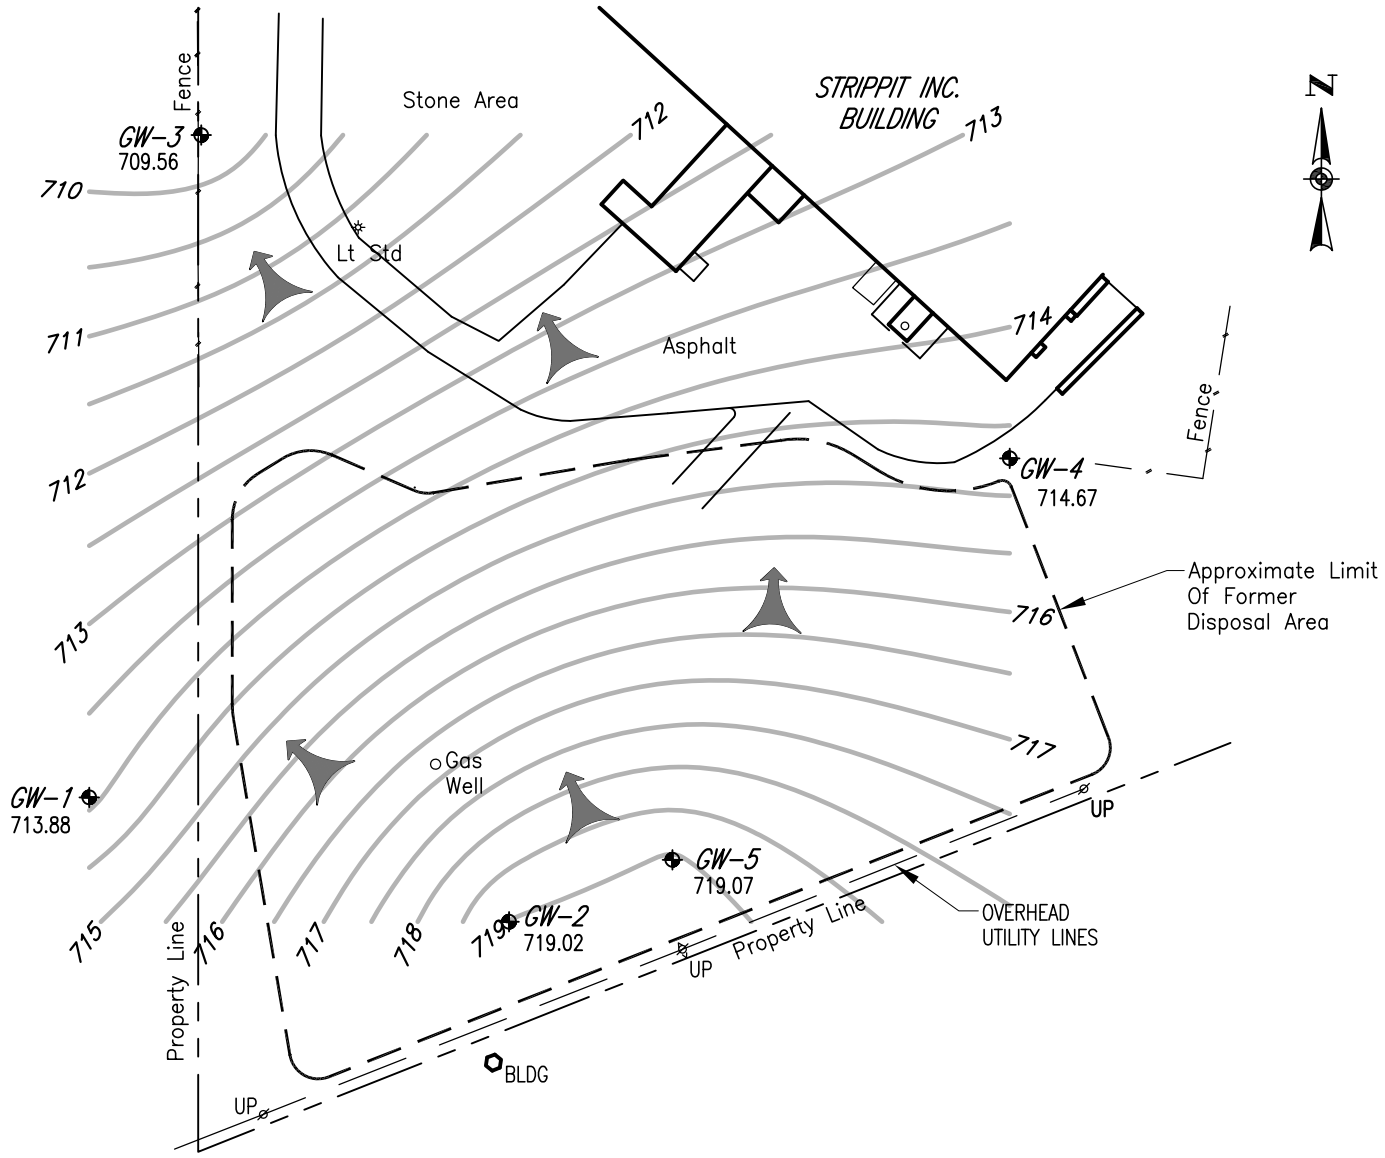
Groundwater contour maps, developed based upon the groundwater elevations calculated using the measurements obtained during the July 15, 2015 and the January 27, 2016 monitoring events, are included as Figure 3 and Figure 4 (respectively). As shown, despite the seasonal variation in groundwater elevation as summarized above, groundwater flow is generally to the north-northwest.

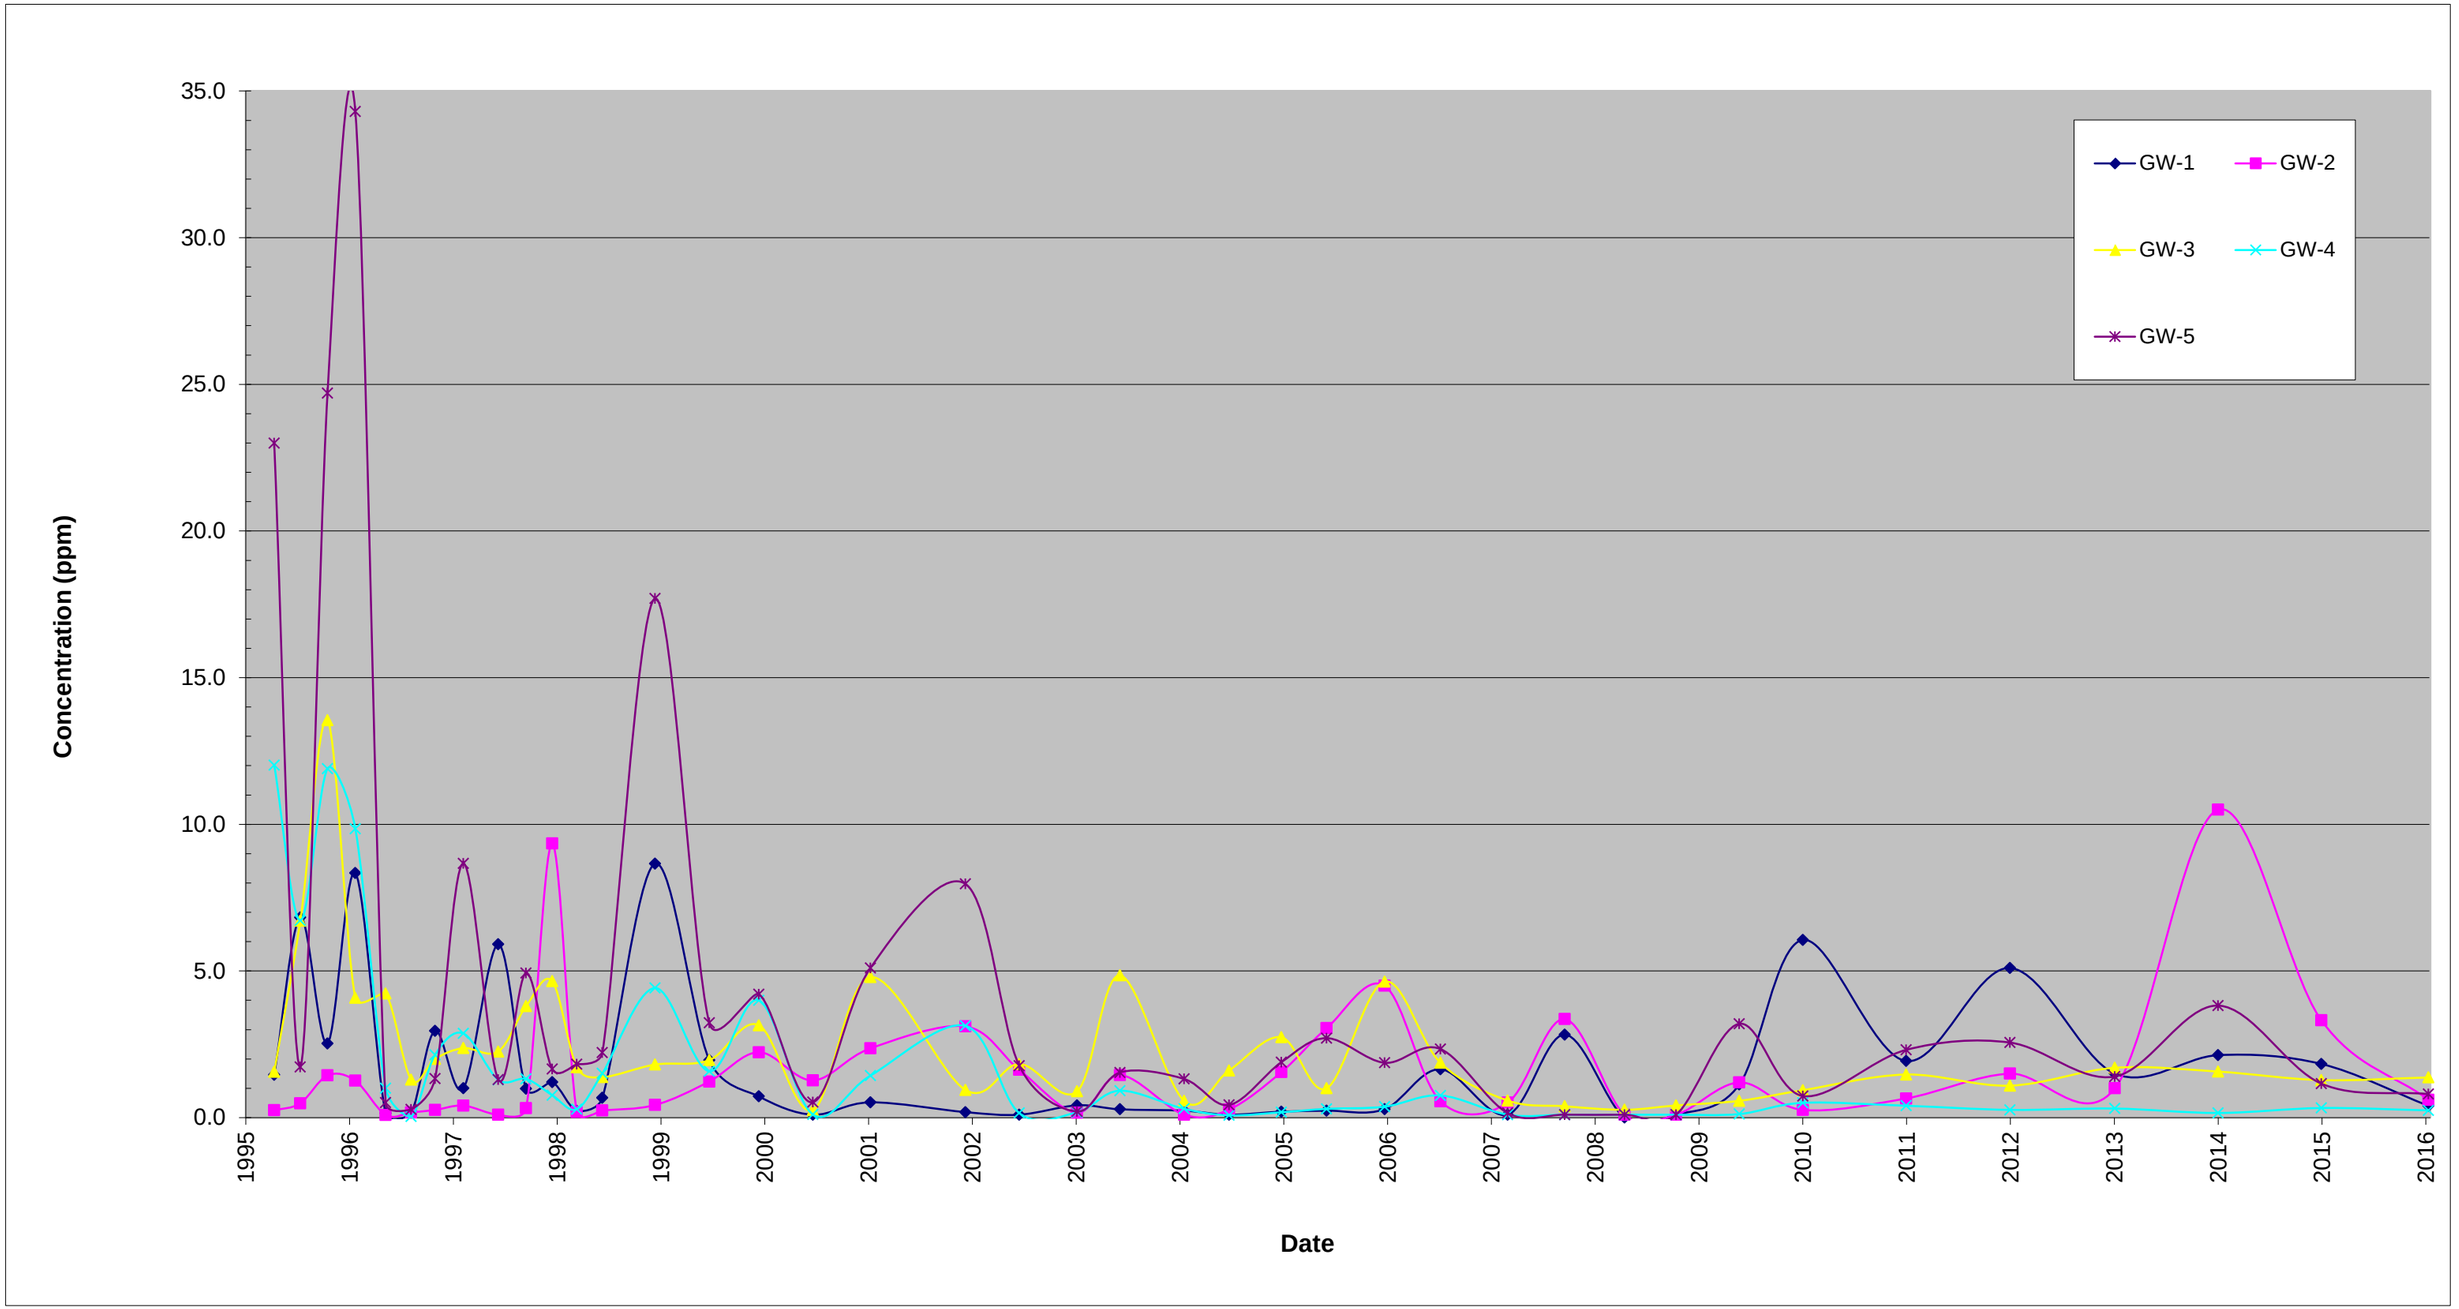
Figure 6

As indicated by Figure 6, the concentrations of total iron detected in samples collected from monitoring wells GW-3 through GW-5 during the reporting period are generally consistent with historic concentrations. However, the total iron concentrations measured in samples collected from monitoring wells GW-1 and GW-2 were less than those measured during the preceding three reporting periods. For example, the total iron concentration measured in the sample collected from monitoring well GW-1 on January 27, 2016 was 0.401 mg/l compared to total iron concentrations of 1.5 mg/l, 2.13 mg/l and 1.83 mg/l measured in 2013, 2014 and 2015, respectively. Historically, the concentrations of total iron measured in samples from groundwater monitoring wells GW-1 through GW-5 fluctuate with no apparent trend evident. The historic concentrations of total iron measured in samples from groundwater monitoring wells GW-1 through GW-5 often exceed the TOGS standard of 0.3 mg/l.

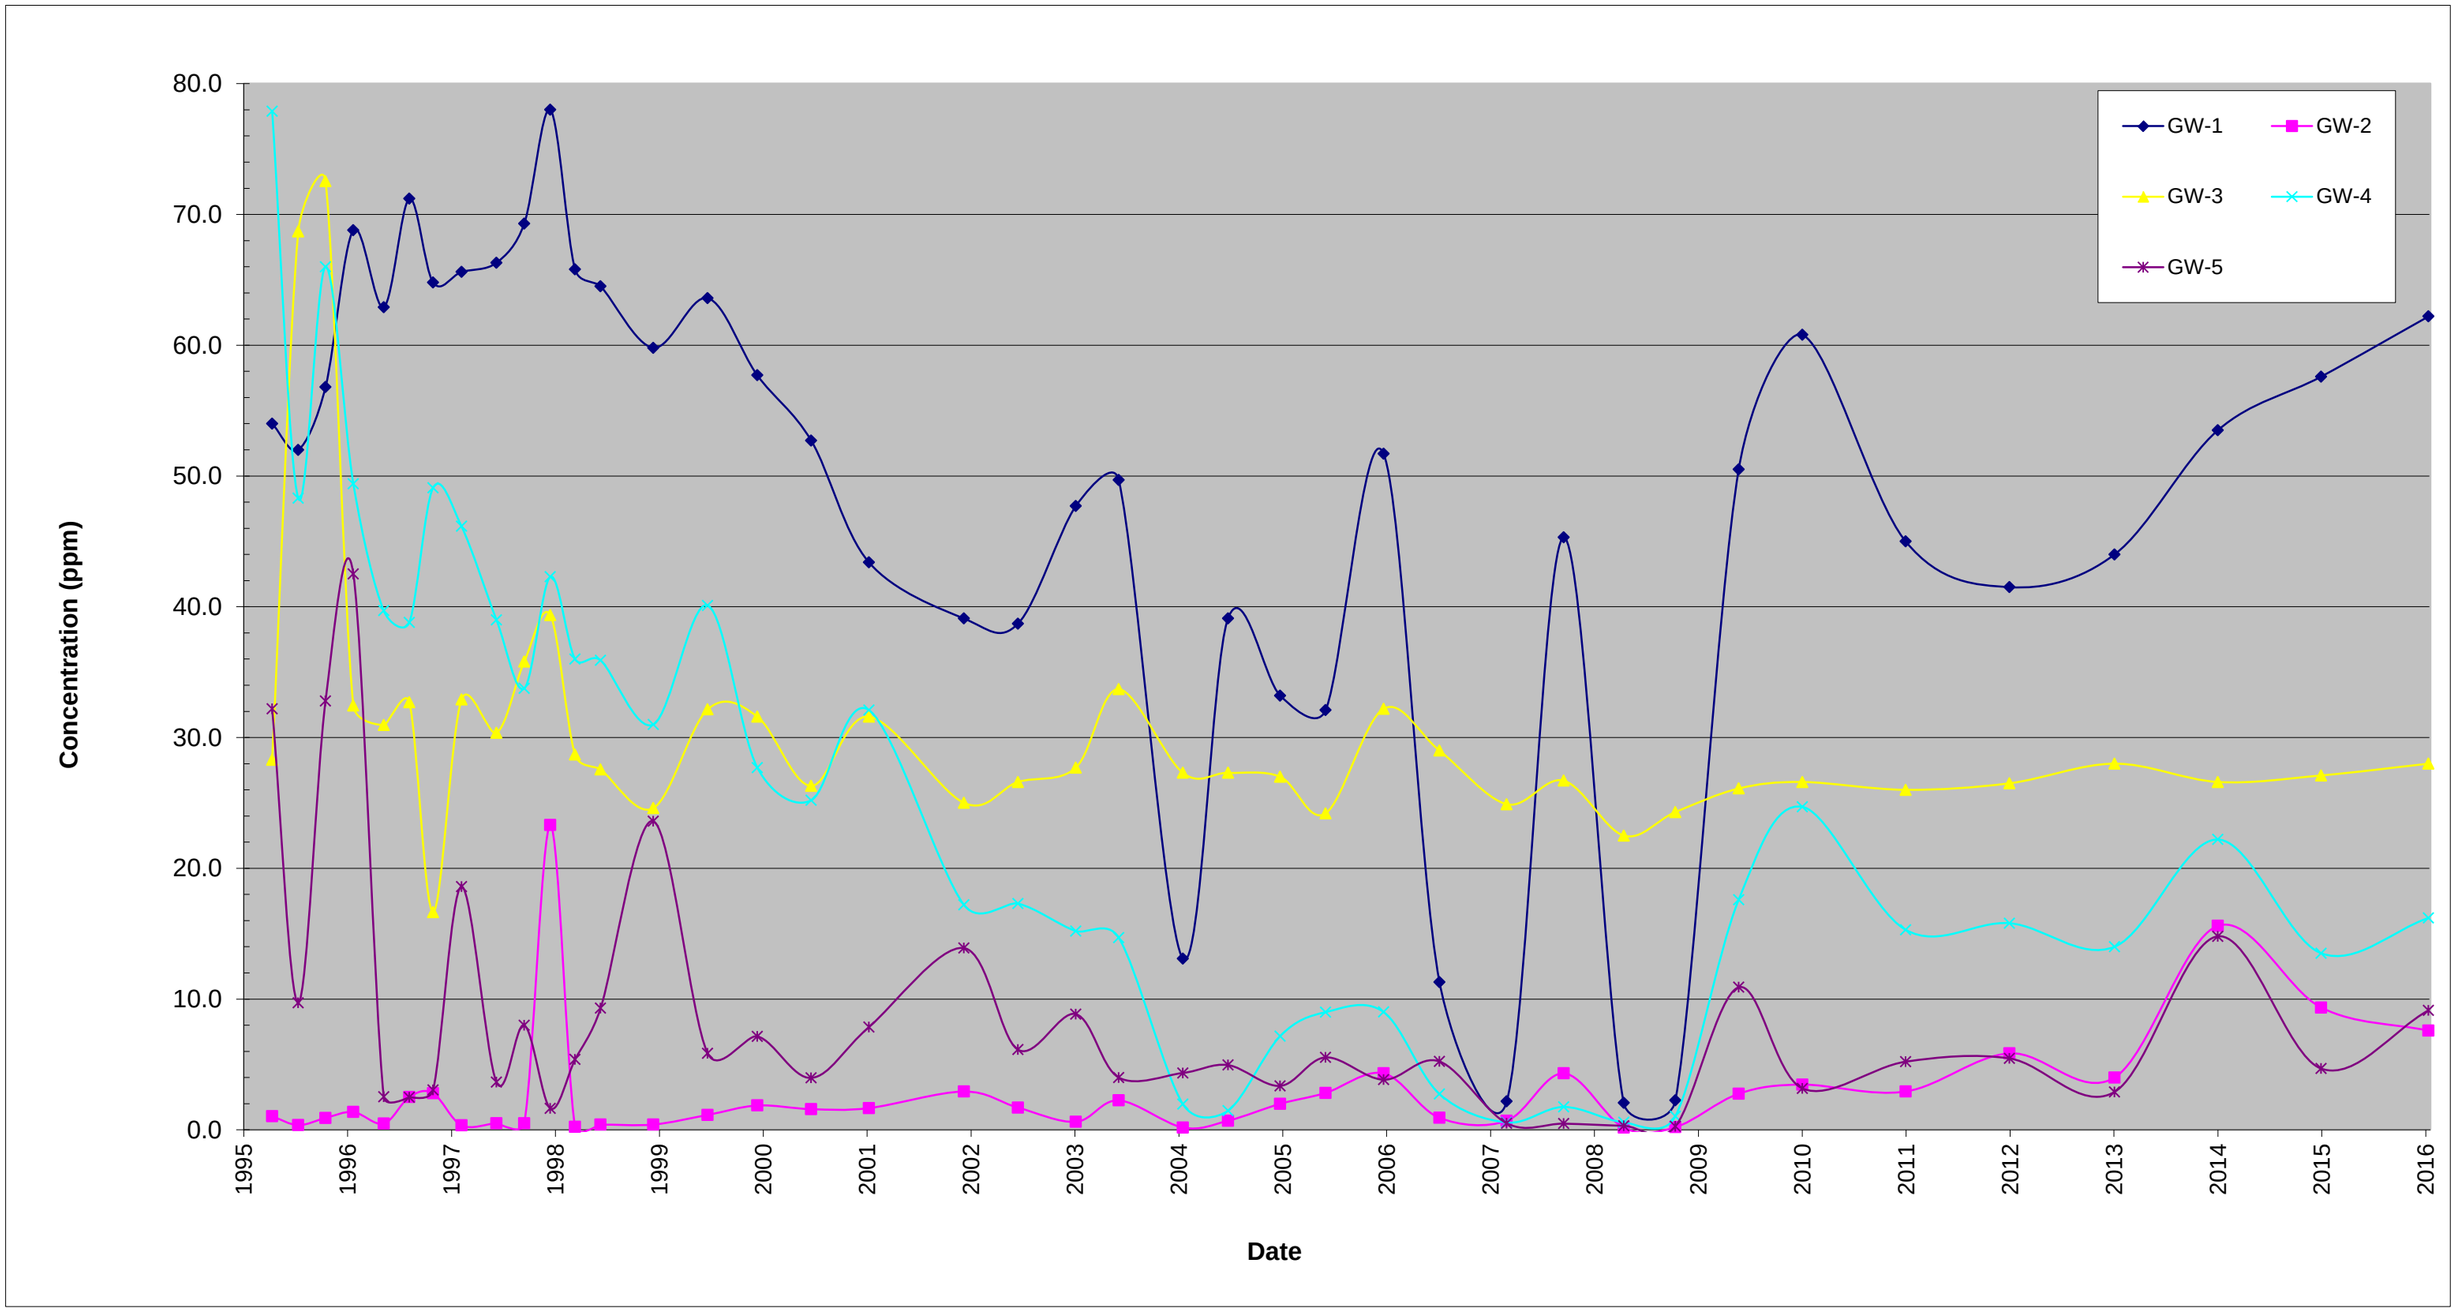
Figure 7

The concentrations of total magnesium detected in samples collected from monitoring wells GW-1 through GW-5 during the reporting period are generally consistent with historic concentrations (refer to Figure 7). Although the magnesium concentrations are variable, with the possible exception of GW-1, concentrations have generally decreased with time. The highest magnesium concentrations have consistently been detected in samples collected from downgradient monitoring wells GW-1 (i.e., generally samples collected from this location contained the highest magnesium concentrations), GW-3 and GW-4. The magnesium concentrations in upgradient monitoring wells GW-2 and GW-5 have historically been lower than those detected in the downgradient monitoring wells. With the exception of the total magnesium concentration measured in the sample collected

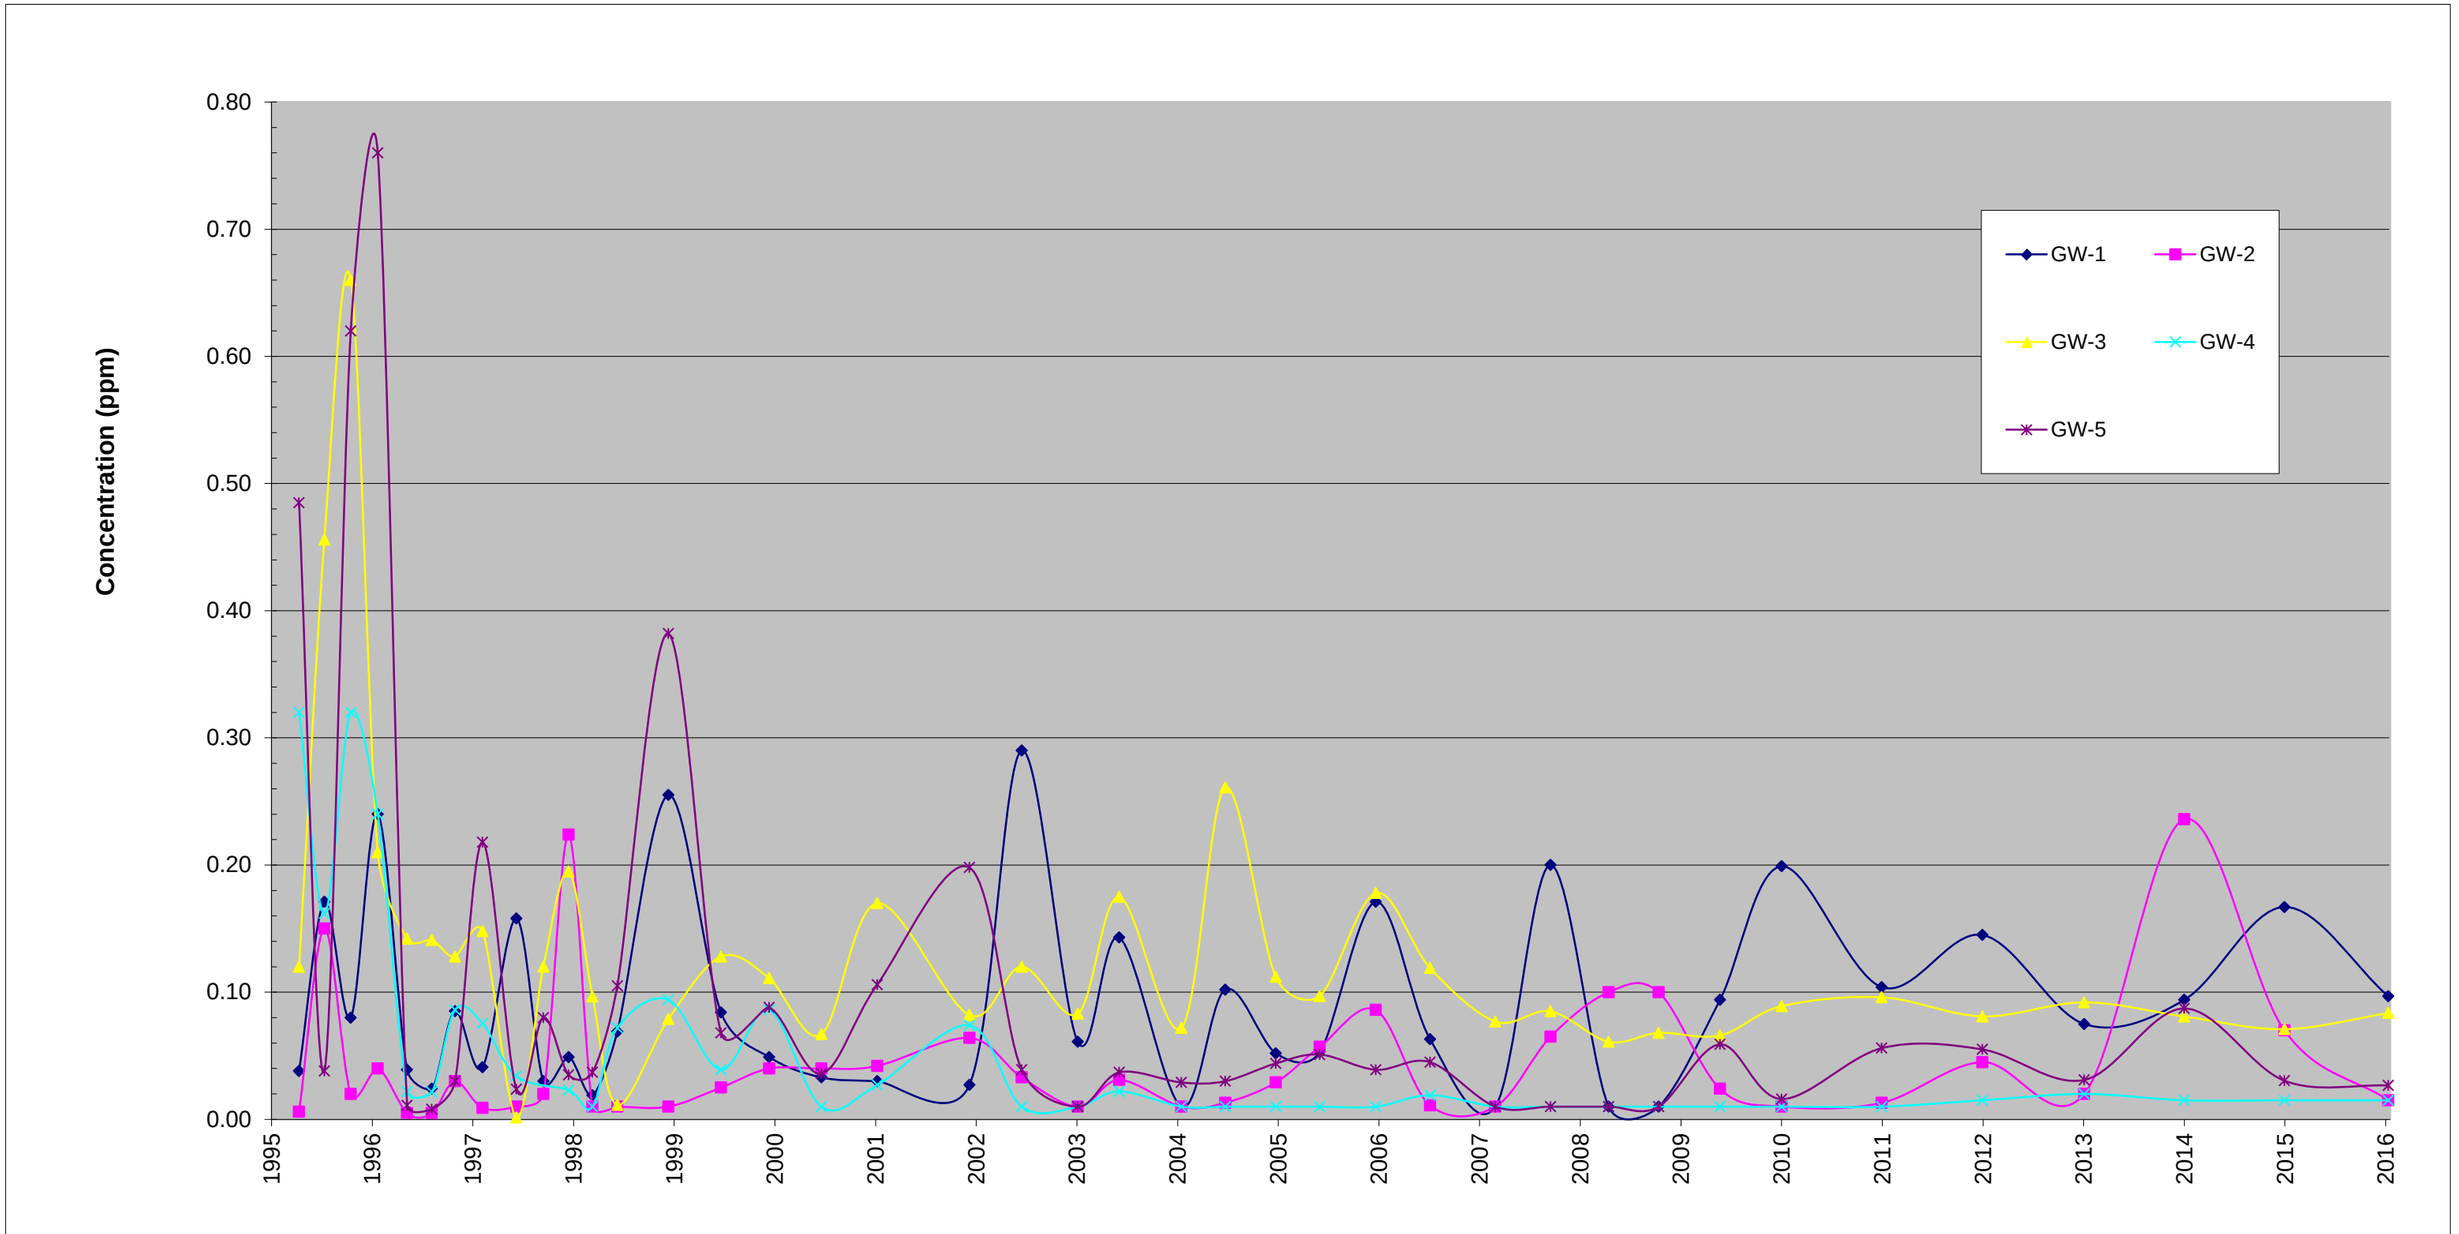
Figure 8

As indicated by Figure 8, concentrations of total manganese detected in samples collected from monitoring wells GW-1 through GW-5 during the reporting period are generally consistent with historic concentrations. Historically, the concentrations of total manganese measured in samples from groundwater monitoring wells GW-1 through GW-5 fluctuate with no apparent trend evident. Since June 1999, concentrations of total manganese in groundwater samples collected from GW-1 through GW-5 have been below the TOGS standard of 0.3 mg/l.

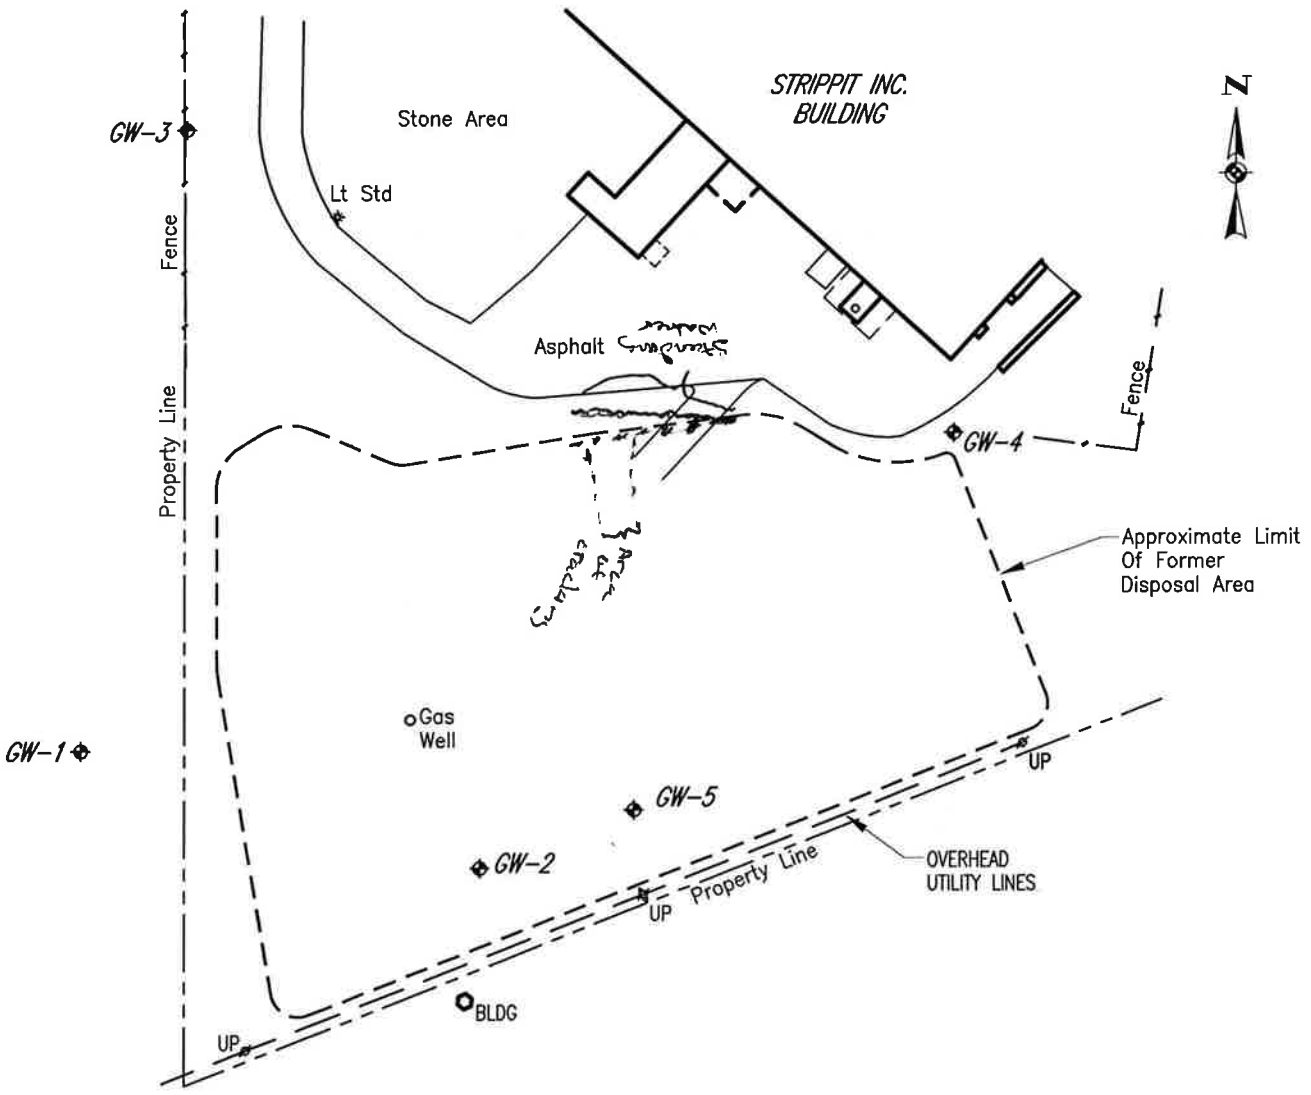
Summary of Observation:
General Condition of Cover: Generally in good condition. Area of cracking and water seepage (as previously documented) observed; but does not appear to be expanding/worsening

Explain (include measurements and site sketch):
- linear cracking observed on North slope of the landfill; as previously documented - size of cracks nor area of cracking not observed to have increased since last observation event

Condition of drainage ways (discuss amount of water/sediments present, vegetative growth unusual staining, blockage, etc.). Drainage ways on northwest portion of landfill clogged with small trees and brush; as previously documented
