Re: Mr. C's Dry Cleaners Site, Contract # D009807, Site # 915157
December 2021 Operations, Maintenance, and Monitoring Report

Ecology and Environment Engineering and Geology, P.C. (E&E) is pleased to provide the December 2021 Operations, Maintenance, and Monitoring (OM&M) Report for the Mr. C's Dry Cleaners Site, NYSDEC Site # 915157, located in the Village of East Aurora, New York.

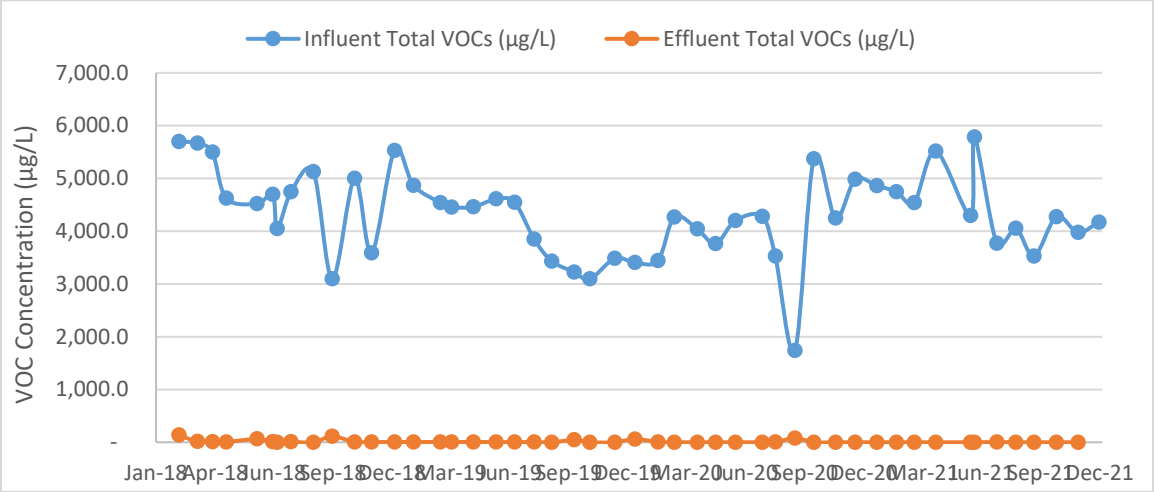
Figure 1: Monthly Influent and Effluent VOC concentrations - 2018 - 2021.

- The analytical summary results of the December 10, 2021 samples revealed the total volatile organic contaminant concentrations of the influent to 4,172.0 µg/L and the concentration of total volatile organic contaminants in the effluent was 0.0 µg/L. The summary of influent and effluent contaminant concentrations for the December 2021 sampling are presented in Table 3. Figure 1 shows the influent and effluent VOC concentrations during each sampling event in 2018, 2019, 2020, and 2021.

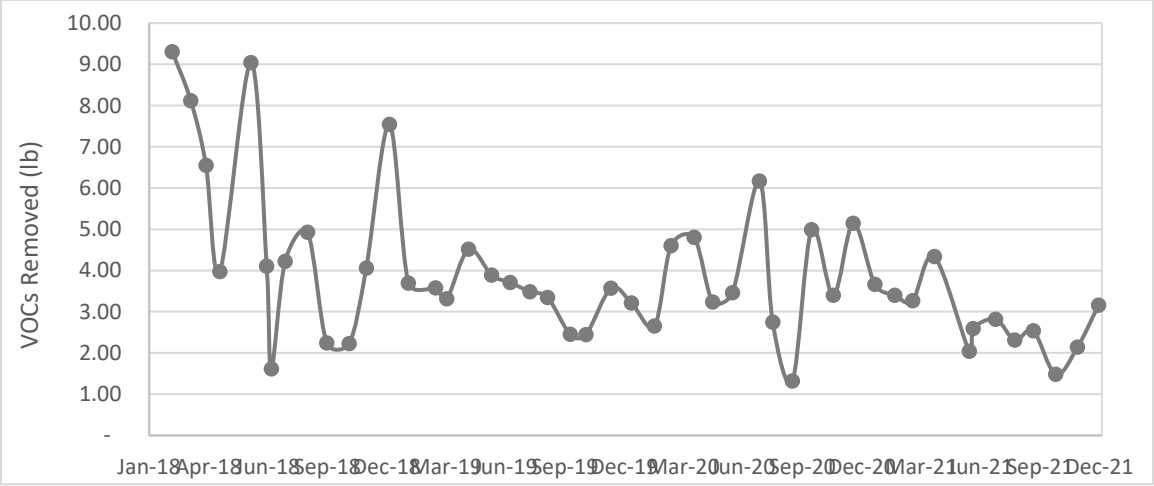
Figure 2: Mass of VOCs removed each month - 2018 - 2021.

- The Mr. C's treatment system, based on the total flows from the uptime operations and the December 10, 2021 sampling results, removed 3.16 lbs. of targeted contaminants from the groundwater between November 30, 2021 through January 3, 2021. The cleanup effectiveness for December 2021 was approximately 100%. The calculations and data for the month are presented in Table 3. The mass of VOCs removed each month throughout 2018, 2019, 2020, and 2021 is shown in Figure 2.
