Corrective Measures Work Plan for Landfill Gas System Maintenance

Pelham Bay Landfill, Bronx, New York

March 2010

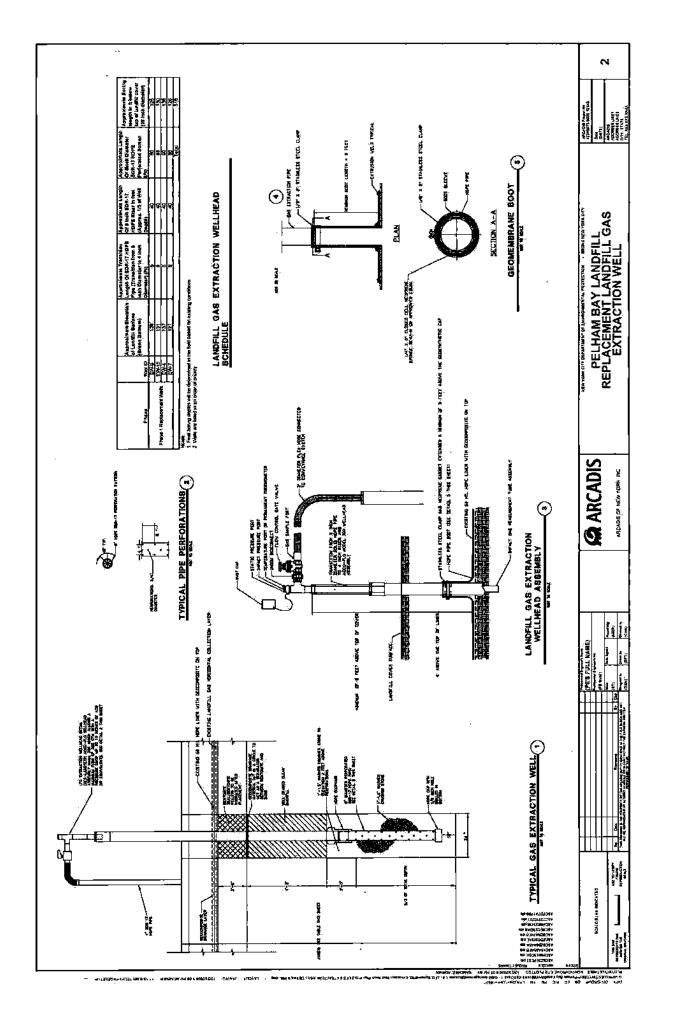
One replacement LFG extraction well will be installed in each borehole. The LFG extraction wells will be constructed of 8-inch diameter perforated high density polyethylene (HDPE) well screen and 8-inch diameter HDPE riser pipe. The riser pipe will extend to five feet above the top of the existing geomembrane liner and will be temporarily finished with a sealed cap until the installation of the wellhead assembly is completed (see Subtask 3.6, below). The proposed screen lengths of each well are presented in Table 1 and shown on Figure 2. Once the well casing and screen have been installed, the gravel pack will be emplaced in the borehole annulus. The gravel pack will consist of 1-inch to 1 1/2-inch washed crushed stone and shall extend to a depth of two feet above the screen perforations. Well graded clean backfill will be emplaced in the borehole annulus from the top of the gravel pack to a depth of 3 feet 4 inches below the geomembrane liner. A bentonite seal will be emplaced from the top of the clean backfill to the bottom of the geomembrane liner. A piece of geocomposite drainage material will be cut into a circle and placed beneath the bentonite to act as a separator between the backfill and bentonite. Typical well construction details are shown on Figure 2.

Upon completion of the well installations, a geomembrane boot will be installed around each gas extraction well. The installation of the geomembrane boot and the repairs to the existing cover system will be conducted by a certified landfill liner installer The geomembrane boot will be sealed to the existing liner and extend a minimum of three feet above the top of the geocomposite liner. Typical geomembrane boot details are shown on Figure 2.

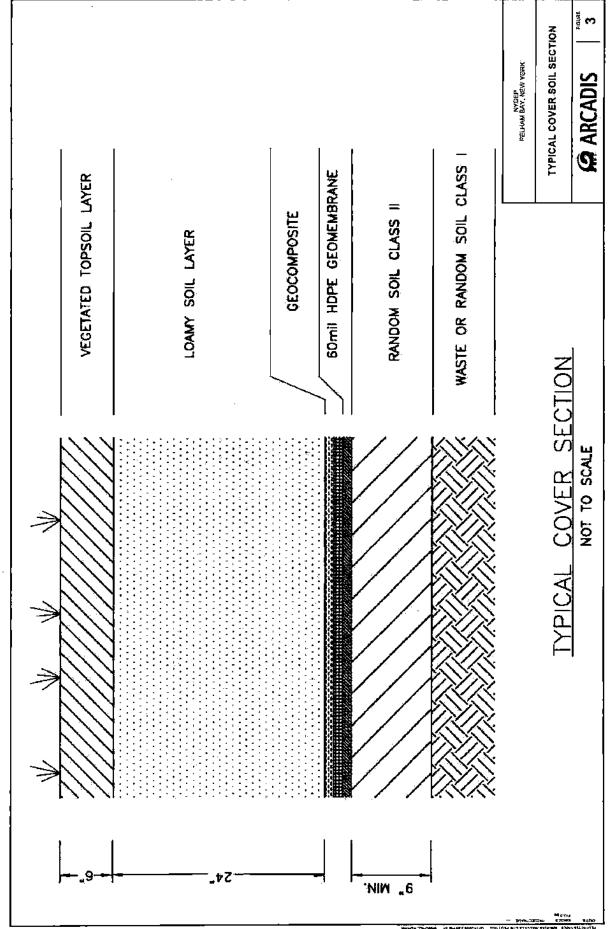
Upon completion of the geomembrane boot installations and liner repairs, each excavation area will be backfilled using the same materials that were excavated while preparing the drill site. The soils will be placed as a two (2) foot layer of loamy soil directly above the geocomposite liner followed by a six (6) inch topsoil layer. The area will be re-seeded, as necessary, in accordance with DEP requirements. A typical cover soil section is shown on Figure 3.

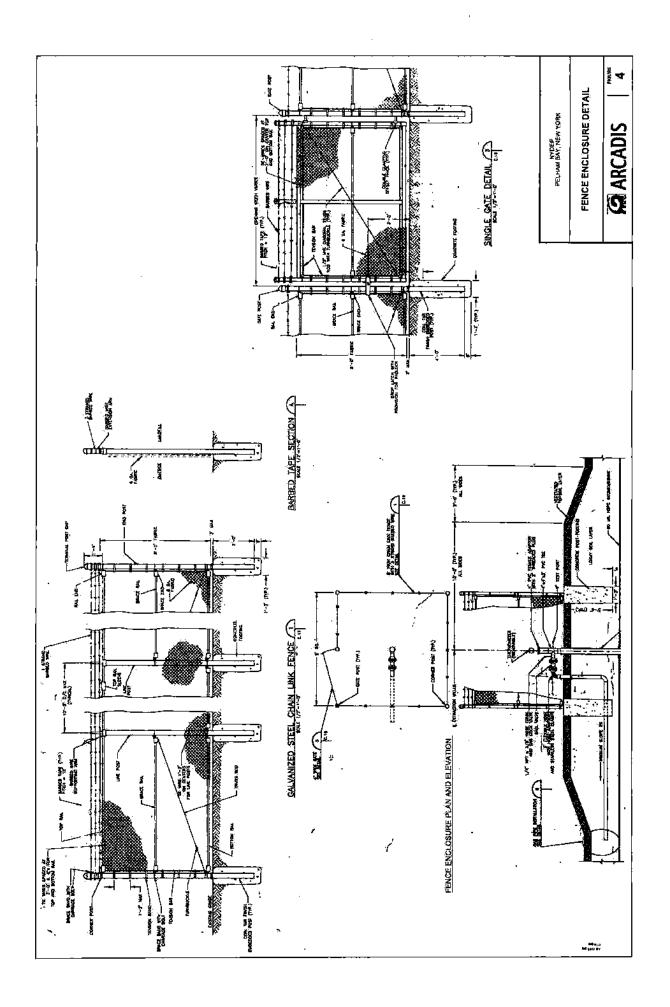
Upon completion of the well installation, liner and cover system repairs, and wellhead installation, a new chain link fence enclosure will be installed around each LFG extraction well. The fence enclosure details are shown on Figure 4.
