2020 Annual Periodic Review Report

102nd Street Landfill Site
Niagara Falls, New York
NYSDEC Site No. 932022

Glenn Springs Holdings, Inc.

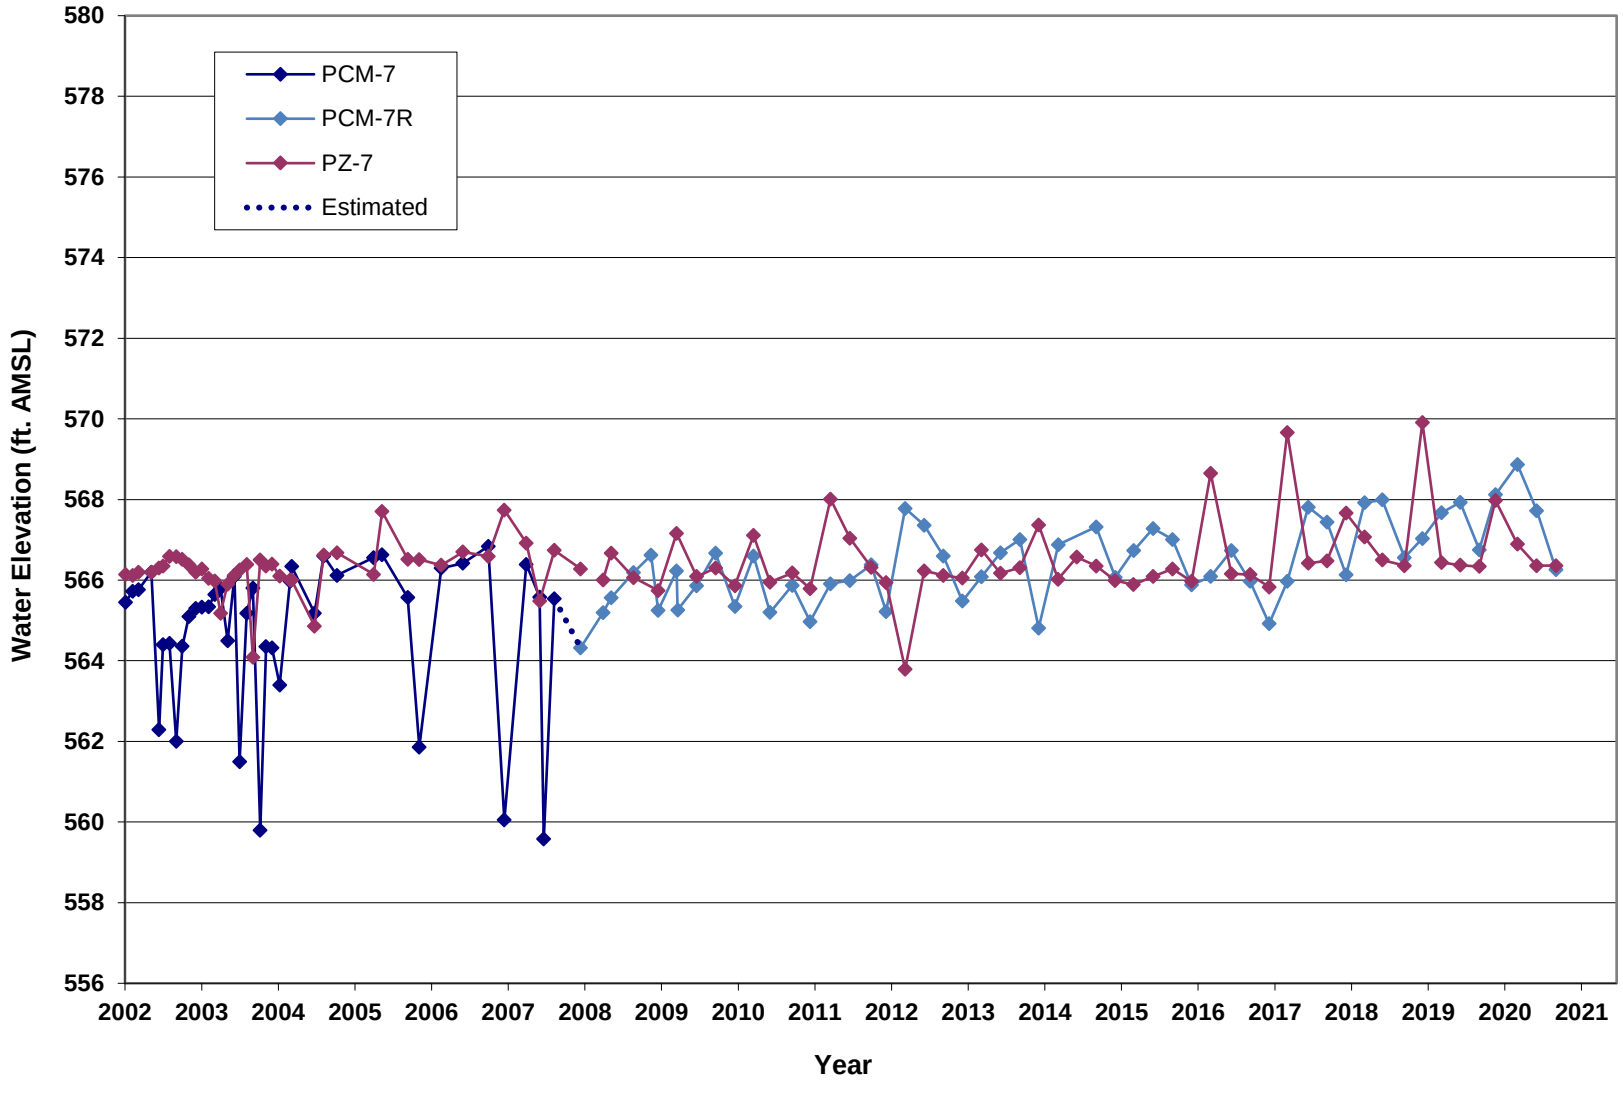
figure C.7
GROUNDWATER LEVELS WELL PAIR 7
102ND STREET LANDFILL SITE
GLENN SPRINGS HOLDINGS, INC
Niagara Falls, New York

Higher water levels have historically been observed in PZ-07 (inside the slurry wall) relative to PCM-07R (outside the slurry wall) during certain quarters (refer to Figure C.7 in Appendix C). The reason for this is unknown. As a result, PZ-07 was redeveloped on June 5, 2018. Following redevelopment, the groundwater elevation in PZ-07 was lower than the groundwater elevation in PCM-07R during the September 2018 monitoring event, indicating an inward gradient, but was still higher than the groundwater elevation in PCM-07R during the December 2018 monitoring event, indicating an outward gradient. However, given the thickness and the low permeability of the slurry wall that separates these two wells, and that the natural and current groundwater flow direction

along the northern portion of the Site (where PCM-07R and PZ-07 are located) is from the north (off-Site) to the south (on-Site), the potential for chemical migration to occur through the wall is negligible. This is confirmed by the fact that there has not been any chemical evidence to suggest that contaminants have migrated from the landfill at this location. Therefore, no further evaluation is warranted at this time. Water levels will continue to be monitored on a semiannual basis at these locations.
