**CONSTRUCTION COMPLETION REPORT**

**COLLEGE POINT 3 IRM**

**SITE No. 2-41-122**

**COLLEGE POINT, NEW YORK**

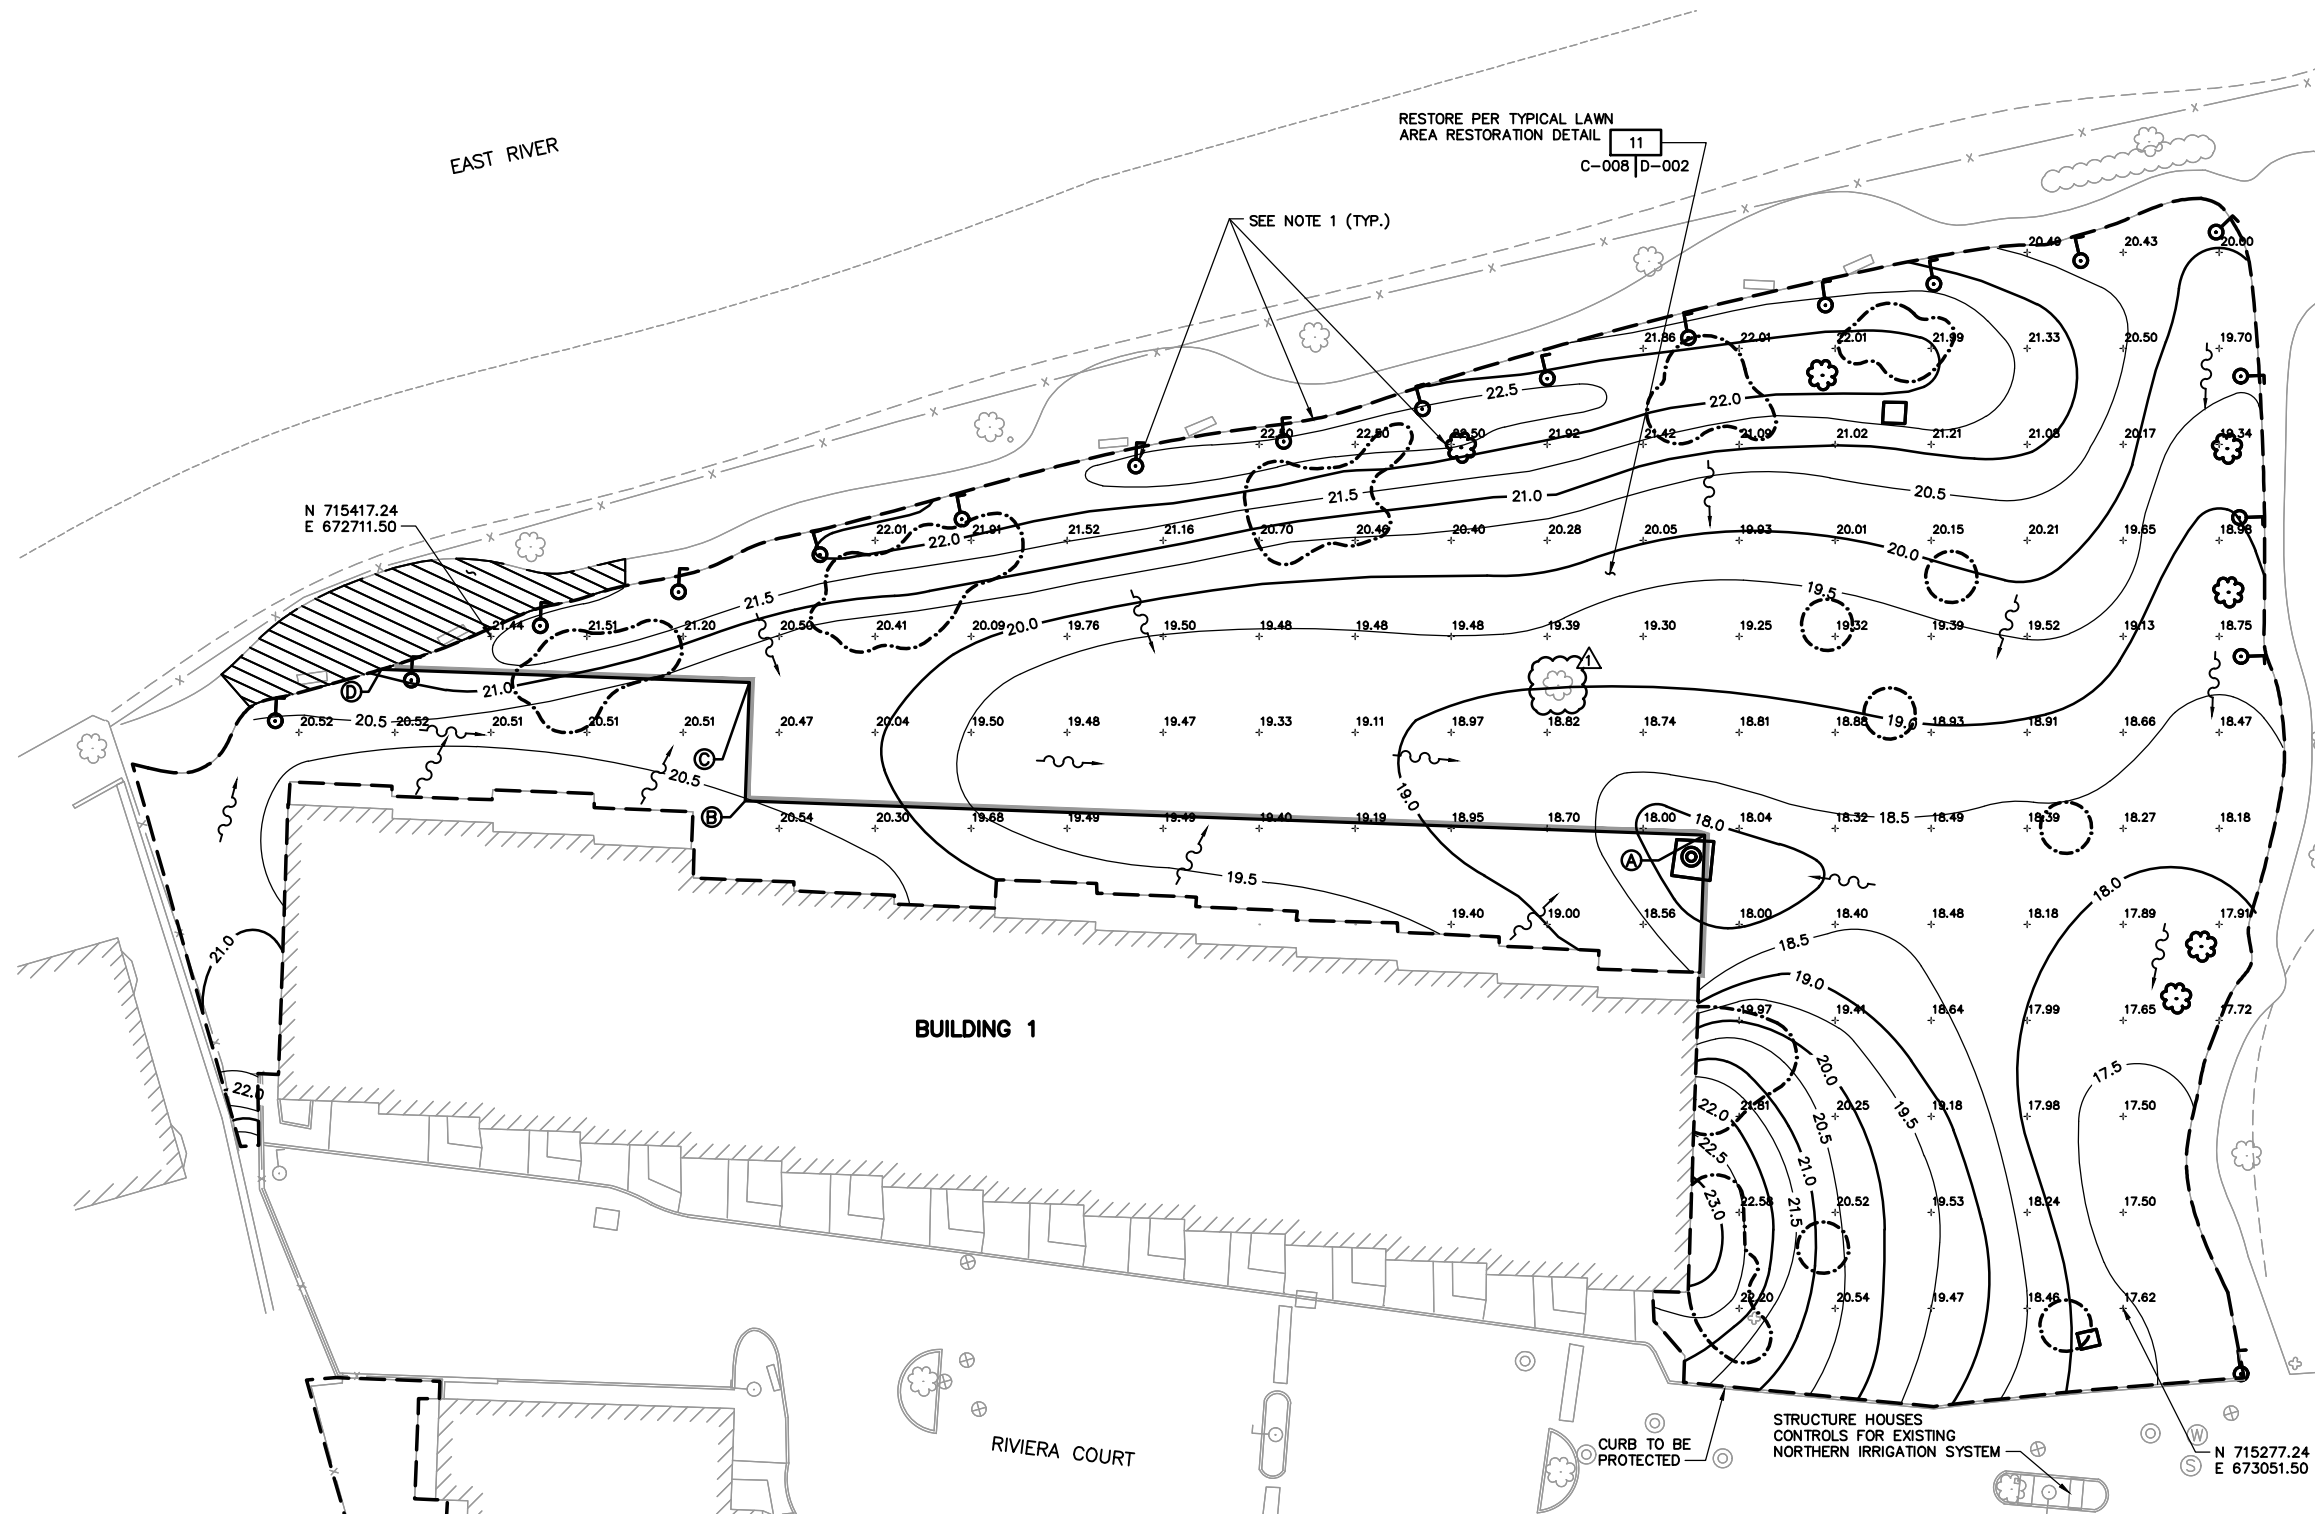
1. RESTORED GRADES SHALL MATCH PRE-EXISTING GRADES AT ALL FEATURES SHOWN TO BE PRESERVED INCLUDING TREES, AND ALONG EDGES OF EXCAVATION AREA (PATHS AND BUILDINGS).
2. FINAL GRADES SHALL DRAIN AWAY FROM BUILDINGS.
3. PROPOSED PLANTING FROM DWG. C-010 NOT SHOWN.
4. THE SUBCONTRACTOR SHALL REPLACE THE EXISTING UNDERGROUND IRRIGATION SYSTEM WITH A NEW SYSTEM THAT PROVIDES EQUAL SERVICE TO THE NORTH LAWN AREA.

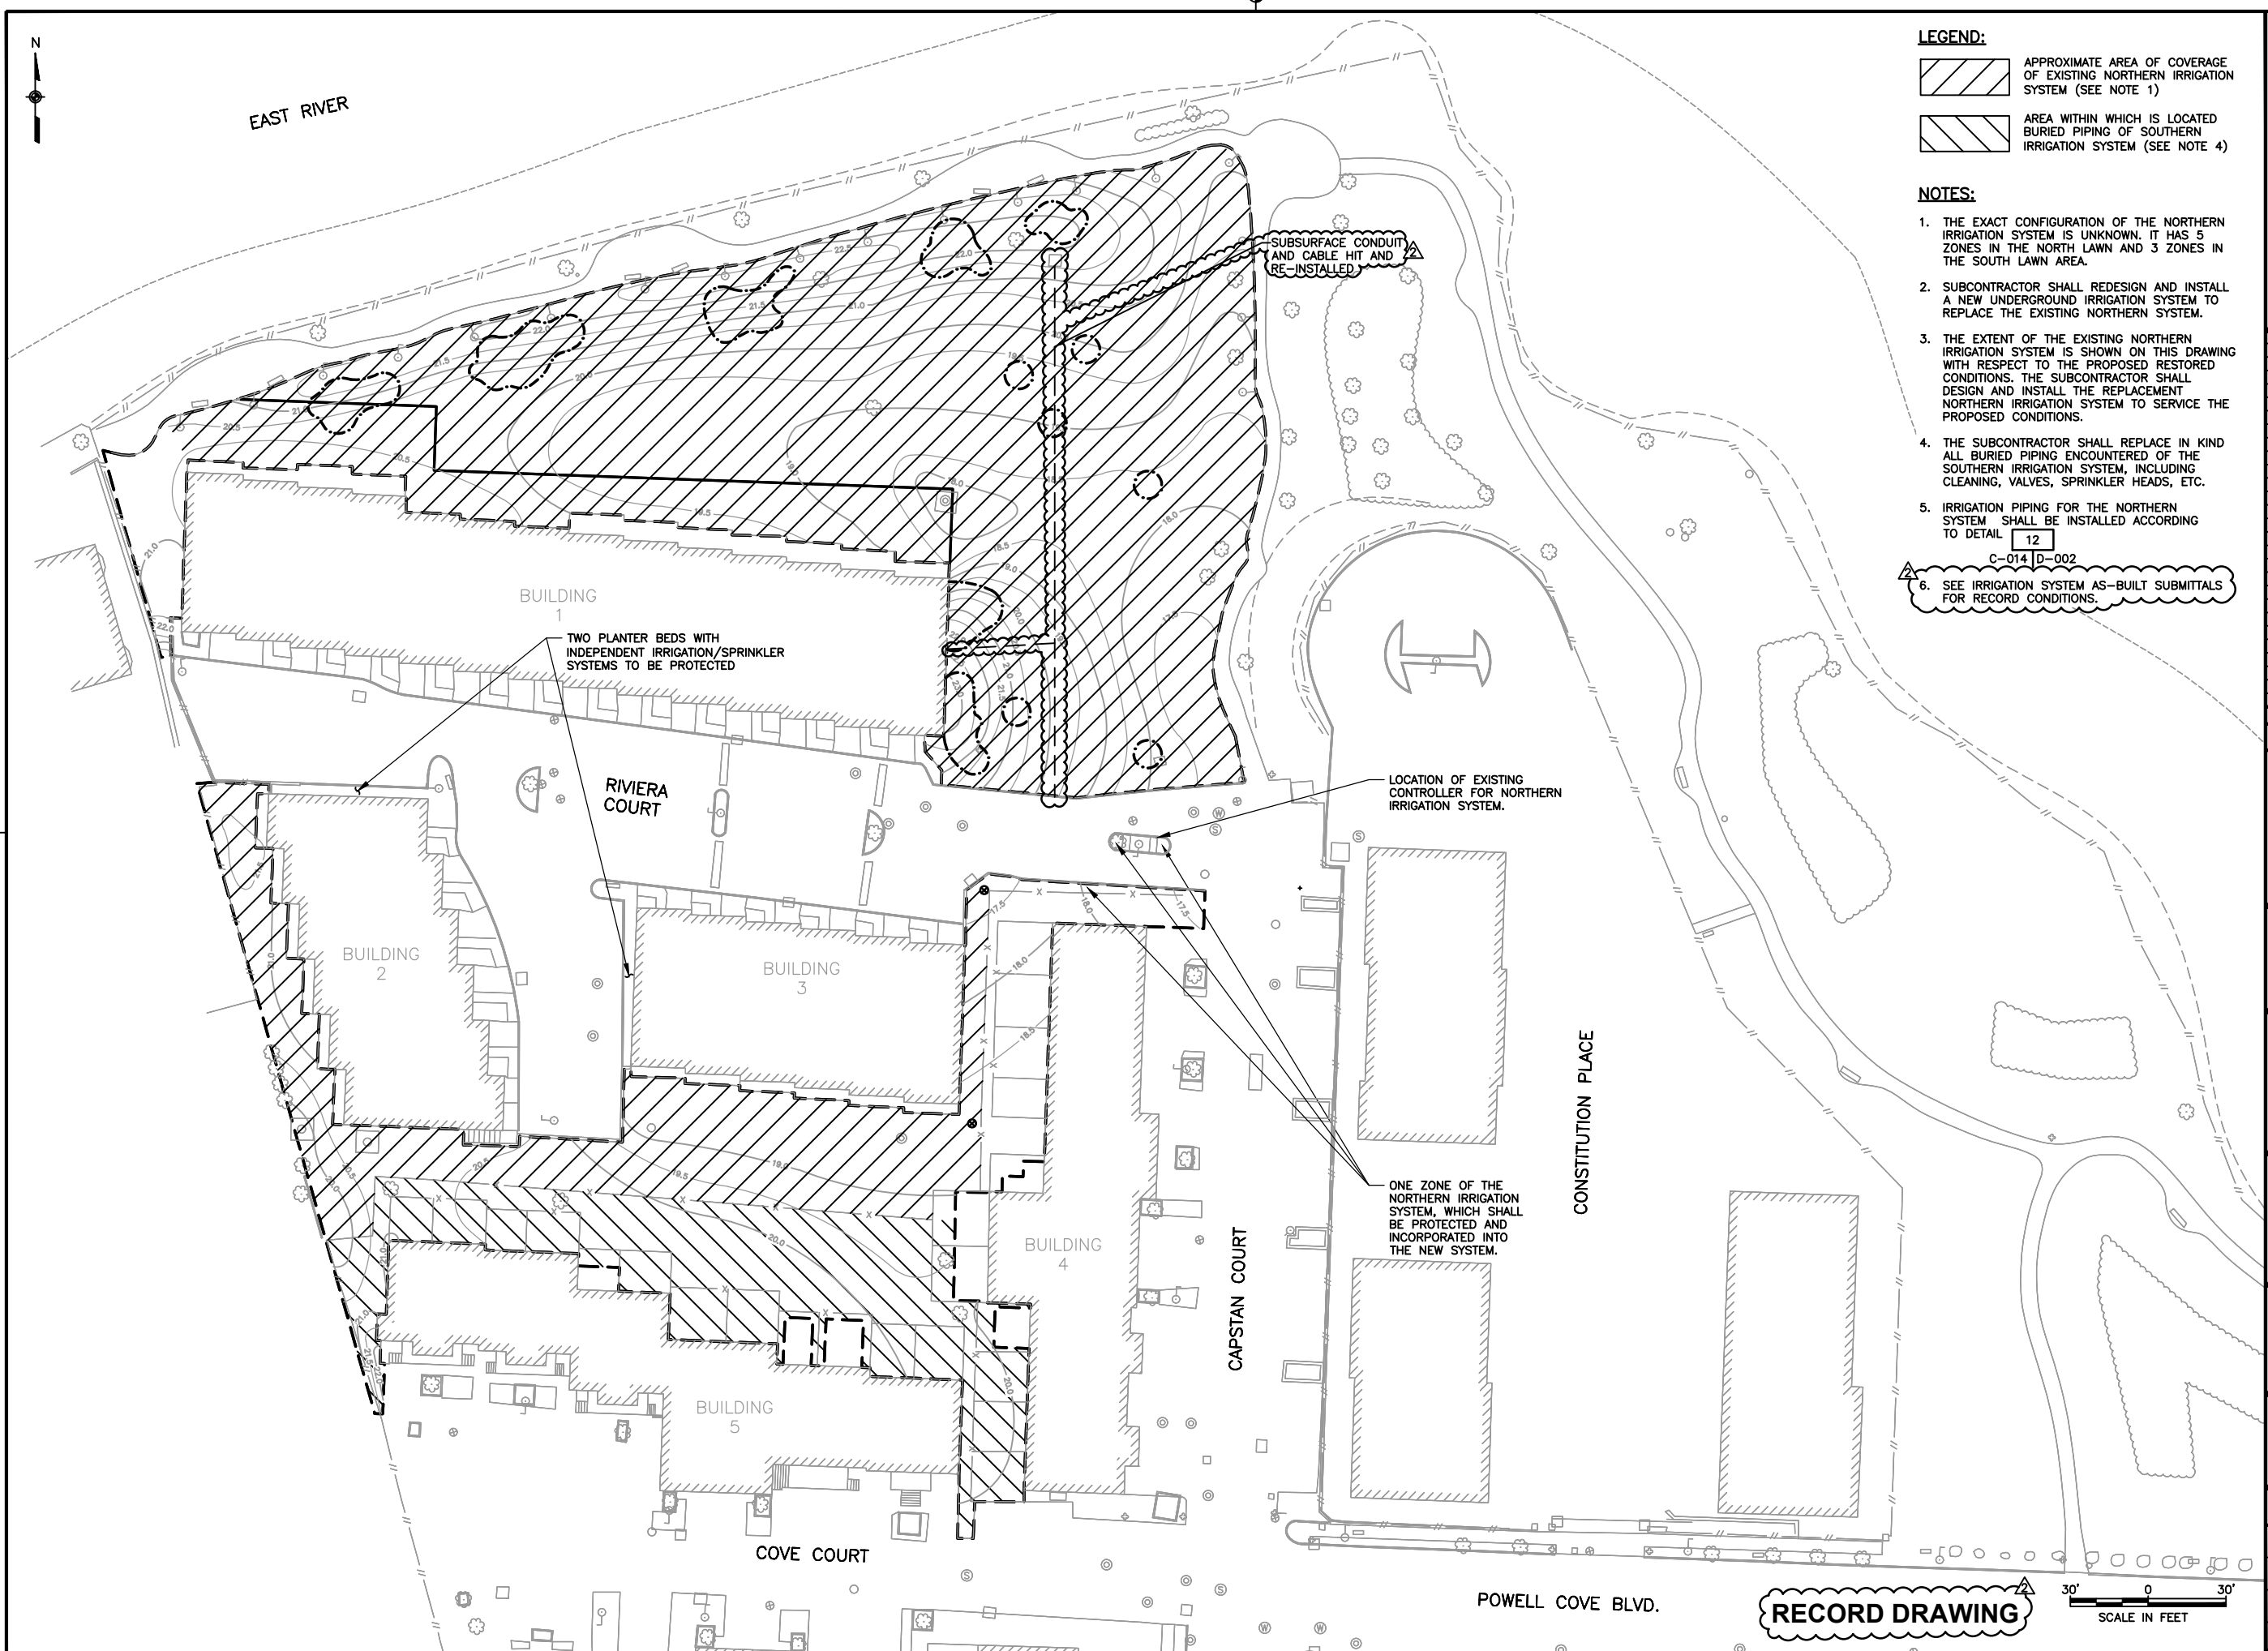
APPROXIMATE AREA OF COVERAGE  
OF EXISTING NORTHERN IRRIGATION  
SYSTEM (SEE NOTE 1)

AREA WITHIN WHICH IS LOCATED  
BURIED PIPING OF SOUTHERN  
IRRIGATION SYSTEM (SEE NOTE 4)

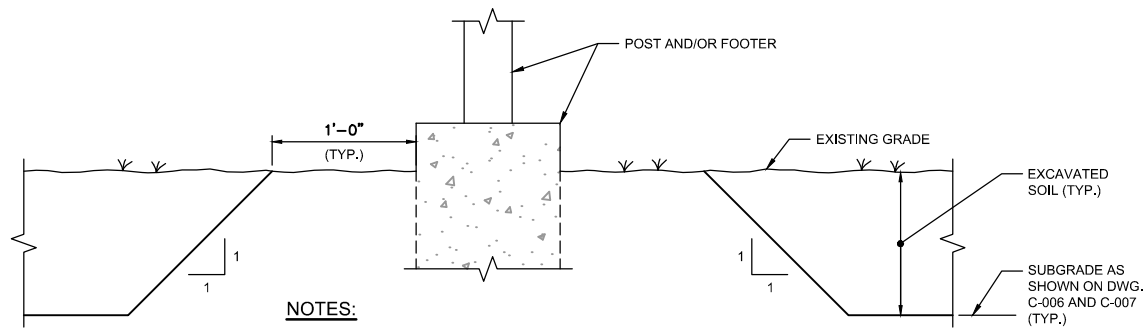
POST/FOOTER PROTECTION DETAIL 1  
N.T.S. C-005 | D-001

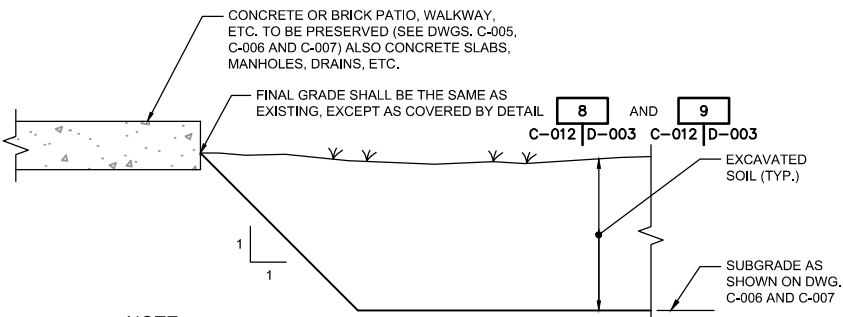
PATIO / WALKWAY PROTECTION DETAIL 2  
N.T.S. C-005 | D-001

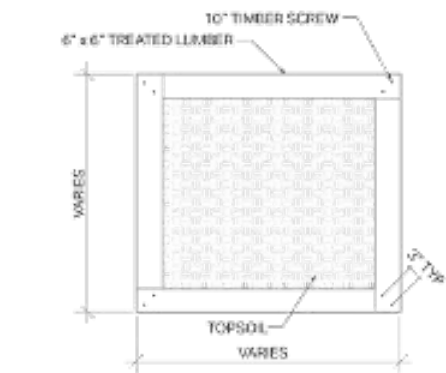
REPLACEMENT PLANTER DETAIL 3  
NOT TO SCALE C-012 | D-001

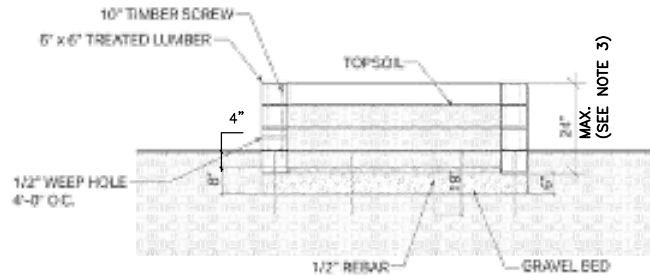
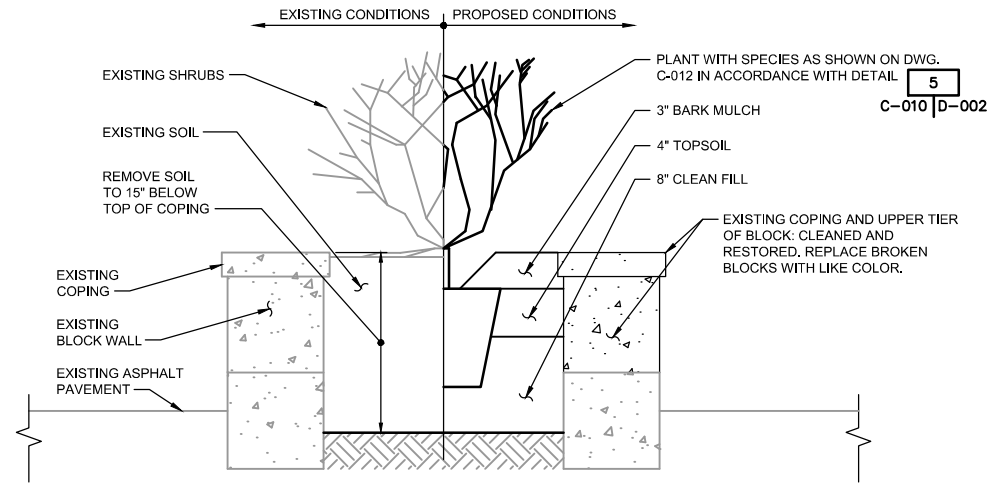
RESTORATION OF CONCRETE BLOCK PLANTERS 6  
N.T.S. C-012 | D-001

SEQUENCE OF WORK:

1. REMOVE, CLEAN, AND RETAIN COPING AND UPPER TIER OF BLOCK. BLOCK SHALL BE POWER WASHED OR BRUSHED CLEAN.
2. REMOVE SOIL TO 15" INCHES BELOW TOP OF CASING, DISPOSE OF SOIL.
3. REPLACE UPPER TIER OF BLOCK.
4. PLACE SHRUBS TO BE PLANTED AND BACKFILL PLANTER WITH CLEAN FILL AND TOPSOIL.
5. PLANT REMAINDER OF PLANTS.
6. COVER EXPOSED SOIL WITH BARK MULCH.

- Excavation of approximately 15 inches of soil from approximately 75 planters and islands.
- Replacement of the wood edging on approximately 50 planters.
- Reconstruction of 5 block planters with existing, cleaned blocks.
- Transportation and disposal of waste, soils, and all debris generated from the planter box excavations.
- Collection and analysis of documentation soil samples from excavation areas.
- Restoration of excavated areas with demarcation layer, common backfill, topsoil, and sod or mulch.
- Planting and establishment of trees and shrubs.

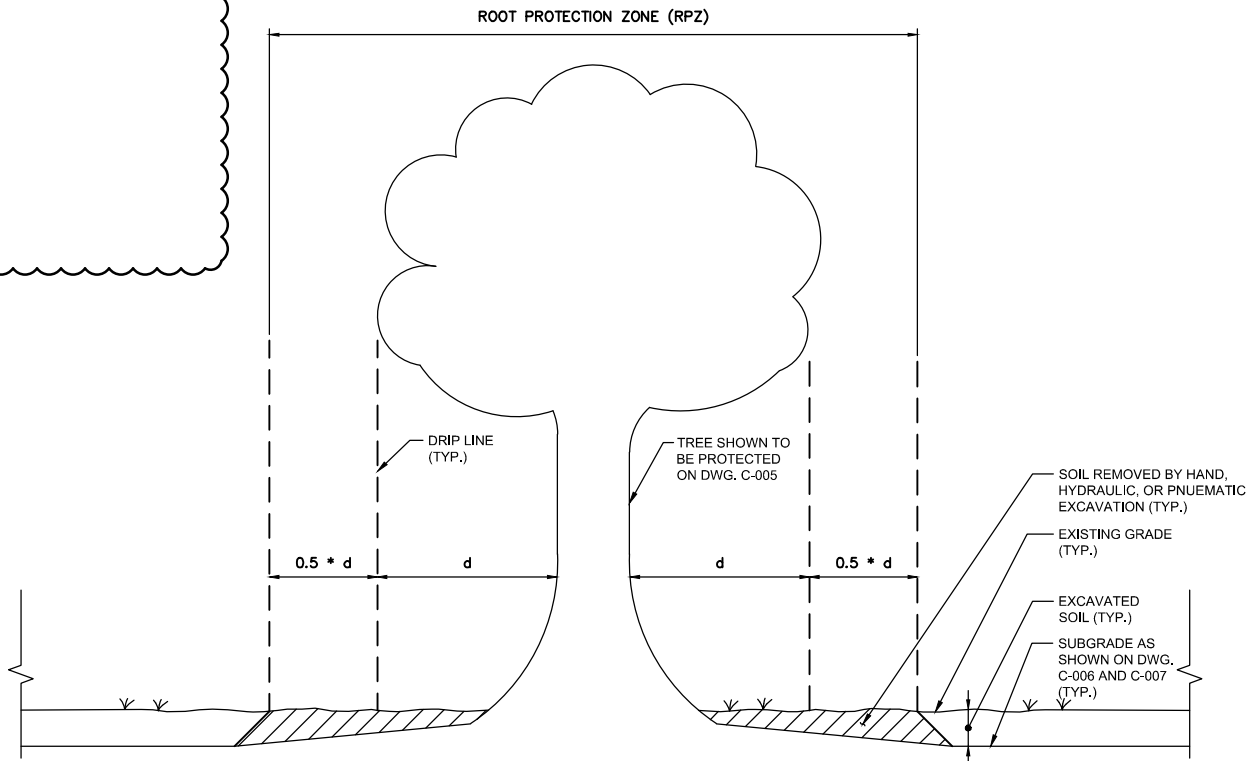
TREE PROTECTION DETAIL 5  
N.T.S. C-005 | D-001

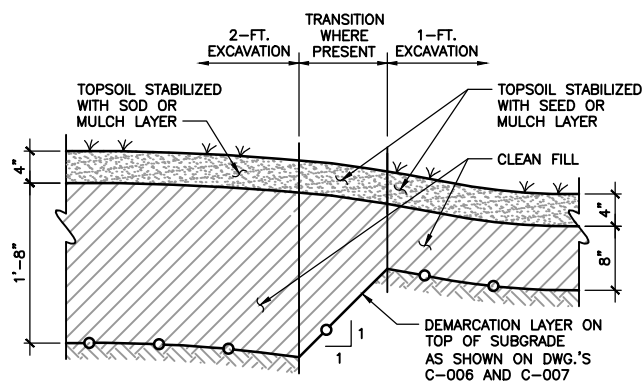
TYPICAL LAWN AREA RESTORATION 11  
NOT TO SCALE C-008 | D-002

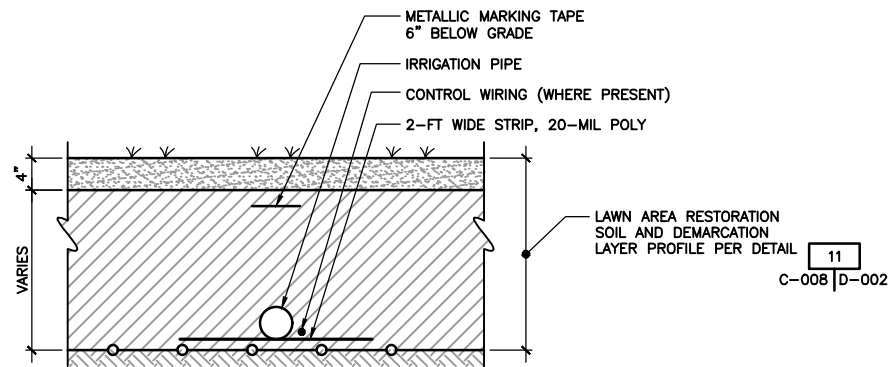
NOTE:  
1. FOR INSTALLATION OF IRRIGATION MAINS IN AREAS OF 1-FT EXCAVATION, THE DEPTH OF EXCAVATION SHALL BE INCREASED TO PROVIDE A MINIMUM OF 18 INCHES COVER.

TYPICAL IRRIGATION PIPE INSTALLATION 12  
NOT TO SCALE C-014 | D-002

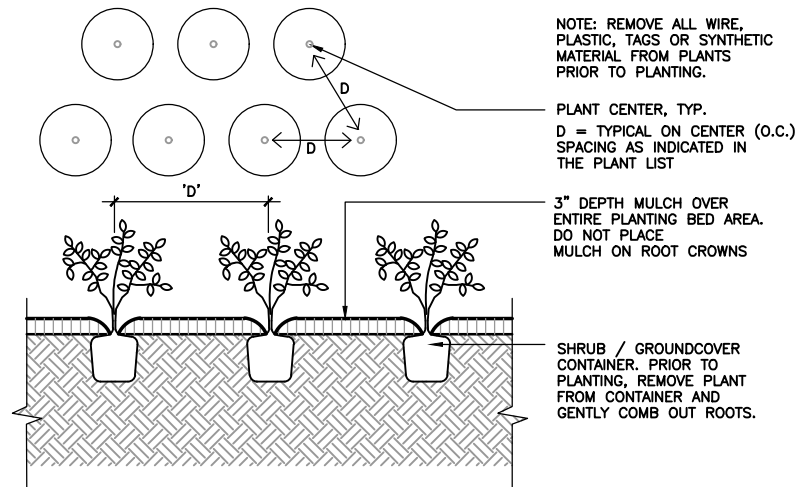
TYPICAL SHRUB AND GROUNDCOVER PLANTING 13  
NOT TO SCALE D-003 | D-002

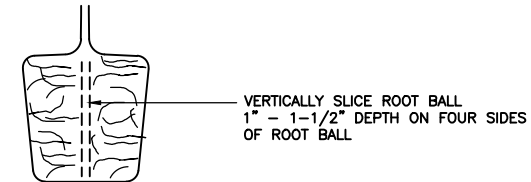
NOTE:  
THIS DETAIL APPLIES TO CONTAINERIZED SHRUBS AND PERENNIALS, BUT NOT TO HERBACEOUS PLUGS.

TYPICAL PREPARATION OF CONTAINERIZED ROOT BALL  
NOT TO SCALE

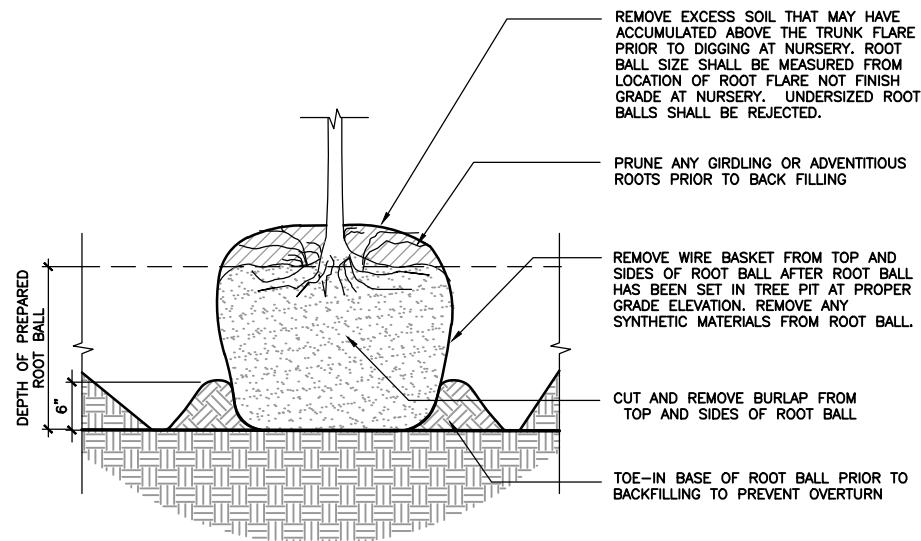
NOTE:  
1. EXPOSE TRUNK FLARE IN BALL PRIOR TO DIGGING HOLE TO DETERMINE CORRECT DEPTH.

TYPICAL PREPARATION OF B&B ROOT BALL  
NOT TO SCALE

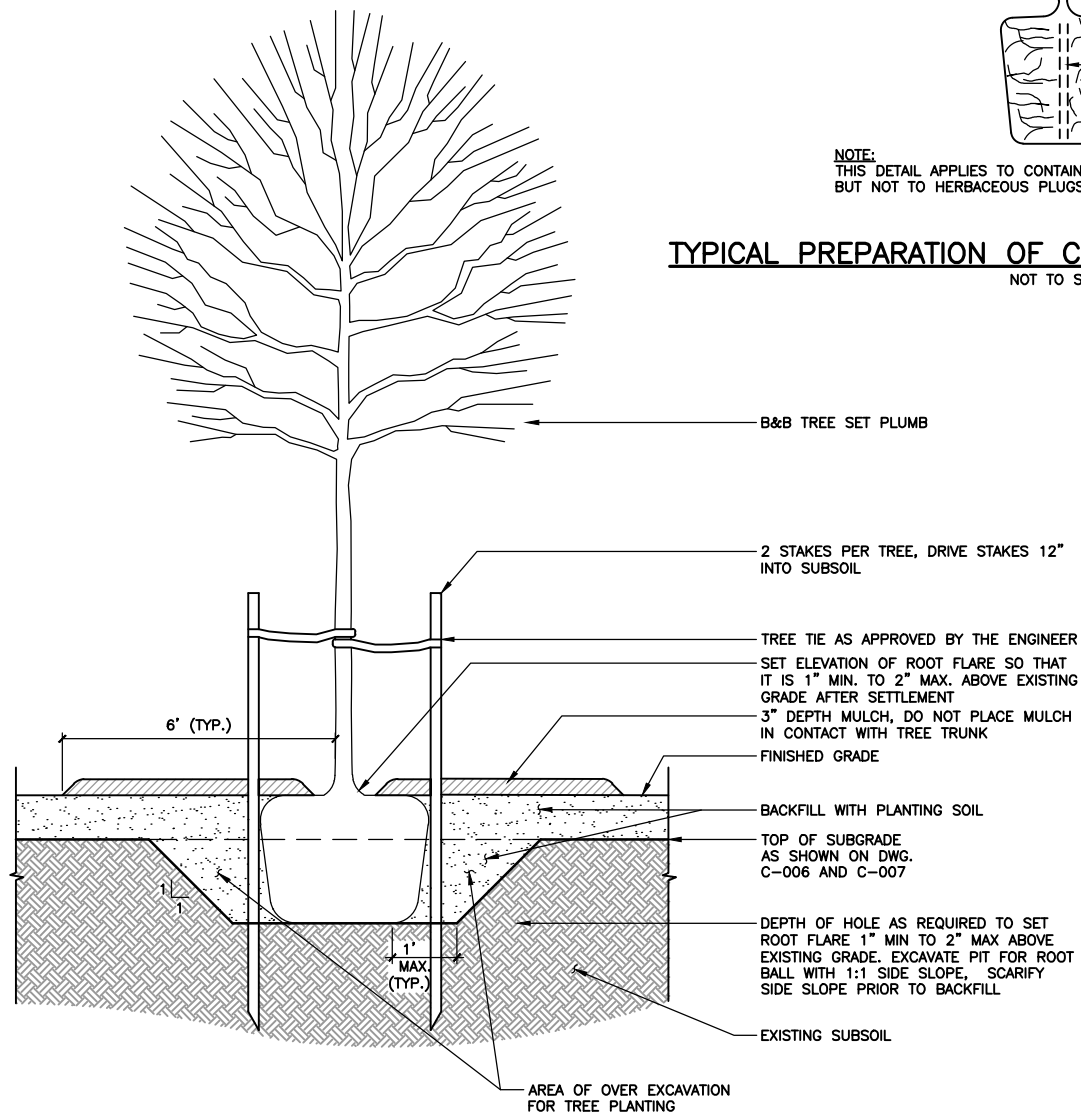
TYPICAL TREE PLANTING DETAIL 14  
NOT TO SCALE D-002

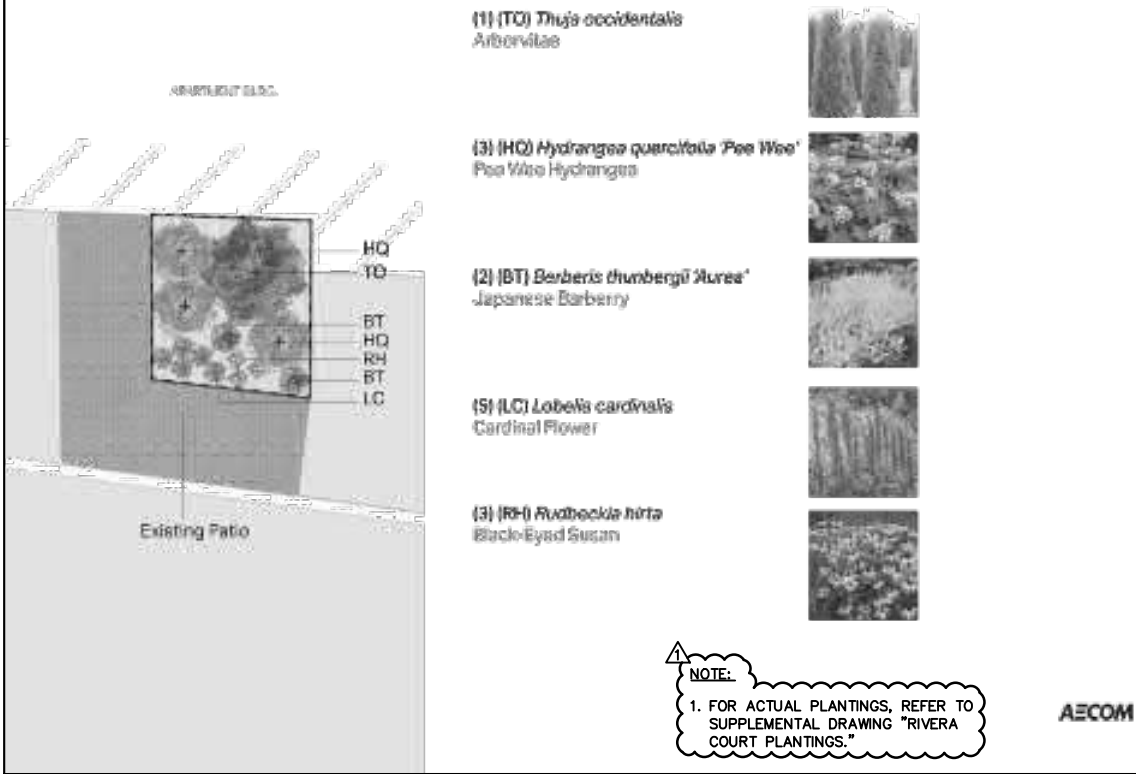
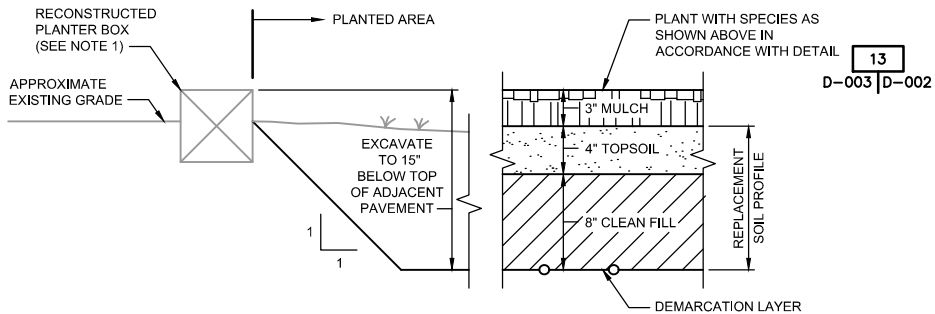
RIVIERA COURT PLANTERS

RIVIERA COURT PLANTER REMEDIAL EXCAVATION AND RESTORATION 7

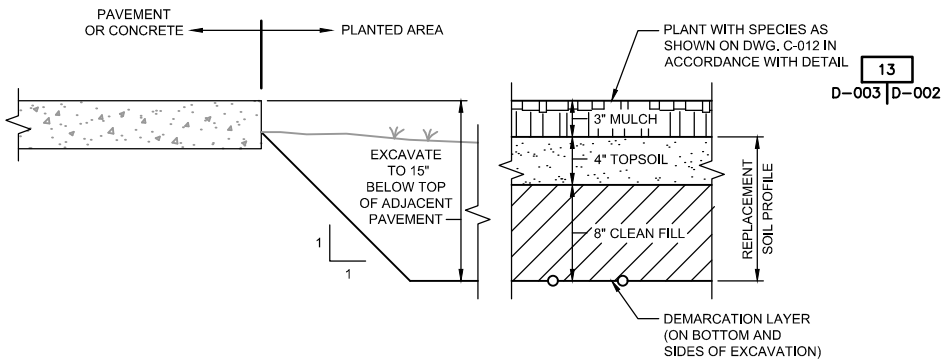
RIVIERA COURT ISLAND REMEDIATION / RESTORATION 9

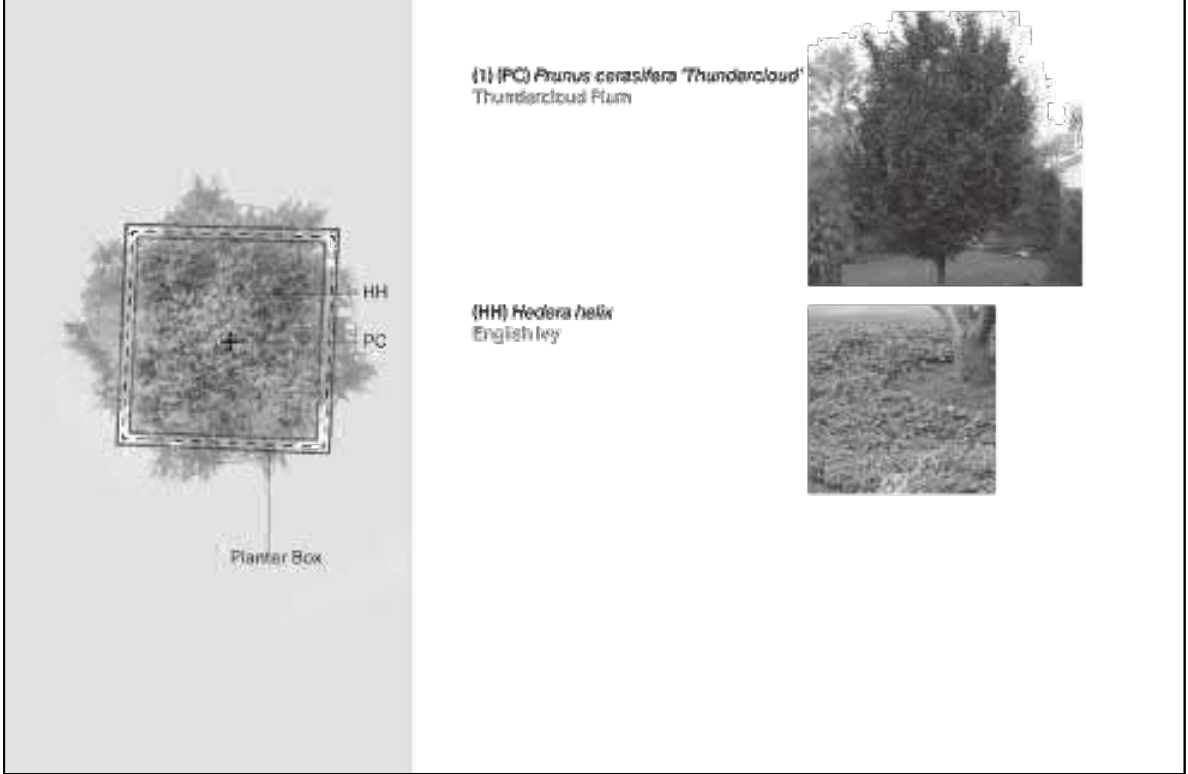
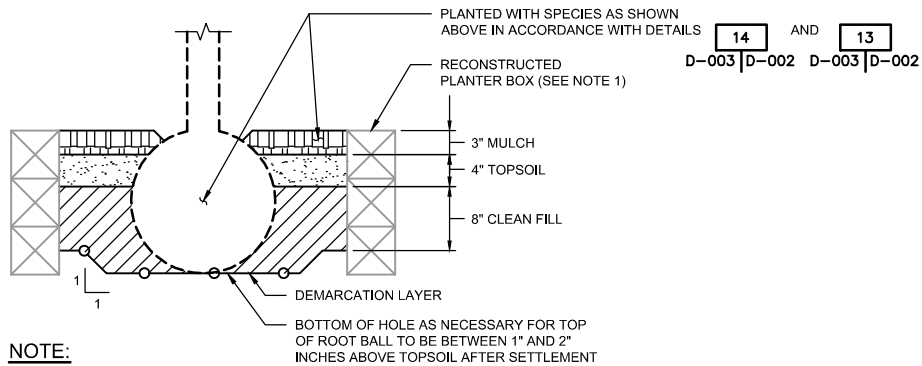
CAPSTAN COURT / COVE COURT PLANTERS

CAPSTAN / COVE COURTS PLANTERS 10

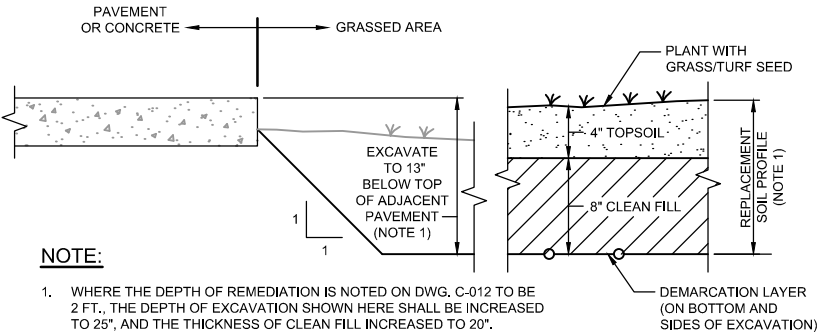
GRASSED AREA REMEDIATION / RESTORATION 8

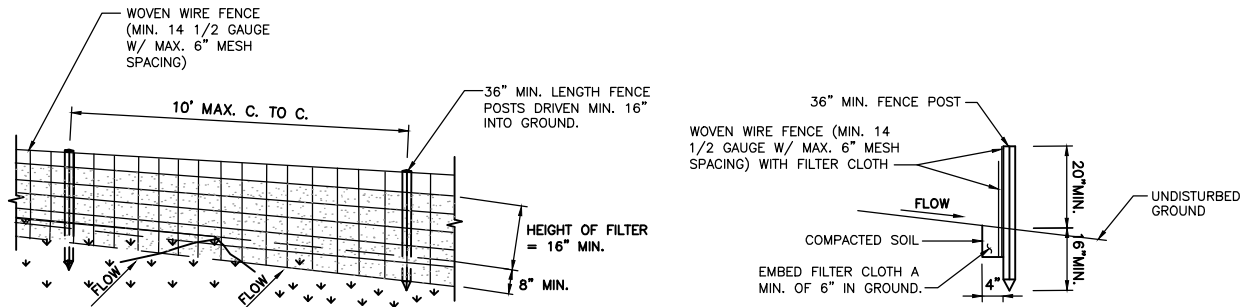
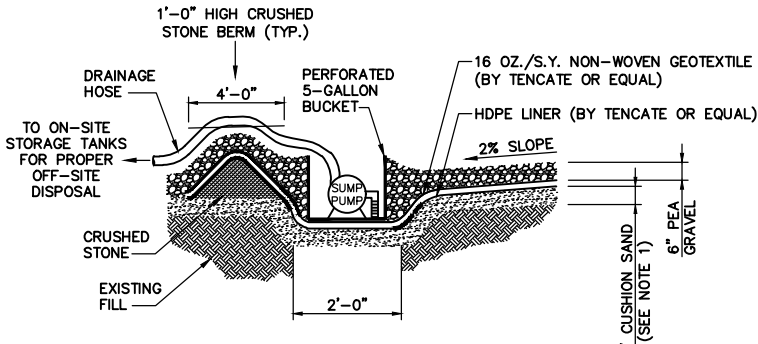
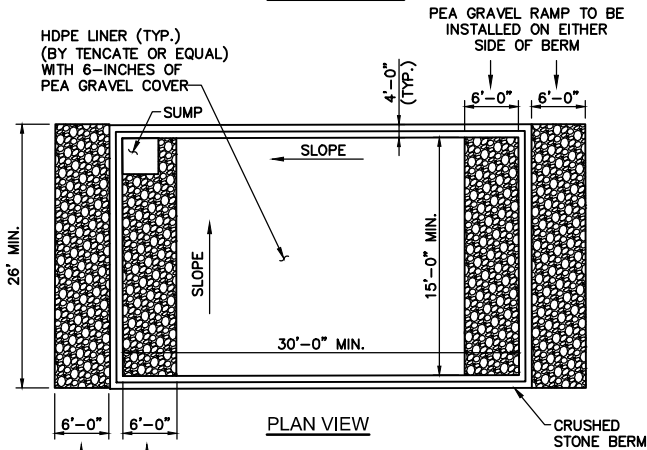
PERSPECTIVE VIEW

SECTION VIEW

SILT FENCE DETAIL

PLAN VIEW

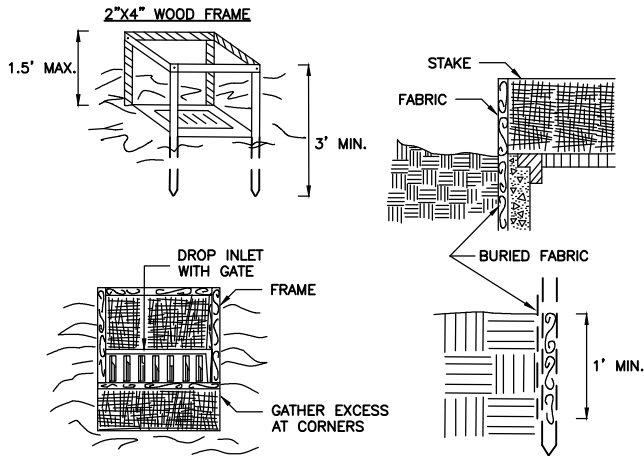
STORM DRAIN INLET PROTECTION

CONSTRUCTION SPECIFICATIONS

- FILTER FABRIC SHALL HAVE AN EOS OF 40-85. BURLAP MAY BE USED FOR SHORT TERM APPLICATIONS.
- CUT FABRIC FROM A CONTINUOUS ROLL TO ELIMINATE JOINTS. IF JOINTS ARE NEEDED THEY WILL BE OVERLAPPED TO THE NEXT STAKE.
- STAKE MATERIALS WILL BE STANDARD 2" x 4" WOOD OR EQUIVALENT. METAL WITH A MINIMUM LENGTH OF 3 FEET.
- SPACE STAKES EVENLY AROUND INLET 3 FEET APART AND DRIVE A MINIMUM 18 INCHES DEEP. SPANS GREATER THAN 3 FEET MAY BE BRIDGED WITH THE USE OF WIRE MESH BEHIND THE FILTER FABRIC FOR SUPPORT.
- FABRIC SHALL BE EMBEDDED 1 FOOT MINIMUM BELOW GROUND AND BACKFILLED. IT SHALL BE SECURELY FASTENED TO THE STAKES AND FRAME.
- A 2" x 4" WOOD FRAME SHALL BE COMPLETED AROUND THE CREST OF THE FABRIC FOR OVER FLOW STABILITY.

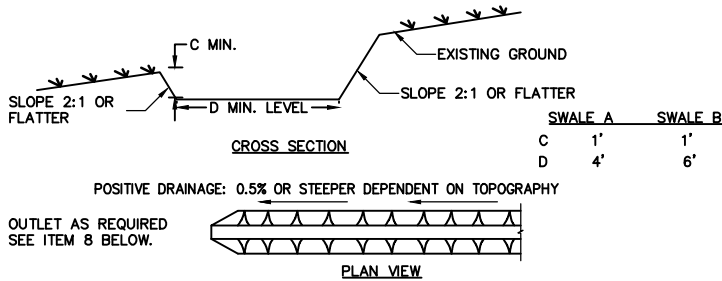
CONSTRUCTION SPECIFICATIONS

- ALL CONSTRUCTION DITCHES SHALL HAVE UNINTERRUPTED POSITIVE GRADE TO AN OUTLET.
- DIVERTED RUNOFF FROM A DISTURBED AREA SHALL BE CONVEYED TO A SEDIMENT TRAPPING DEVICE.

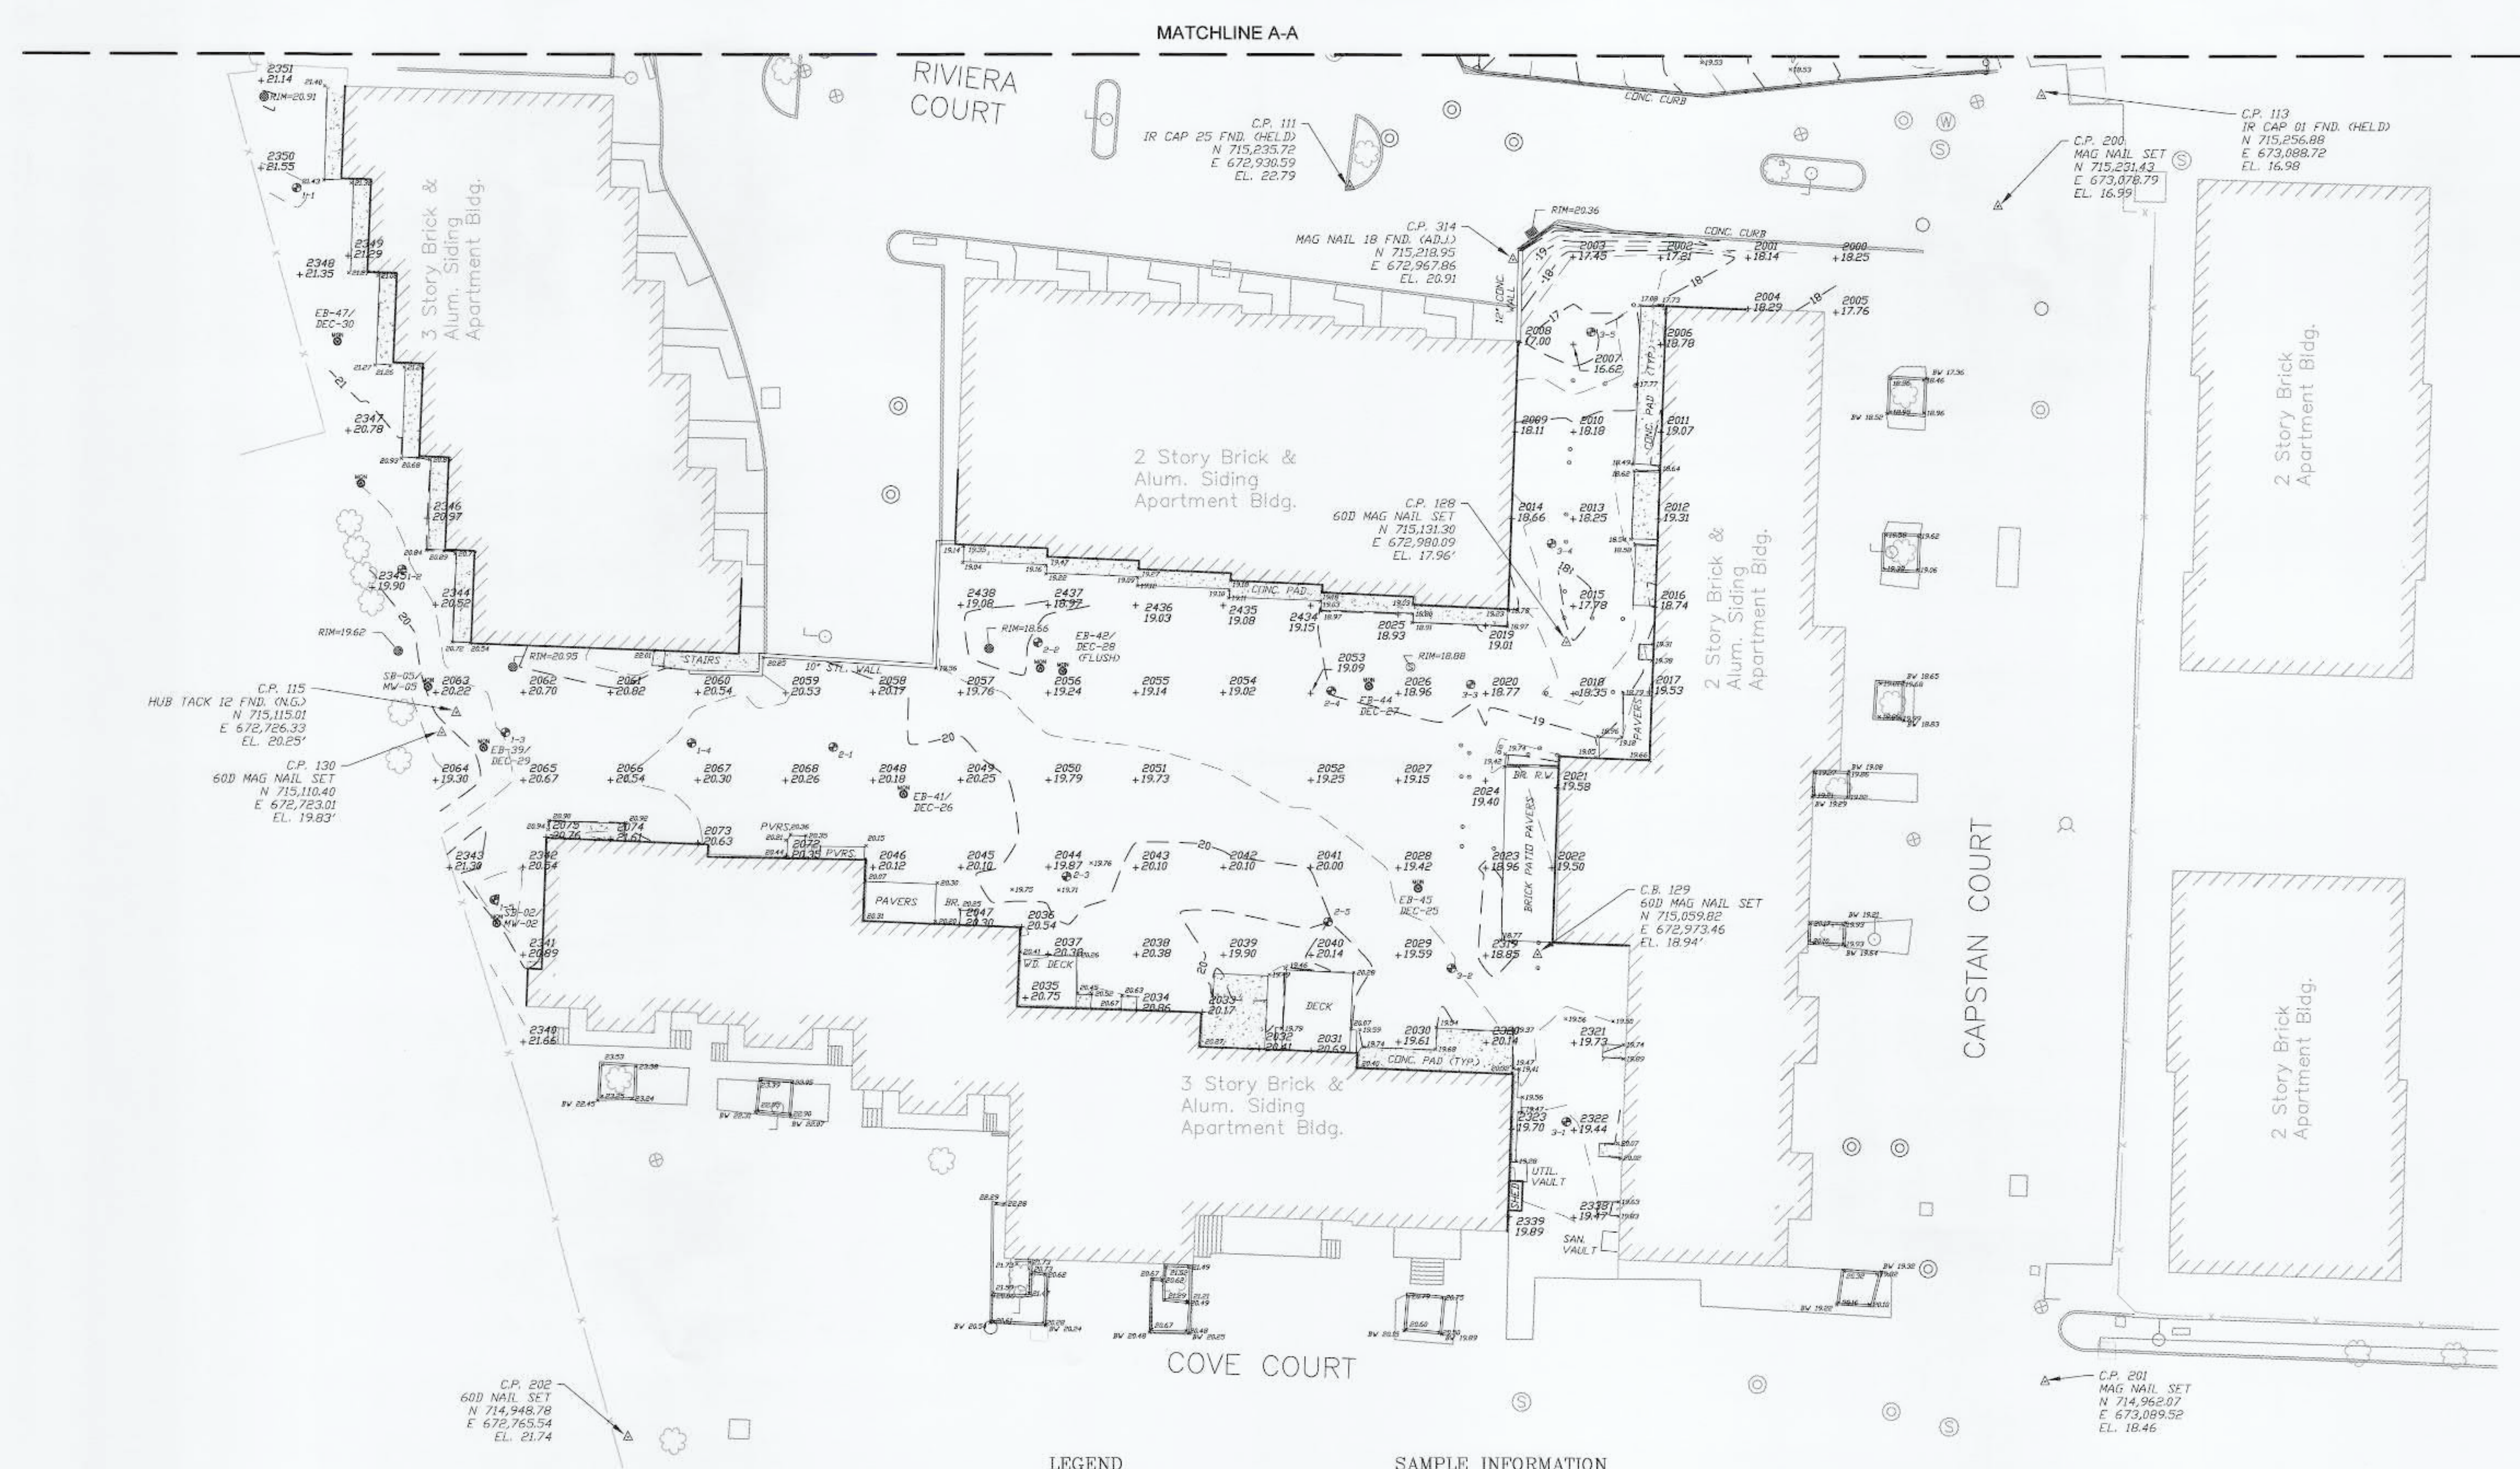
- NOTES**
- MEASUREMENTS ARE IN ACCORDANCE WITH U.S. STANDARDS.
  - HORIZONTAL DATUM IS REFERENCED TO THE NEW YORK STATE PLANE COORDINATE SYSTEM, NAD83, EAST ZONE. CONTROL POINT INFORMATION WAS PROVIDED BY CONTRACTOR THROUGH ELECTRONIC DRAWING FILES PREPARED BY URS CORP. (BUFFALO, N.Y.) IN DEC. 2017, PROJECT NO. 60536797.
