**CONSTRUCTION COMPLETION REPORT**

**COLLEGE POINT 3 IRM**

**SITE No. 2-41-122**

**COLLEGE POINT, NEW YORK**

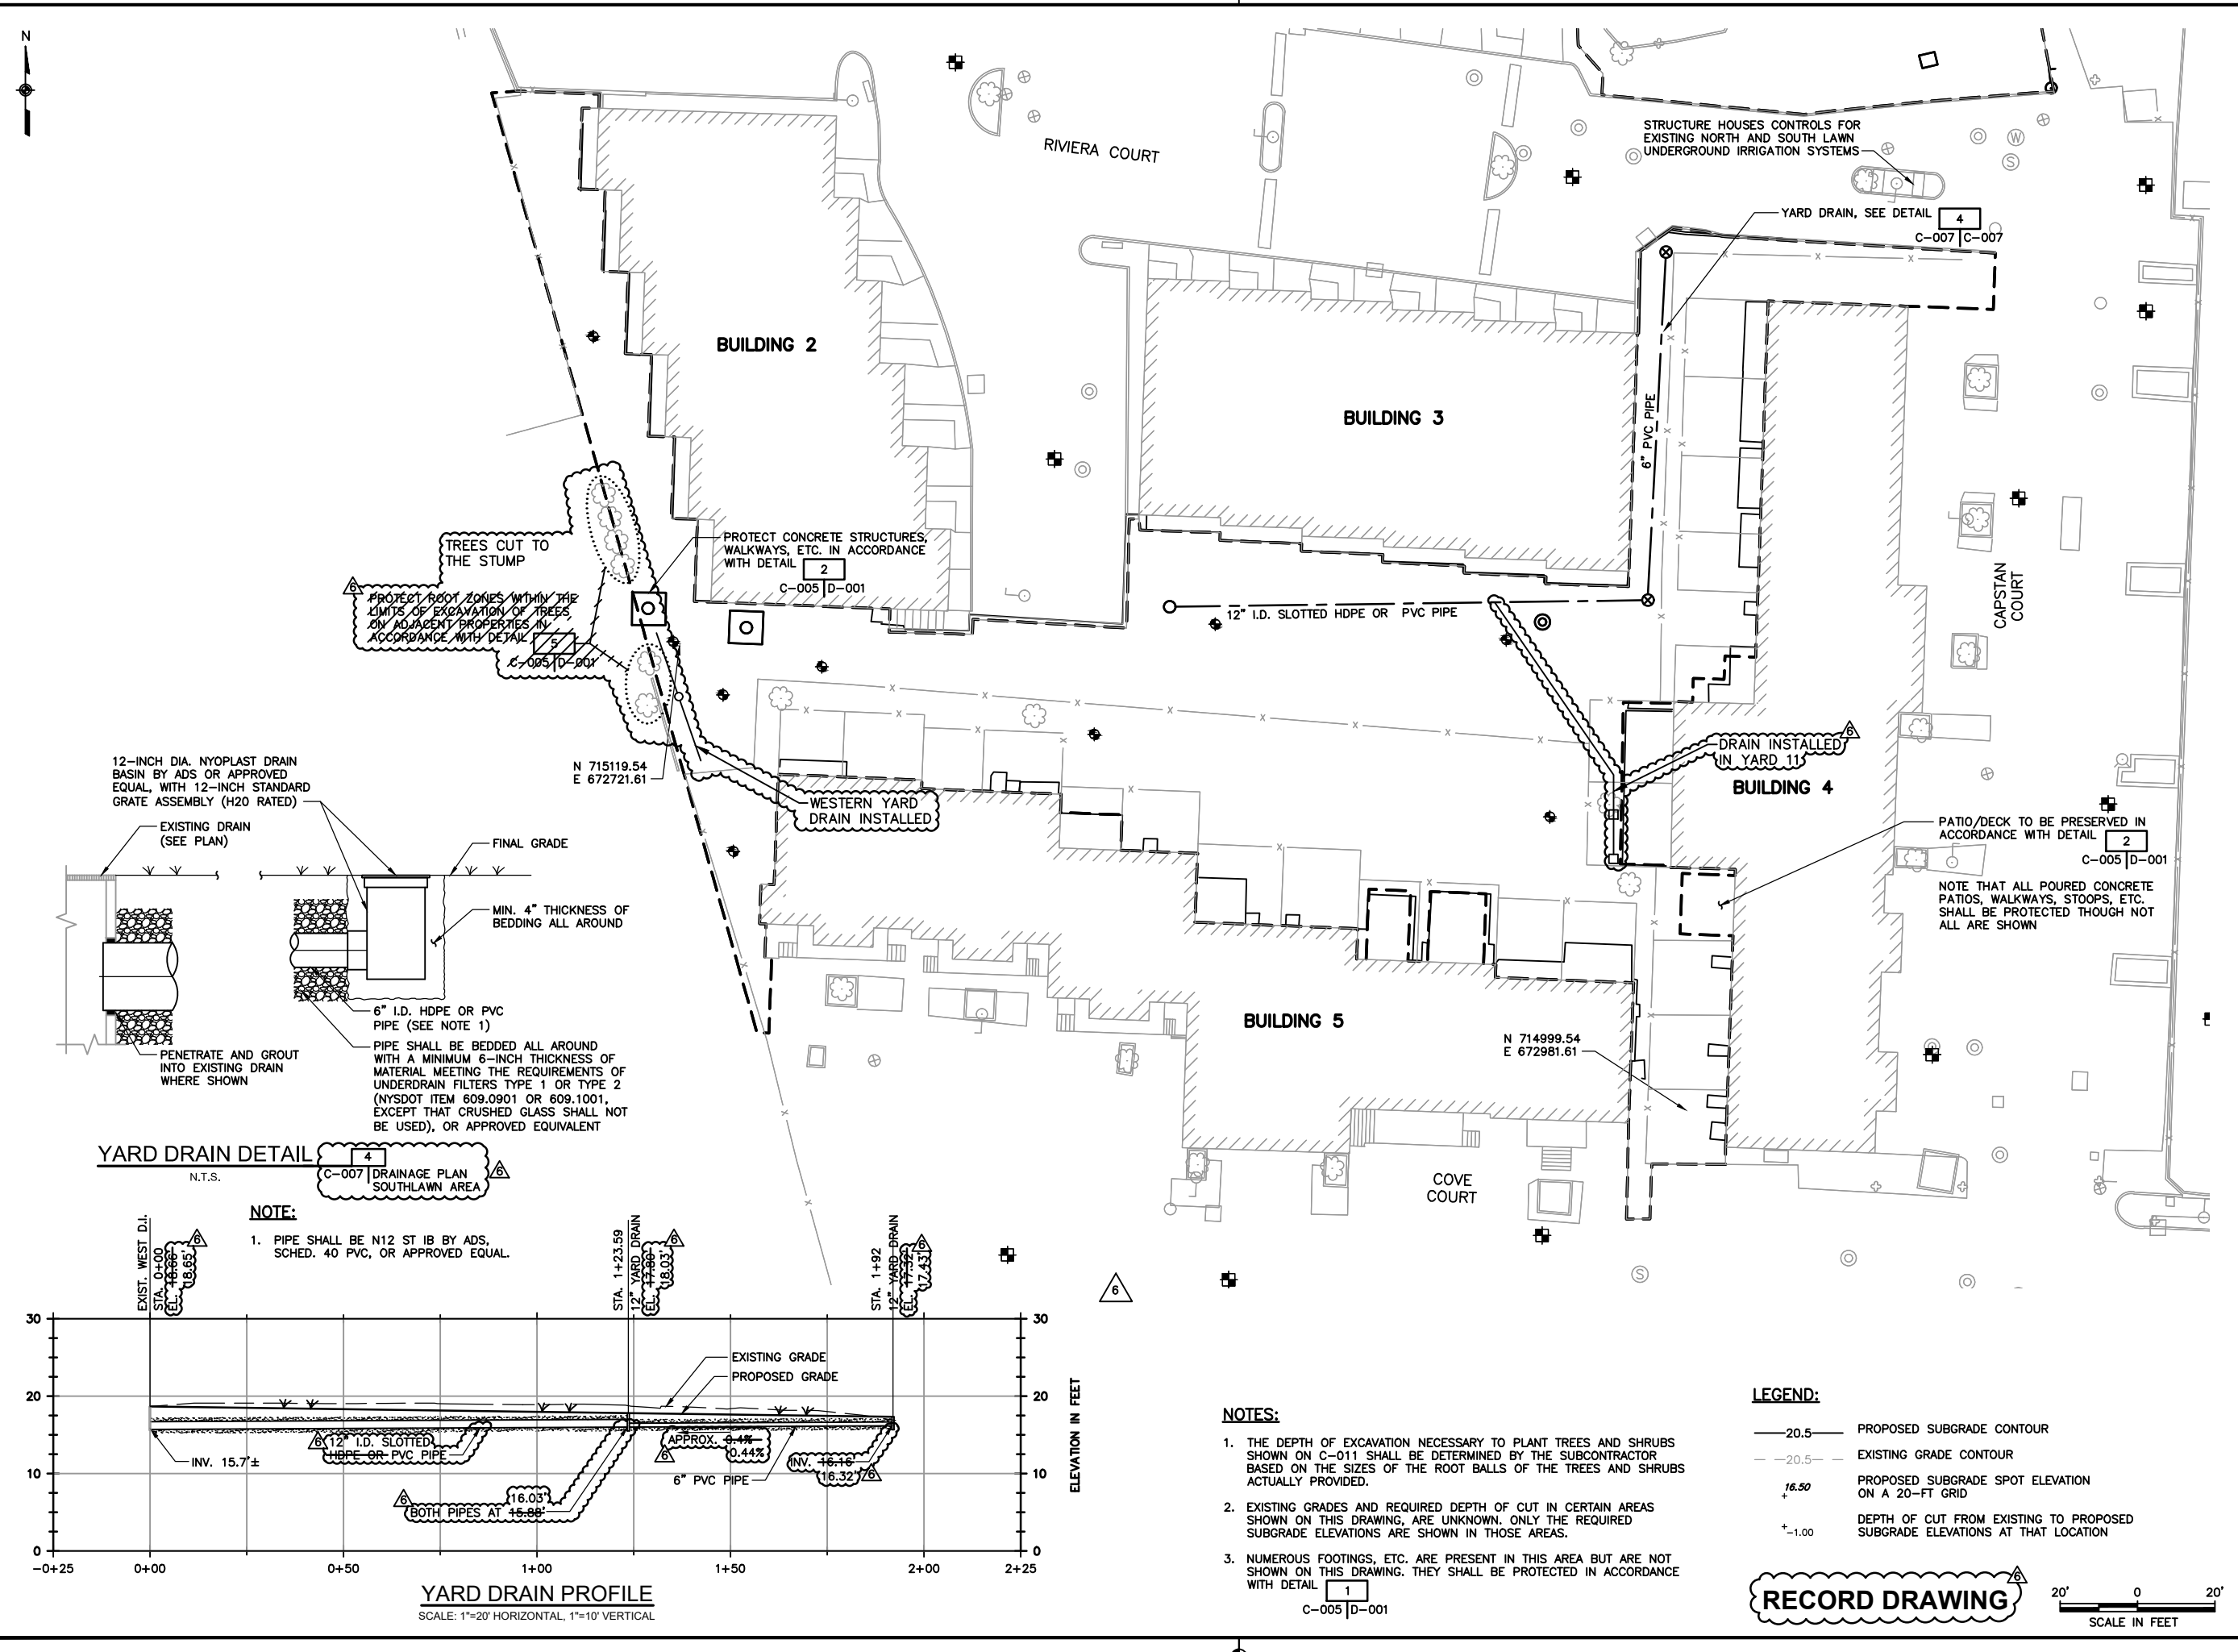
- NOTES:**
- THE DEPTH OF EXCAVATION NECESSARY TO PLANT TREES AND SHRUBS SHOWN ON C-011 SHALL BE DETERMINED BY THE SUBCONTRACTOR BASED ON THE SIZES OF THE ROOT BALLS OF THE TREES AND SHRUBS ACTUALLY PROVIDED.
  - EXISTING GRADES AND REQUIRED DEPTH OF CUT IN CERTAIN AREAS SHOWN ON THIS DRAWING, ARE UNKNOWN. ONLY THE REQUIRED SUBGRADE ELEVATIONS ARE SHOWN IN THOSE AREAS.
  - NUMEROUS FOOTINGS, ETC. ARE PRESENT IN THIS AREA BUT ARE NOT SHOWN ON THIS DRAWING. THEY SHALL BE PROTECTED IN ACCORDANCE WITH DETAIL 1
- C-005 | D-001
