DAILY FIELD REPORT

Project	291 Wallabout Street Site	**Report No.**	50
BCP Site	NYSDEC BCP SITE C224416	**Date**	08/26/2026
Location	291 Wallabout St	**File No.**	0211139
Client	291 Wallabout Realty LLC	**Temperature**	L: 65 H: 81
Contractor	Concrete Raptor Construction American Dewatering Grouting	**Wind Direction**	NW to SE up to 14 mph
Weather	Sunny	**Personnel on Site**	B. Chan
Humidity	60%	**Time on Site**	7:00am – 6:30pm

Haley & Aldrich of New York (Haley & Aldrich) was present to document implementation of the NYSDEC-Approved Remedial Action Work Plan (RAWP) and Decision Document dated November 2025. Site observations are summarized below.

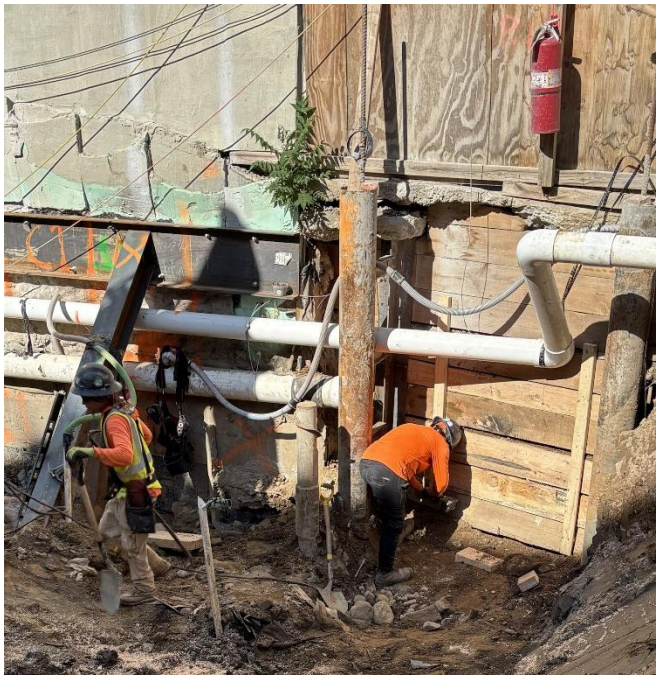
Photo 1: Contractor receiving construction material deliveries, facing east.
