18-46 Decatur Street
Periodic Review Report

18-46 Decatur Street, Ridgewood, Queens, New York
Block 3579, Lot 45
NYSDEC BCP Site Number: C241194

May 2022

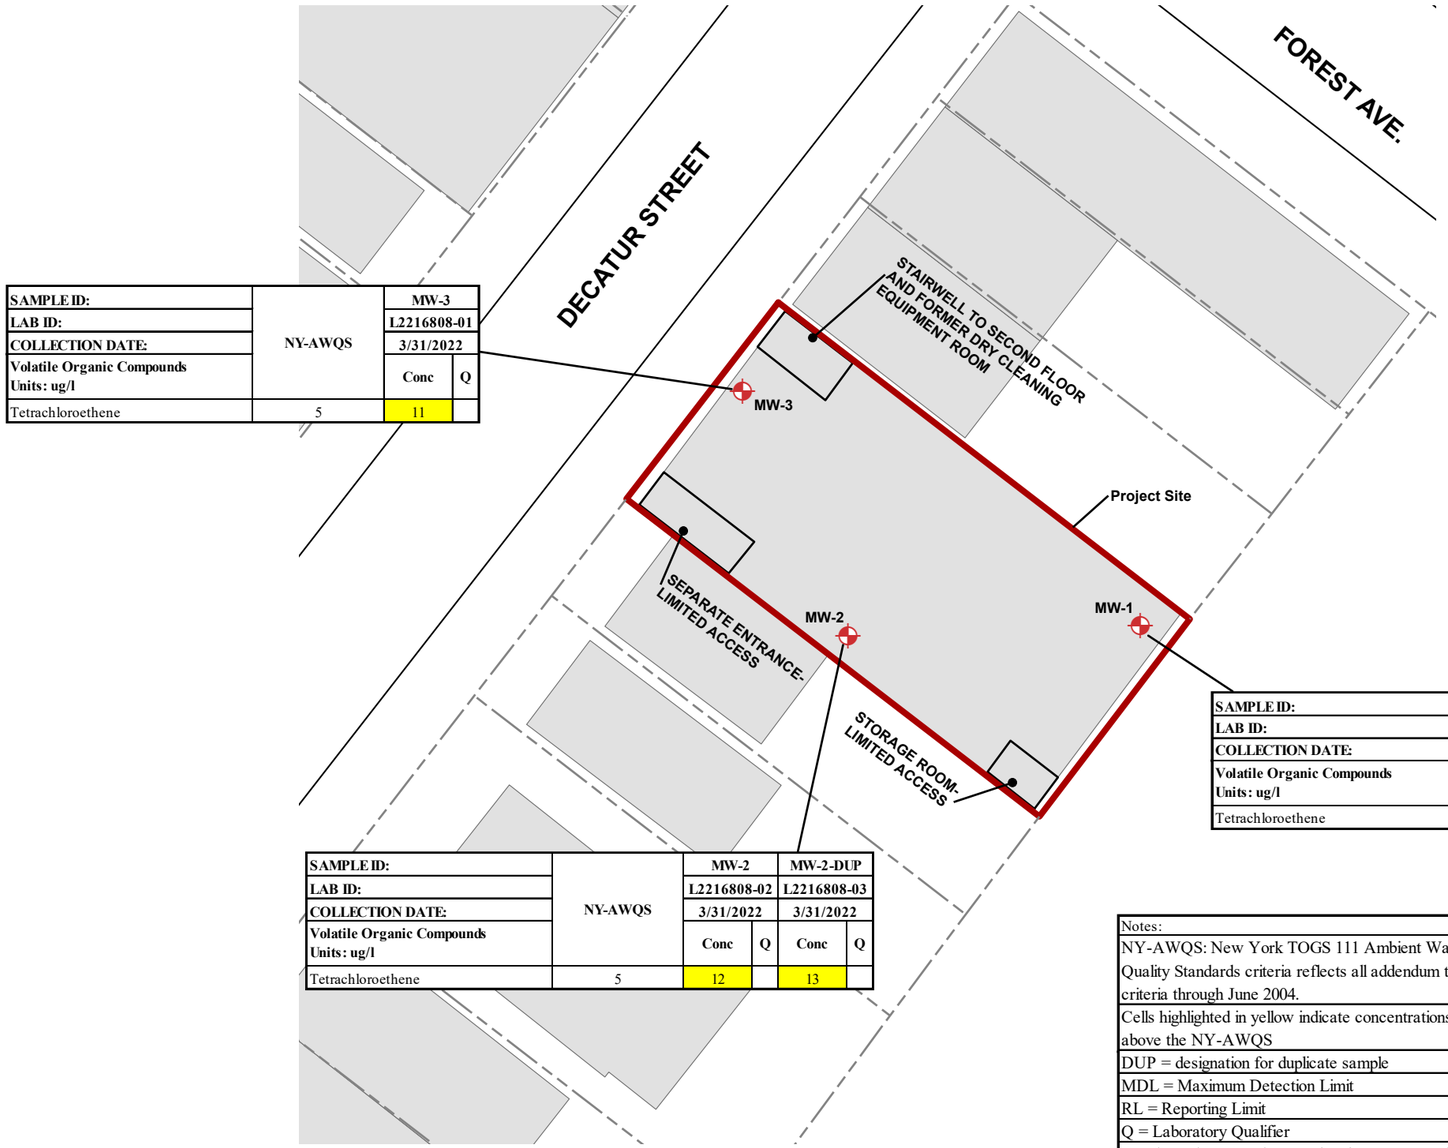
Drawing No: **Figure 4**

SAMPLE ID:		MW-3	
LAB ID:		L2216808-01	
COLLECTION DATE:	NY-AWQS	3/31/2022	
Volatile Organic Compounds Units: ug/l		Conc	Q
Tetrachloroethene	5	11

SAMPLE ID:		MW-1	
LAB ID:		L2216808-04	
COLLECTION DATE:	NY-AWQS	3/31/2022	
Volatile Organic Compounds Units: ug/l		Conc	Q
Tetrachloroethene	5	11
