From:	Montroy, Brian <brian.montroy@hdrinc.com></brian.montroy@hdrinc.com>
Sent:	Tuesday, September 01, 2020 9:18 AM
То:	Spellman, John (DEC)
Subject:	RE: Clarkstown Landfill, 344001
Attachments:	Operation and Maintenance Report 2019 Final.pdf

I am sorry for the delay in getting you this report. Please find attached the 2019 Annual O&M Report for the Clarkstown Landfill. If you need any additional information or if you have any questions please feel free to contact me. Thank you and have a great day.

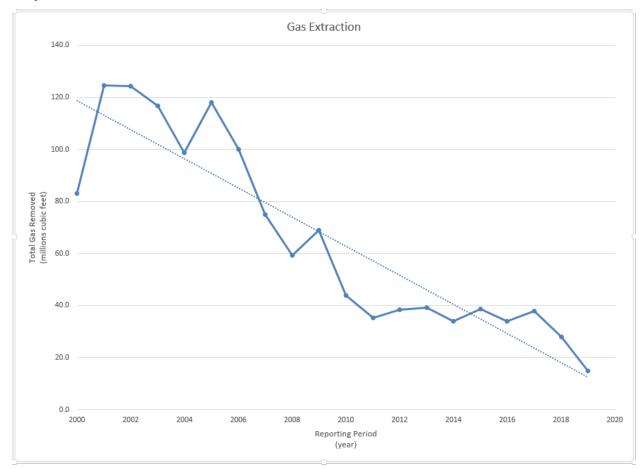
Graph 4-1: Gas Volume Extraction Trends

Graph 4-1 illustrates the volume of landfill gas removed on an annual basis. The graph illustrates a decreasing trend in the volume of gas removed from the Landfill over the past 19 years. This is the typical and expected result of continued landfill gas removal.

The total LFG recovered in 2019 was approximately 15 million cubic feet. This is a significant drop in production compared to the previous year's volume (28 million cubic feet). This is likely a function of decreased production of methane gas at the landfill and the operational down time experience due to the electrical and UV sensor issues. The system operated for 2,348 hours in 2019, which to 65% runtime based on a 10 hour per day operation cycle. This is an increase over the previous reporting year's runtime of 33%.

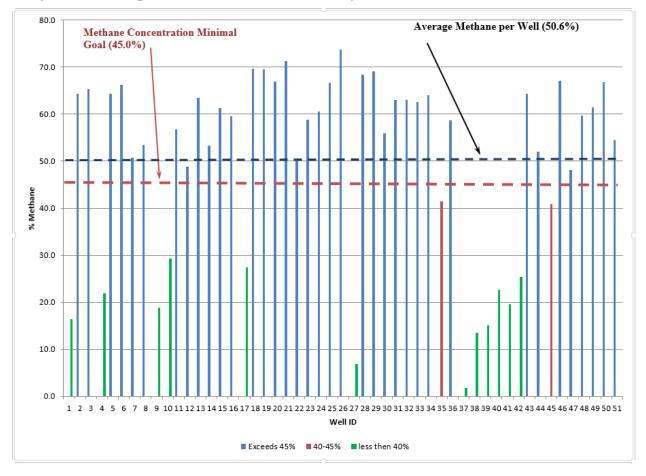
Graph 4-2 Average Methane Concentrations per Extraction Well

At the flare station, oxygen is introduced and controlled by the flare actuator and louvers to create optimum burning conditions. Nitrogen has no effect on the system operation since it is an inert gas; however, the presence of nitrogen in excess of 10% may suggest ambient air intrusion. The gas quality averages for each well are illustrated in the graph below.

The average methane composition during this period was 50.6% (up from 39% the previous year). Thirty eight wells had an average methane concentration above the 45% methane goal. Thirteen of the thirty six wells were below the goal (>45%) but within 5% of it. The remaining twelve wells had average methane concentrations less than 40%. Ten of the twelve wells are located along the perimeter of the Landfill or in low lying areas. Diminishing methane levels are expected in these areas and data from the last 19 years, which show a reduction in methane production along the perimeter, confirms this. Methane production and accumulation along the Landfill perimeter remains low despite limiting the flow using valve settings.

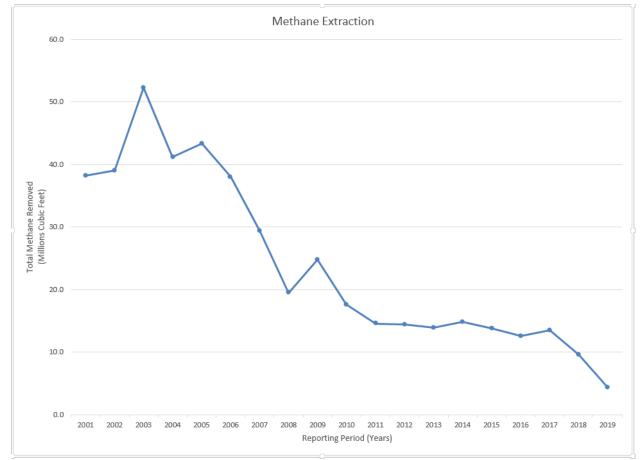
Graph 4-3 Annual Methane Removal over Time

Graph 4-3 illustrates annual methane removal at the Landfill as an approximation based on field measurements recorded during monthly O&M events. An estimated 4.42 million cubic feet of methane were removed during the 2019 reporting period. The graph illustrates the decreasing rate of methane removal from the Landfill over the past 19 reporting periods.
