Clove and Maple Former Manufactured Gas Plant (MGP) Site

Proposed Remedial Action
Plan for Operable Unit 2
January 2012

**CLOVE AND MAPLE FORMER MGP SITE
HAVERSTRAW, NEW YORK**

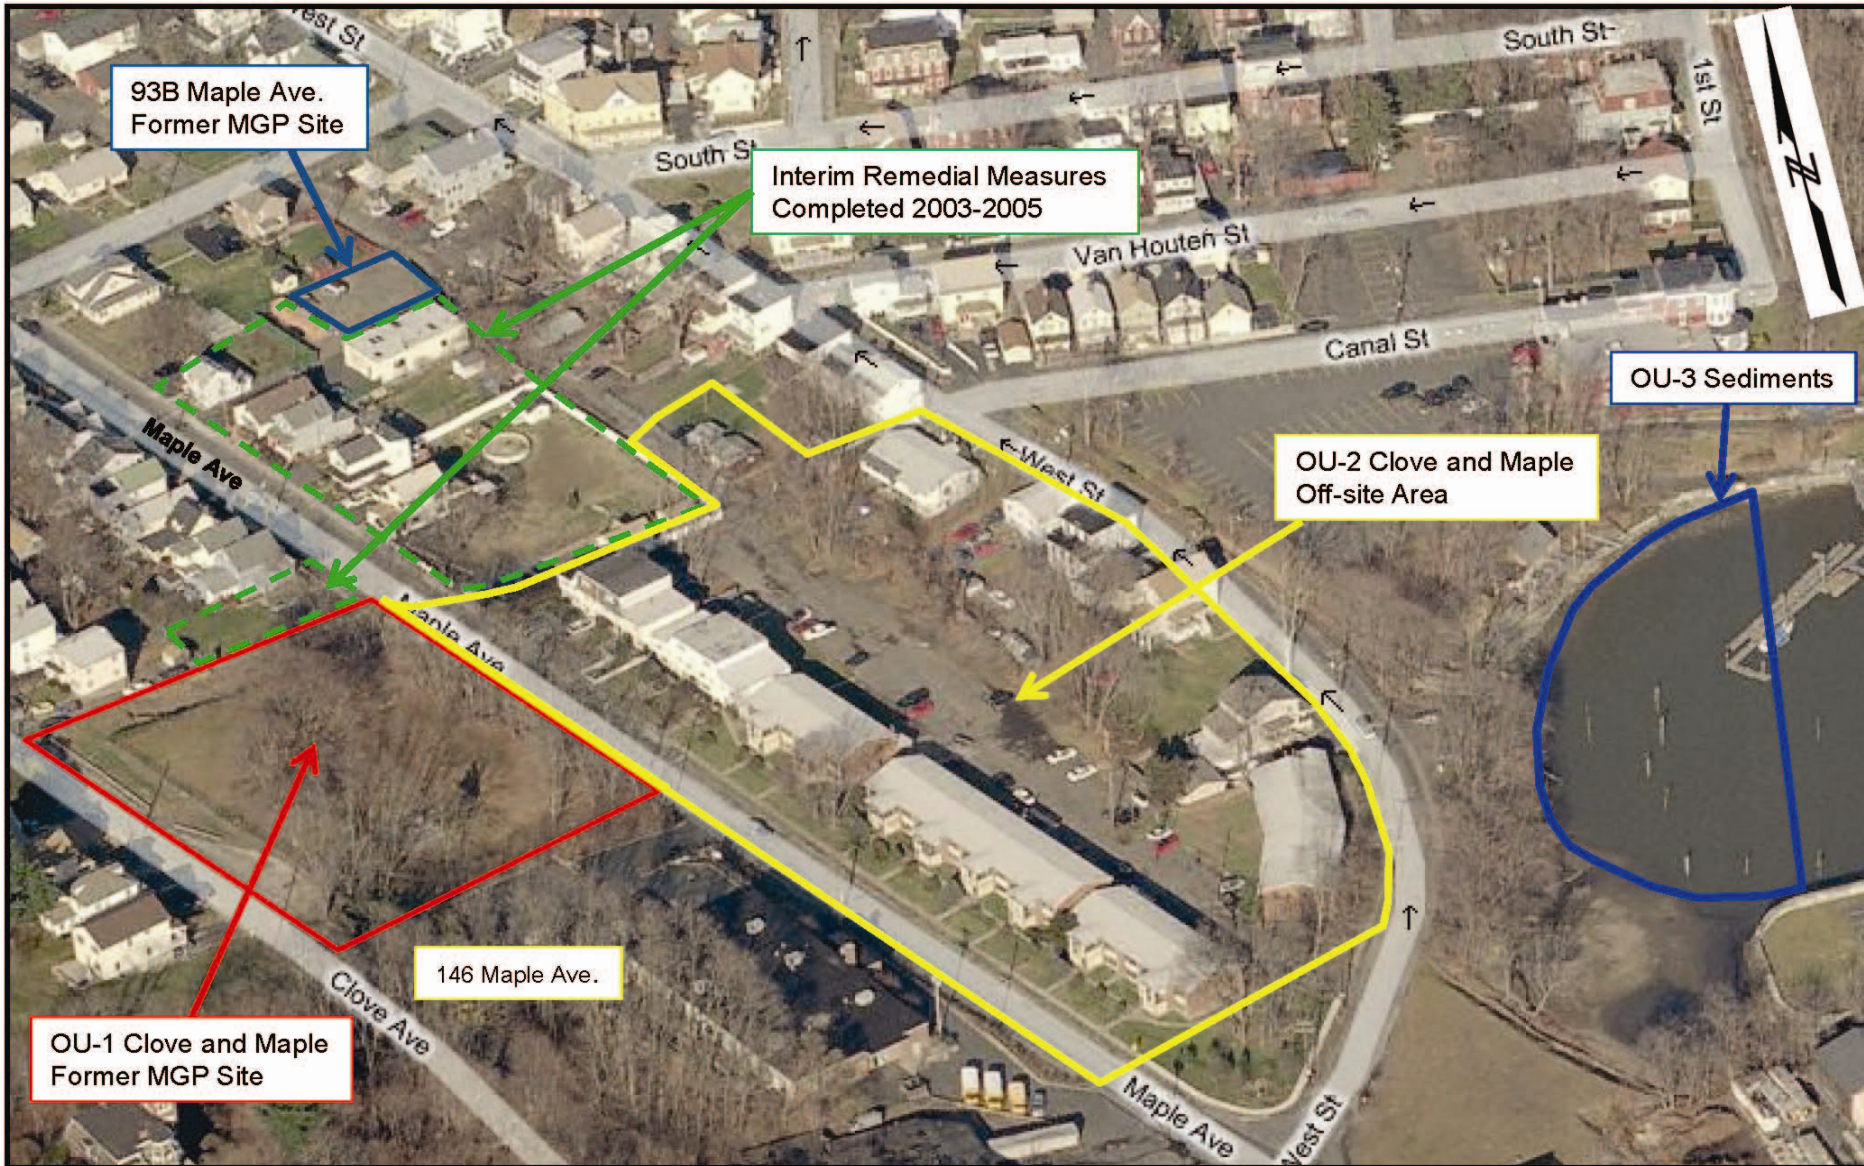
Figure 2

**OU-1 AND OU-2
LOCATION AERIAL
PHOTOGRAPH**
