**CROTON BAY SEEPAGE CONTROL
WORK PLAN
HARMON RAILROAD YARD**

**Harmon Railroad Yard
Croton-on-Hudson, New York**

1 November 1995

ERM-Northeast
*475 Park Avenue South
29th Floor
New York, New York 10016*

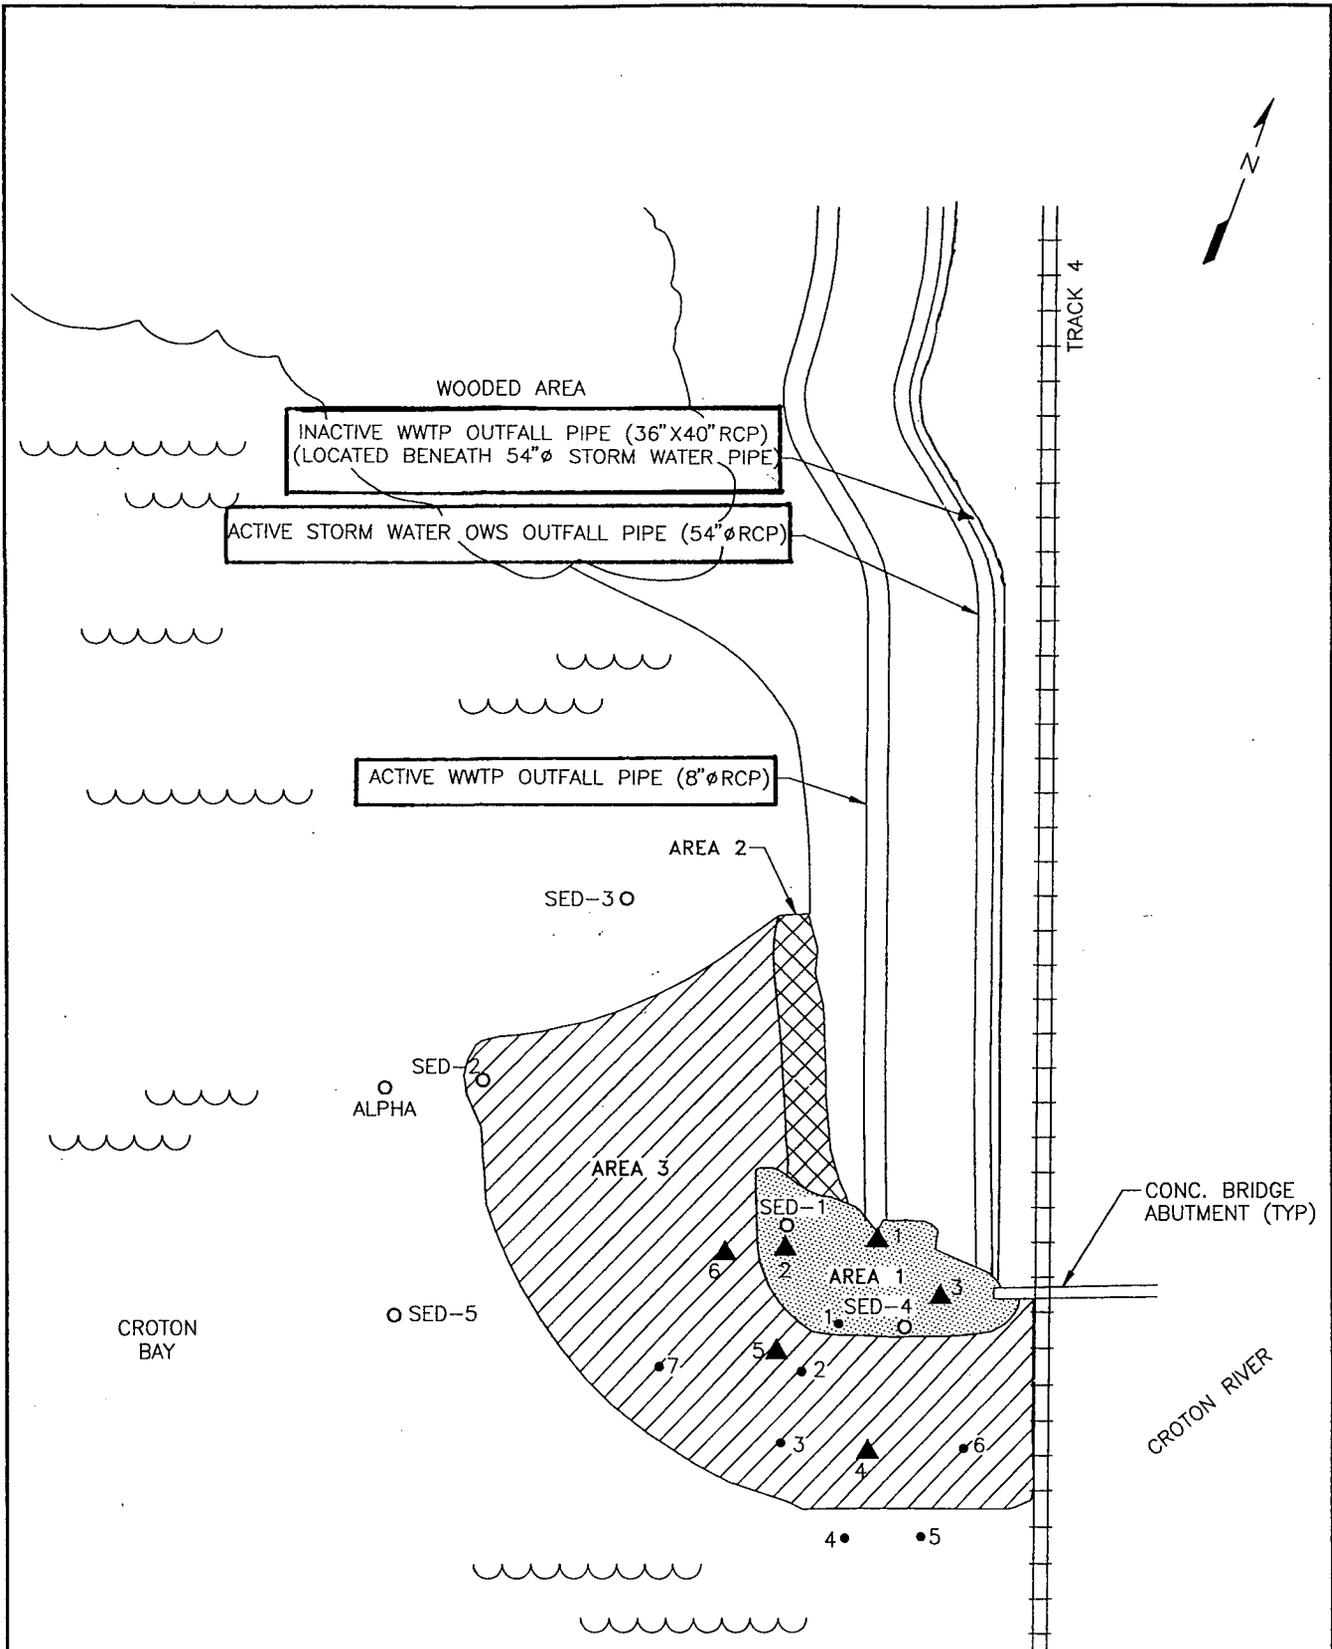
- 5 • SOUNDING POINTS
- SED-5 ○ SEDIMENT SAMPLING POINT
- ▲ PROPOSED SEDIMENT SAMPLING LOCATIONS

TITLE			
CROTON BAY SEDIMENT SAMPLING LOCATIONS HARMON YARD			
PREPARED FOR			
METRO NORTH COMMUTER RAILROAD			
ERM-Northeast Environmental Resources Management ERM	SCALE	FIGURE	
	NTS	A	
DATE	10/27/95		
DRAWN	JOB NO.	FILE NAME

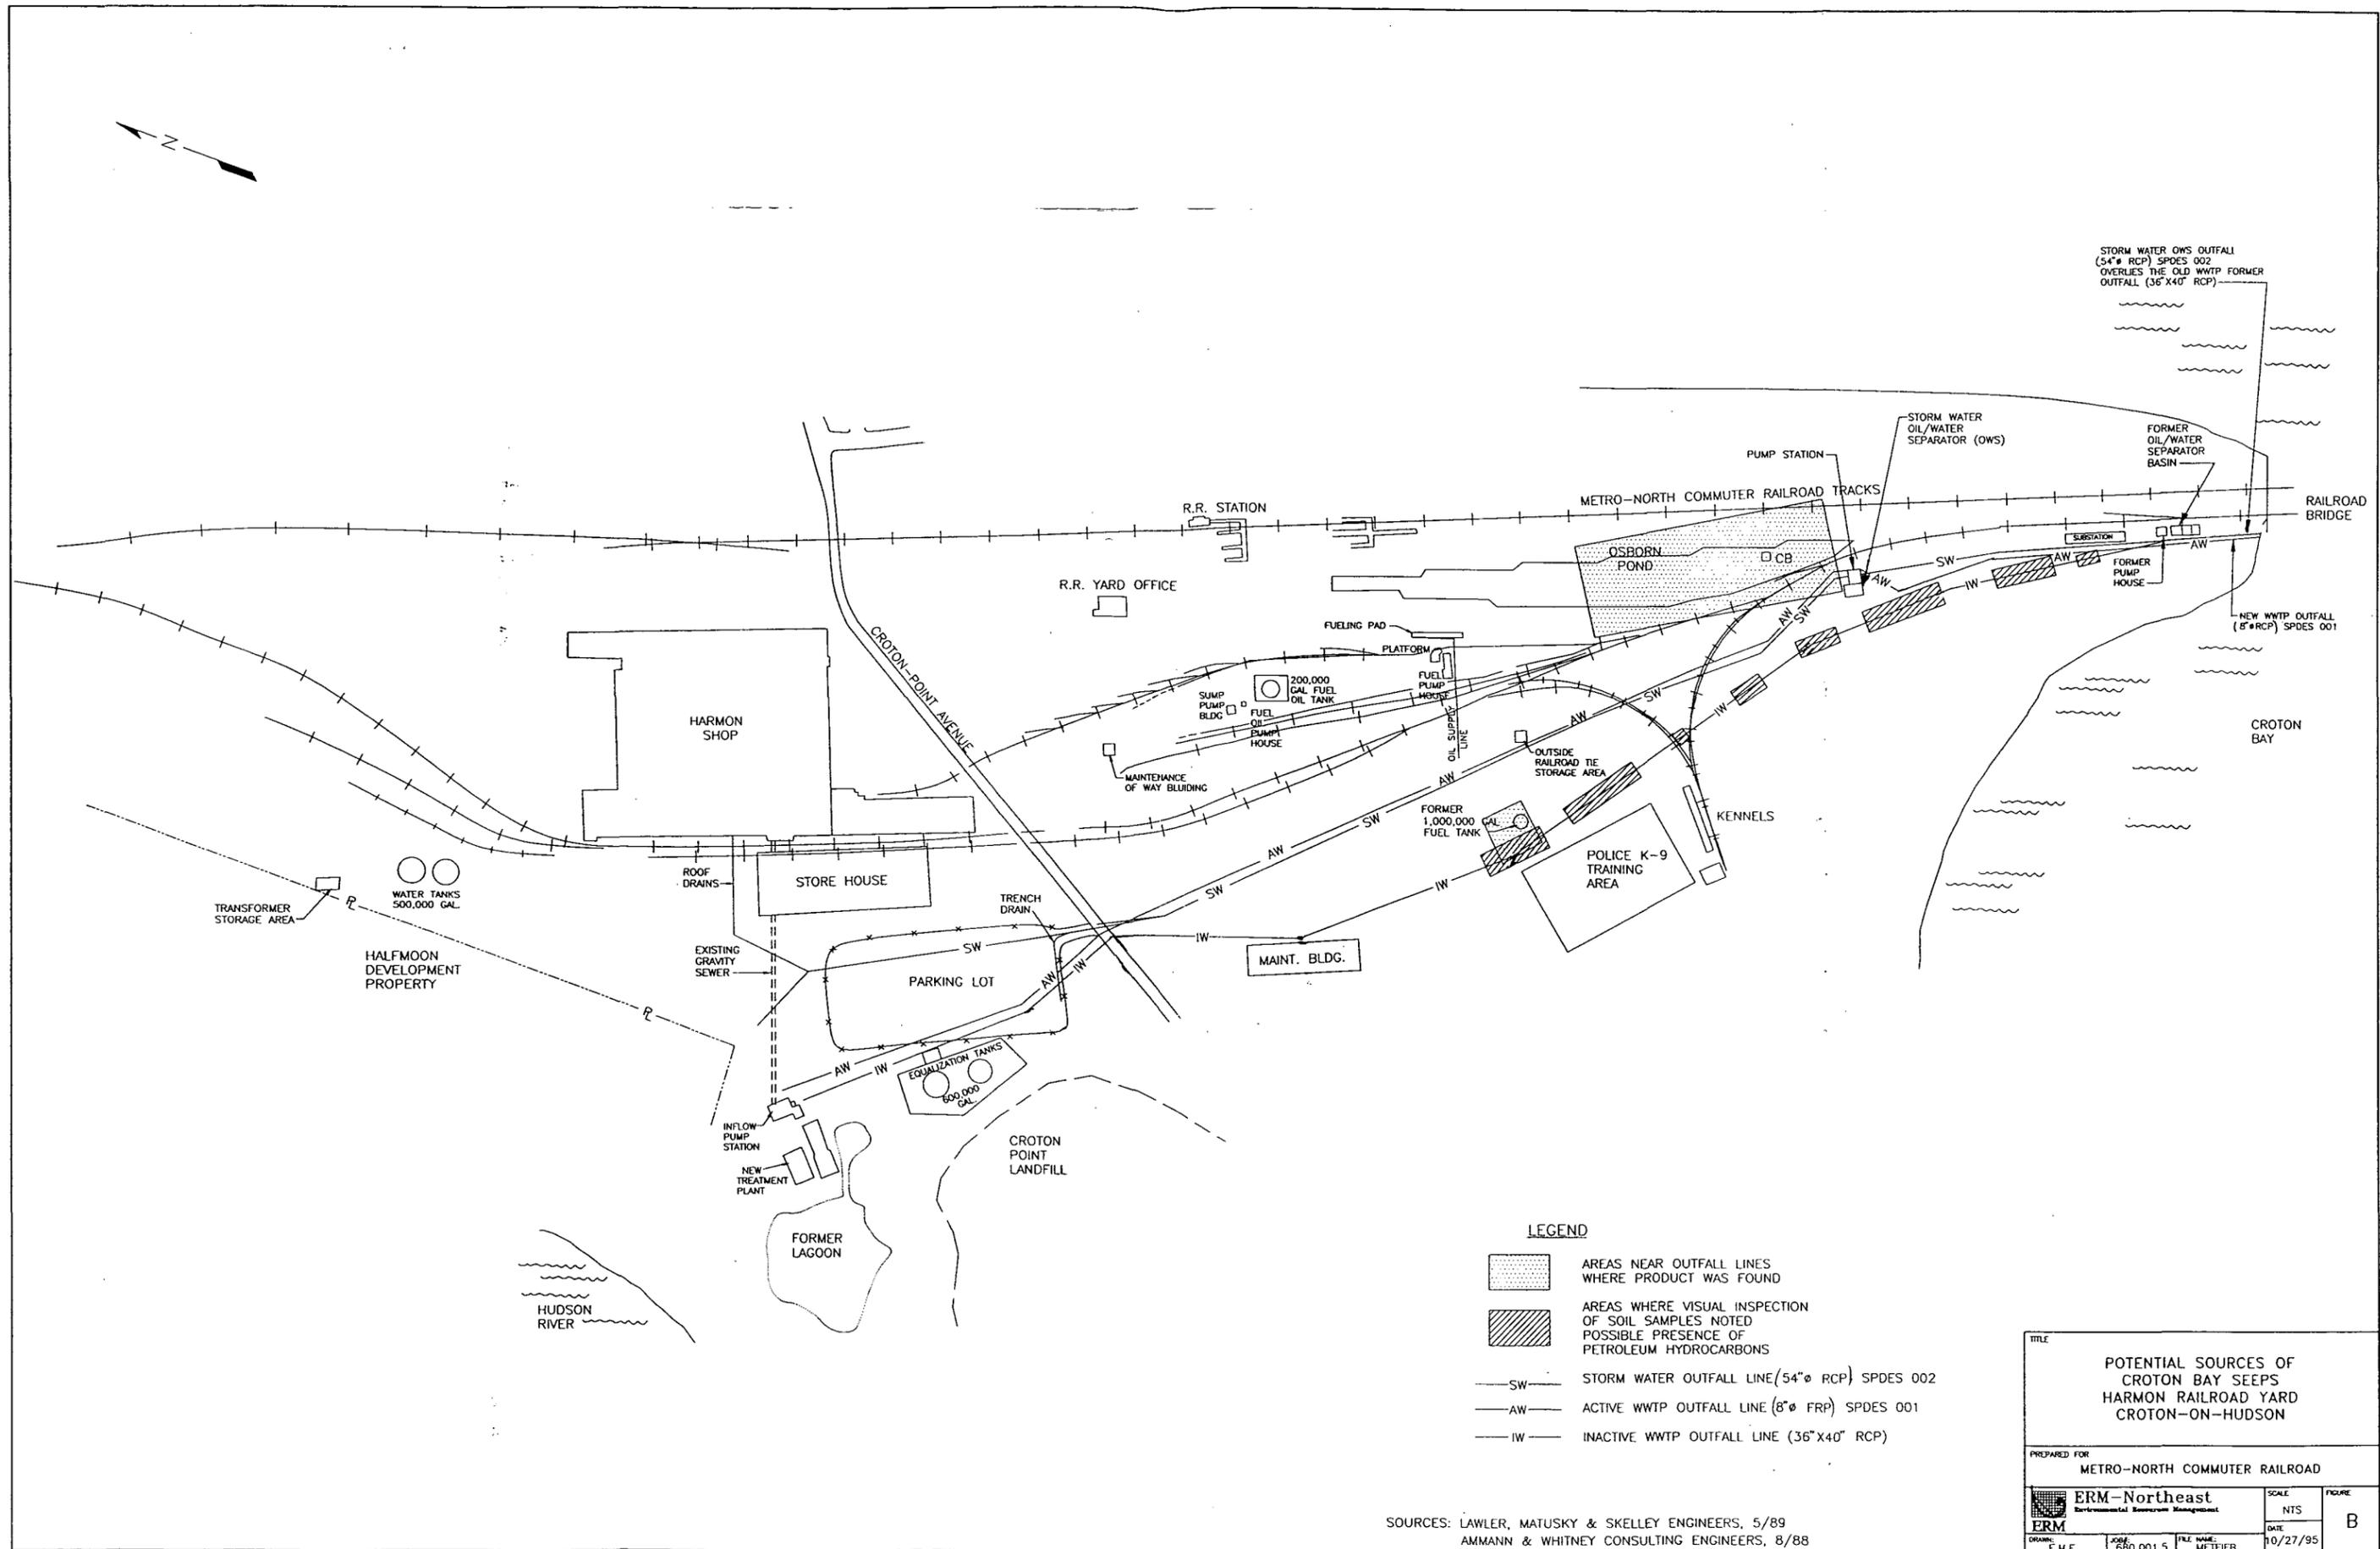
TITLE			
POTENTIAL SOURCES OF CROTON BAY SEEPS HARMON RAILROAD YARD CROTON-ON-HUDSON			
PREPARED FOR METRO-NORTH COMMUTER RAILROAD			
ERM-Northeast Environmental Resource Management	SCALE NTS	FIGURE B	
DRAWN: E.M.F.	JOB: 680.001.5	FILE NAME: MET11FB	DATE 10/27/95

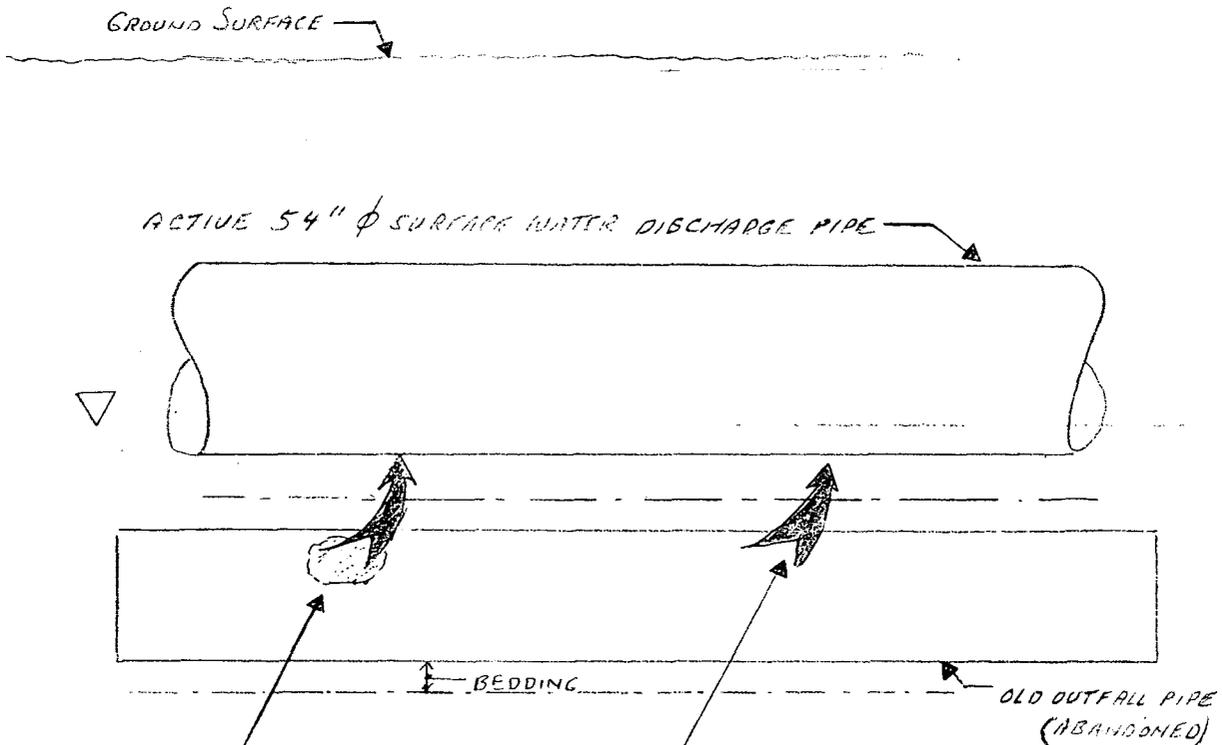
POSSIBLE MIGRATION OF PETROLEUM FROM BEDDING AND SOIL AROUND OLD OUTFALL PIPE TO BEDDING AROUND ACTIVE STORM WATER DISCHARGE PIPE

POSSIBLE MIGRATION OF PETROLEUM FROM CRACKS AND BREAKS IN PIPE TO BEDDING OF ACTIVE STORM WATER PIPES

Possible Petroleum
Migration Pathway

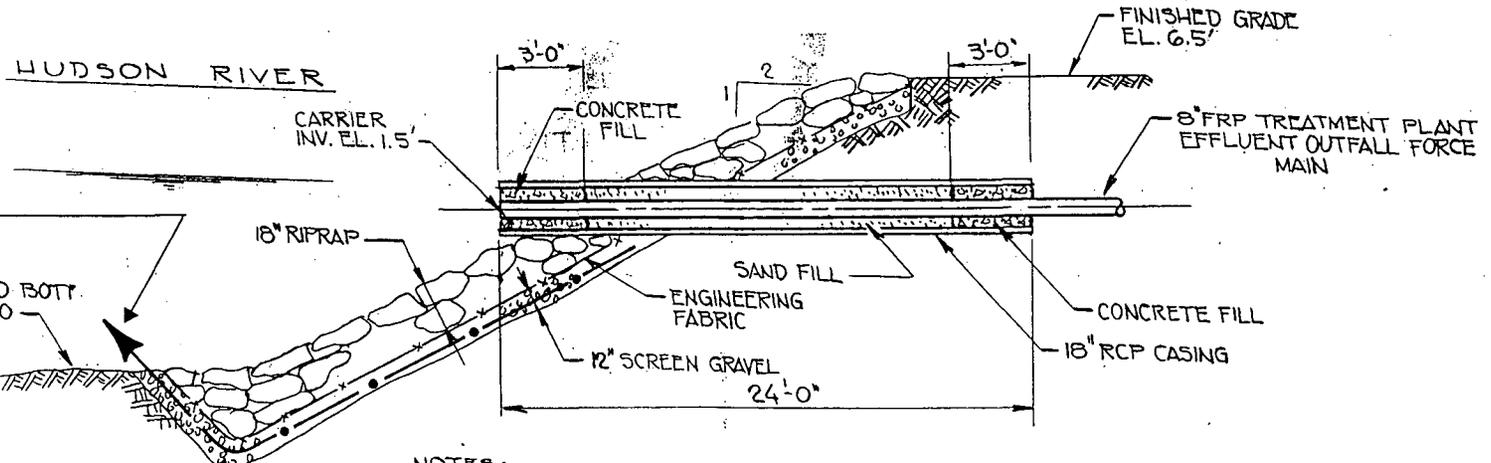
1. PREPARE AREA FOR DISCHARGE PIPE 5 FEET EACH SIDE OF PIPE.
2. RIPRAP TO EXTEND BELOW MEAN LOW WATER.
3. MIN. DIMENSION OF RIPRAP 12",

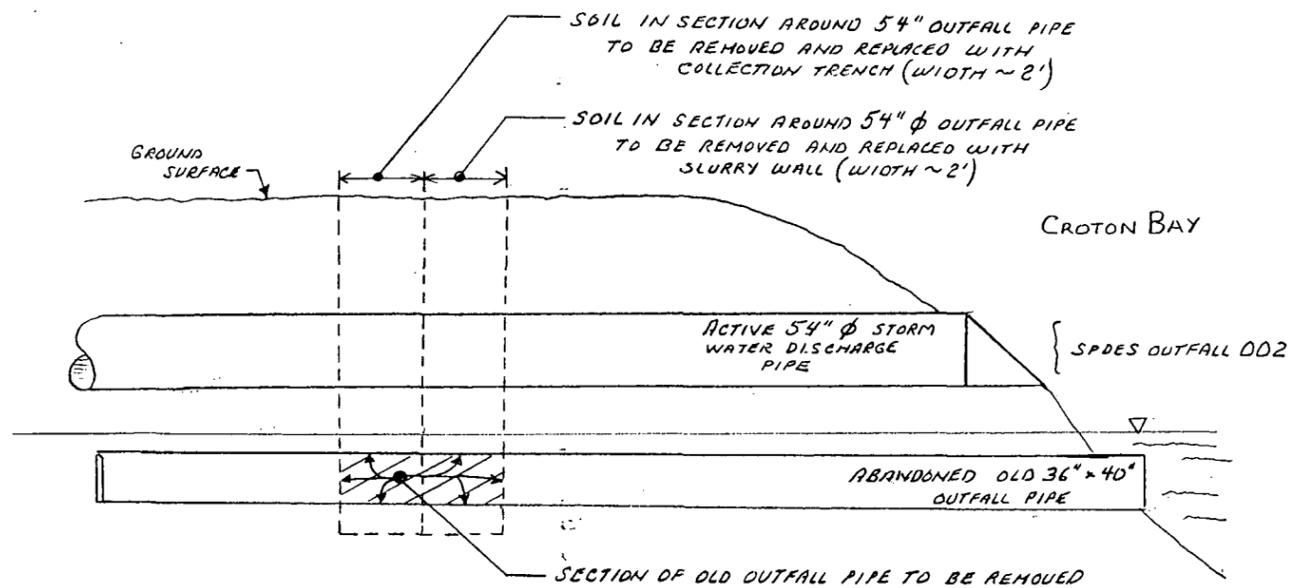
PROFILE VIEW
PRIOR TO CONSTRUCTION

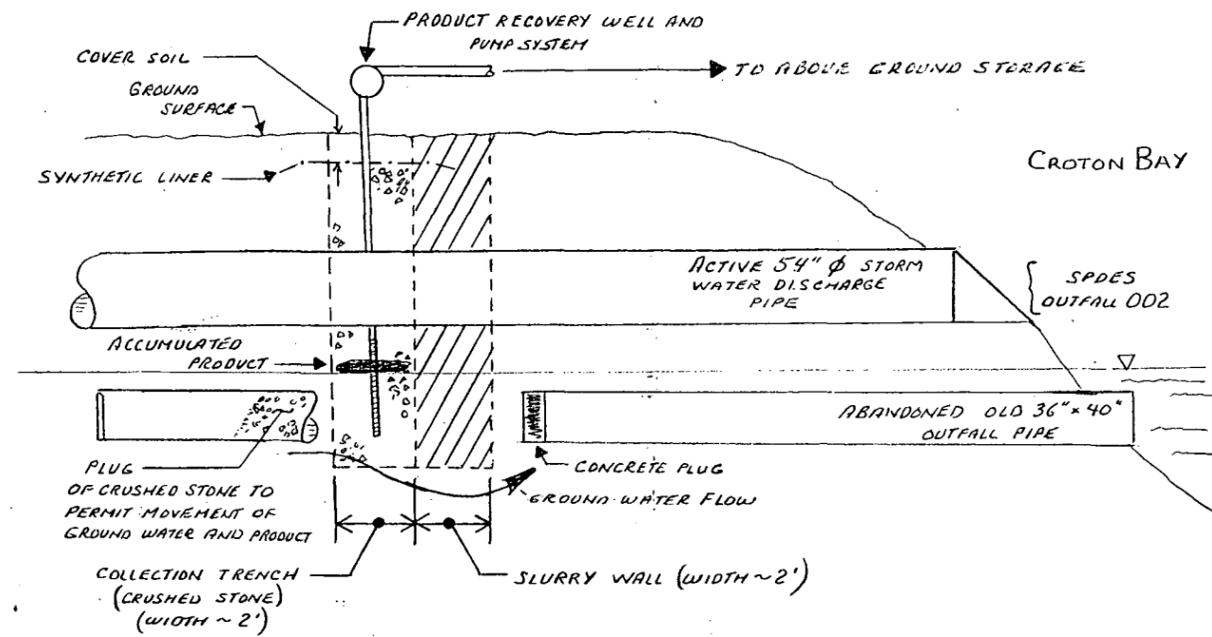
PROFILE VIEW
AFTER CONSTRUCTION

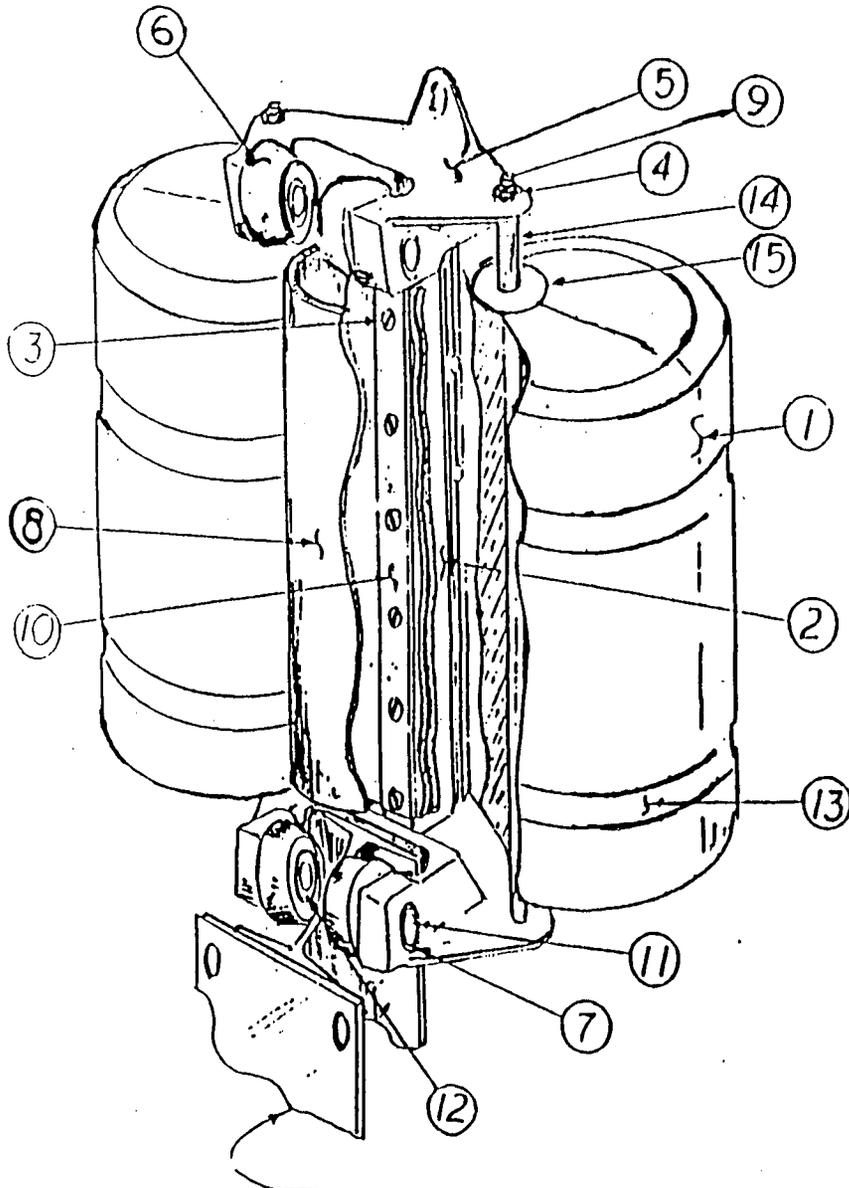
1. MOLDED POLYETHYLENE FLOATS.
2. MK2 EXTRU. 6063-T5
3. 10-32 X 3/4 FHMS S/S
4. 3/8 16 HH NYLOCK NUT
5. RISER CASTINGS AL.
6. 2" DIA. URETHANE WHEEL
7. EXT. IND. RETAIN. RING
8. 1/8" NITRILE RUBBER SEAL
9. 3/8" DIA. THREADED ROD SS.
10. 3/16" X 1" ALUM. STRIP
11. 1/2" RND. X 1 3/4" 303 SS AXLE
12. 1/2" ID X 7/8" OD FLAT WASH.
13. SS HOSE CLAMP
14. 1/2" ID NYLON TUBE SPACER
15. 3/8" ID X 2" OD X 1/8" POLY WASH.

BULKHEAD RISERS AVAILABLE IN NOMINAL 18", 24" 36"
AND SPECIAL SIZES IN STANDARD AND HEAVY DUTY MODELS

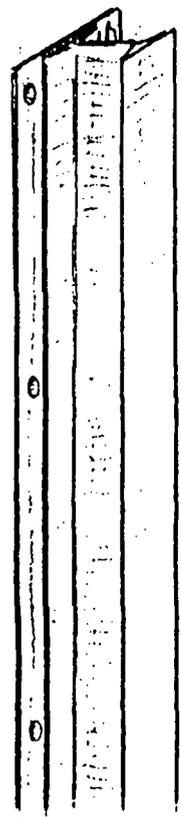
STRAIGHT

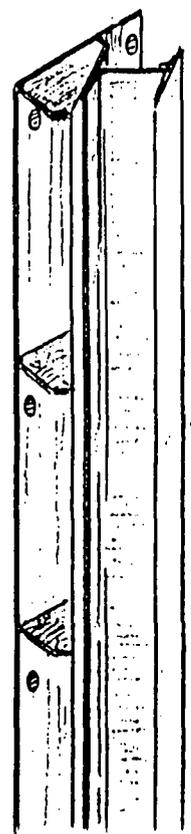
ANGLED

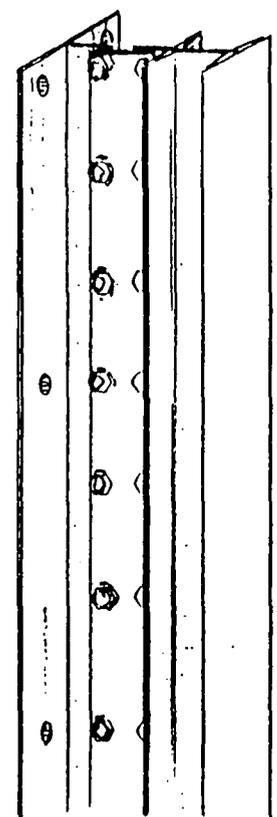
FLEXIBLE
± 60°

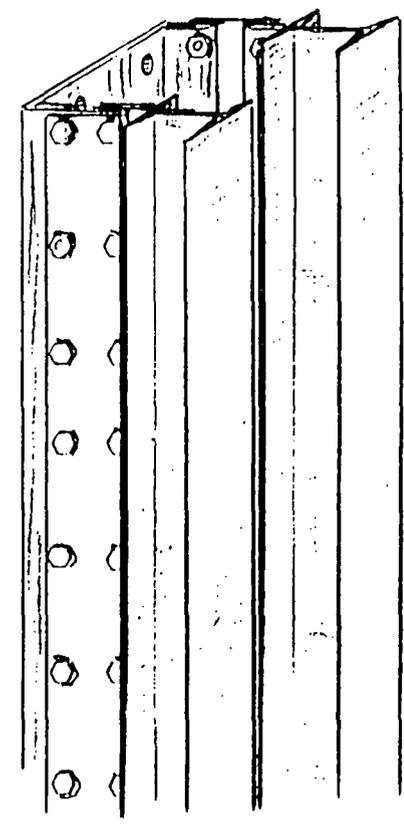
DOUBLE FLEXIBLE
± 60° x 2

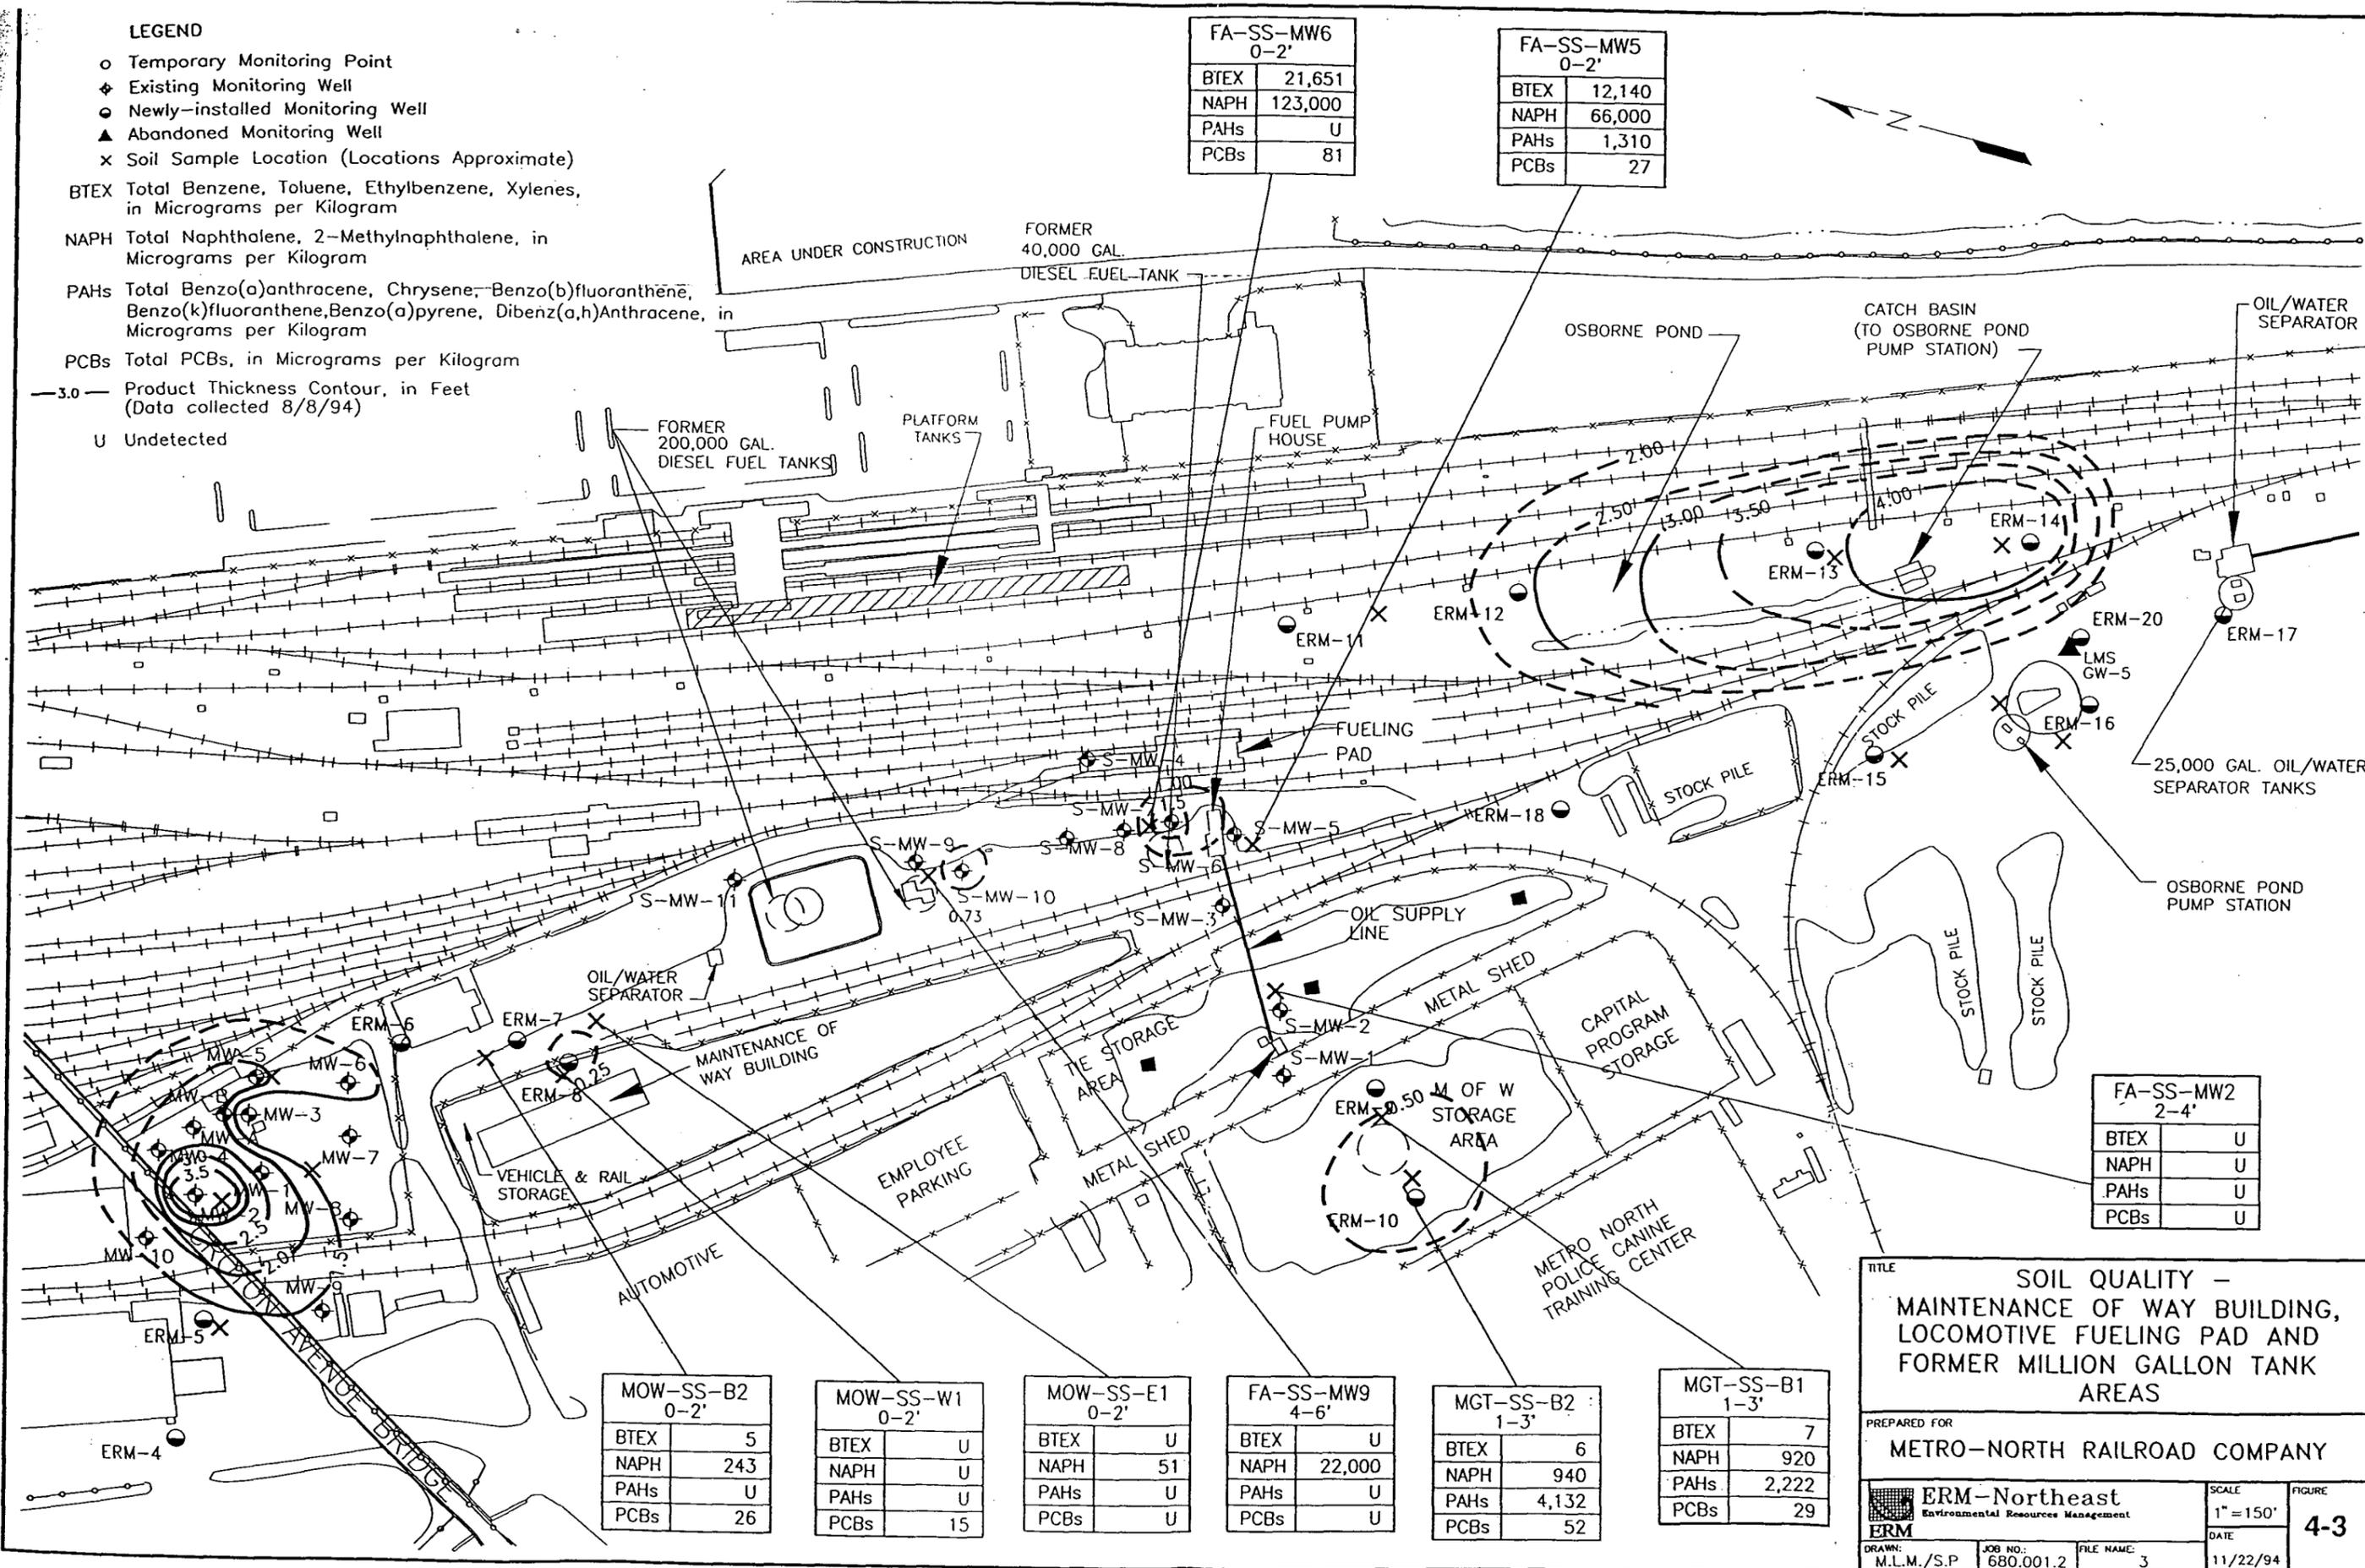
TITLE
**SOIL QUALITY -
 MAINTENANCE OF WAY BUILDING,
 LOCOMOTIVE FUELING PAD AND
 FORMER MILLION GALLON TANK
 AREAS**

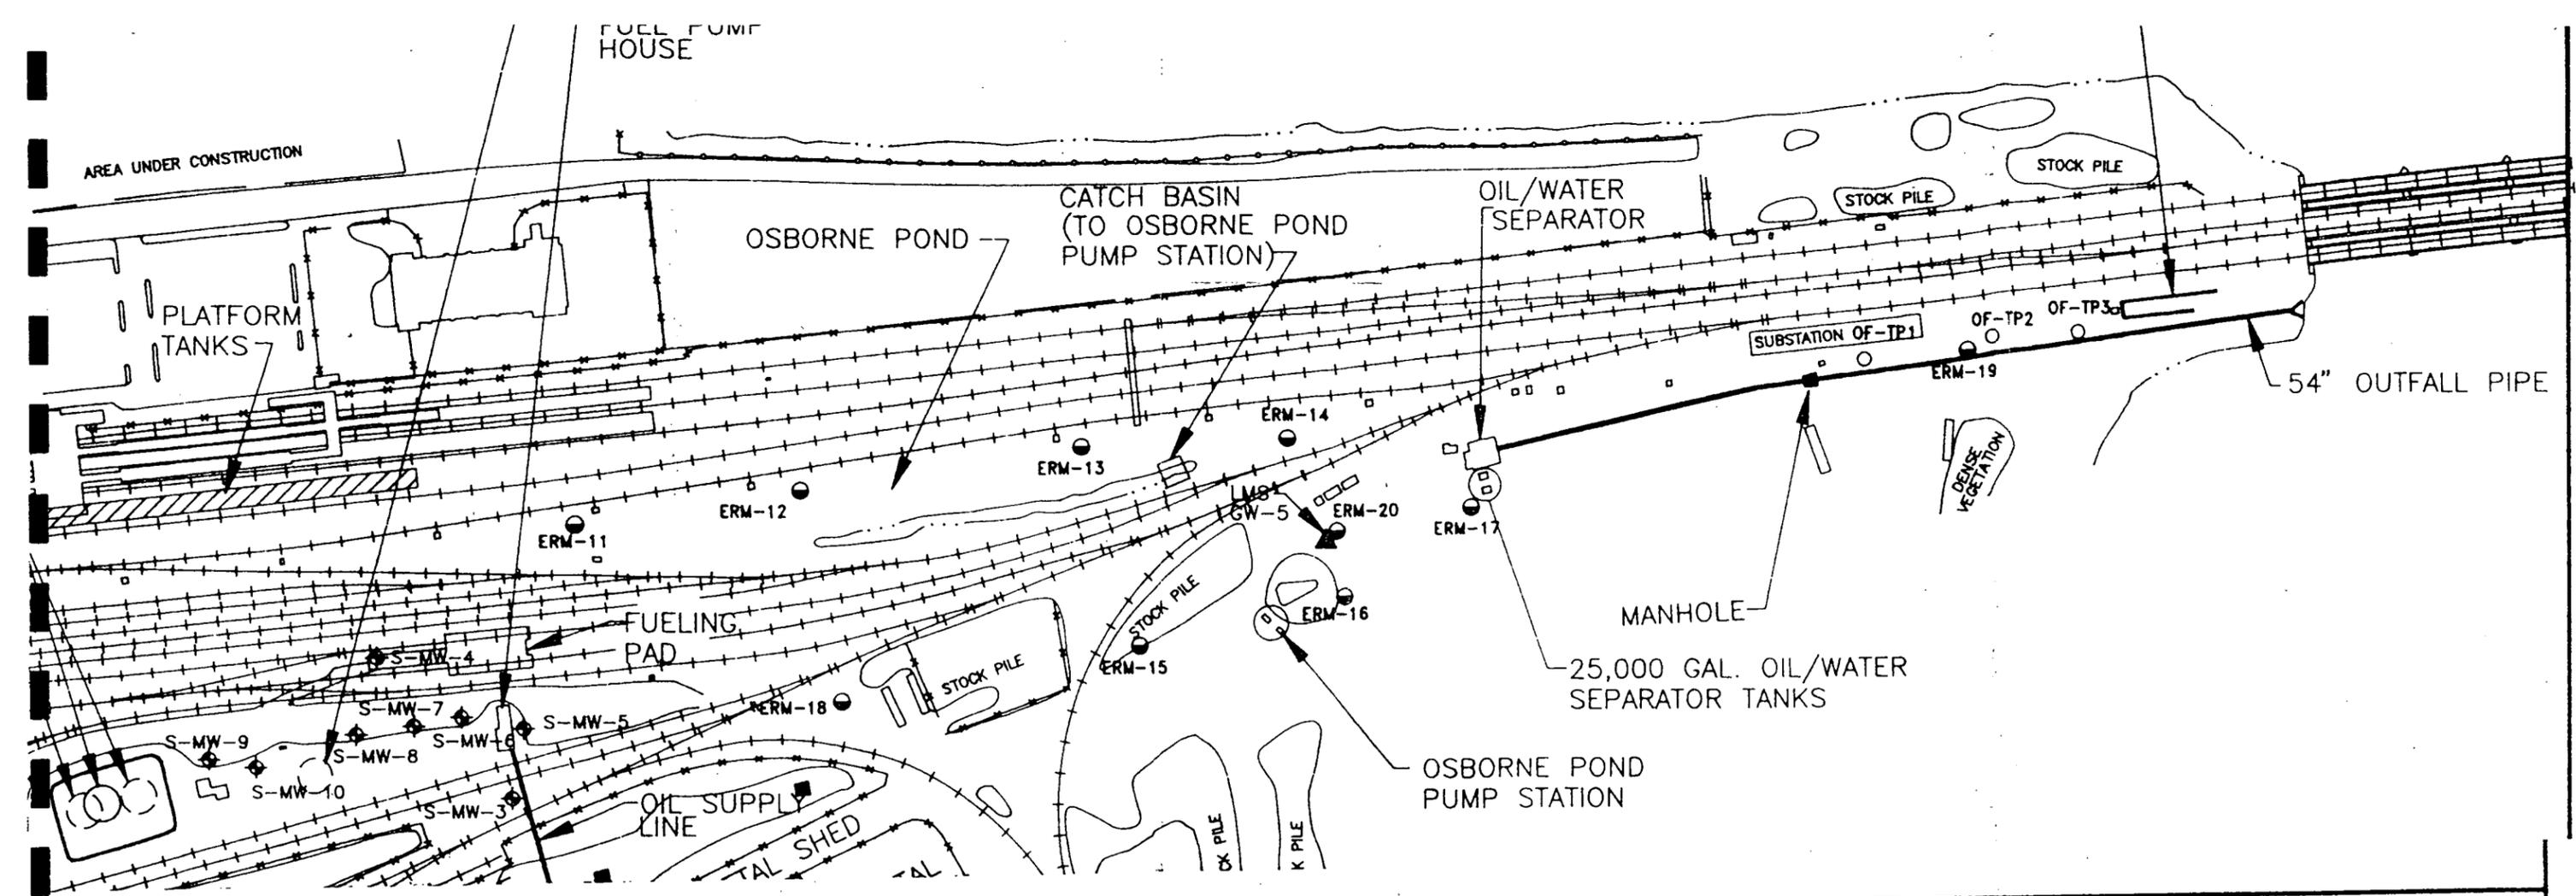
CHECKED	DATE	<h2 style="margin: 0;">SITE PLAN AND MONITORING WELL LOCATIONS</h2>			DRAWING NO.			
		DESIGN ENGINEER					1-2		REV. NO.	
		PROJECT ENGINEER								
		PROJECT MANAGER								
		APPROVED					DRAWN	S.G./E.M.F.	DATE	OCT. 20, 1994
		APPROVED		SCALE	1"=150'	JOB NO.	680.001.5	FILE NAME	94METRO	
								SHEET	OF

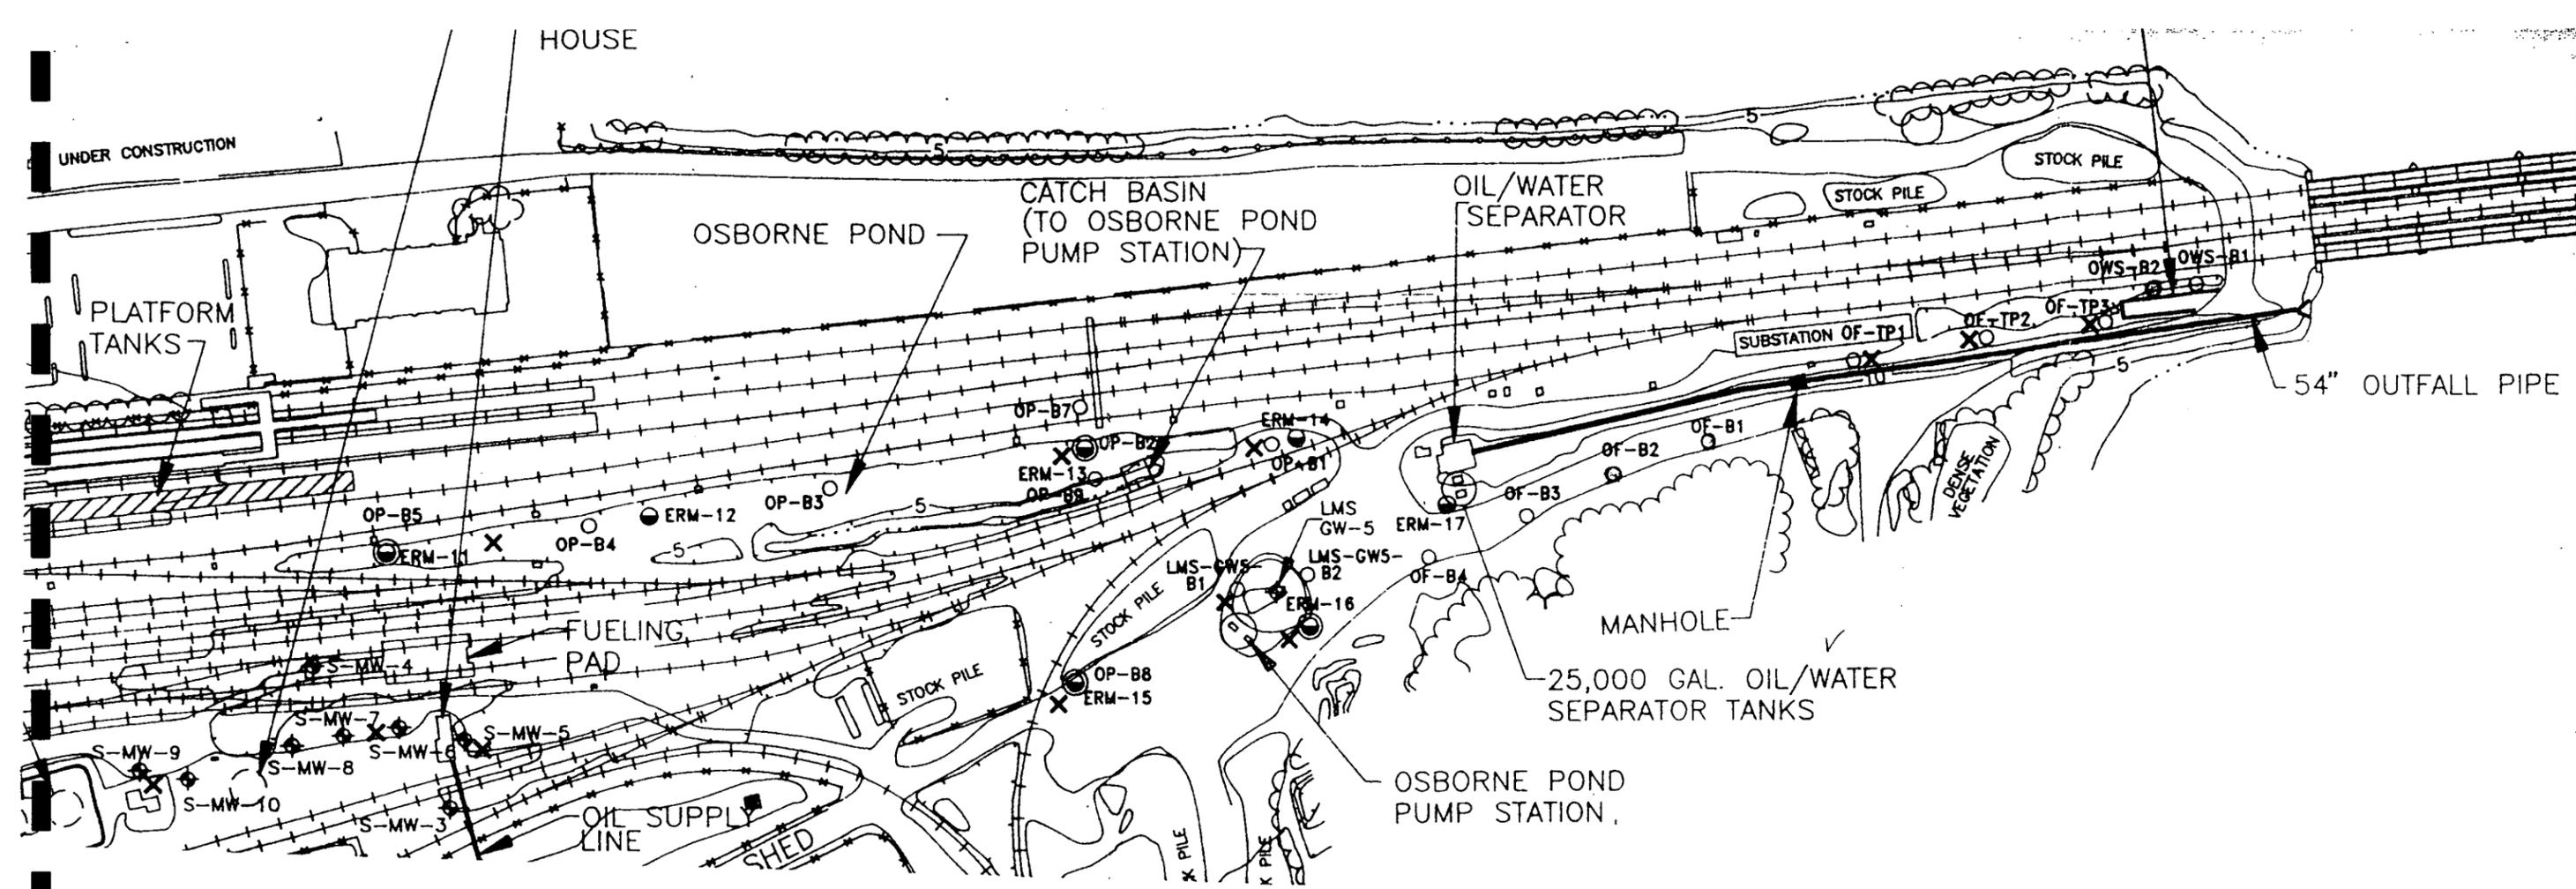
SOIL SAMPLE AND TEMPORARY NAPL WELL LOCATIONS

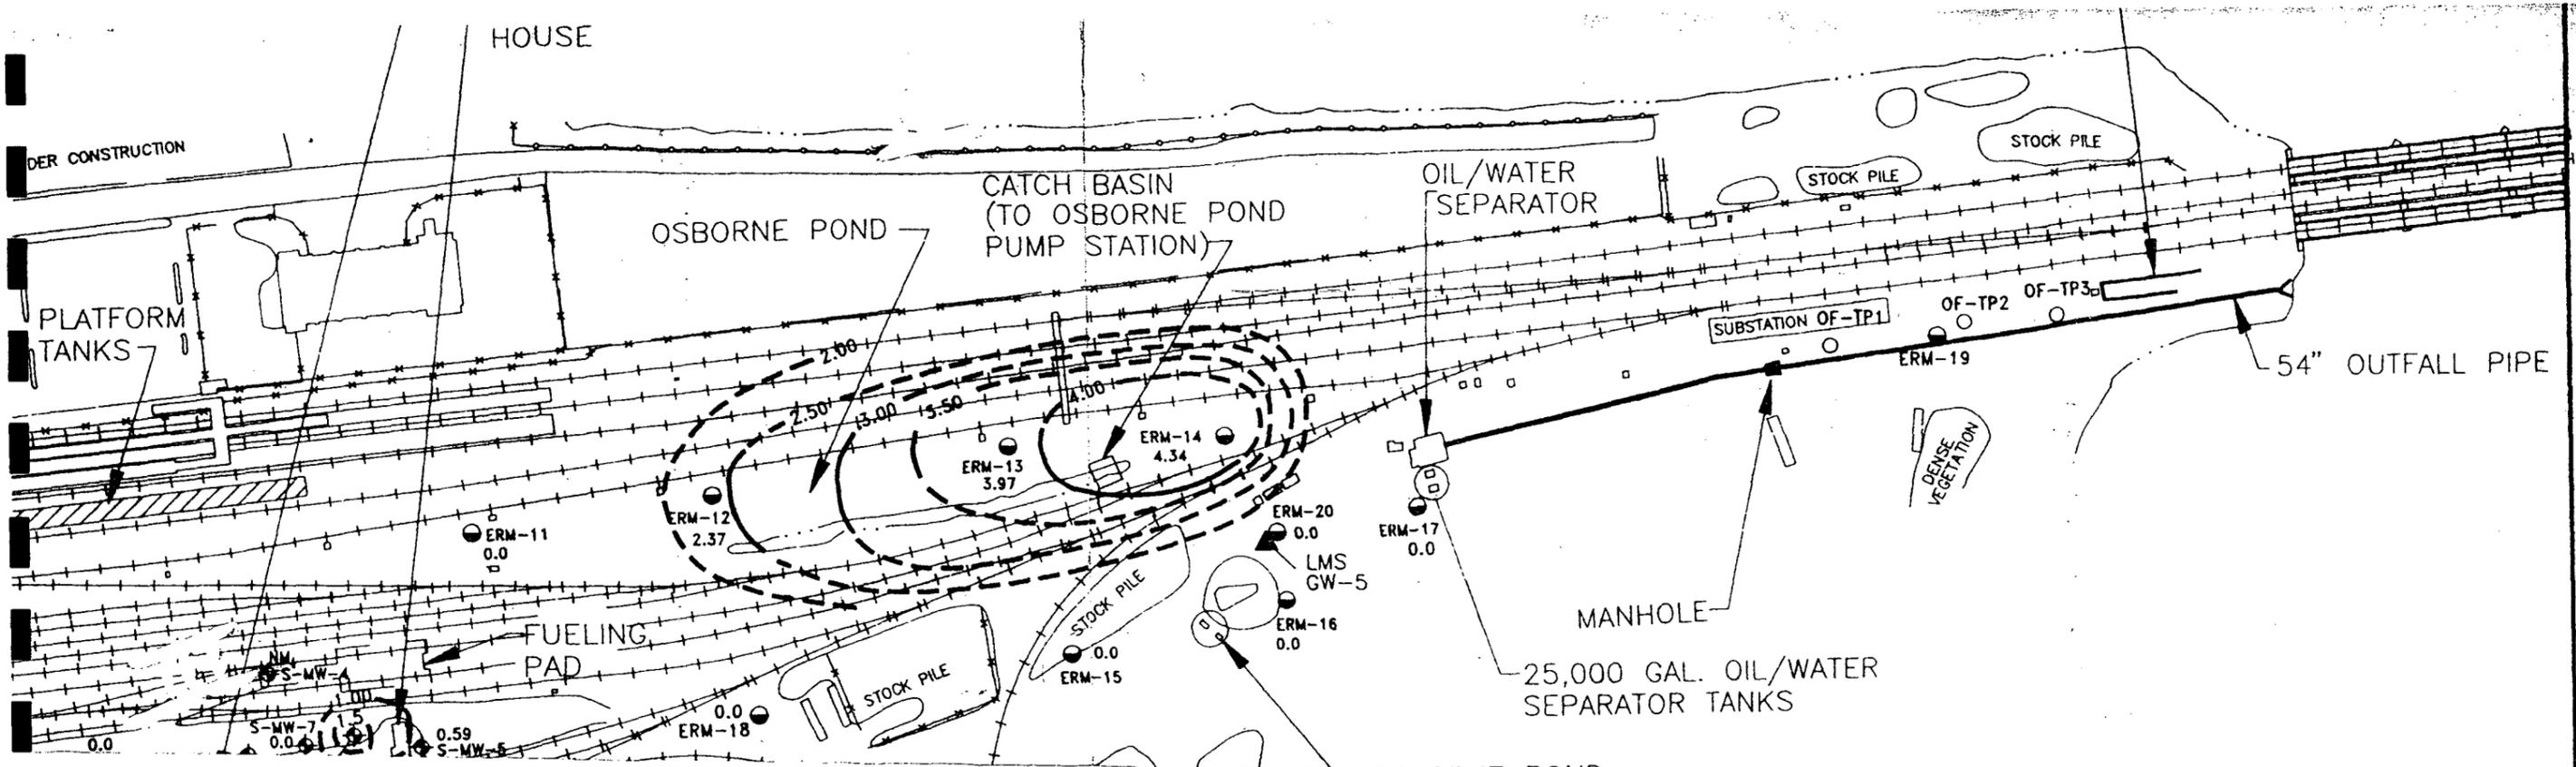
CHECKED	DATE	PRODUCT THICKNESS IN MONITORING WELLS - 9/19/94			DRAWING NO.	3-2		
	DESIGN ENGINEER					REV. NO.			
	PROJECT ENGINEER								
	PROJECT MANAGER			DRAWN	E.M.F./S.P.	DATE	NOV.1, 1994	REVISED DATE	
	APPROVED			SCALE	1" = 150'	JOB NO.	680.001.2	FILE NAME	OIL-CONT
	APPROVED						SHEET	OF
