**CROTON BAY SEEPAGE CONTROL
WORK PLAN
HARMON RAILROAD YARD**

**Harmon Railroad Yard
Croton-on-Hudson, New York**

1 November 1995

ERM-Northeast
*475 Park Avenue South
29th Floor
New York, New York 10016*

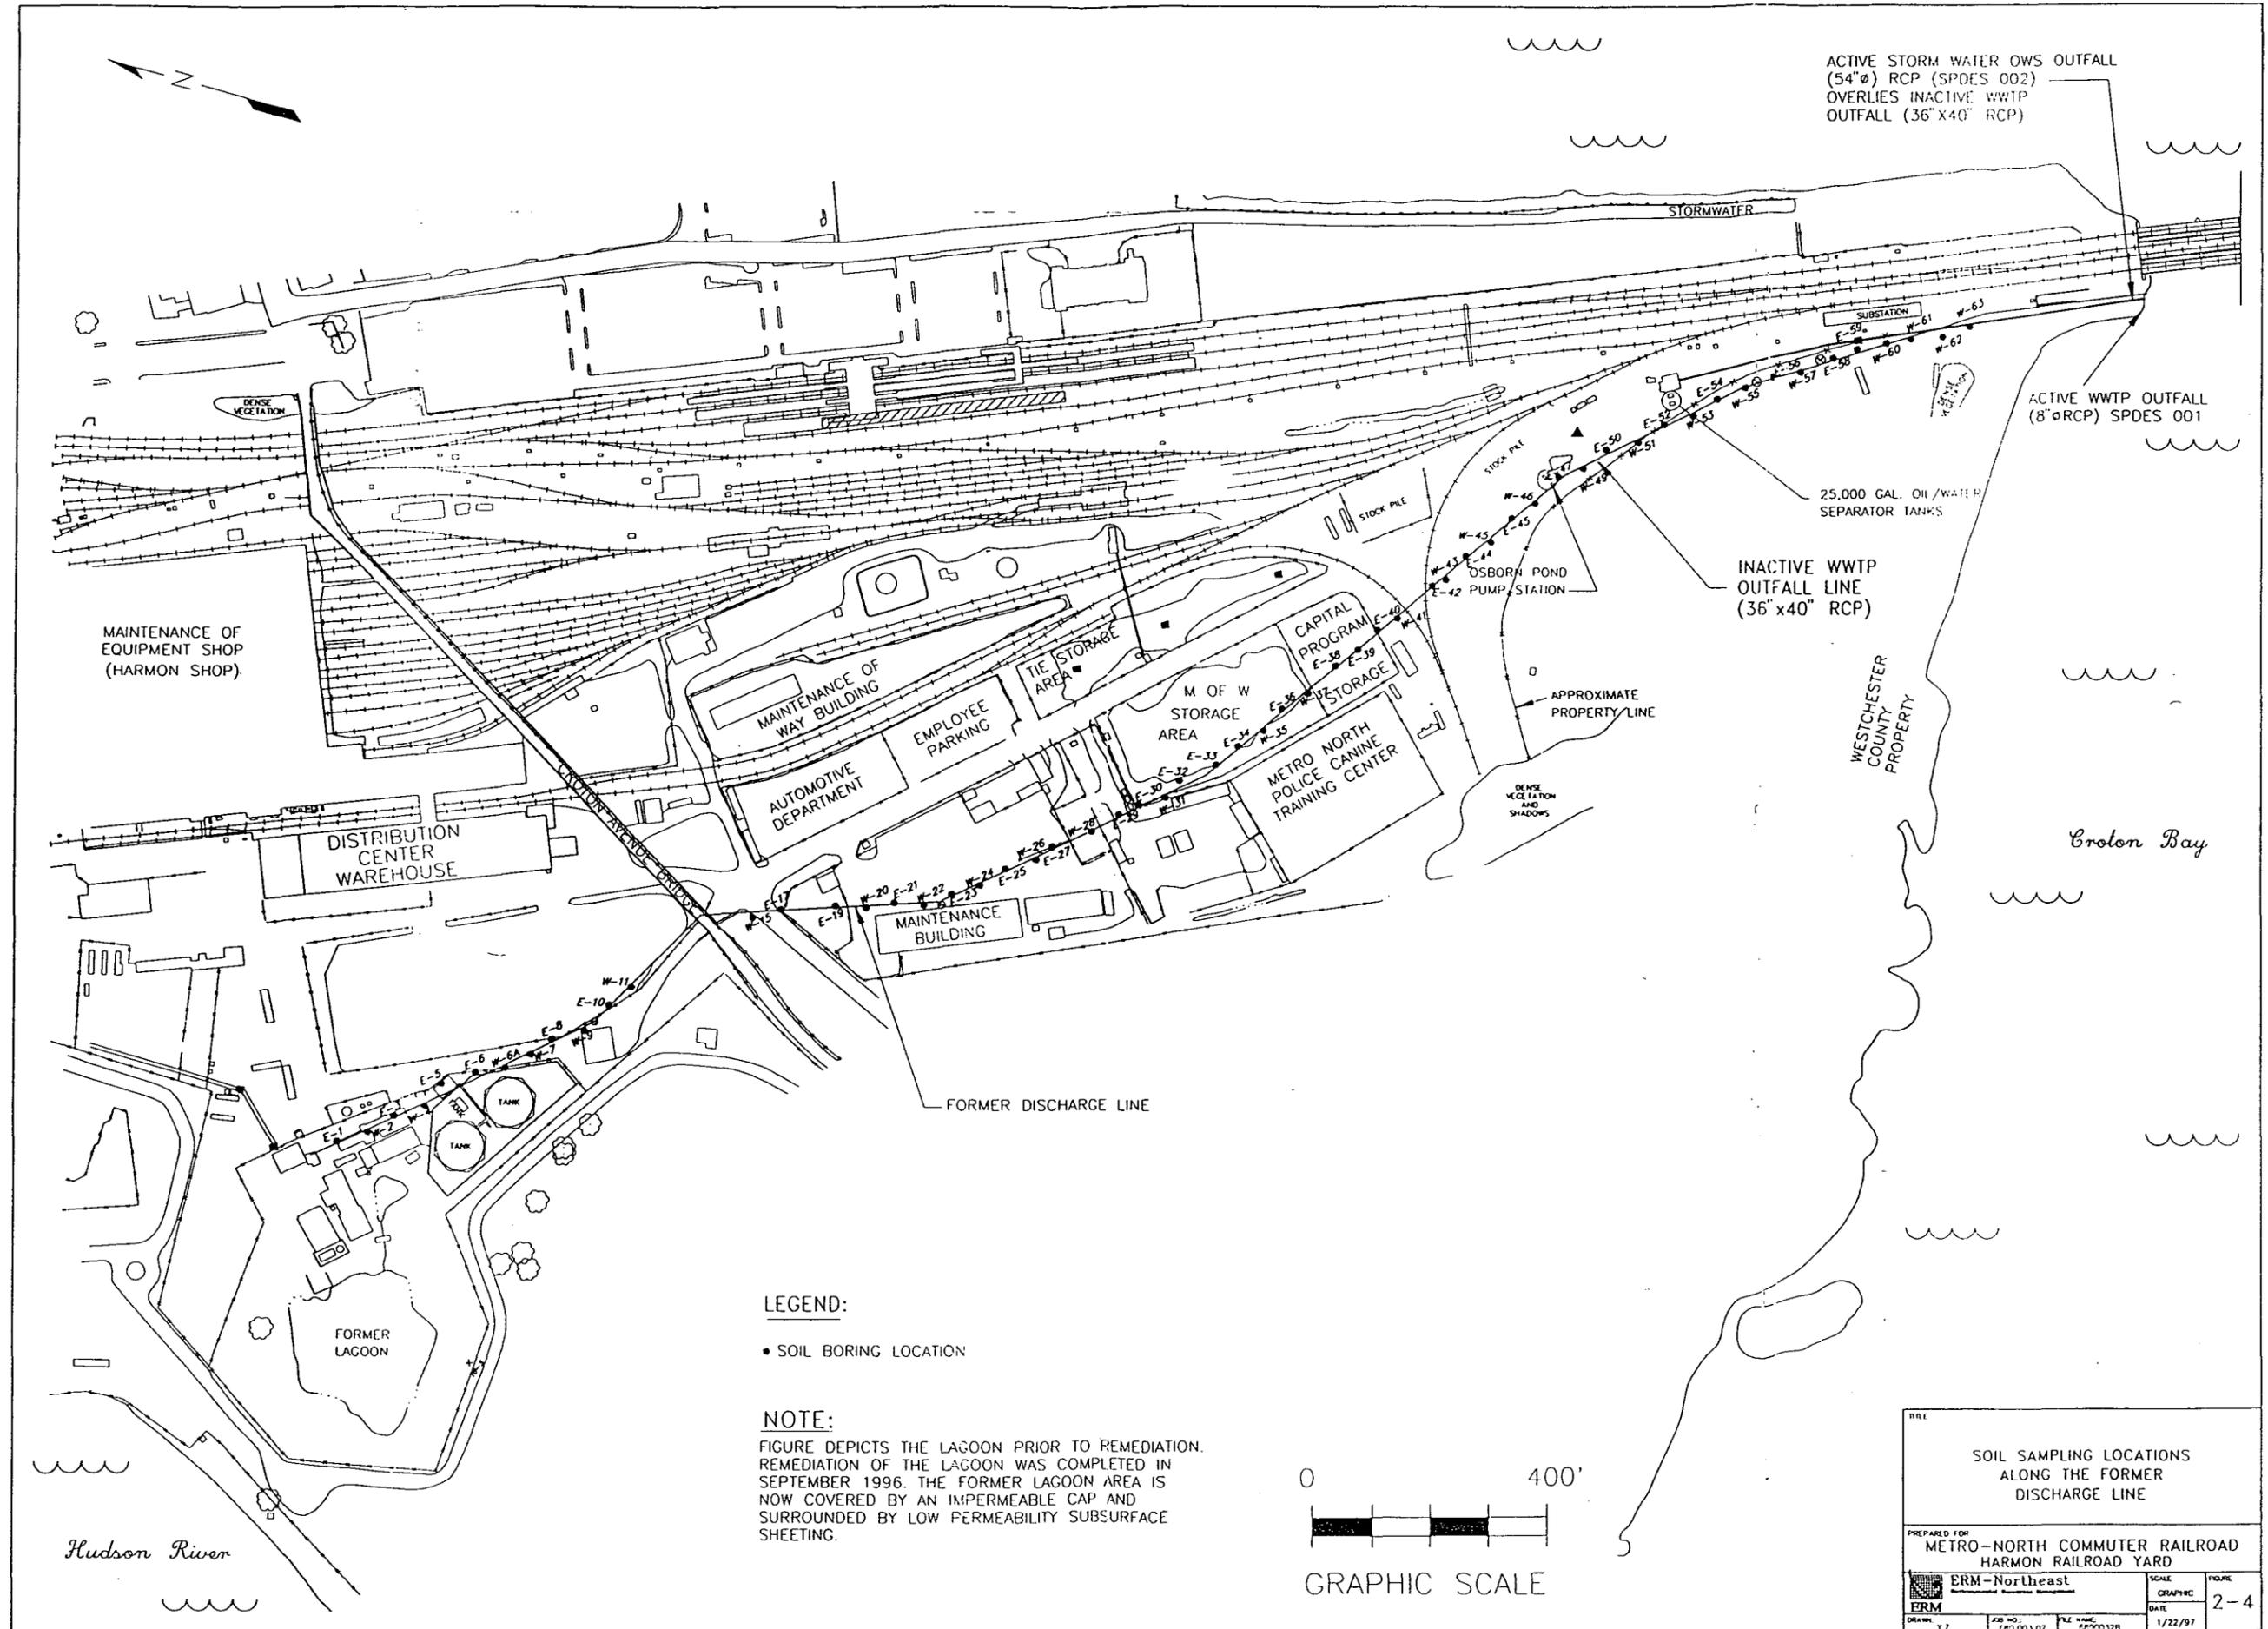
TITLE			
SOIL SAMPLING LOCATIONS ALONG THE FORMER DISCHARGE LINE			
PREPARED FOR METRO-NORTH COMMUTER RAILROAD HARMON RAILROAD YARD			
ERM-Northeast	SCALE	FIGURE	
ERM	GRAPHIC	2-4	
DATE	1/22/97		
DRAWN	FILE NAME

As part of the OU-II remedial investigation work, a total of 62 soil borings were installed along the full length of the inactive wastewater sewer line, from the treatment plant to Croton Bay. One soil sample was collected from each of these 62 soil boring locations. These samples were analyzed for Target Compound List constituents and for Total Organic Carbon. The inactive wastewater sewer line is present in generally the same location as the new wastewater discharge line that replaced it. In the narrow land area at the southern tip of Harmon Yard near Croton bay, all three sewer pipes (the inactive wastewater line, the active wastewater line that replaced it and the storm water sewer line) were all constructed in close proximity to one another.

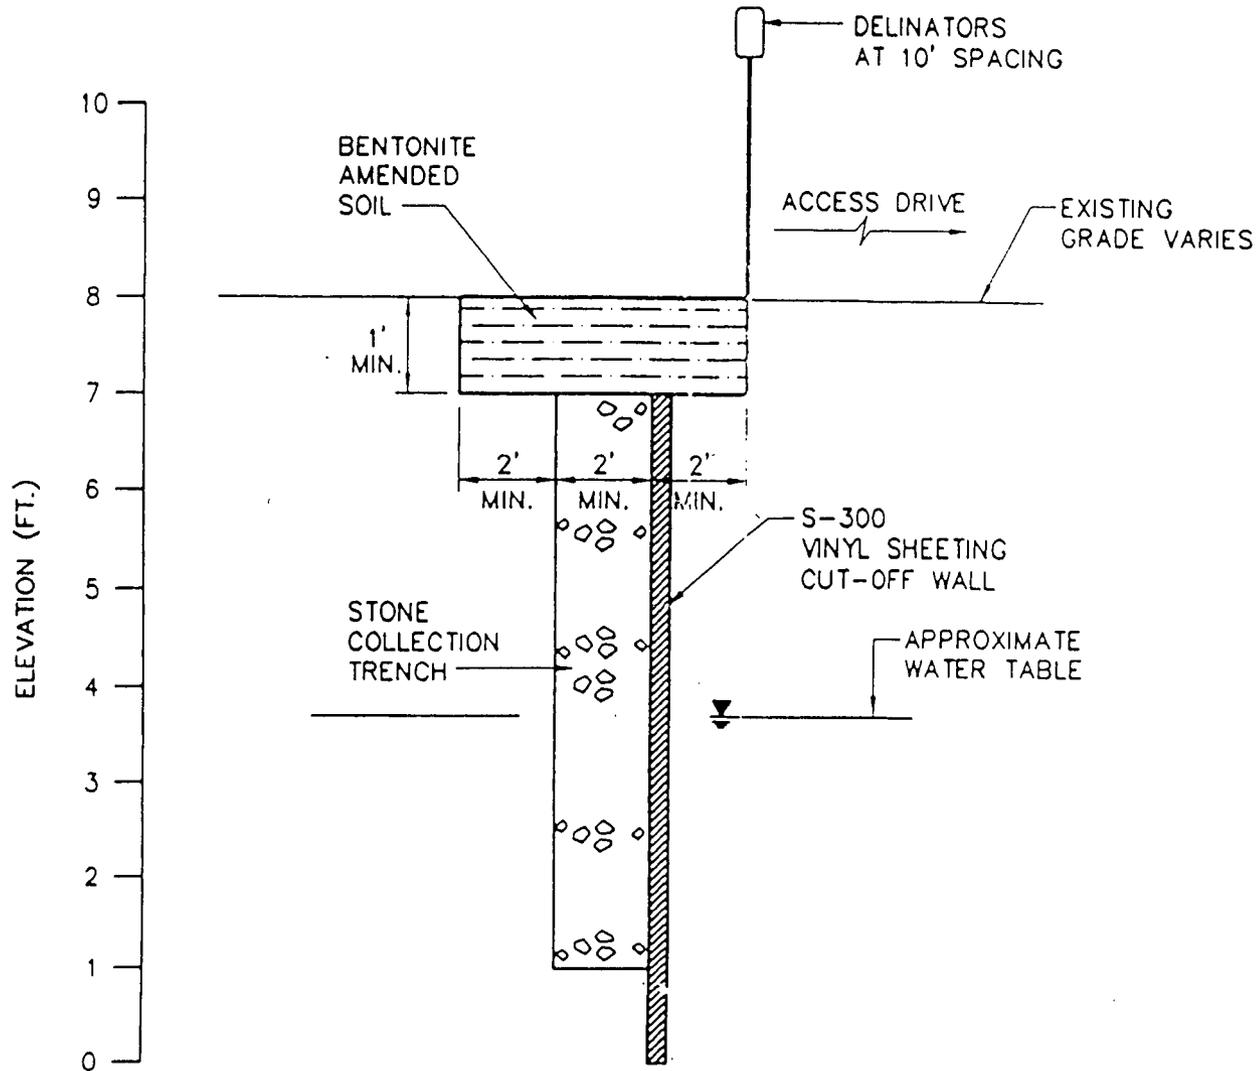
VINYL SHEET PILING/STONE COLLECTION TRENCH DETAIL

CROTON BAY SEEPAGE CONTROL PLAN
 Barrier Wall and NAPL Recovery Trench
 Details
 Source: Drawing -
 "Cut-Off Wall"
 Harmon Yard Groundwater Remediation
 Phase I; Details; Submittal 25.0"
 The Tyree Organization, Inc.
 Clough, Harbour & Associates, LLP
 February 1997

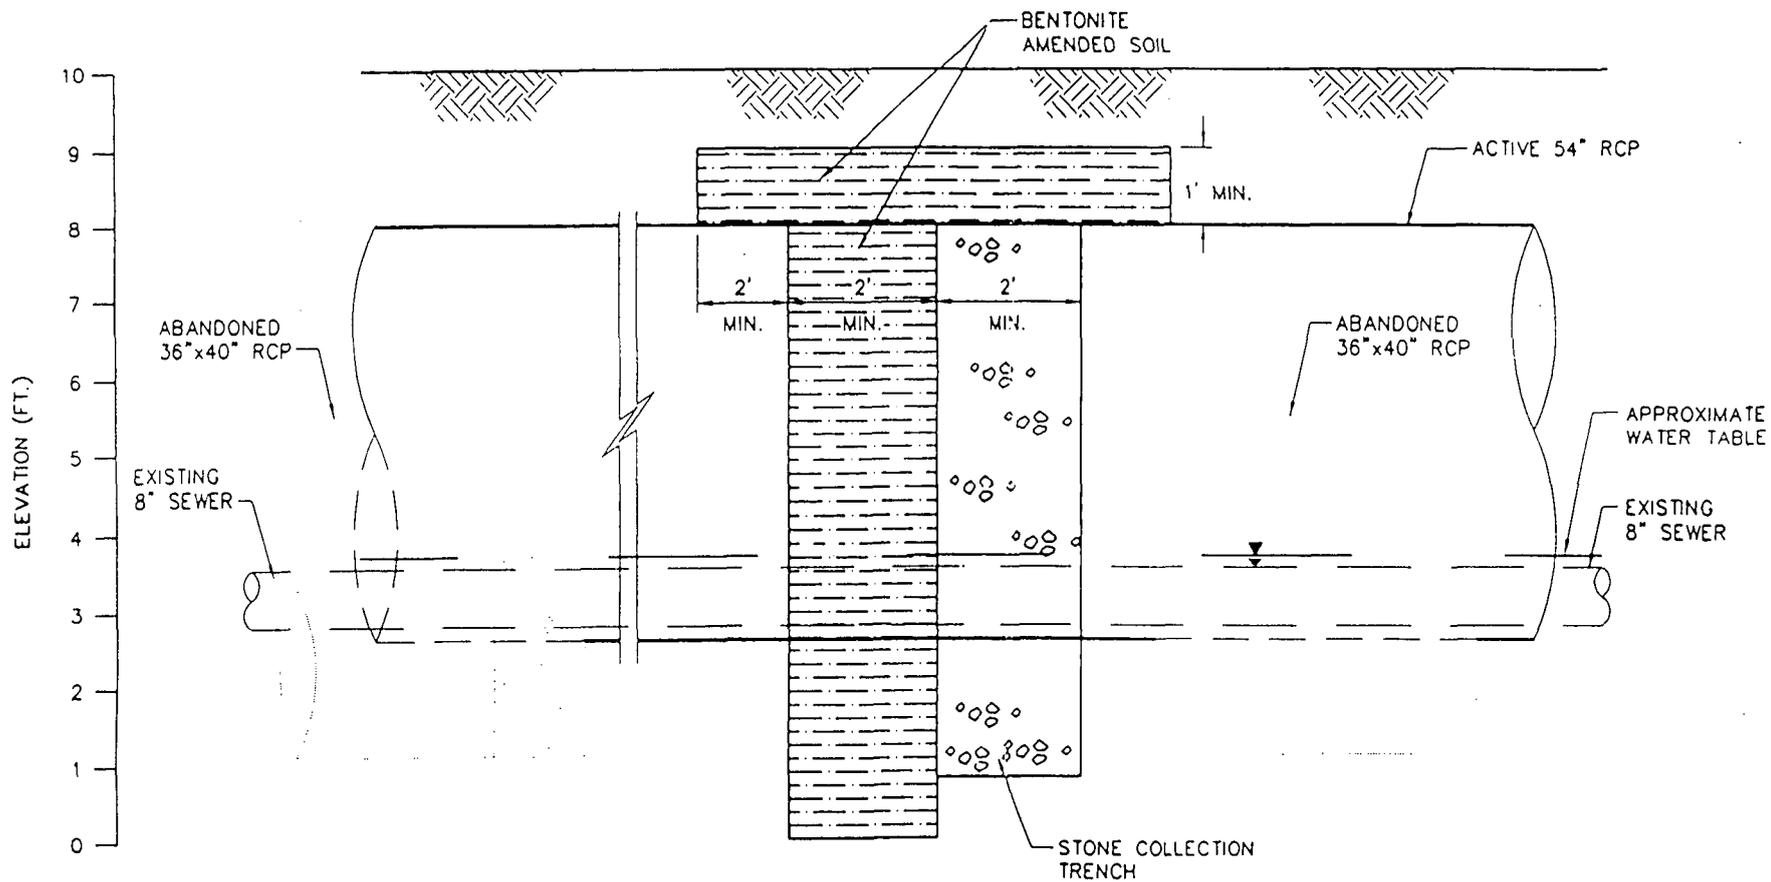
BENTONITE AMENDED SOIL/STONE COLLECTION TRENCH
DETAIL AT PIPE CROSSING

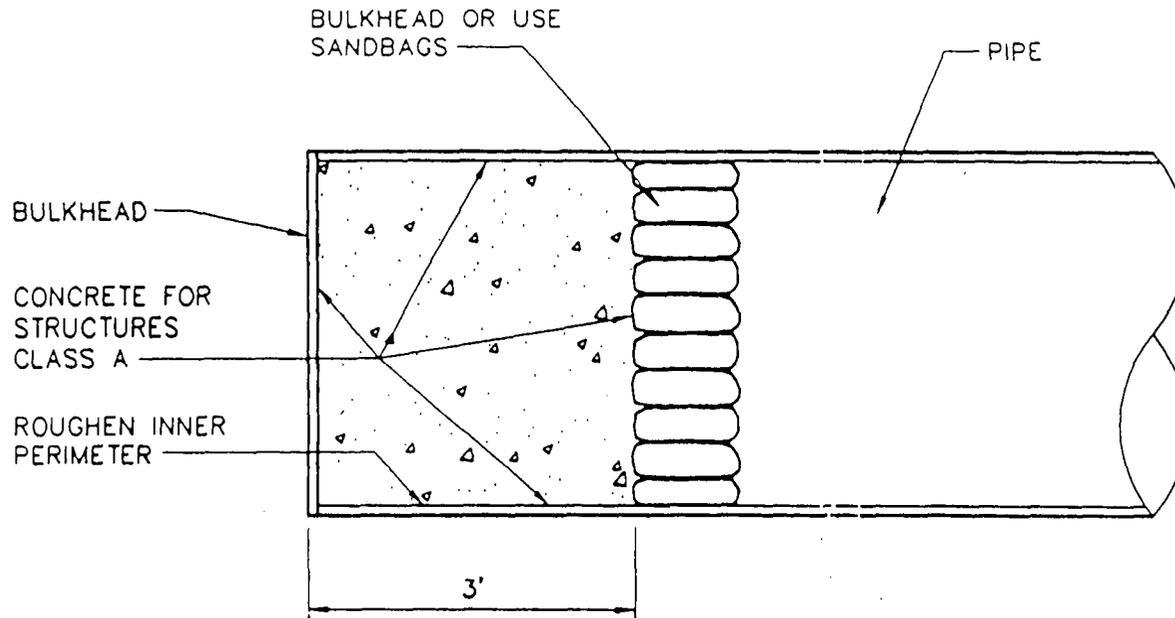
EXISTING 36"x40" PIPE
ABANDONMENT DETAIL

CROTON BAY SEEPAGE CONTROL PLAN
Barrier Wall and NAPL Recovery Trench
Details

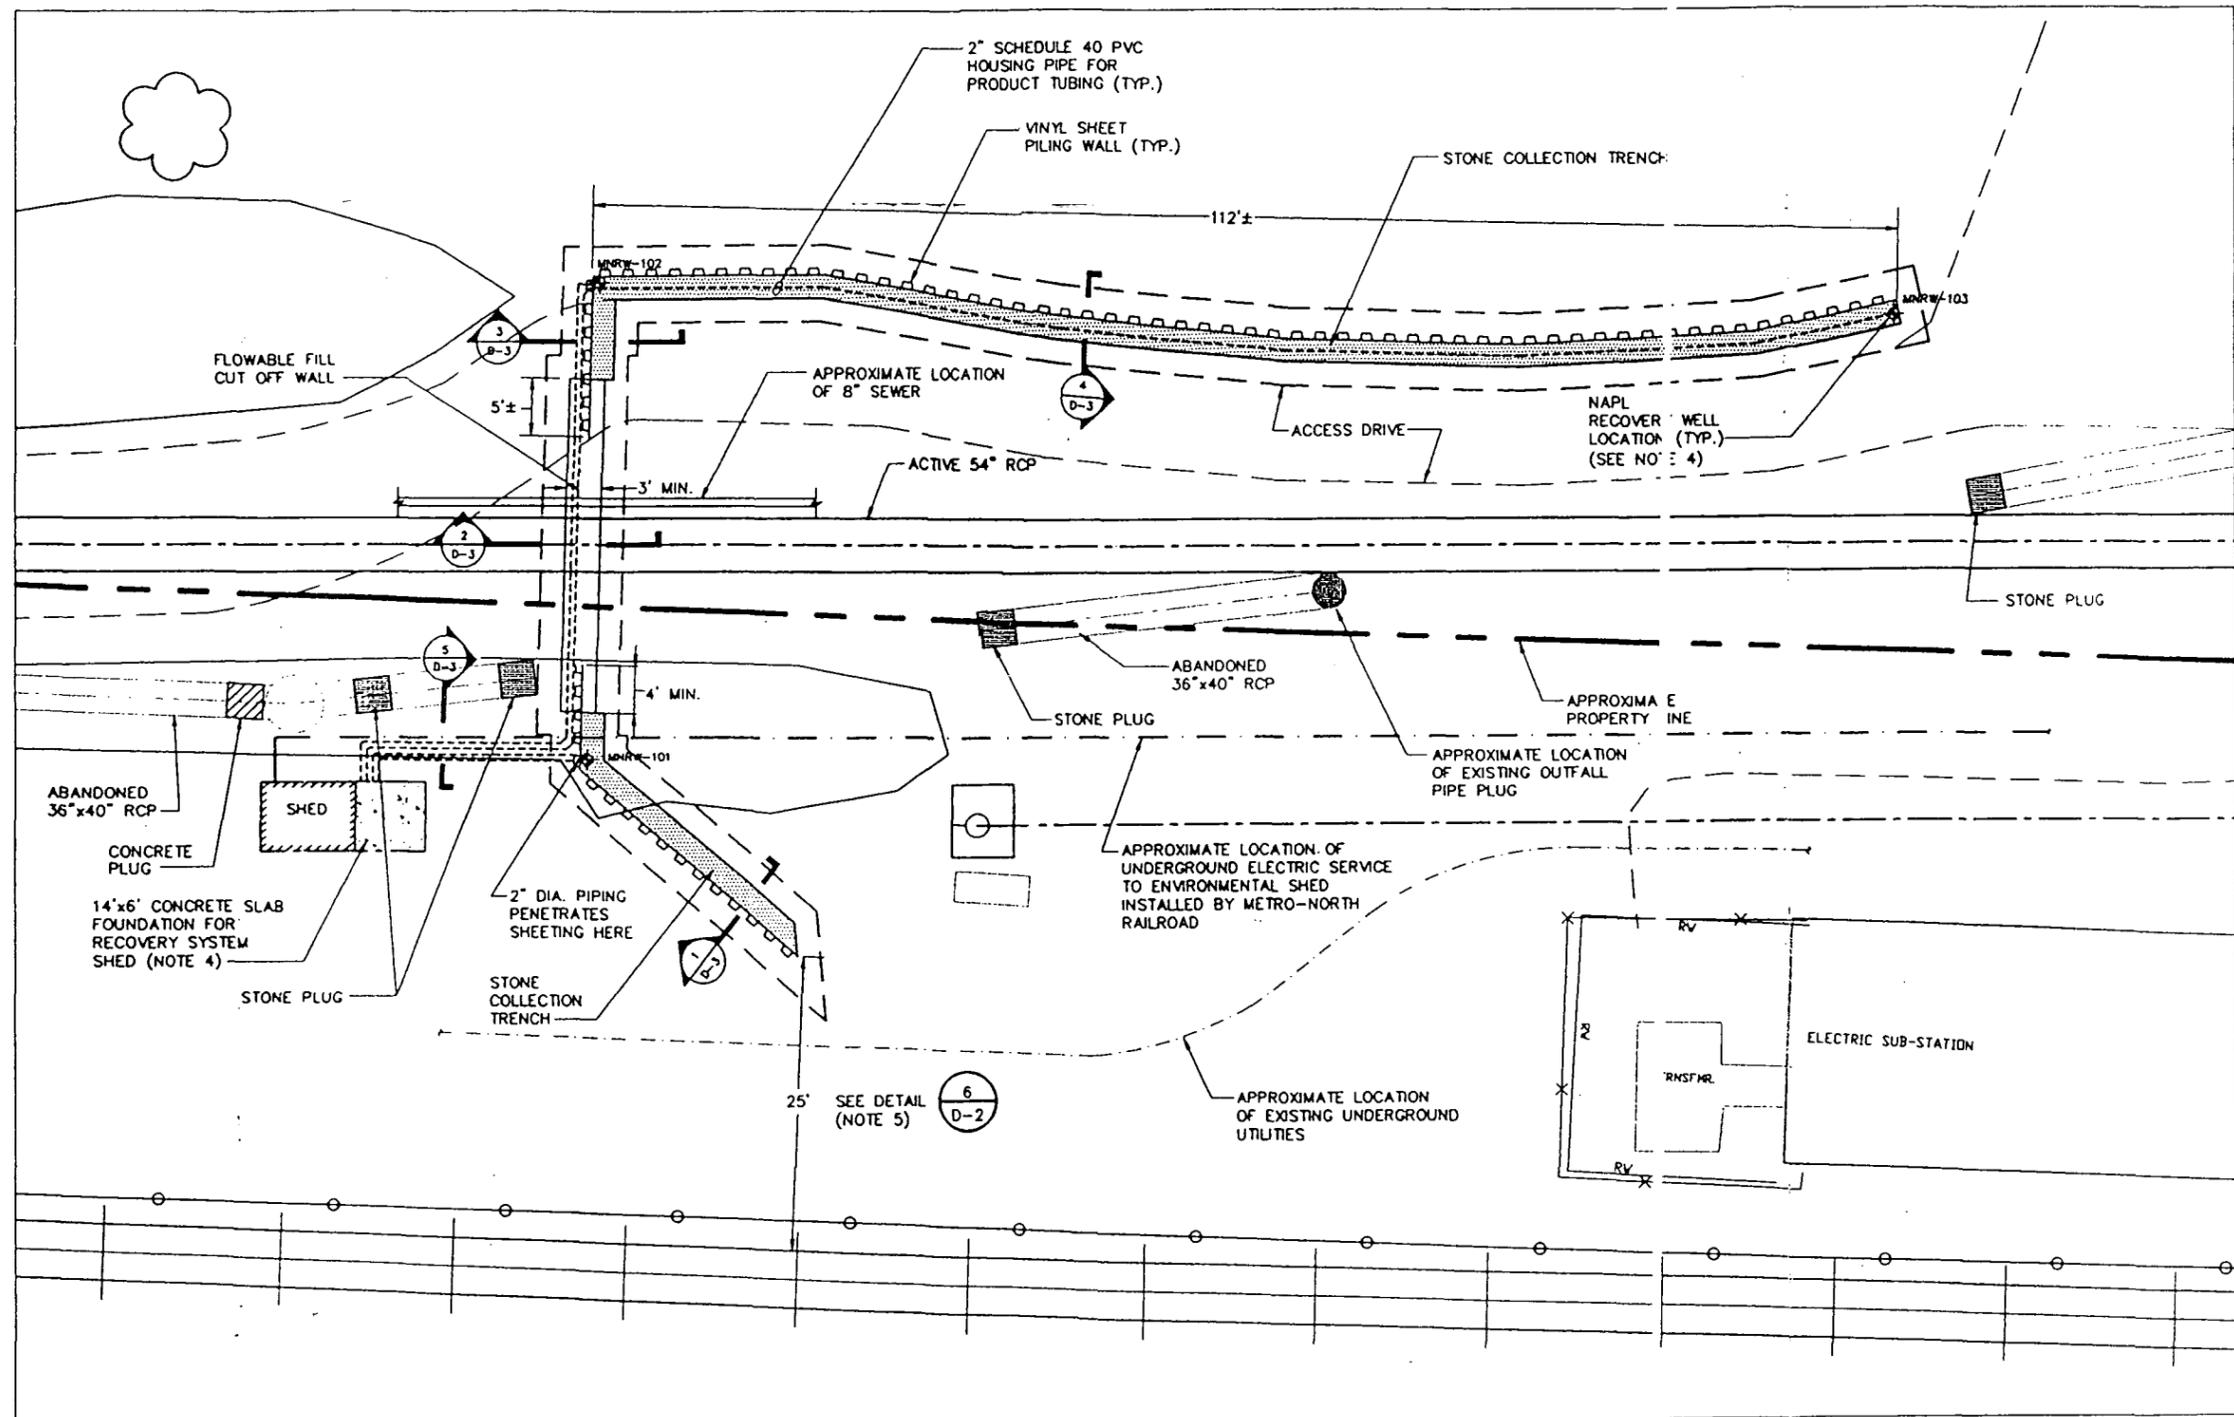
**SHEET PILING WALL - STONE COLLECTION TRENCH
PLAN VIEW**

CROTON BAY SEEPAGE CONTROL PLAN
 Location of Barrier Wall, NAPL Recovery Trench and NAPL Recovery Wells
 Construction Record (As-Built) Drawing
 Source: Record Drawing, June 1997
 Drawing No. 2A
 "Cut-Off Wall Harmon Yard Groundwater Remediation Phase I"
 Phase I Harmon Yard Remediation
 The Tyree Organization, Inc.
 and
 Clough, Harbour & Associates, LLP

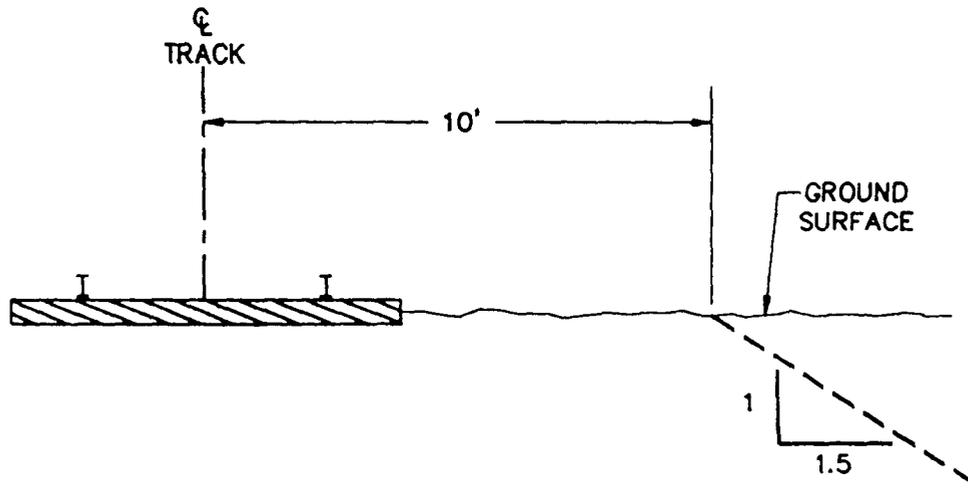
6
D-2

RAIL ROAD SHEET
PILING DETAIL

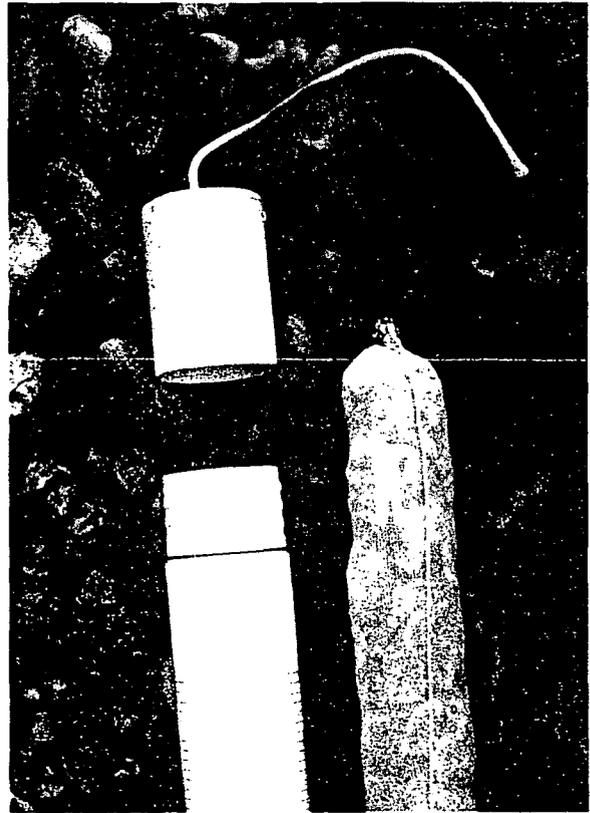
4" WELL

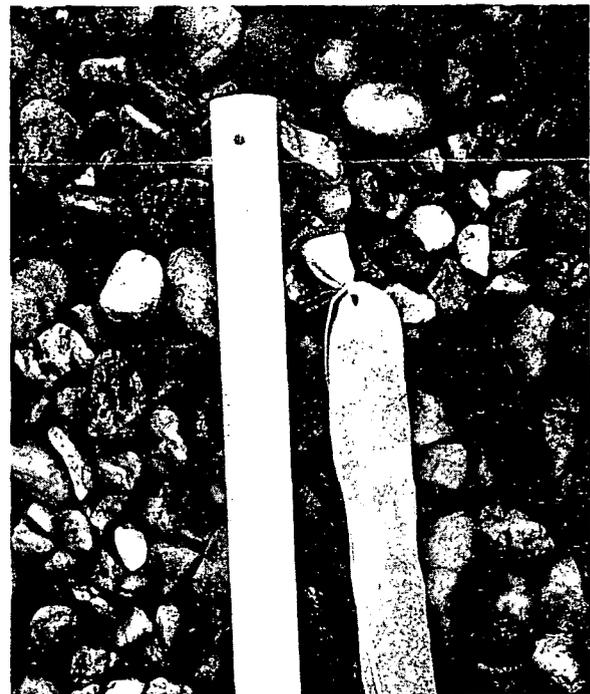
2" WELL

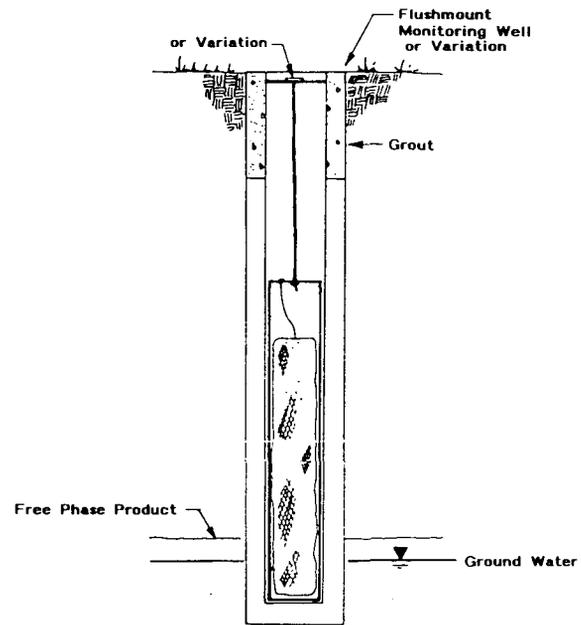
Absorbent Material - Peatwick™ systems utilize a dehydrated peatmoss. The dehydration process creates a porous structure with an affinity for hydrocarbon absorption while repelling water. This process also creates a natural capillary action which draws hydrocarbons into the "wick" and provides continuous recovery until the "wick" becomes saturated. The Peatwick absorbs approximately one gallon of hydrocarbons per pound of absorbent material.

DETAIL OF 'PEATWICK'™ INSTALLATION

ERM recommends that to address NYSDEC concerns regarding this system, the NAPL recovery pumps that have been installed in the wells placed within the NAPL recovery trench be removed and replaced with absorbent material designed to remove small amounts of NAPL from recovery wells. ERM recommends that these passive hydrocarbon recovery systems be installed in each of the three NAPL recovery wells and used to recover NAPL, if any, for a period of six months. The use of these systems will provide Metro-North and the NYSDEC with the information needed to determine whether even a small amount of NAPL is accumulating in this recovery trench.
