DURACELL INC.
NORTH TARRYTOWN, NEW YORK

HAZARDOUS WASTE
STORAGE FACILITY
CLOSURE PLAN
ADDENDUM REPORT NO. 1

PROJECT #425-1
REVISED APRIL 1986

EDER ASSOCIATES
CONSULTING ENGINEERS, P.C.
85 Forest Avenue
Locust Valley, New York

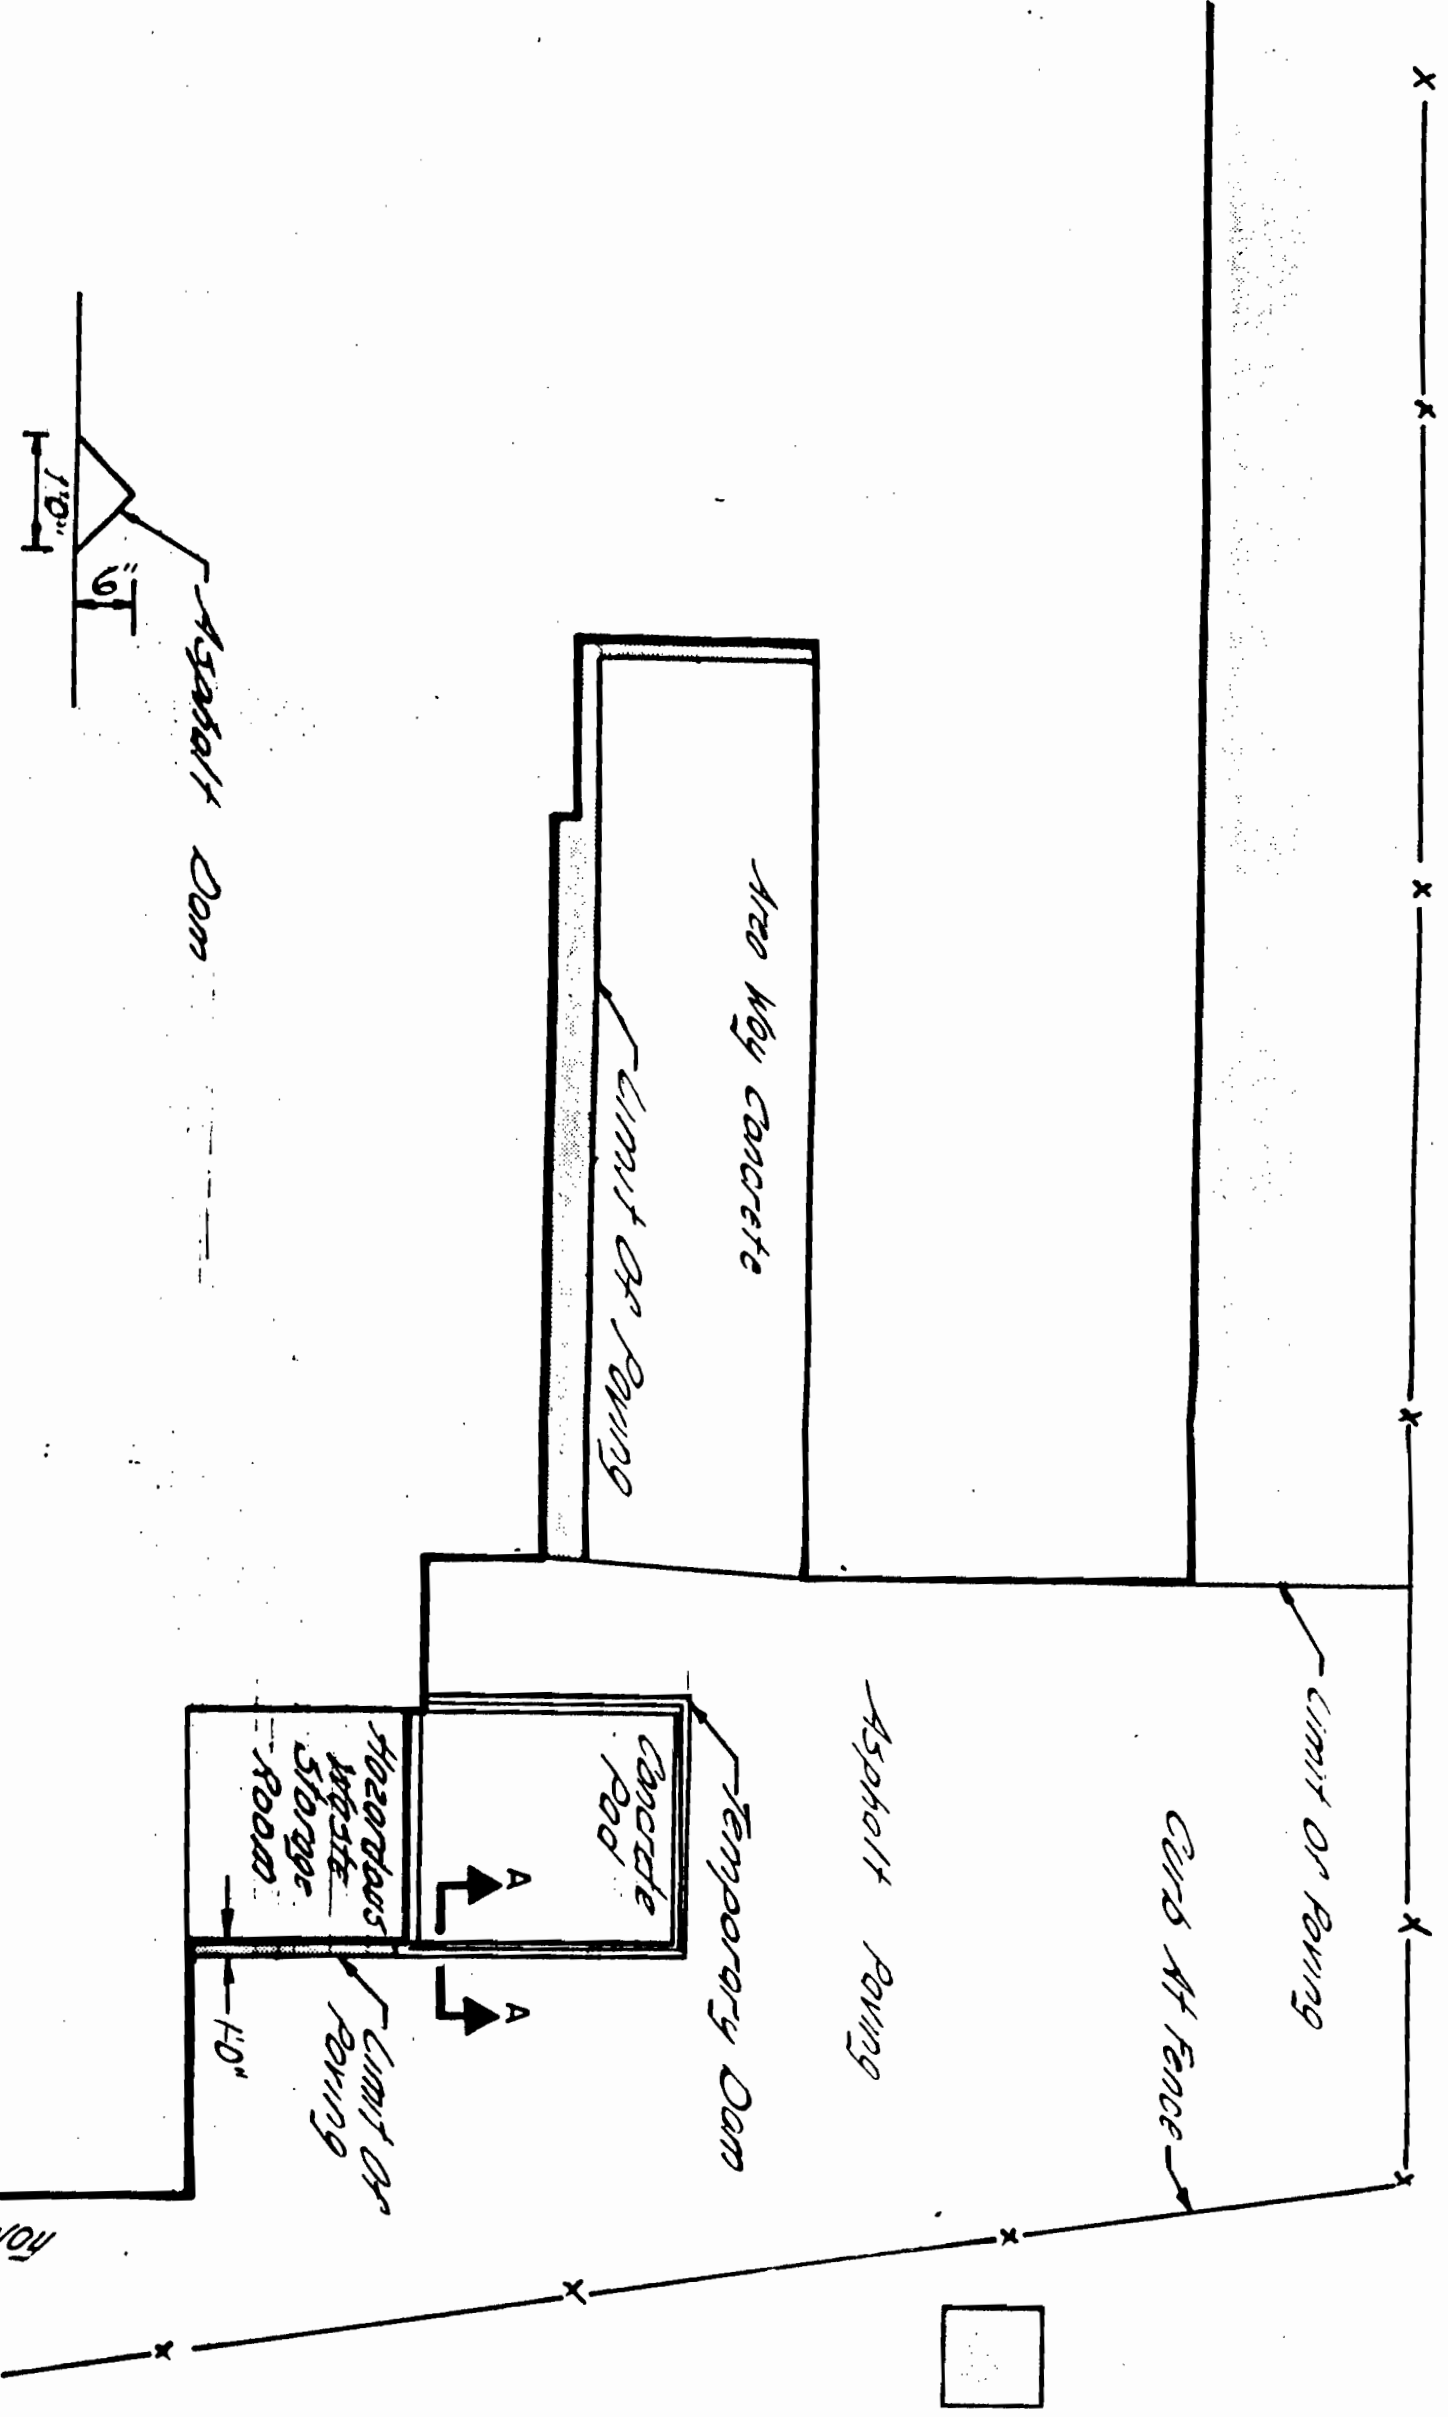
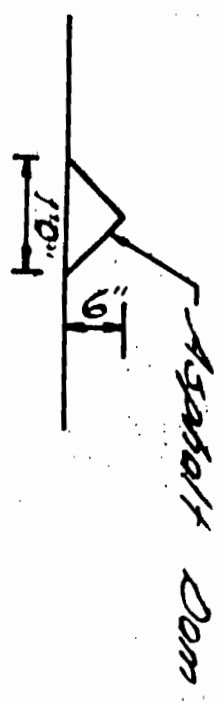
FIGURE 1

Figure 1 shows a plot plan of the southeast yard area with the Hazardous Waste Storage Facility consisting of two storage rooms and concrete pad. The temporary dam will be constructed to collect runoff from washing activities related to decontamination of the Hazardous Waste Storage Facility (refer to Item 11). Most of the yard area, including the driveway along the south property line, is either paved with asphalt or concrete. An asphalt curb is located along the south and east property line. The limit of paving is indicated at the southeast corner of the plant. Two thin strips of non-paved areas are located along the west side of the areaway and adjacent to the south wall of the storage rooms.

LEGEND
 ONSITE AREAS WHICH ARE NOT PAVED

SECTION A-A

SOUTH EAST YARD AREA

The southeast yard area is paved with the exception of two small strips and the east side yard as shown in Figure 1. Soils in these areas will be removed under the on-site soil remediation plan. If any unreported spills at the Hazardous Waste Management Facility were to have occurred, the spill would probably have been minimal and would have occurred on the paved surfaces. If not removed, most of the

The soil remediation program, described in the On-Site Report, includes removal of soil from much of the southeast yard area. This includes most of the non-paved area in the areaway and adjacent to the storage rooms.

The proposed dam around the Hazardous Waste Storage Facility is shown in Figure 1. The area enclosed by the dam is:

and the containment volume is 2600 gallons. The estimated amount of wash and rinse water to be generated in cleaning the hazardous waste storage facility should not exceed 300 gallons. Runoff will be collected by wet vacuuming. Following cleaning, the dam consisting of 15 cubic feet of asphalt will be scrapped and packaged in polyethylene bags for disposal as hazardous waste.

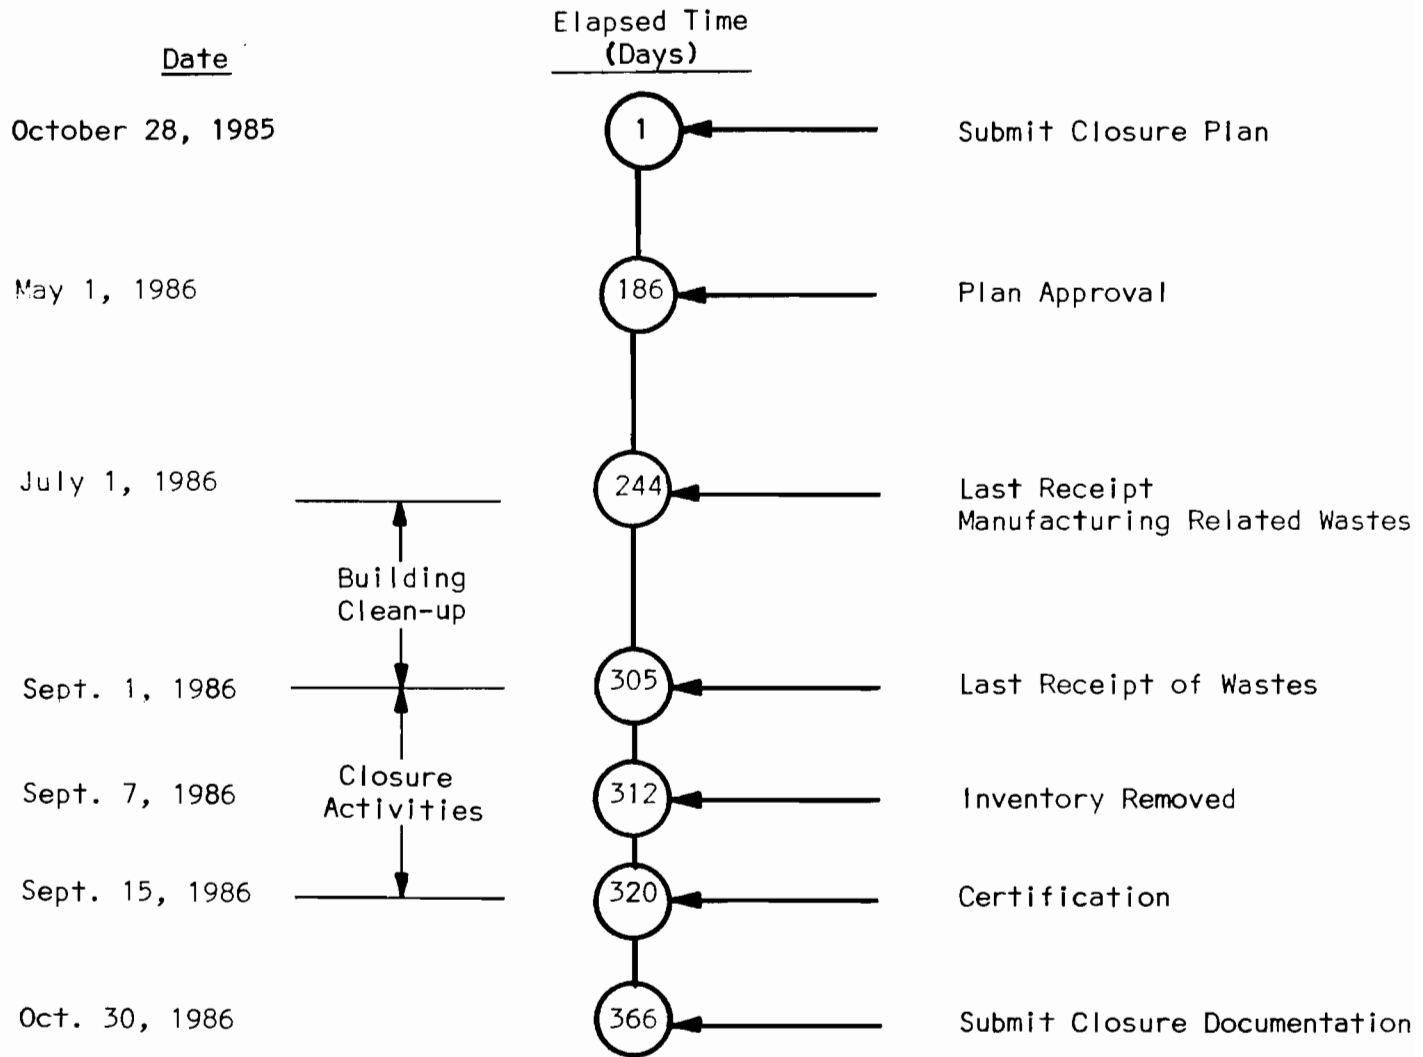
DURACELL, INC.
 NORTH TARRYTOWN, NEW YORK

The revised closure schedule is presented in Figure 2. The schedule is dependent upon the DEC approval of the remediation plans including building clean-up which must precede closure of the Hazardous Waste Management Facility.
