DURACELL INC.  
NORTH TARRYTOWN, NEW YORK

TEST CLEANING  
DOCUMENTATION REPORT

PROJECT #425-1  
JANUARY 1987

EDER ASSOCIATES  
CONSULTING ENGINEERS, P.C.  
85 Forest Avenue  
Locust Valley, New York 11560

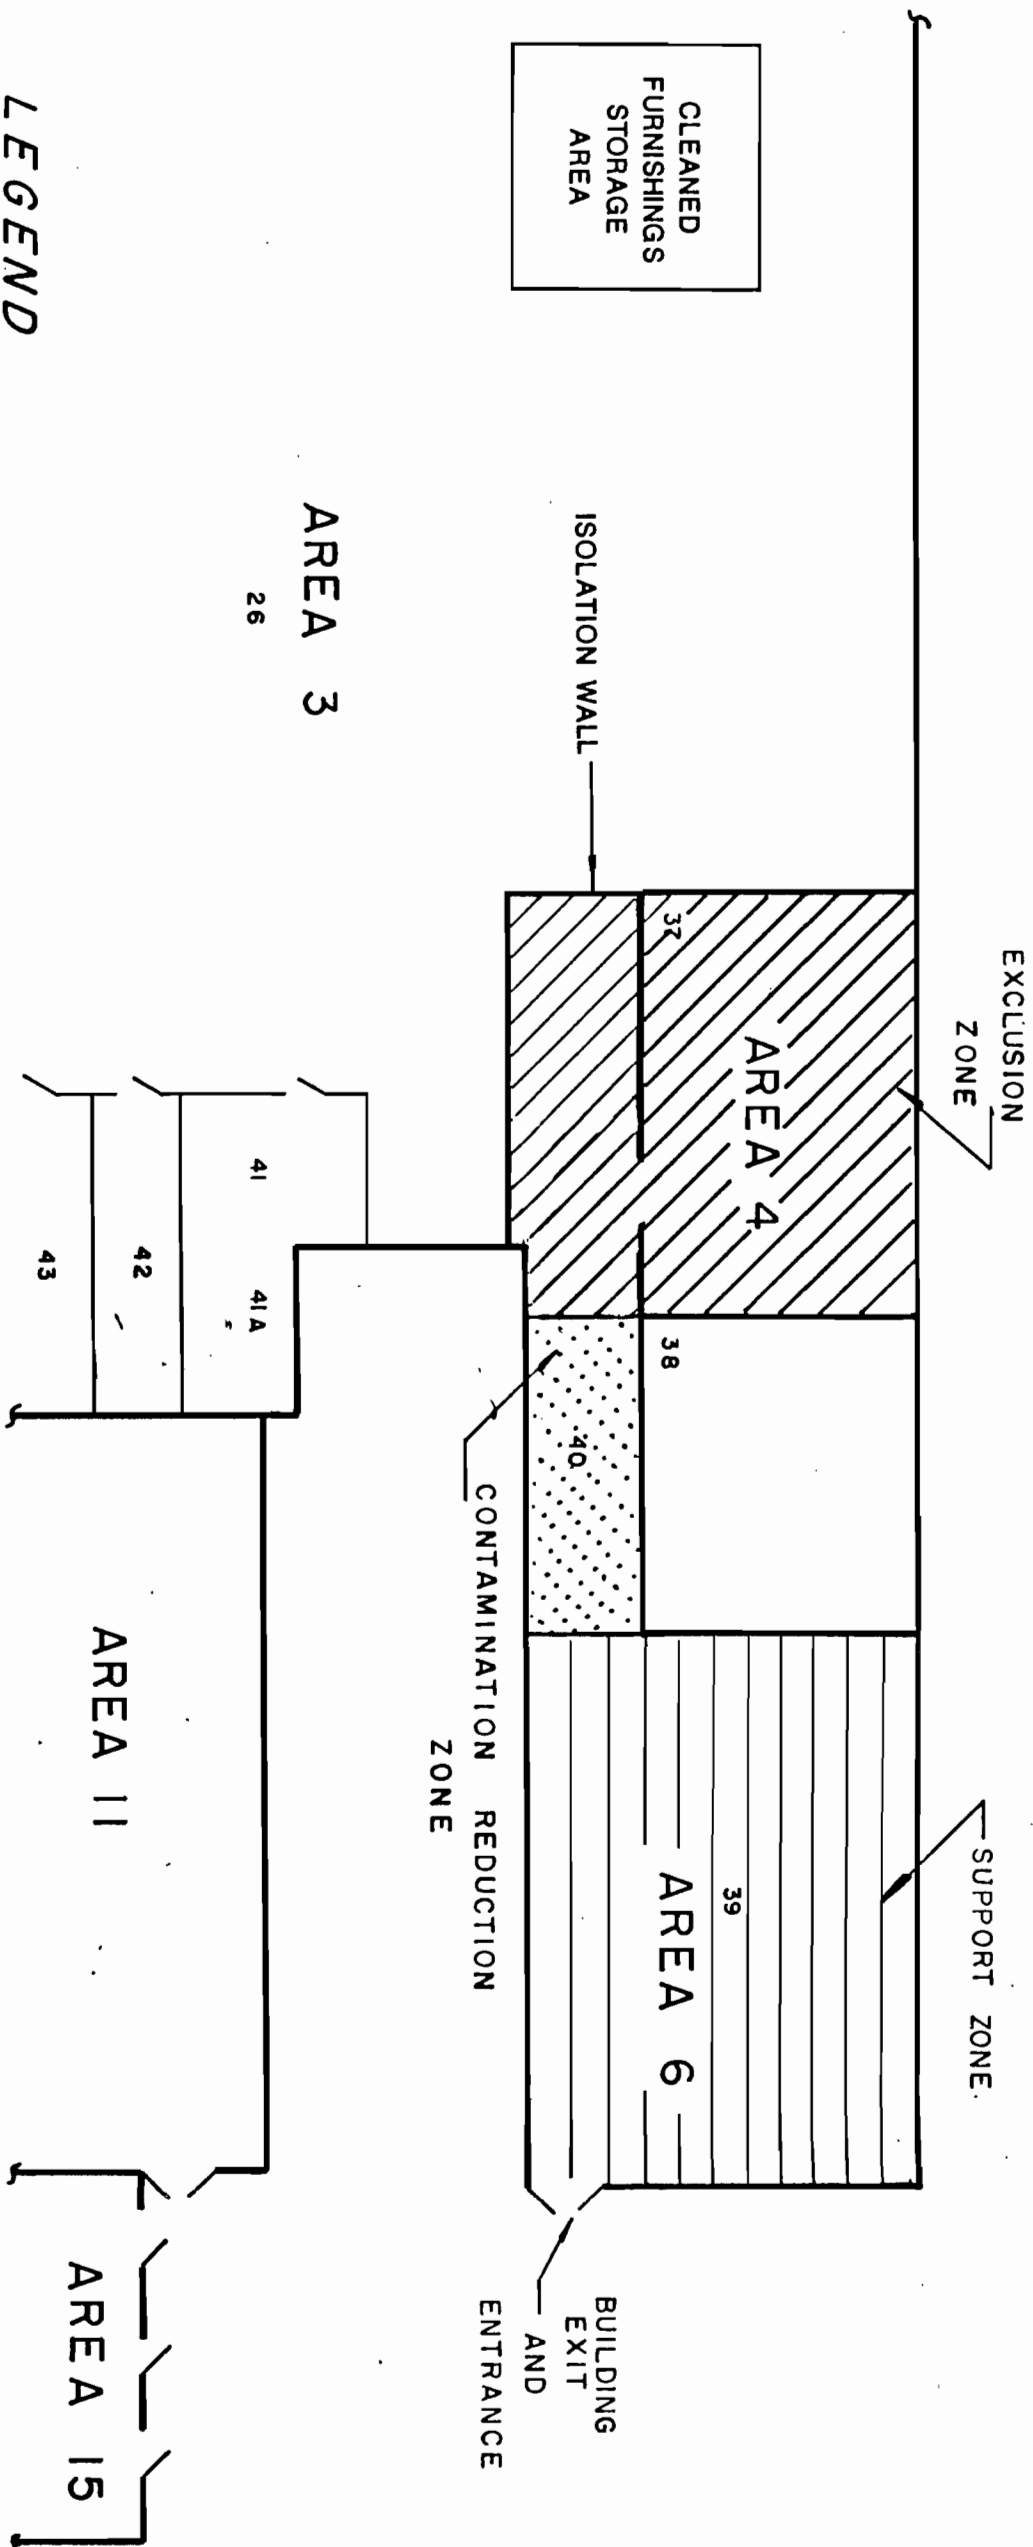
FIGURE 1

HEALTH AND SAFETY ZONE  
DESIGNATION

The Contract Documents included a Health and Safety Plan (HASP) which specified the minimum level of personnel protection and operating procedures to reduce contaminant migration and the risk of personnel exposure during the work. Three zones were established for the performance of the work as shown in Figure 1 in order to restrict the work area to authorized, trained and protected personnel and reduce the potential for the migration of fugitive emissions during cleaning operations.

Furnishings were manually washed in the Exclusion Zone except ductwork, exhaust fan and loudspeaker which were power washed. Cleaned furnishings were transferred to a storage area outside the decontamination zone as shown in figure 1. The area was underlain by and the cleaned furnishings were covered by polyethylene sheeting. Light bulbs were removed to the support zone and were manually broken inside a cardboard enclosure of sufficient size to contain all glass fragments during breaking. The enclosure was securely closed for off-site transportation and disposal of the breakage. Representative furnishings were sampled to document the level of cleanliness achieved.
