**CONSOLIDATED EDISON COMPANY OF NEW YORK, INC.**  
New York, New York

**ECHO AVENUE STATE SUPERFUND SITE  
SUMMARY REPORT**

June 2007

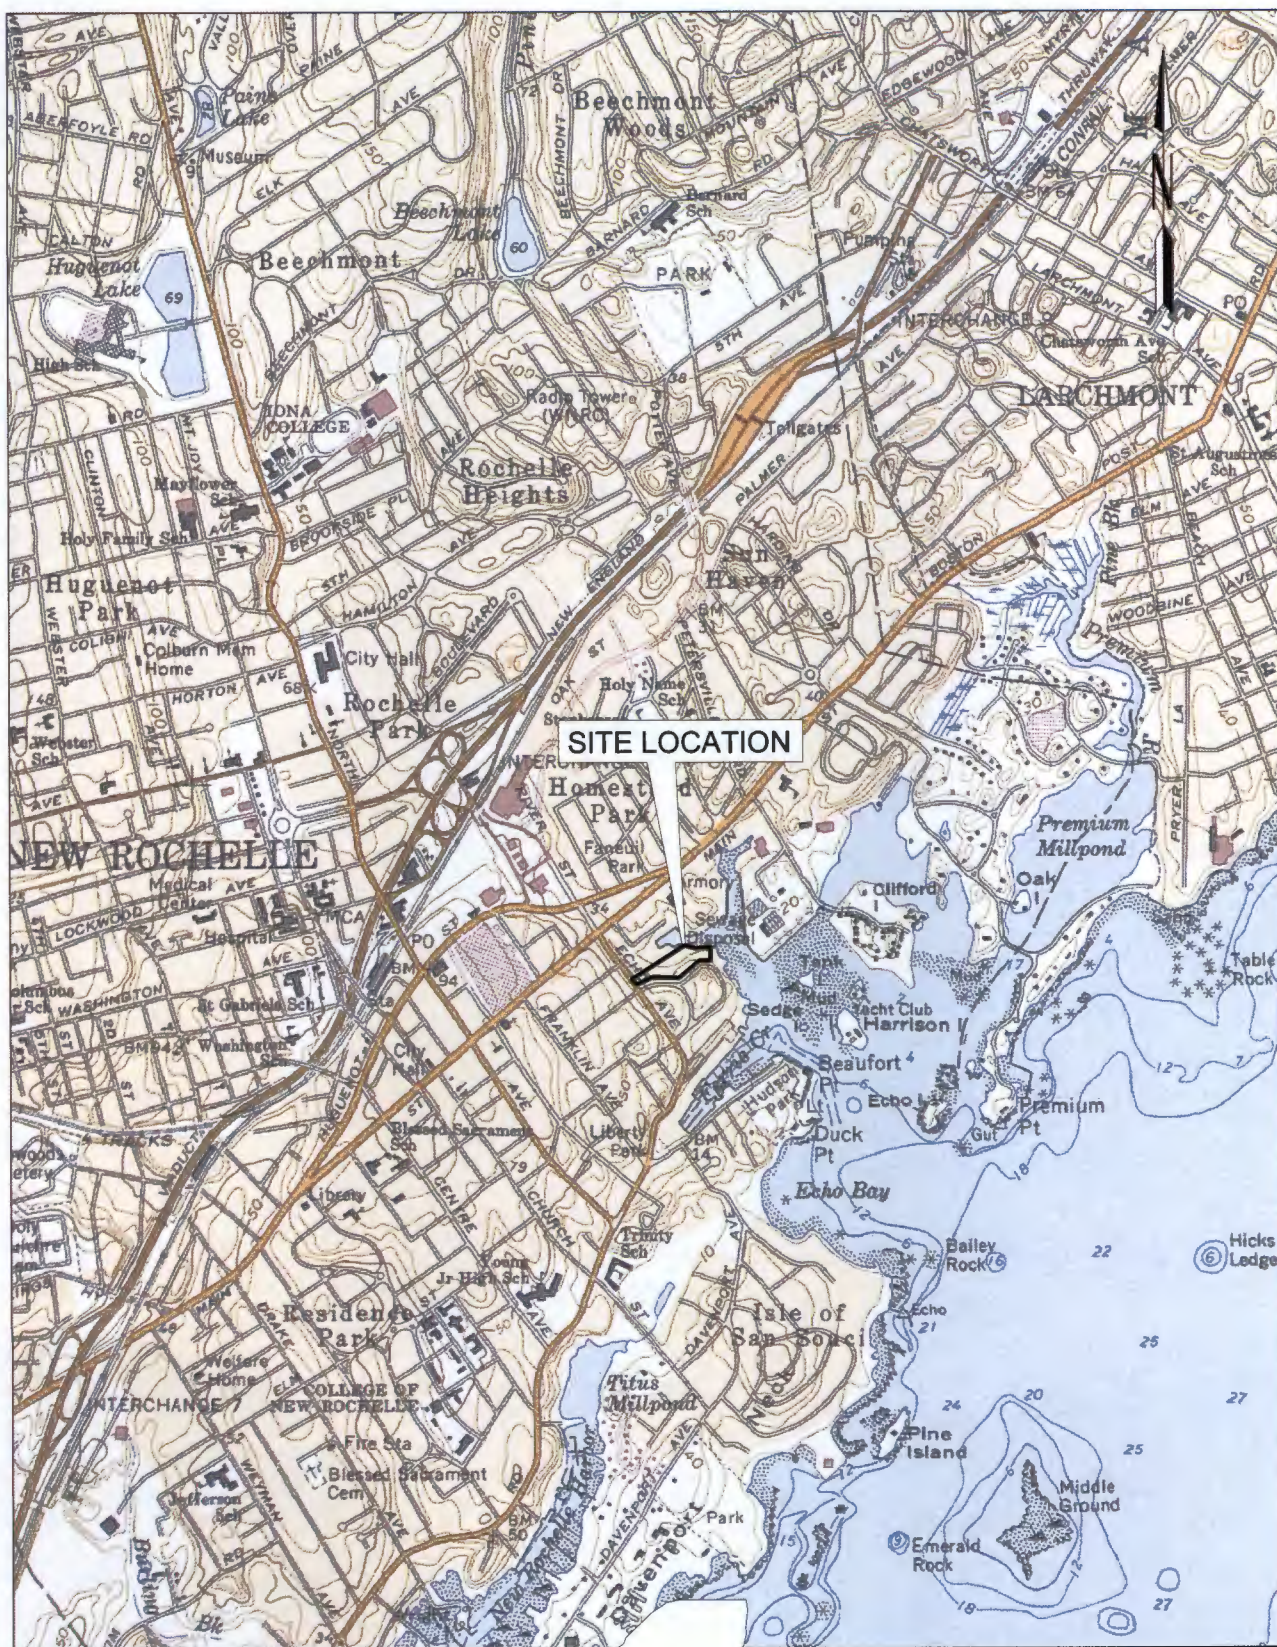
Figure 1-1

## Site Location

The Site is located at 78 Echo Avenue in New Rochelle, Westchester County, New York (Figure 1-1). It is bordered to the north by Echo Bay, an estuary of the Long Island Sound. It is bordered to the east and south by residential properties, to the southwest by Echo Avenue, and to the west by a former commercial fuel oil terminal (Sentinel Fuel Oil Company) that is now operated as a storage yard for landscaping equipment and supplies (Figure 1-2).

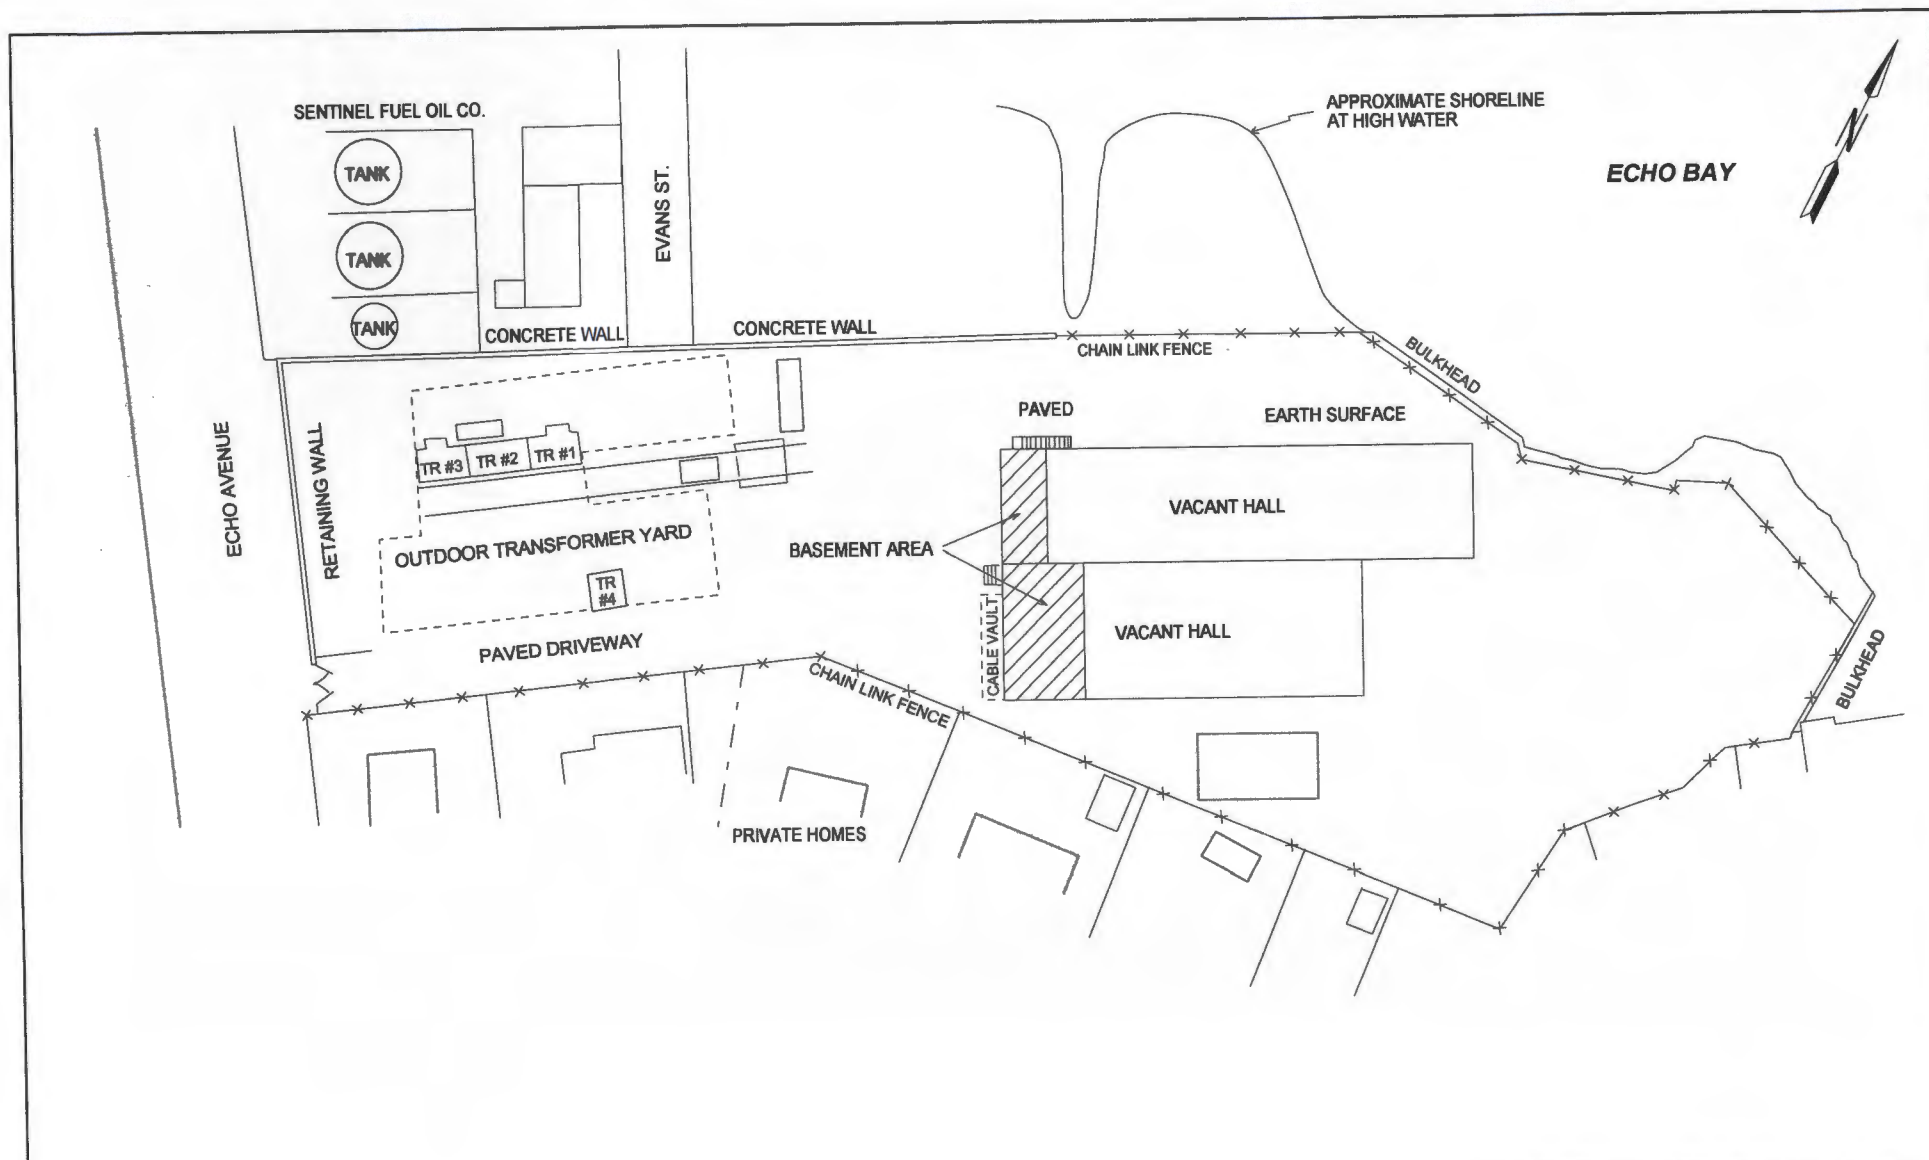
Figure 1-2\*

## Site Sketch

\*Figure 1-2 from June 2001 Remediation Report

The substation building was demolished down to the slab by Con Edison in 1995. Prior to demolition, the basement area, at the western end of the building (see Figure 1-2), was dewatered and concrete chip samples were collected from the basement and basement storage area. These results are provided on Figure 5-21, formerly Figure 4-1 from the *Second Report on Sampling Required in Revised Addendum No. 2 Final Work Plan* (the "April 1996 Second Report") dated April 1996 (Ref. 10, Appendix A). The concrete in the basement contained low levels of PCBs with two samples having PCBs of 3.37 and 3.61 mg/kg; all other samples were less than 1 mg/kg. The NYSDEC determined that the area did not require additional remediation and authorized Con Edison to proceed with backfilling the basement with debris from the building demolition.

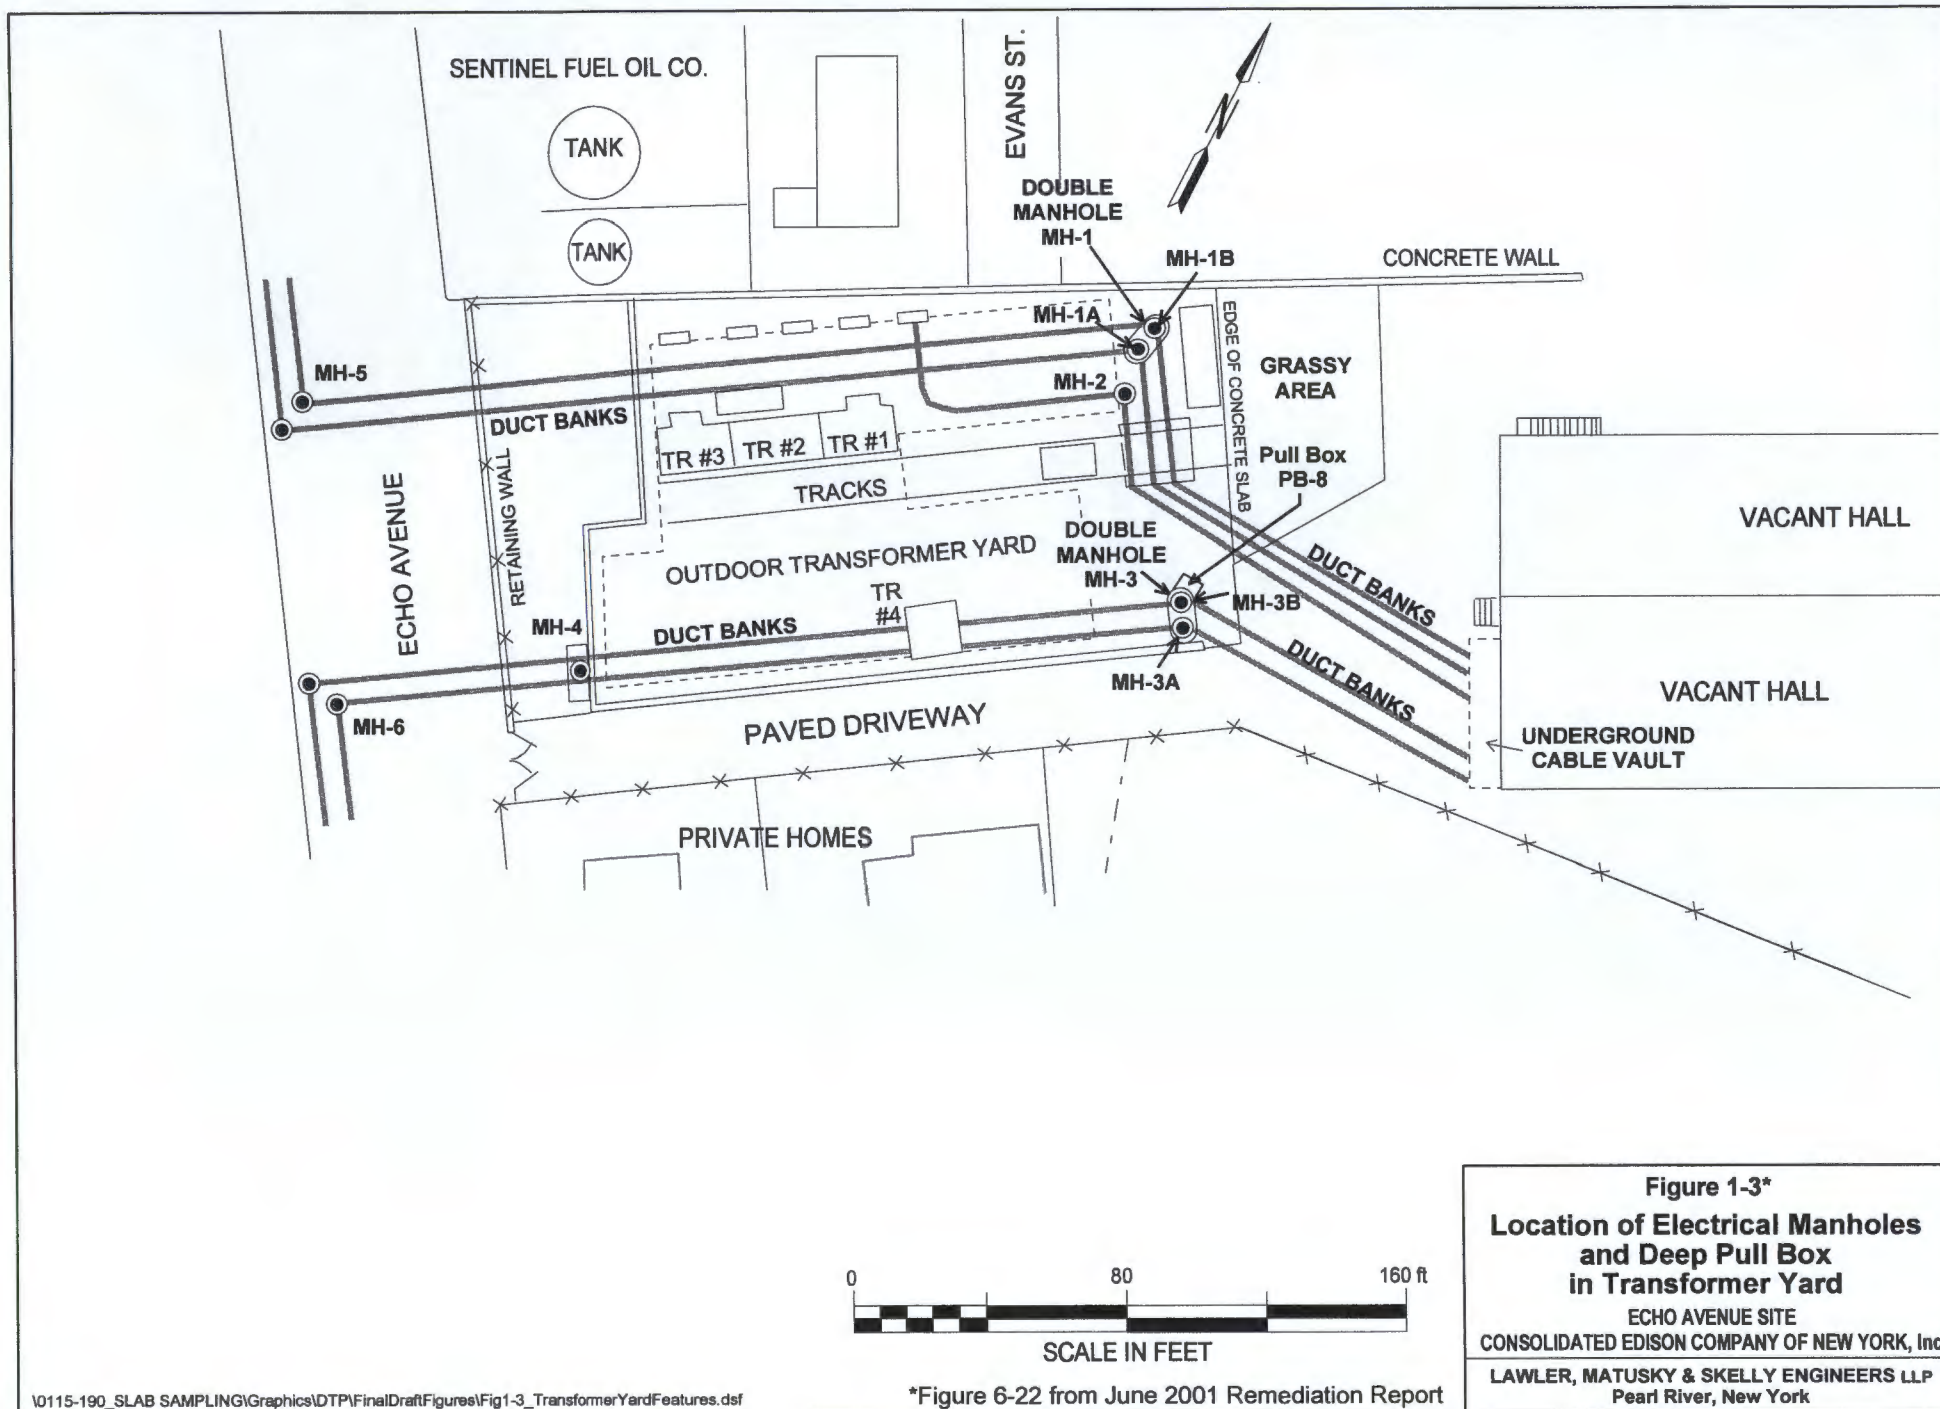
**Figure 1-3\***  
**Location of Electrical Manholes**  
**and Deep Pull Box**  
**in Transformer Yard**  
 ECHO AVENUE SITE  
 CONSOLIDATED EDISON COMPANY OF NEW YORK, Inc.  
 LAWLER, MATUSKY & SKELLY ENGINEERS LLP  
 Pearl River, New York

- The duct banks between the manholes on Echo Avenue and the concrete retaining wall on the western end of the site were not removed. The duct banks were cleaned and plugged on both ends and manhole MH-4 was completely filled with concrete (see Figure 1-3).

- Sediment in the drainage pipes on the Site and in Echo Bay contained levels of PCBs of less than 1 mg/kg.
- Sediment in manhole MH-3 (see Figure 1-3) on the Site contained PCBs at concentrations over 10 mg/kg of PCBs in the north side of the manhole.

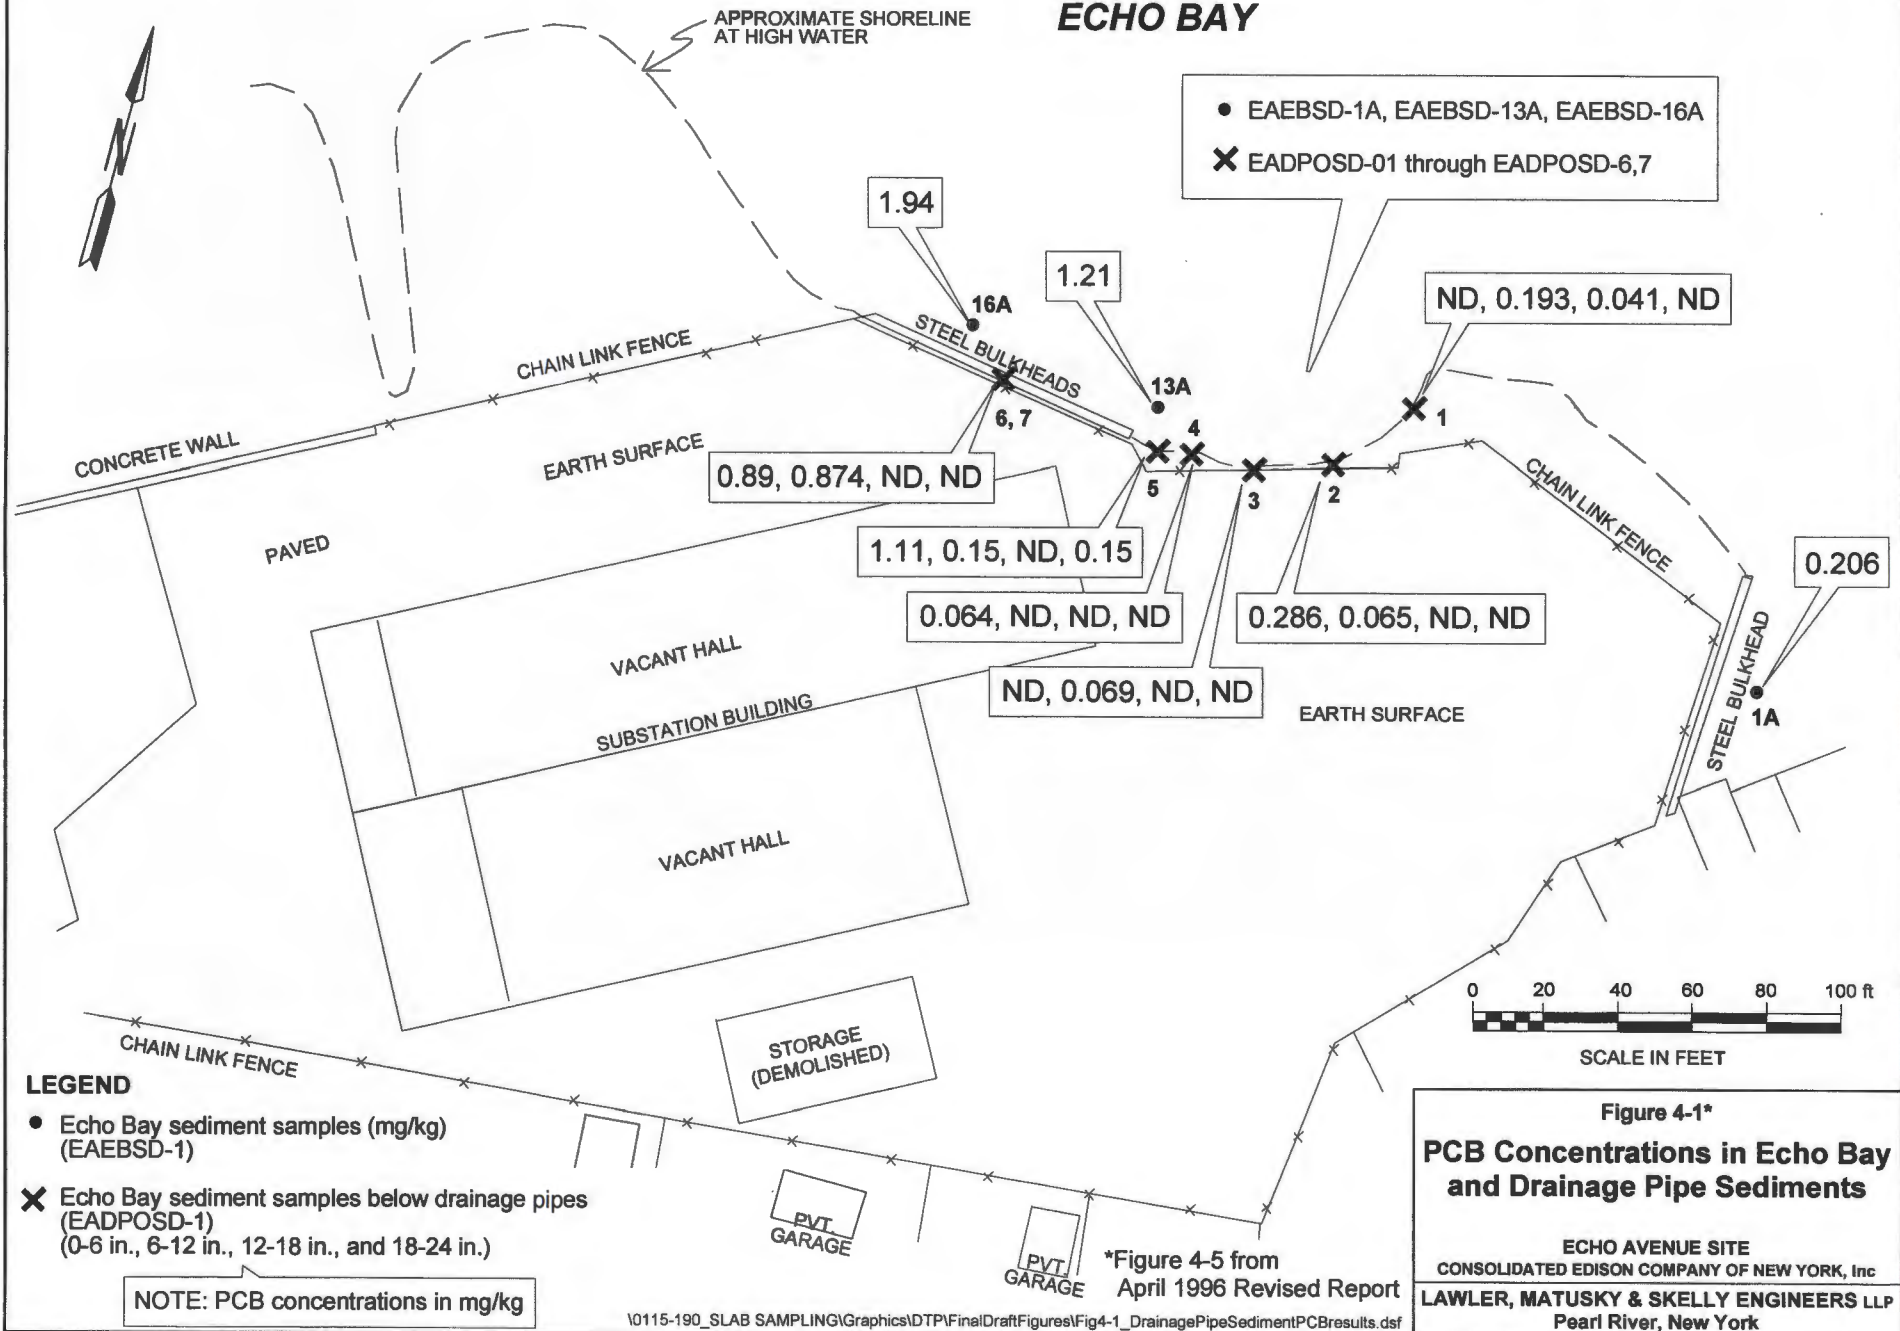
**Figure 4-1\***  
**PCB Concentrations in Echo Bay  
 and Drainage Pipe Sediments**

Based on a review of TRC's RAR (Ref. 22, Appendix A of this Report) for the sediment remediation activities conducted in 2003 and 2004 and a review of the sediment sample results collected by HDR/LMS, there appeared to be three locations where samples collected by HDR/LMS contained concentrations of PCBs above 1 mg/kg and additional sediment was not removed during the remediation activities by TRC. HDR/LMS contacted Con Edison to discuss this information after review of the various reports was completed. A Site visit was conducted by Con Edison, TRC, and HDR/LMS on January 12, 2007 to have personnel involved with the sampling activities from TRC and HDR/LMS look at the locations in question. Apparently, TRC was not provided with HDR/LMS' report which contained the data from these three locations [*Report on Sampling Required in Revised Addendum No. 2 Final Work Plan* (the "April 1996 Revised Report") dated April 1996 (Ref. 8, Appendix A of this Report)] when they were preparing their proposal and the RAWP for the sediment remediation activities. The following paragraphs describe the three locations in question (see Figure 4-1, formerly Figure 4-5 from the April 1996 Revised Report for the location of these samples).

fill material previously placed was removed and that which was in contact with the sediment was disposed. It is possible that the surface of this area was excavated during this process. However, the deteriorated wooden crib that EADP-5 drained into was still visible suggesting that TRC did not remove the fill material much below the top of the sediment in this area. Therefore, it appeared that the sediment at location EADPOSD-5 had not been removed by TRC. As mentioned previously in this Section, the results from these three sediment samples collected in 1995 ranged from 1.11 to 1.94 mg/kg PCBs (see Figure 4-1).

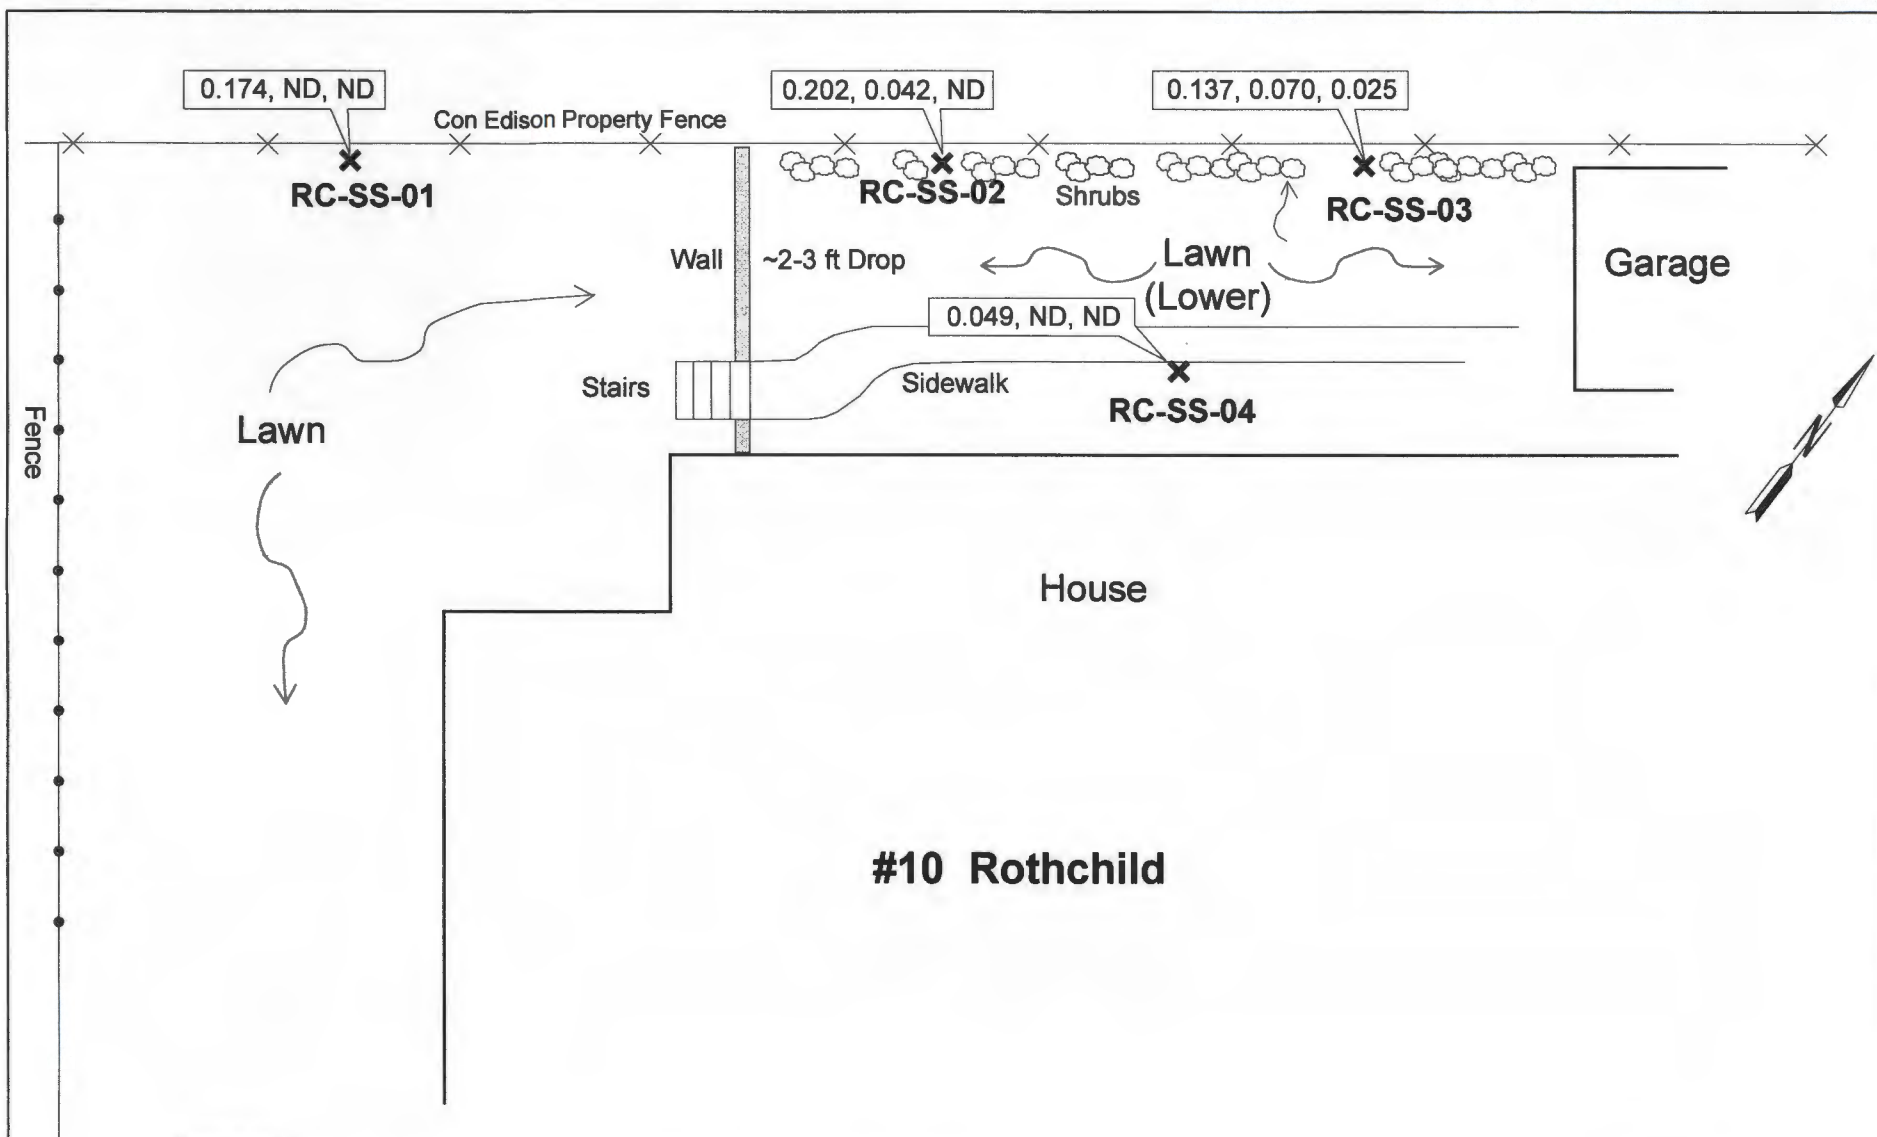
✕ Shallow soil sample location (0-2 in., 2-12 in., 12-24 in.)

**Figure 5-3\***  
**PCB Concentrations in  
Shallow Soil Samples  
at Rothchild Property**

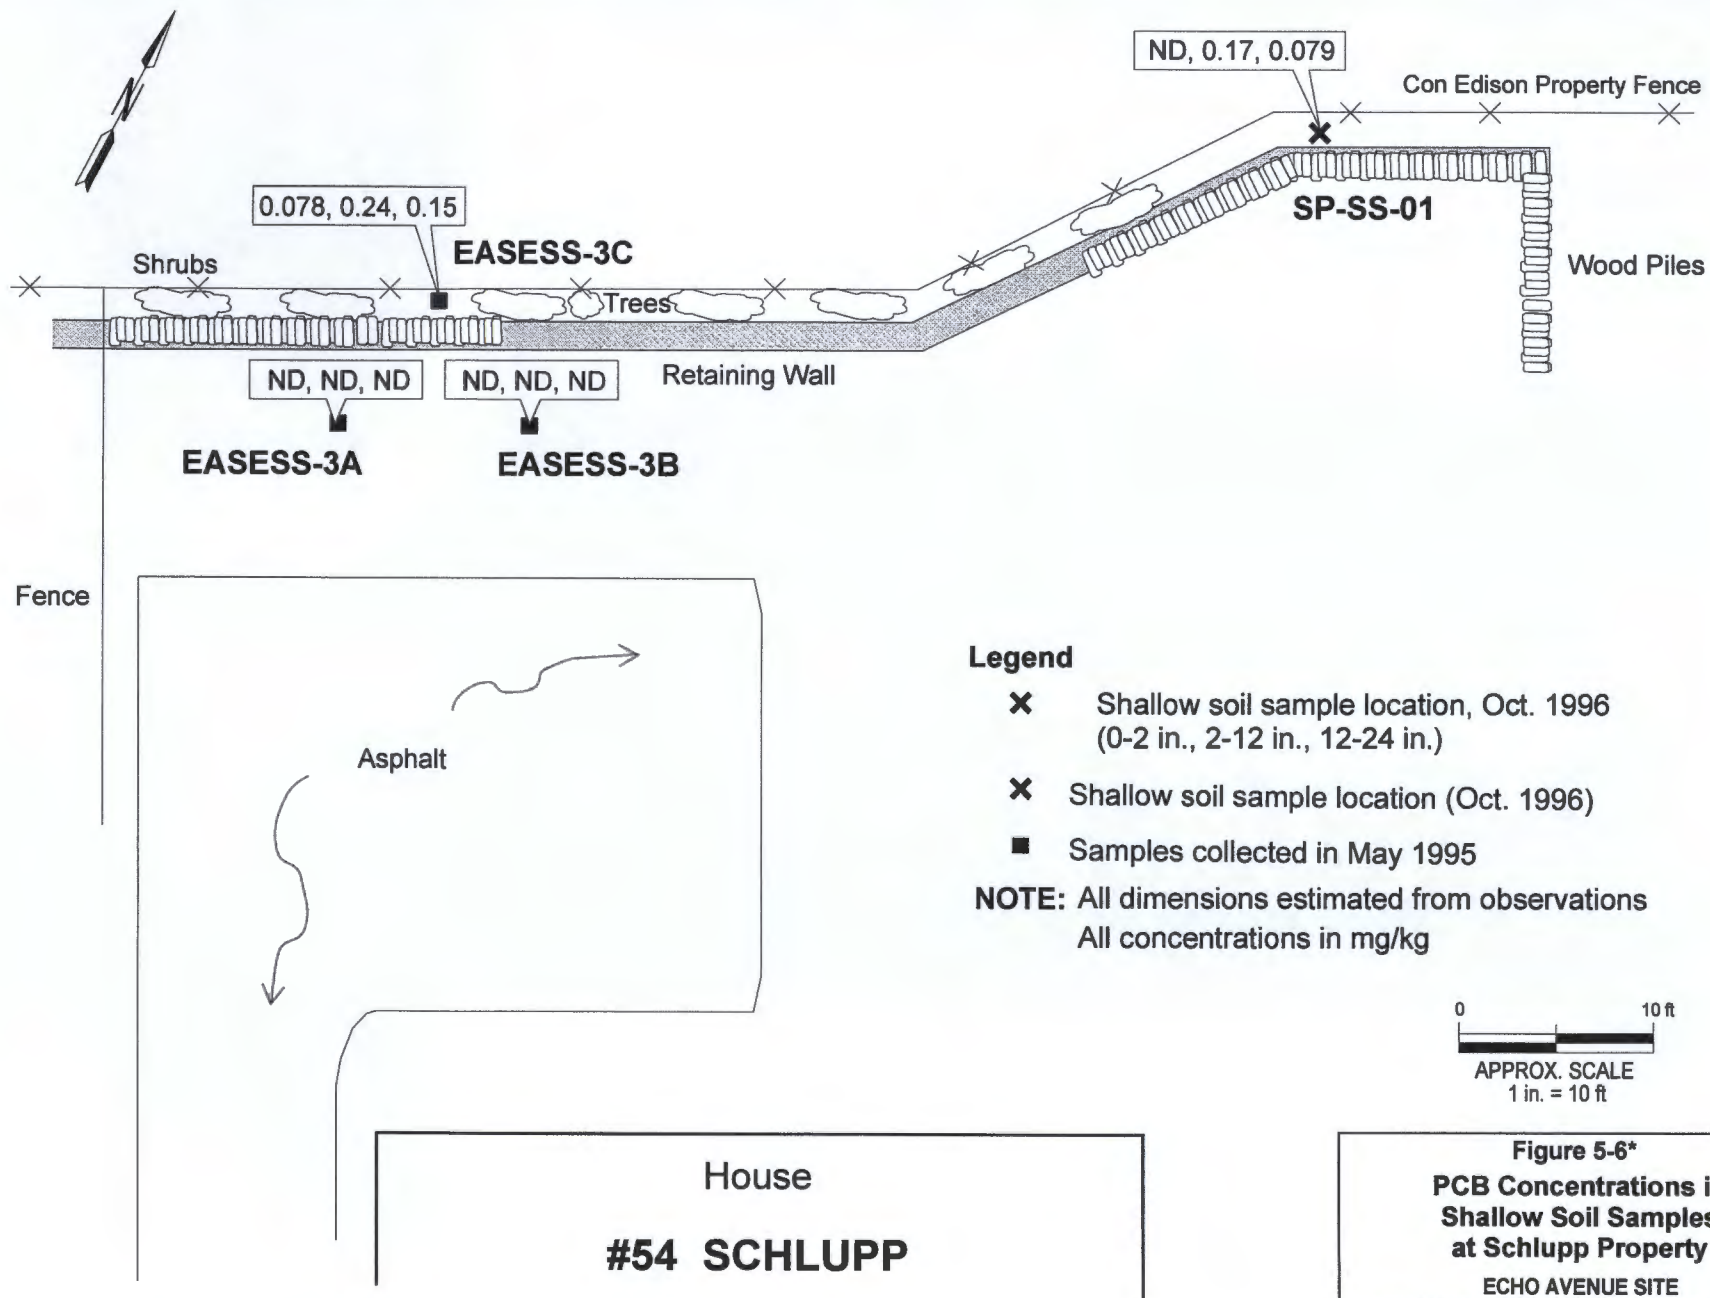
**Figure 5-6\***  
**PCB Concentrations in  
Shallow Soil Samples  
at Schlupp Property**

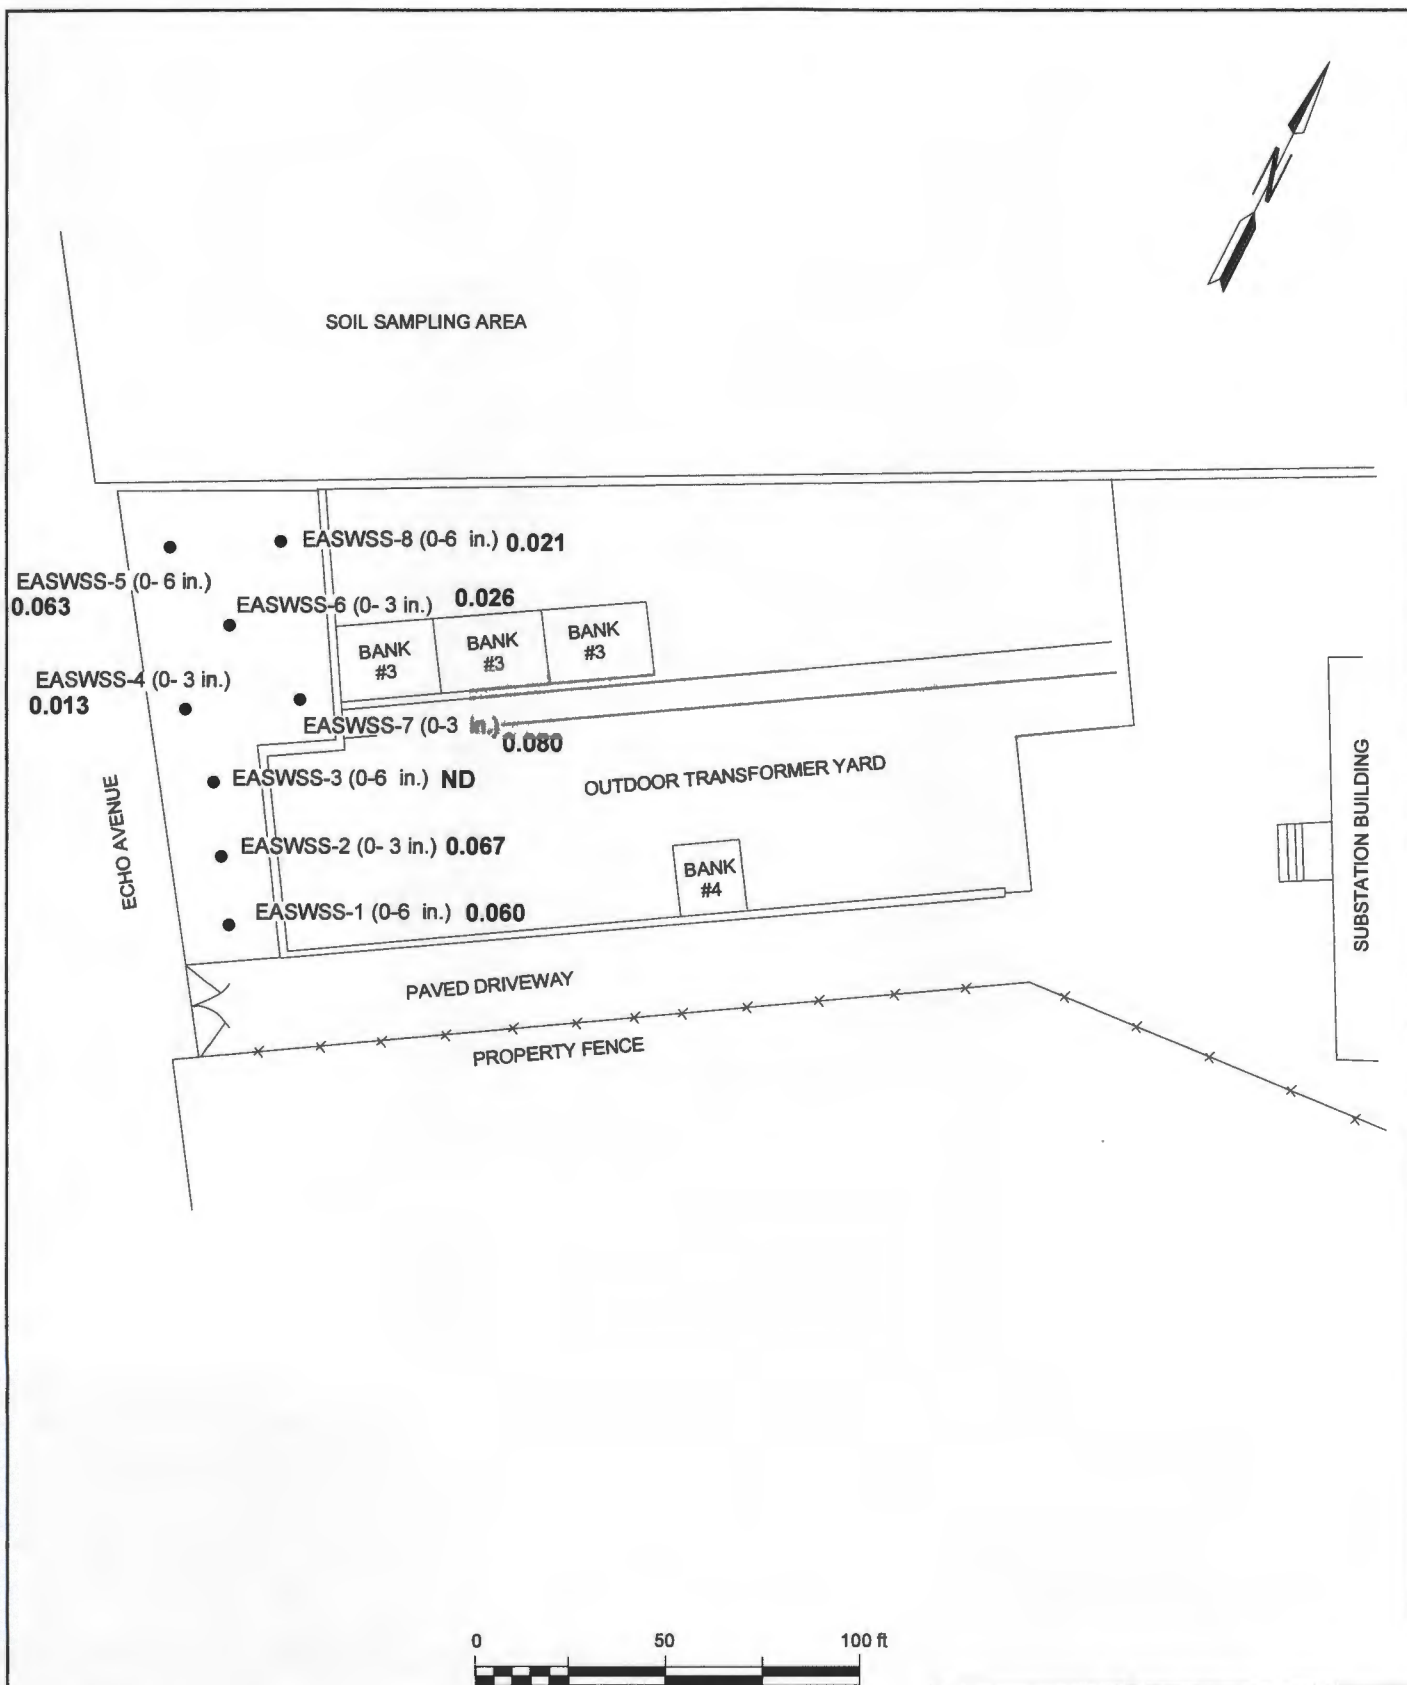
Figure 5-12\*

#### LEGEND

- Soil sample point
- ND No detection

\*Figure 4-20 from February 1993 Phase II Investigation Report

As part of the Phase II investigation conducted on the site in 1992, shallow soil samples and deeper soil samples were collected on-site. At two areas, EASW and EASE, shallow soils were sampled in 1992 (see Figure 5-12 and 5-13, formerly Figures 4-20 and 4-18, respectively, from the February 1993 Phase II Investigation report). Figure 5-13 also shows the data collected from soil borings constructed on the site in 1992. With the exception of soils collected during the construction of monitoring well MW-6, all samples were analyzed only for PCBs. At six additional scattered locations throughout the Site, shallow soil samples were collected and labeled with the EADEC prefix. Three of the samples, EADEC-B, D, and E were analyzed for TCL organics and TAL inorganics; all of the remaining samples were analyzed for PCBs only (see Figure 5-14, formerly Figure 4-19 from the February 1993 Phase II Investigation report for location). None of the samples in the EASW area or in the deeper boring samples had PCBs above 1 mg/kg; therefore, no remediation was required. One of the six samples from the EADEC locations (EADEC-E with 12.0 mg/kg) and two of the EASE locations (EASESS-3 with 6.2 mg/kg and EASESS-7 with 1.09 mg/kg) had PCBs above the RSCO of 1 mg/kg. These areas were subsequently remediated as part of the 1997-1998 remediation as described later in this Section.

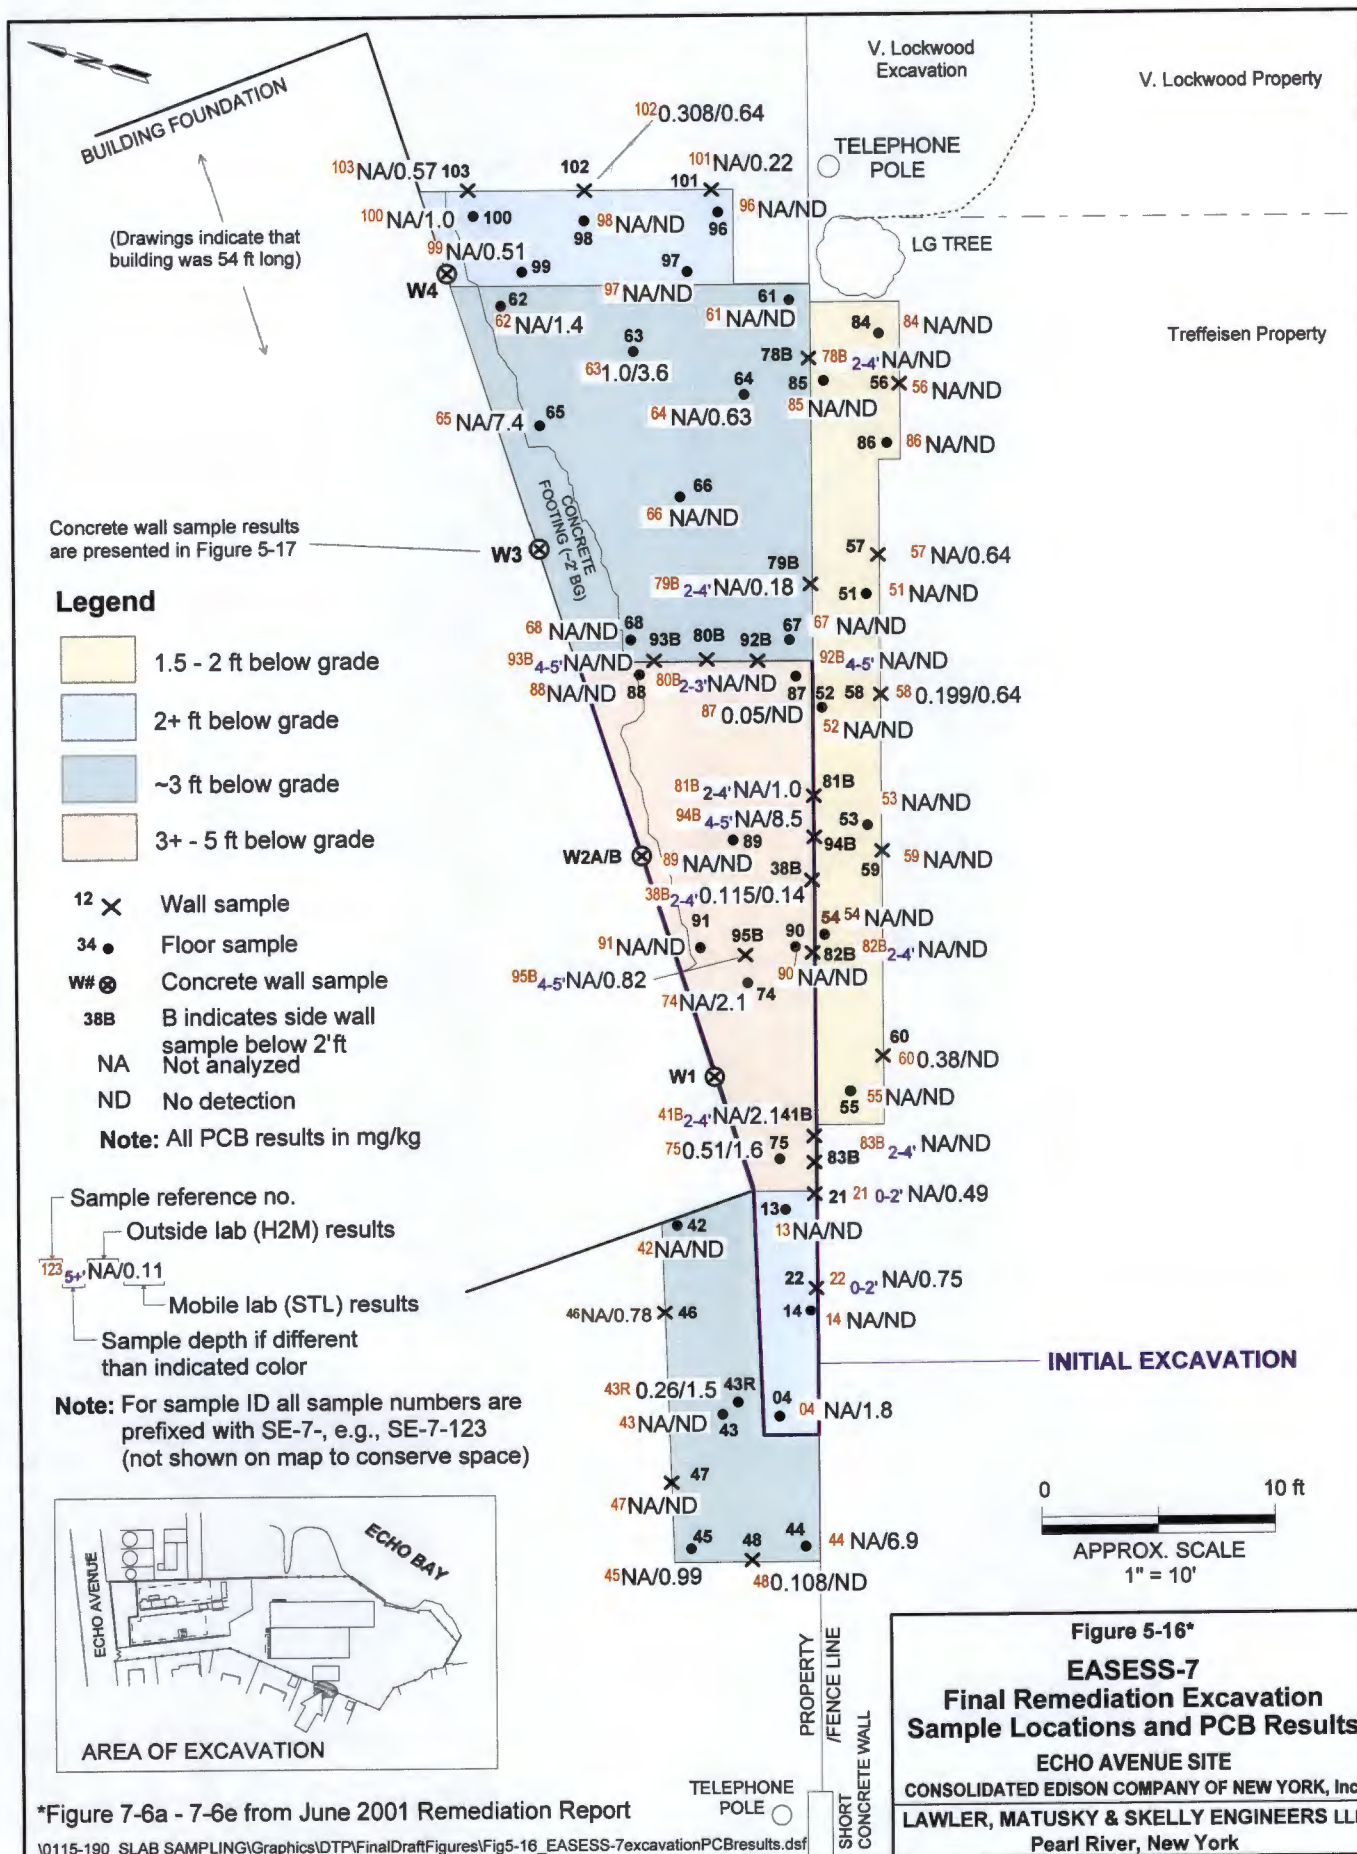
\*Figure 7-6a - 7-6e from June 2001 Remediation Report

Figure 5-16, a composite of Figures 7-6a to e taken from the June 2001 Remediation Report, shows the remaining PCBs after the remediation was completed at the EASESS-7 area in February 1998. The excavated area on the east end met the limits of the V. Lockwood excavation and extended onto the Treffeisen property along the fence line to the south. At the request of NYSDEC, concrete samples were collected from the former office building foundation wall on the northwest side of the excavation; the concrete sample results as shown on Figure 5-17, formerly Figure 7-7 from the June 2001 Remediation Report, were all less than 1 mg/kg. Note that the office building had been demolished and the first floor slab removed by Con Edison in 1995. After the final results were received, and the results verified that the cleanup objectives were met, the area was backfilled with clean certified backfill to the original grade. The bottom of the deep excavation area (excavated to 5 ft deep) was backfilled with clean crushed stone to ensure proper compaction would be obtained. The Treffeisen side of the property line was replanted with shrubs and ground cover, and the Echo Avenue site was covered with wood chips.

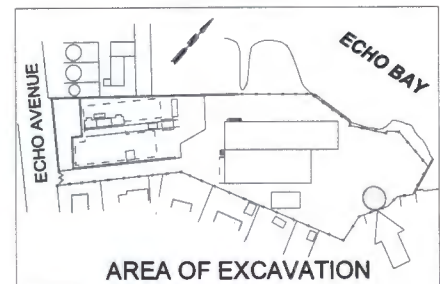
**Note:** For sample ID all sample numbers are prefixed with SE-3-, e.g., SE-3-123 (not shown on map to conserve space)

**Figure 5-15\***  
**EASESS-3**  
**Final Remediation Excavation**  
**Sample Locations**  
**and PCB Results**

Figure 5-15, a composite figure of Figures 7-5a to g from the June 2001 Remediation Report, documents the PCB levels remaining at the EASESS-3 area after the remediation was completed in March 1998. The area was backfilled with certified clean backfill; the deeper areas were backfilled in lifts to ensure proper compaction. The area was backfilled to the original grade and covered with a layer of wood chips.

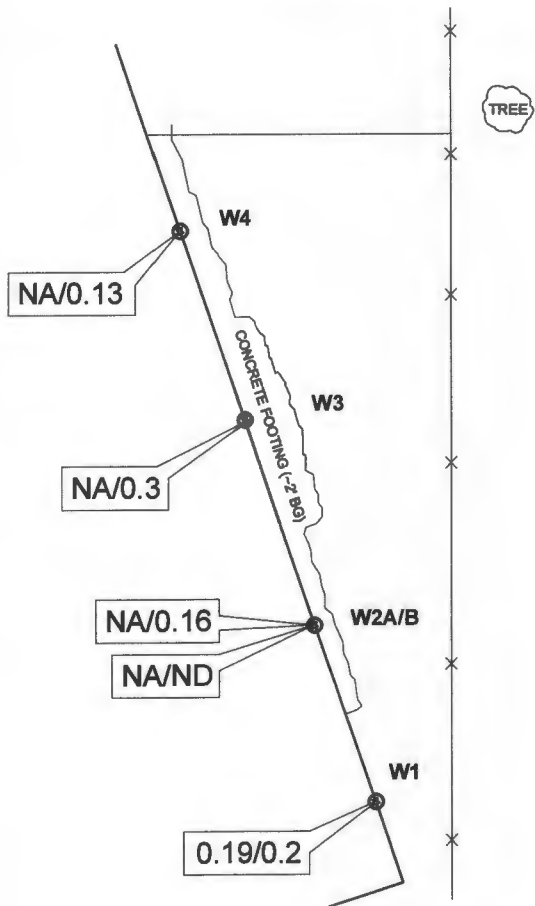
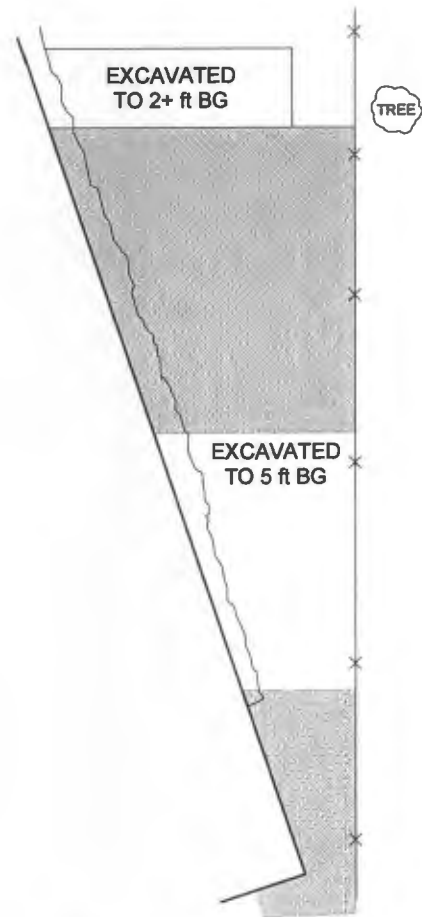
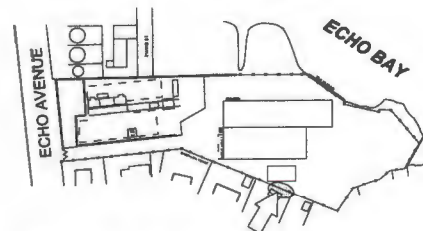
### EASESS-7 (Concrete Samples From Building Foundation)

### EASESS-7 (East End Extension and Deep Pipe Area)

- Floor sample
- × Wall sample
- ⊙ Concrete wall sample
- A Designates wall sample from above 2 ft
- B Designates wall sample from below 2 ft
