**CONSOLIDATED EDISON COMPANY OF NEW YORK, INC.**  
New York, New York

**ECHO AVENUE STATE SUPERFUND SITE  
SUMMARY REPORT**

June 2007

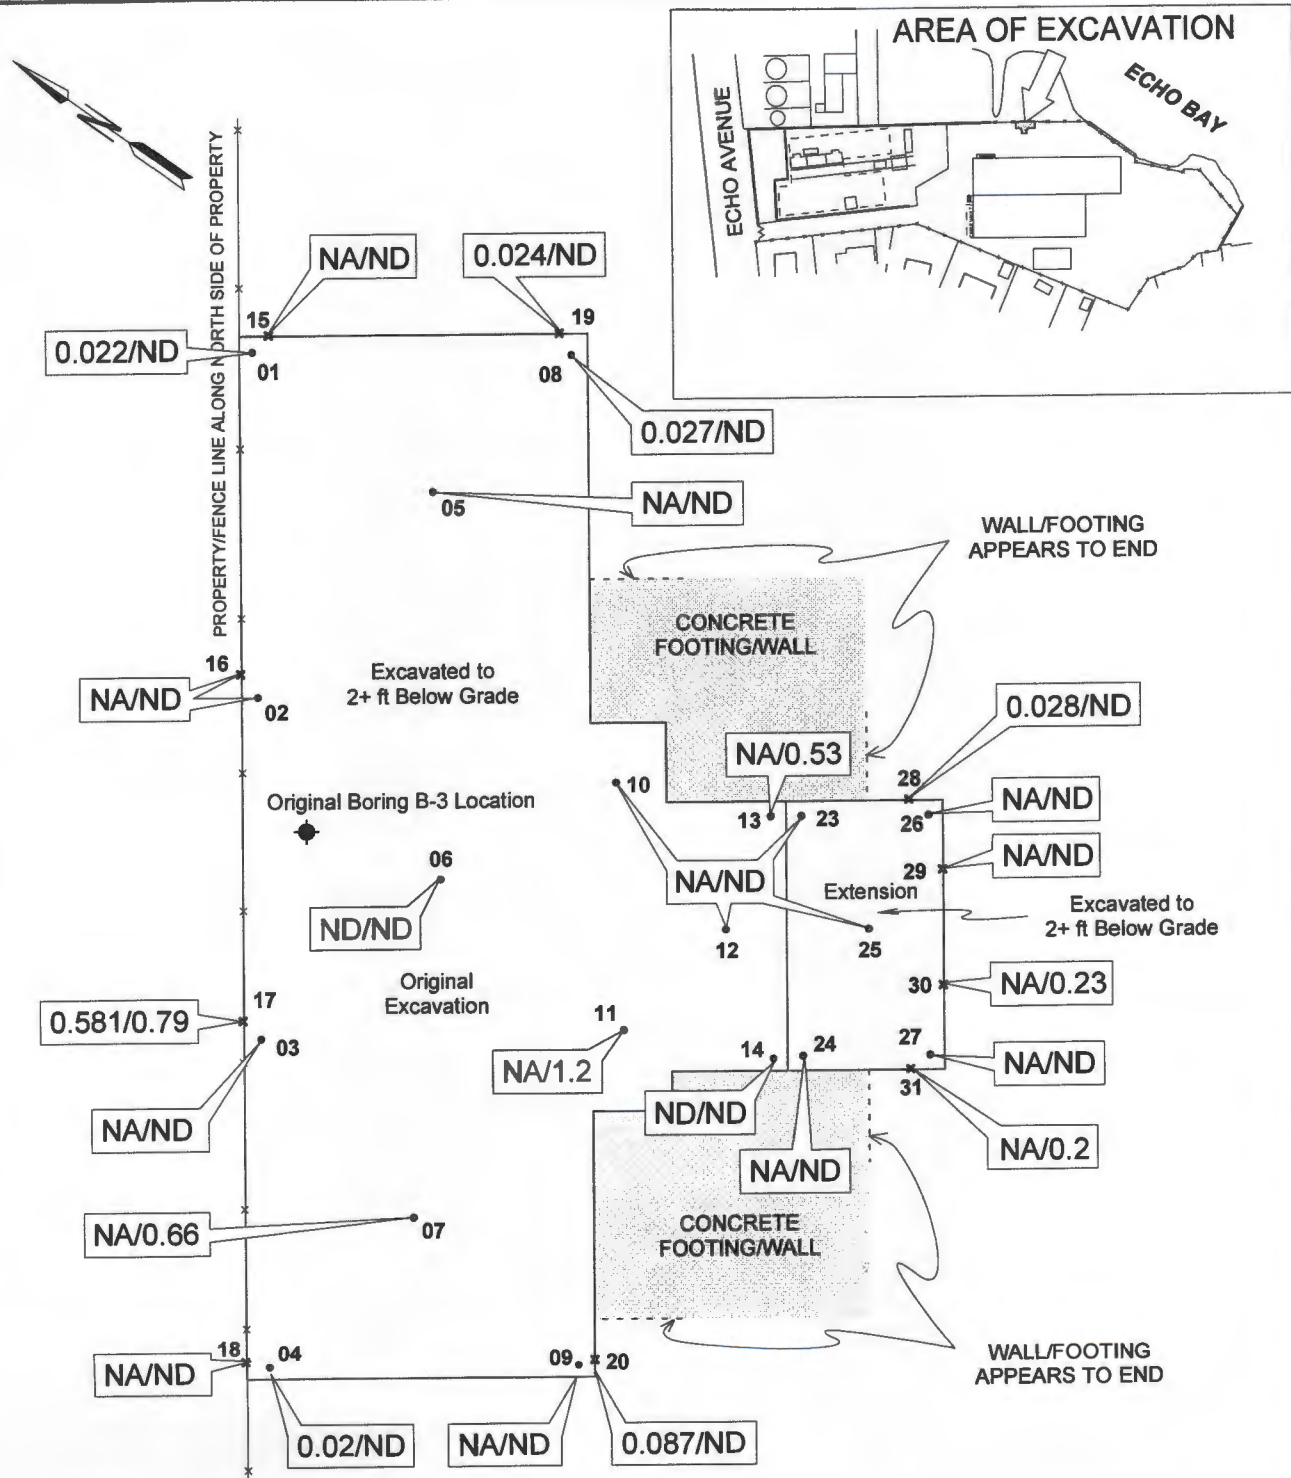
- Floor sample
- × Wall sample
- B Side wall sample below 2 ft

\*Figure 7-9 from June 2001 Remediation Report

Area B-3 was remediated as a result of a sample collected from a boring installed in April 1994 that contained 2.2 mg/kg of PCBs. Figure 5-20, formerly Figure 7-9 from the June 2001 Remediation Report, shows the PCB contamination remaining after the remediation of this area was completed in December 1997. The location of the original boring is also shown on the figure. The area was backfilled with certified clean fill to the original grade and covered with wood chips.

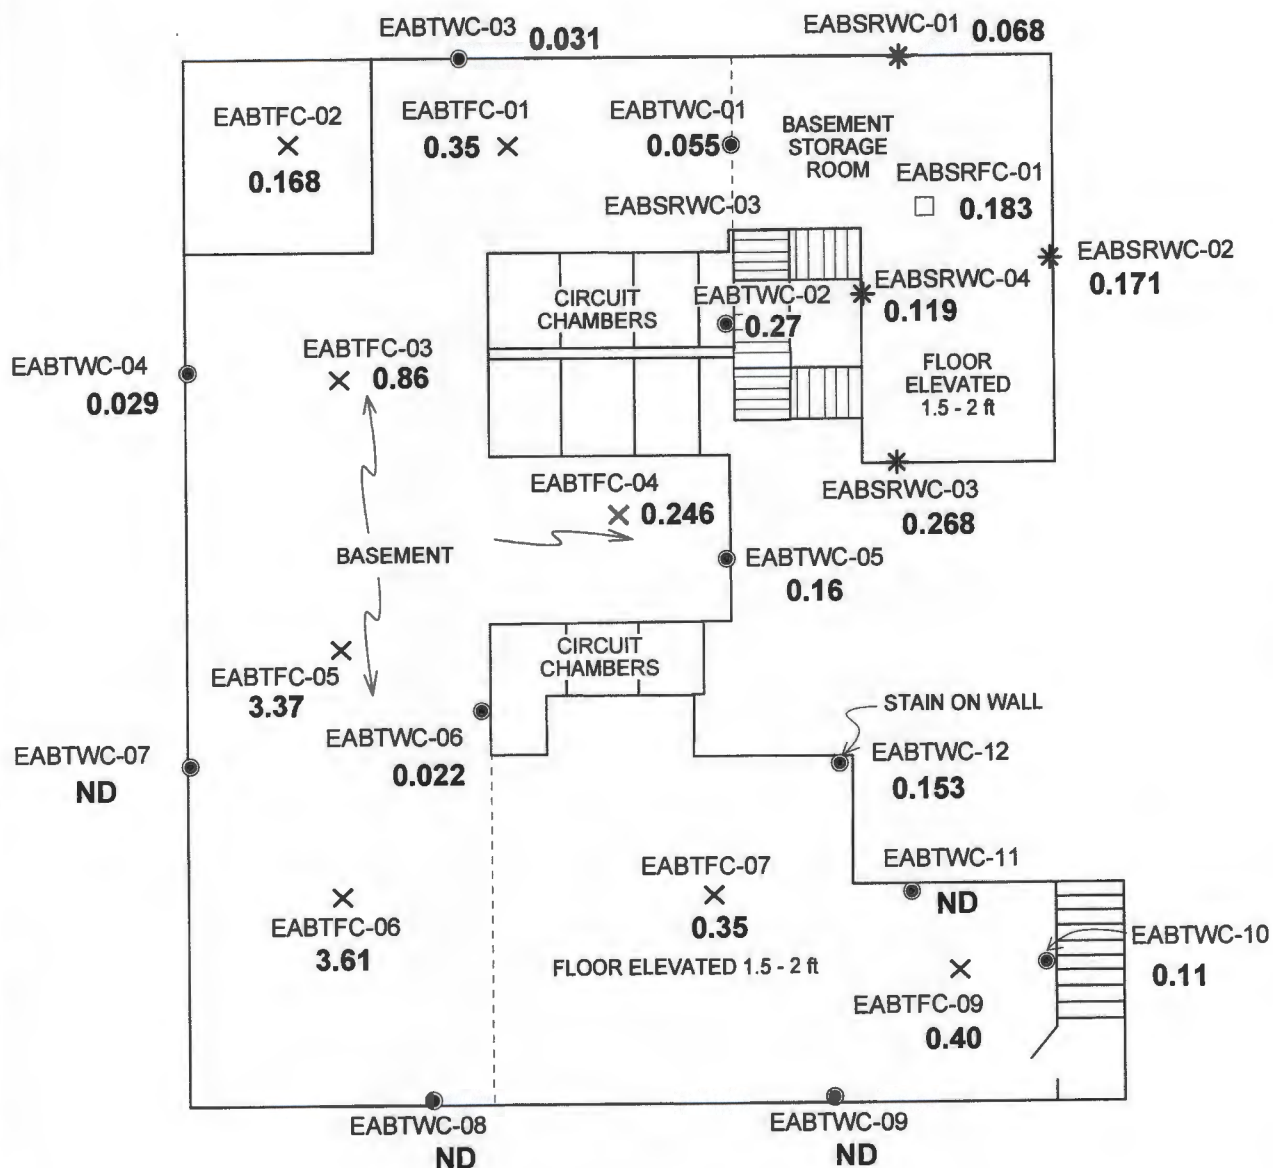
- Basement core wall samples
- \* Basement storage room core wall samples
- X Basement core floor samples
- Basement storage room core floor sample

\*Figure 4-1 from April 1996 Second Report

The substation building was demolished down to the slab by Con Edison in 1995. Prior to demolition, the basement area, at the western end of the building (see Figure 1-2), was dewatered and concrete chip samples were collected from the basement and basement storage area. These results are provided on Figure 5-21, formerly Figure 4-1 from the *Second Report on Sampling Required in Revised Addendum No. 2 Final Work Plan* (the "April 1996 Second Report") dated April 1996 (Ref. 10, Appendix A). The concrete in the basement contained low levels of PCBs with two samples having PCBs of 3.37 and 3.61 mg/kg; all other samples were less than 1 mg/kg. The NYSDEC determined that the area did not require additional remediation and authorized Con Edison to proceed with backfilling the basement with debris from the building demolition.

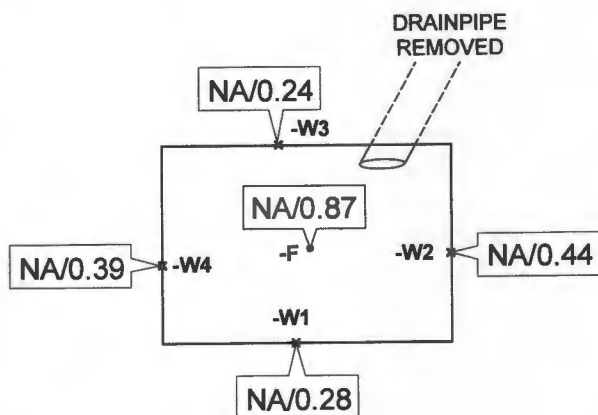
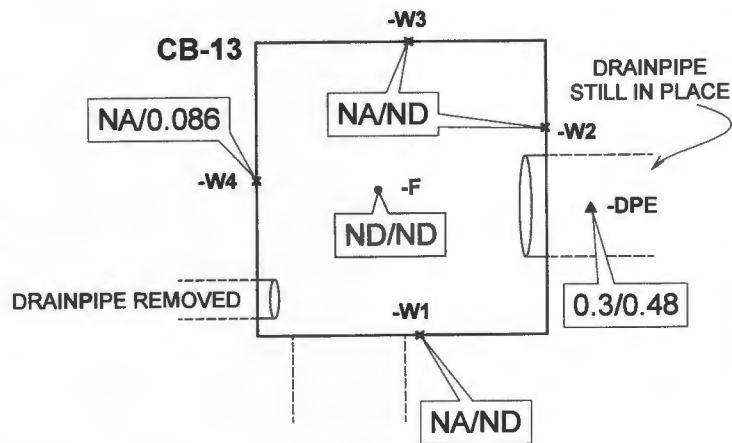
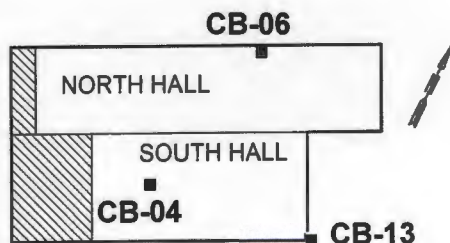
## CB-04

Catch Basin Wall Composite  
CB-04-C  
0.208/0.38

Catch basin is 1.5 ft deep

## CB-13

Catch Basin Wall Composite  
CB-13-C  
ND/ND

Figure 5-25\*  
South Hall  
Catch Basin Concrete,  
and Sediment Sample Locations  
and PCB Results

In January 2000, Con Edison received approval from NYSDEC to backfill the South Hall building slab area with clean certified fill. At the time, CB-04 and CB-13 were allowed to remain in place. Figure 5-25, formerly Figure 7-21b from the June 2001 Remediation Report, shows the PCB concentrations in the concrete from these two catch basins. In 2002-2003, CB-13, which consisted of two catch basins adjacent to each other, and the drainpipe were removed. The results of the confirmatory PCB concentrations are provided on Figure 5-26, previously Figure 5-10 from the July 2003 Remediation Report Addendum. CB-04 remains in place.

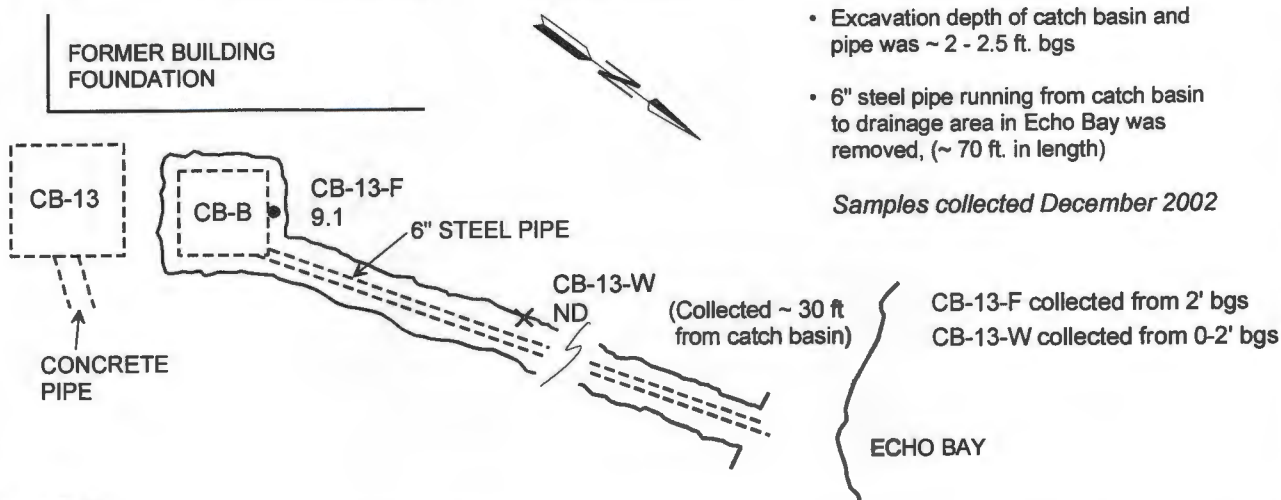
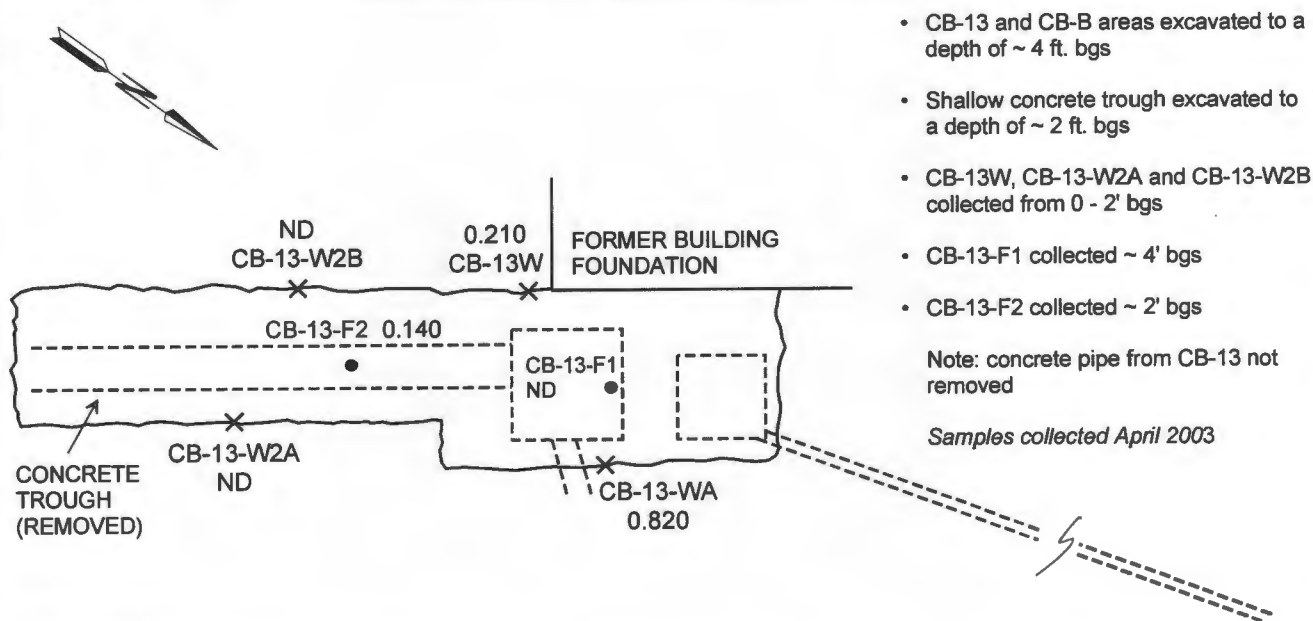
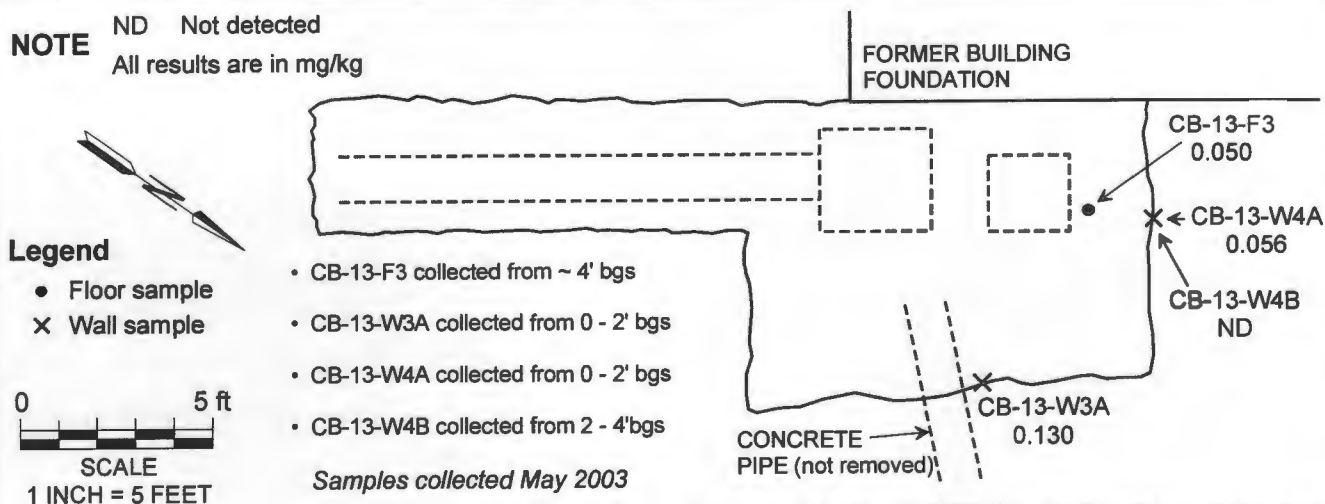
Figure 5-10a

Figure 5-10b

\*Figure 5-10 from July 2003 Remediation Report Addendum

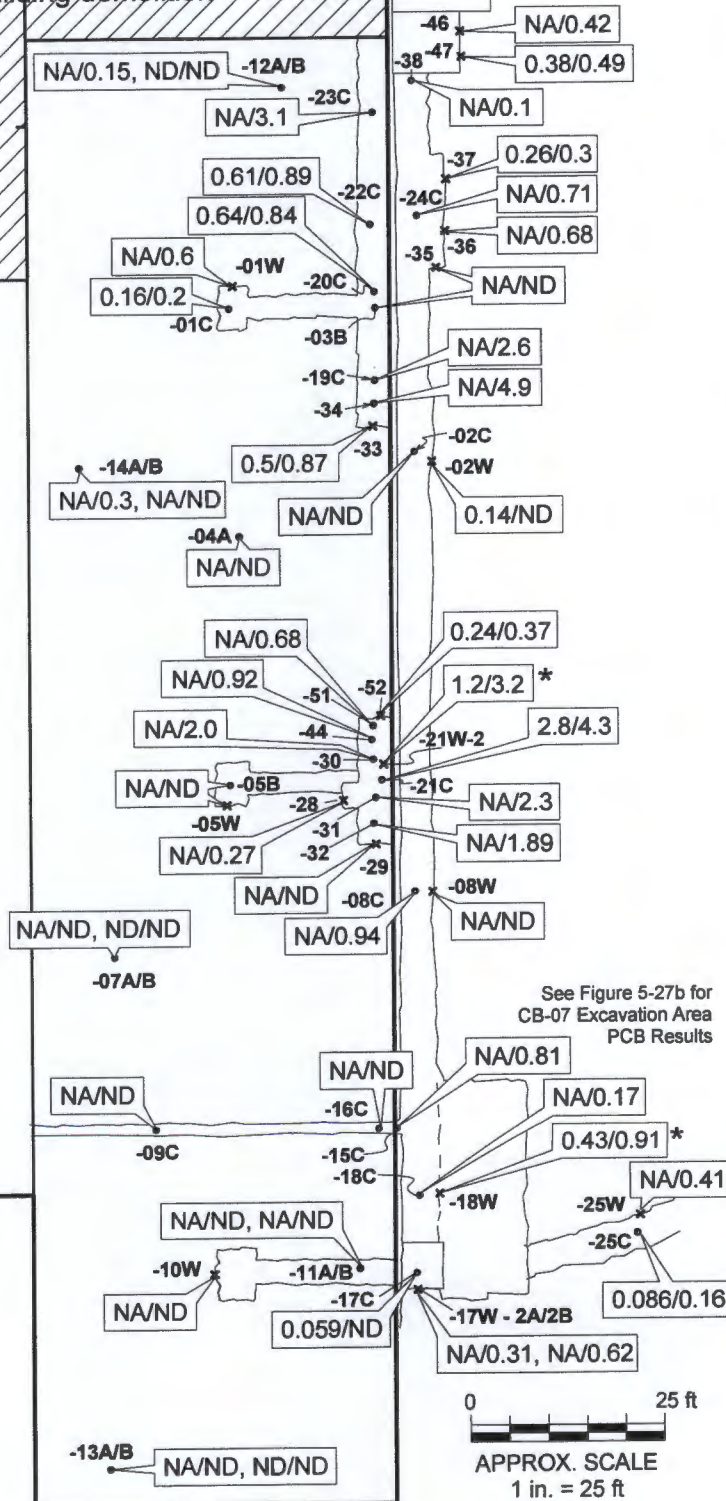
## SOUTH HALL NORTH HALL

NOTE: All sample numbers  
are prefixed with  
NH-, e.g. NH-09C

**\*Figure 7-22b from June 2001 Remediation Report**

The North Hall substation slab was also removed as part of the 1999-2000 remediation. In addition, catch basins CB-01, CB-02, CB-03, CB-07, CB-12, and CB-15, the drainpipes from CB-01, CB-02, CB-03, and CB-15, the drainpipe that ran from CB-04 and CB-05 under the North Hall slab to CB-12, and the drainpipe between CB-07 and CB-12 along the outside of the northern foundation wall were all removed. A concrete trough along the inside of the north wall foundation in the northwest corner area was also removed. CB-06 and a concrete pit near CB-15 were allowed to remain in place. The confirmatory PCB samples from the North Hall slab, catch basins and drainpipe removal are shown on Figure 5-27a to d, formerly Figures 7-22a to 7-22d from the June 2001 Remediation Report.

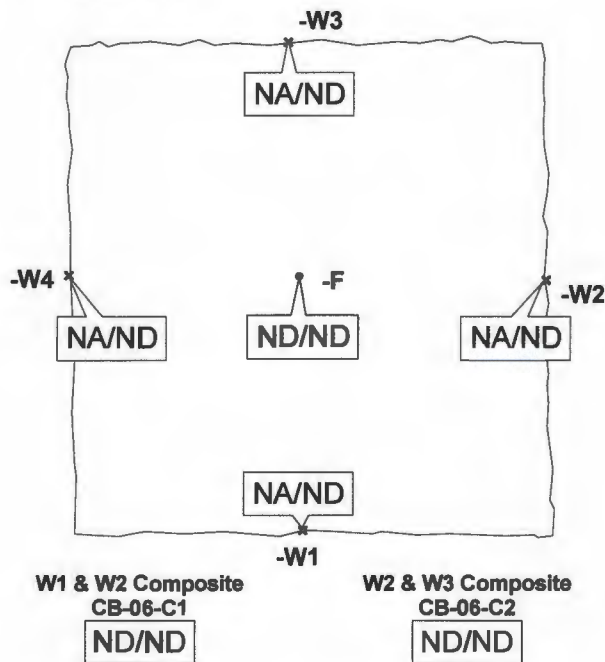
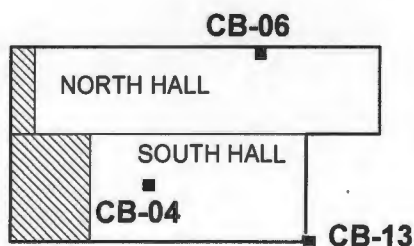
## CB-06

All sample numbers are prefixed with catch basin ID, e.g. CB-06-W2

0.27/0.44 Outside lab (H2M) results/  
Mobile lab (STL) results  
PCB concentration (mg/kg)

Figure 5-27d\*  
North Hall  
Catch Basin Concrete, and  
Soil Sample Locations  
and PCB Results

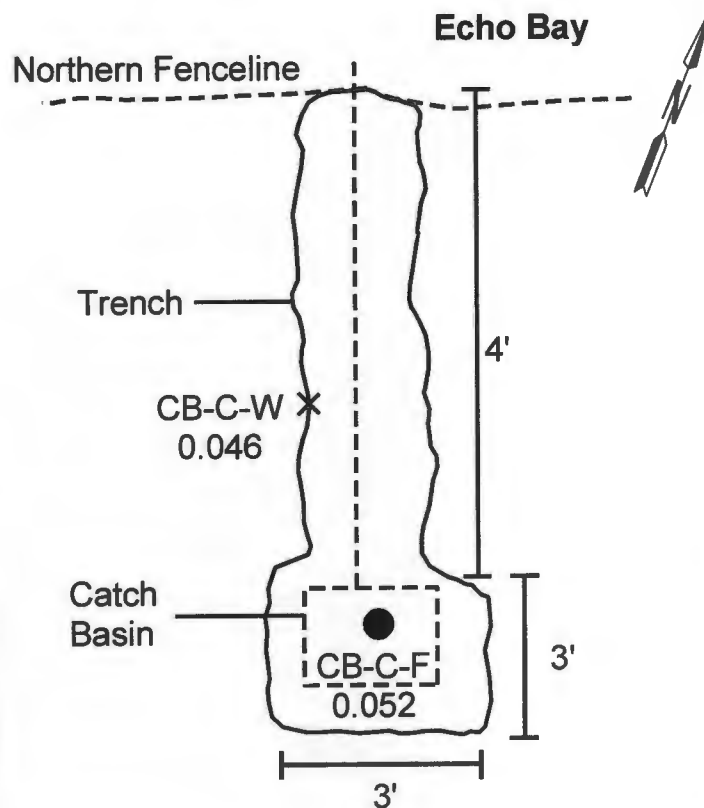
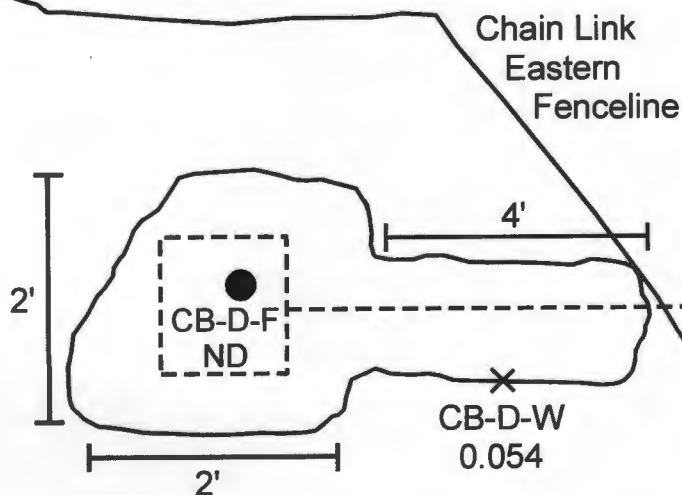
Figure 5-38\*

### CB-C and CB-D Confirmatory PCB Soil Sample Results

\*Figure 5-9 from July 2003 Remediation Report Addendum

2003. The results of the soil samples collected after removal are provided in Figures 5-38 and 5-39, formerly Figures 5-9 and 5-11 from the July 2003 Remediation Report Addendum.

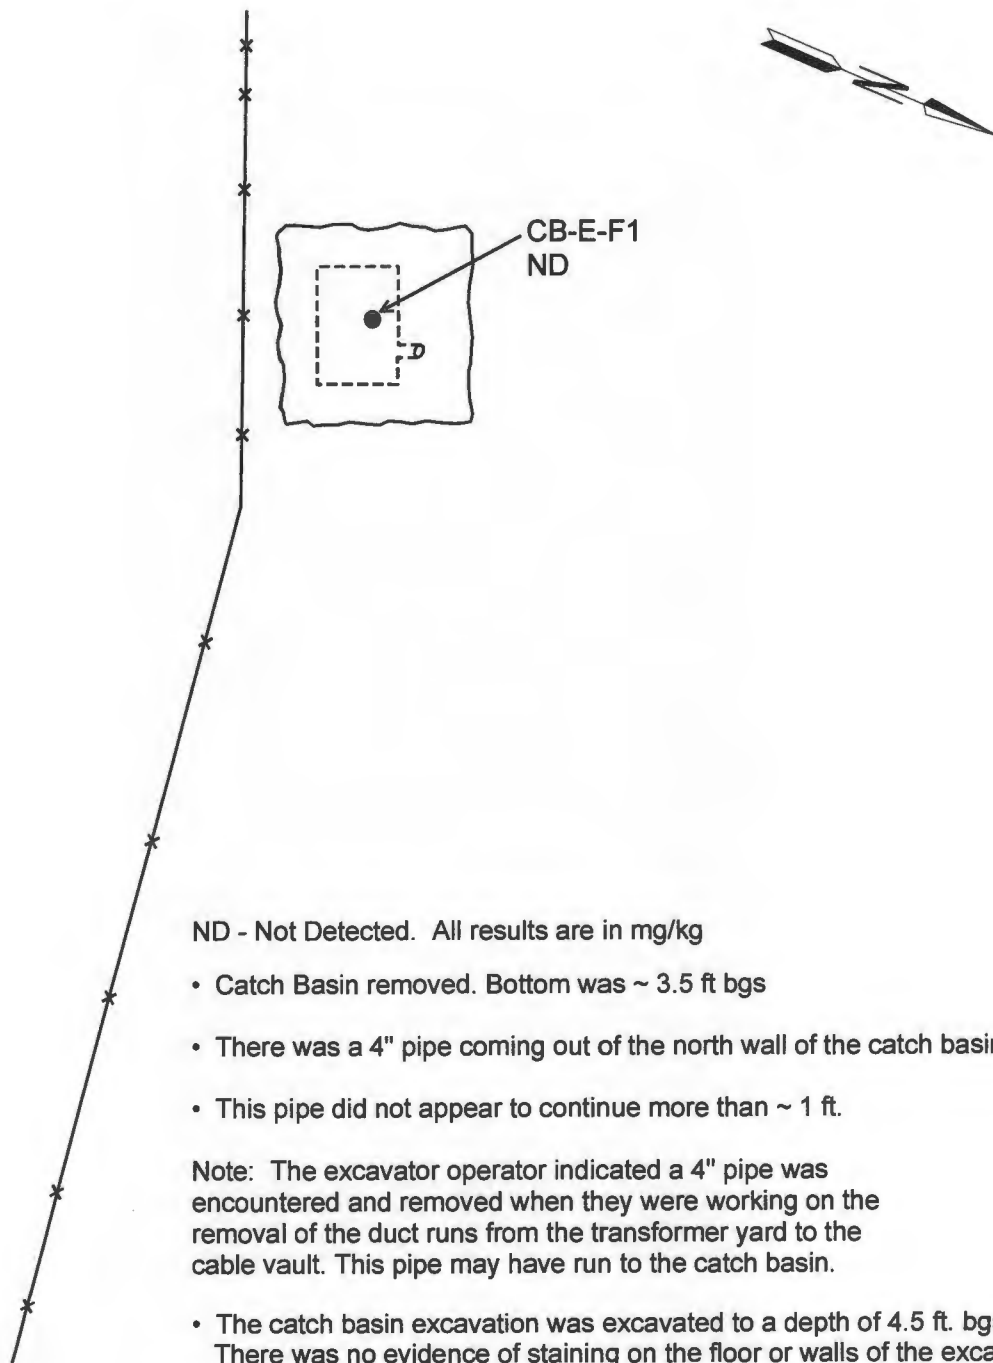
Figure 5-39\*

### CB-E Confirmatory PCB Soil Sample Result

\*Figure 5-11 from July 2003 Remediation Report Addendum

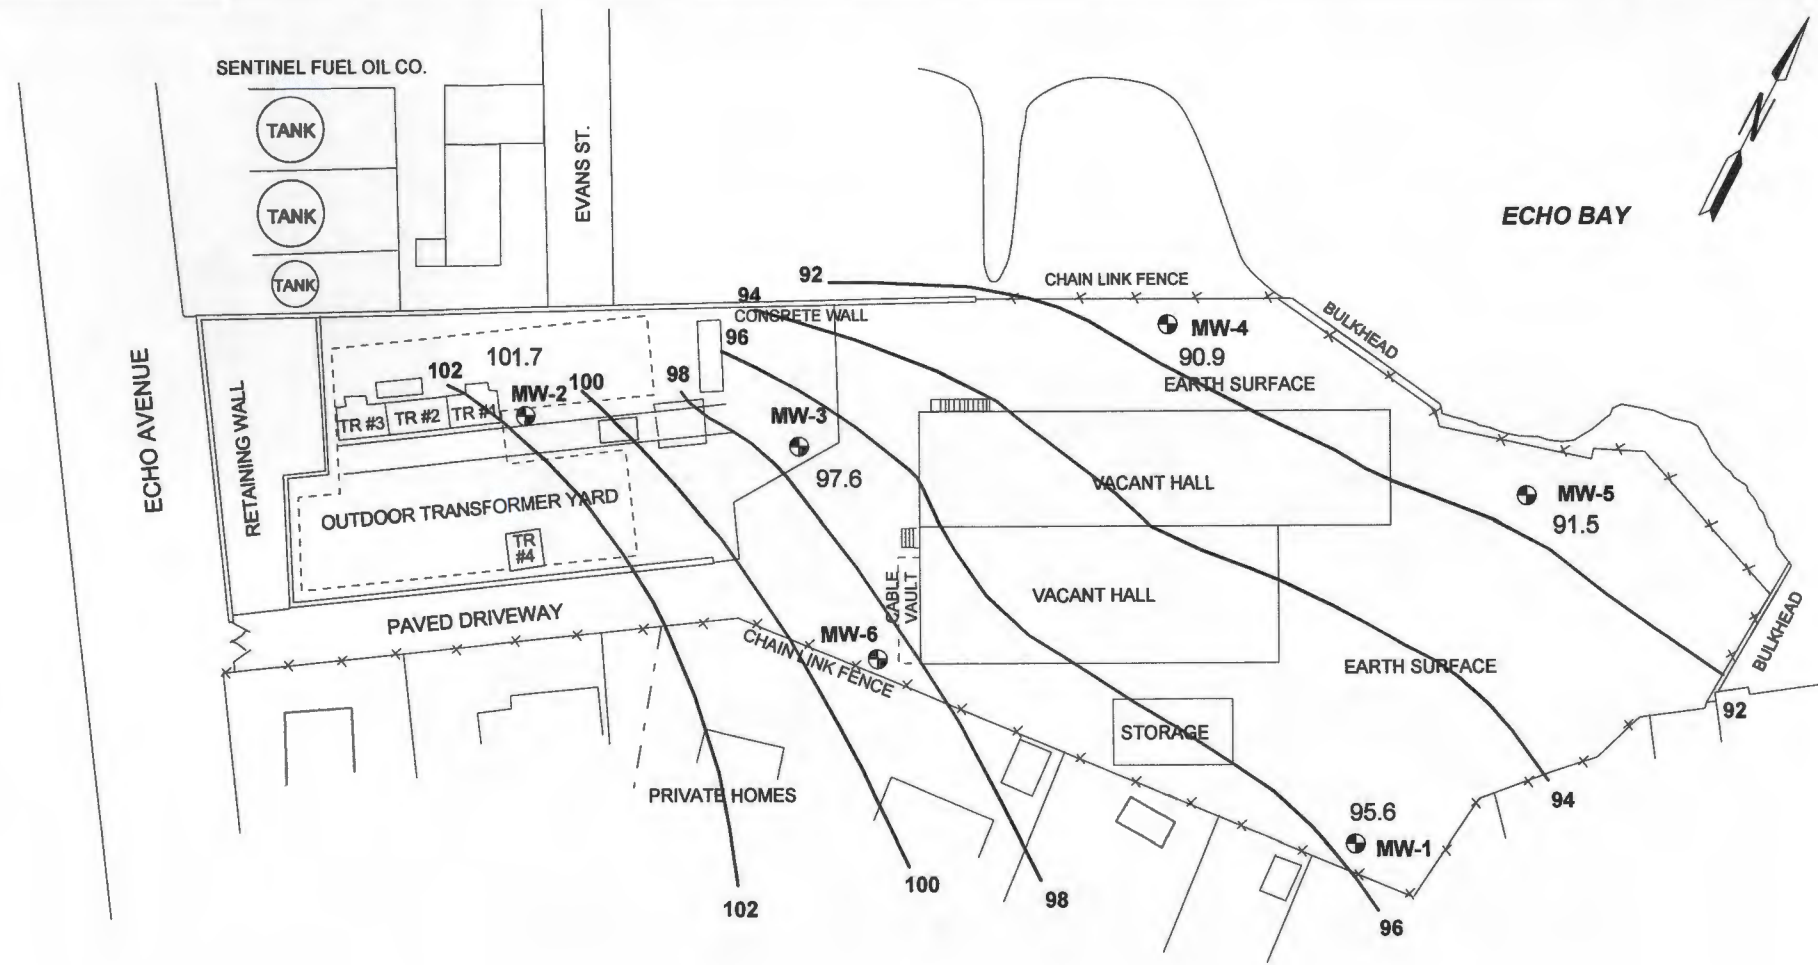
- Location of monitoring well
- 101.7 Groundwater elevation
- 98 Groundwater contour
- Contour interval is 2 ft, datum is MSL

**Water Table Contour Map:  
Rising Tide**

Five monitoring wells were originally installed on the site in 1987 and one additional well was installed as part of the Phase II Investigation in 1992. Figures 5-40 to 5-43, formerly Figures 3-2 to 3-5 from the February 1993 Phase II Investigation report, show the water table contour maps for the various tidal phases; as can be seen there is a 6 ft difference in the water table elevation in MW-4 and MW-5. The six wells were all sampled in 1992 as part of the Phase II Investigation and analyzed for TCL organics and TAL inorganics. The results are provided on Table 5-3, formerly Table 4-19 from the 1993 Phase II investigation report and presented graphically on Figure 5-44, formerly Figure 4-21 taken from the 1993 Phase II Investigation report. Table 5-3 presents results for TCL organics that were detected in at least one sample and results for all TAL inorganics. Figure 5-44 presents results for all substances with TAGM 4046 RSCO exceedances and for PCBs. Natural ambient groundwater concentrations have been added to the table (Ref. 30, Appendix A of this Report). In 2002, NYSDEC requested that the remaining wells on the site be re-sampled for TCL organics and TAL inorganics. Only two wells, EAMW-1 and EAMW-4, could be sampled. EAMW-2 and EAMW-3 were destroyed during the transformer yard excavation, EAMW-6 was destroyed during the cable vault drainpipe investigation, and EAMW-5 was bent so severely that it was impossible to sample. The results are provided in Table 5-4, formerly Table 5-14 of the July 2003 Remediation Report Addendum, and presented graphically on Figure 5-45, previously Figure 5-13 taken from the July 2003 Remediation Report Addendum. Table 5-4 summarizes results for TCL organics by category, indicates concentrations of TCL organics, and provides results for all TAL inorganics. Figure 5-45 presents results for all substances with TAGM 4046 RSCO exceedances and for PCBs. After the sample results were received and reviewed by the NYSDEC, the NYSDEC authorized Con Edison to abandon the wells. The wells were abandoned in January 2003 in accordance with the NYSDEC Decommissioning Document (Ref. 29, Appendix A of this Report).

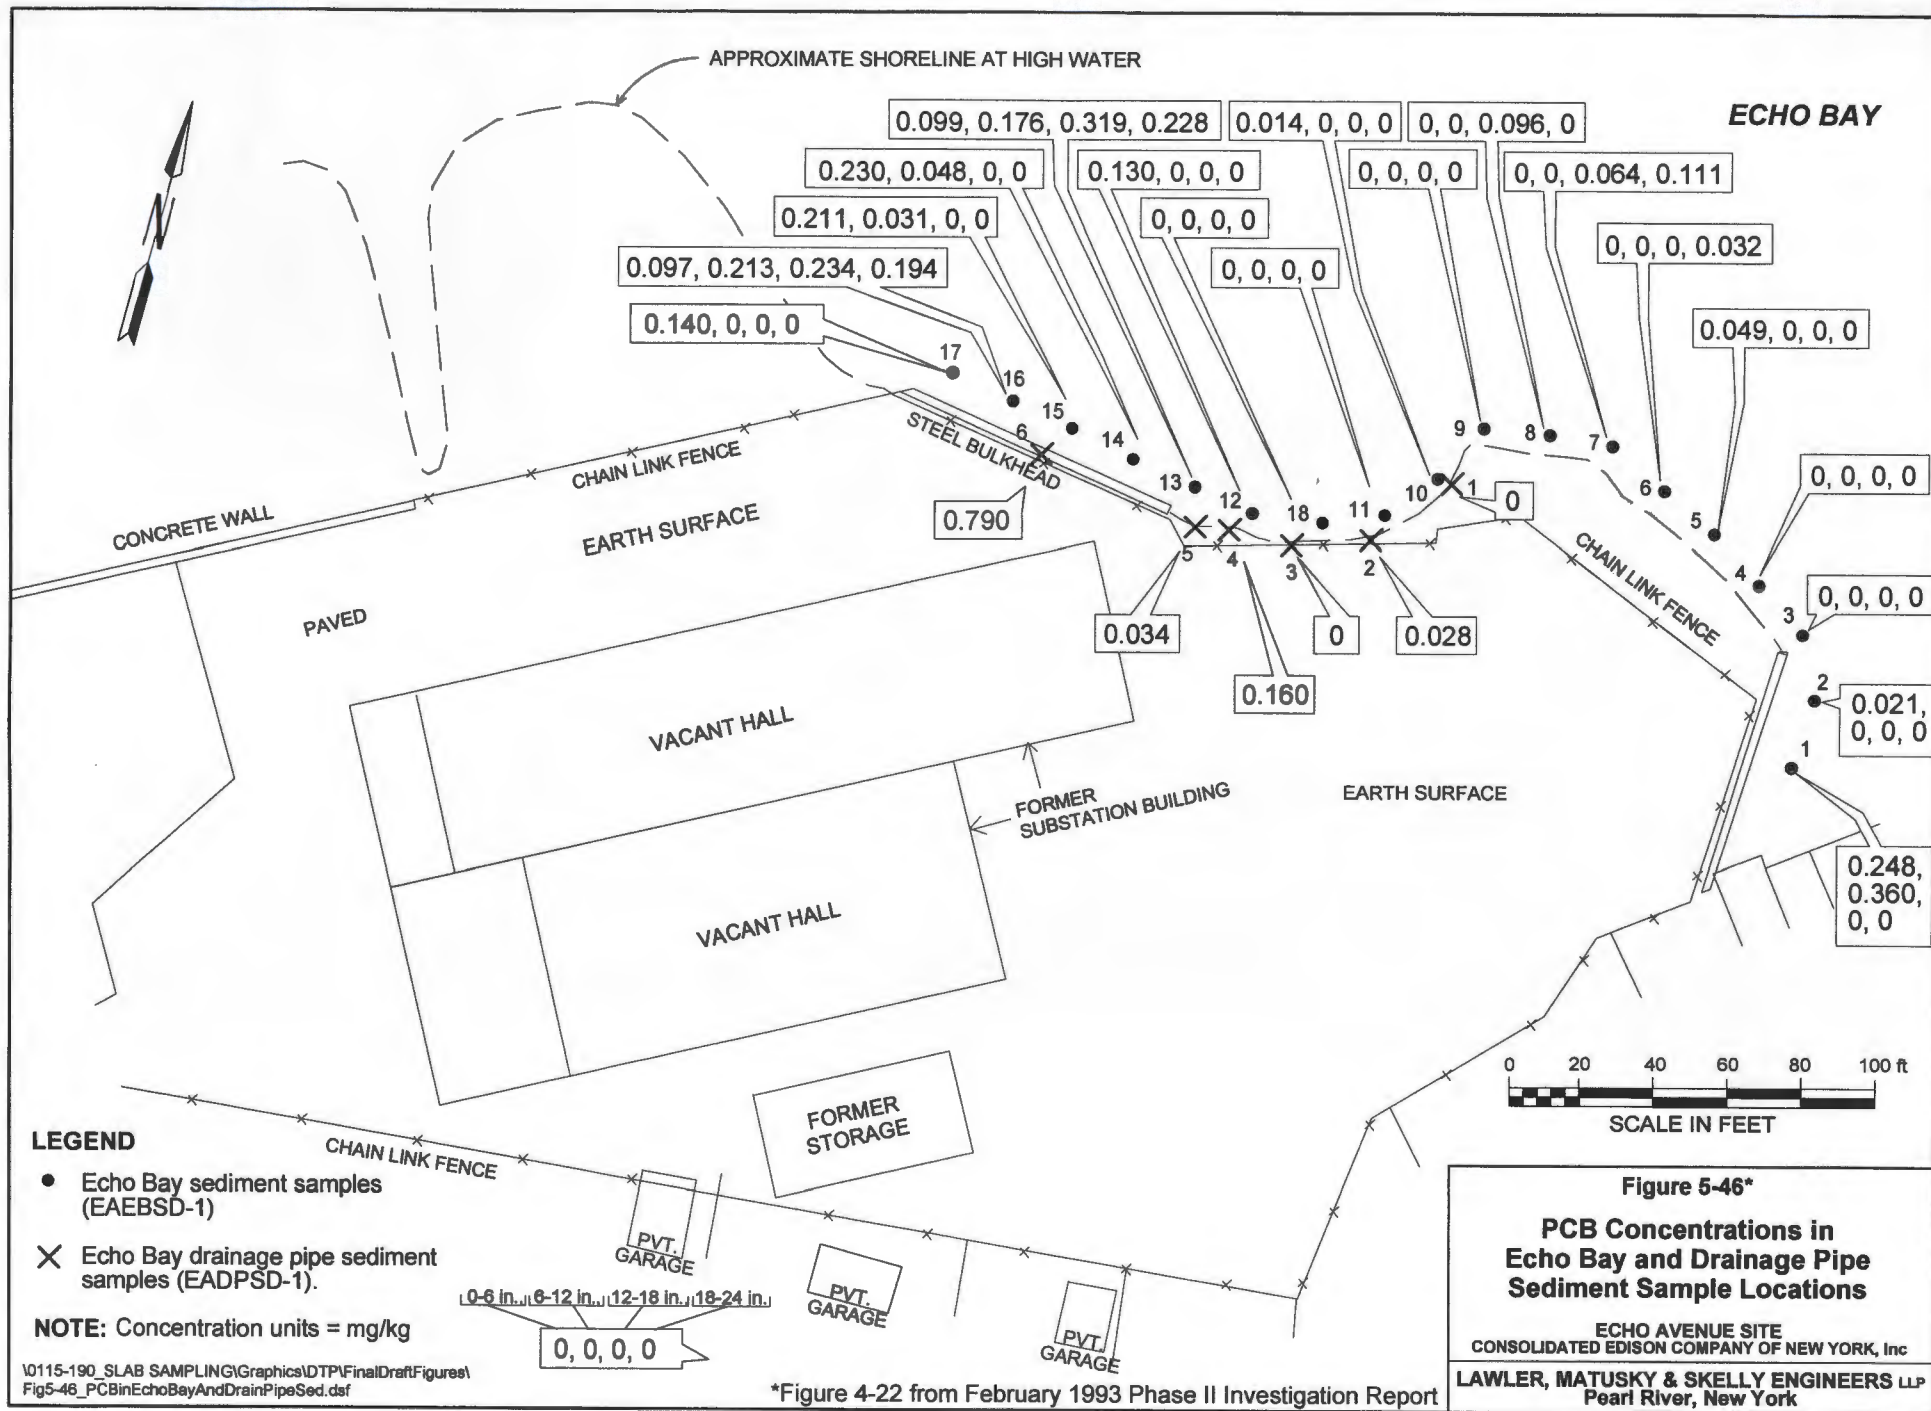
Figure 5-46\*

**PCB Concentrations in  
Echo Bay and Drainage Pipe  
Sediment Sample Locations**
