**PERIODIC REVIEW REPORT (2017)  
AMERICAN VALVE MANUFACTURING  
NYSDEC SITE NO. 420002**

**WORK ASSIGNMENT NO. D007619-17**

**MACTEC Engineering and Consulting, P.C.  
Portland, Maine**

**JANUARY 2018**

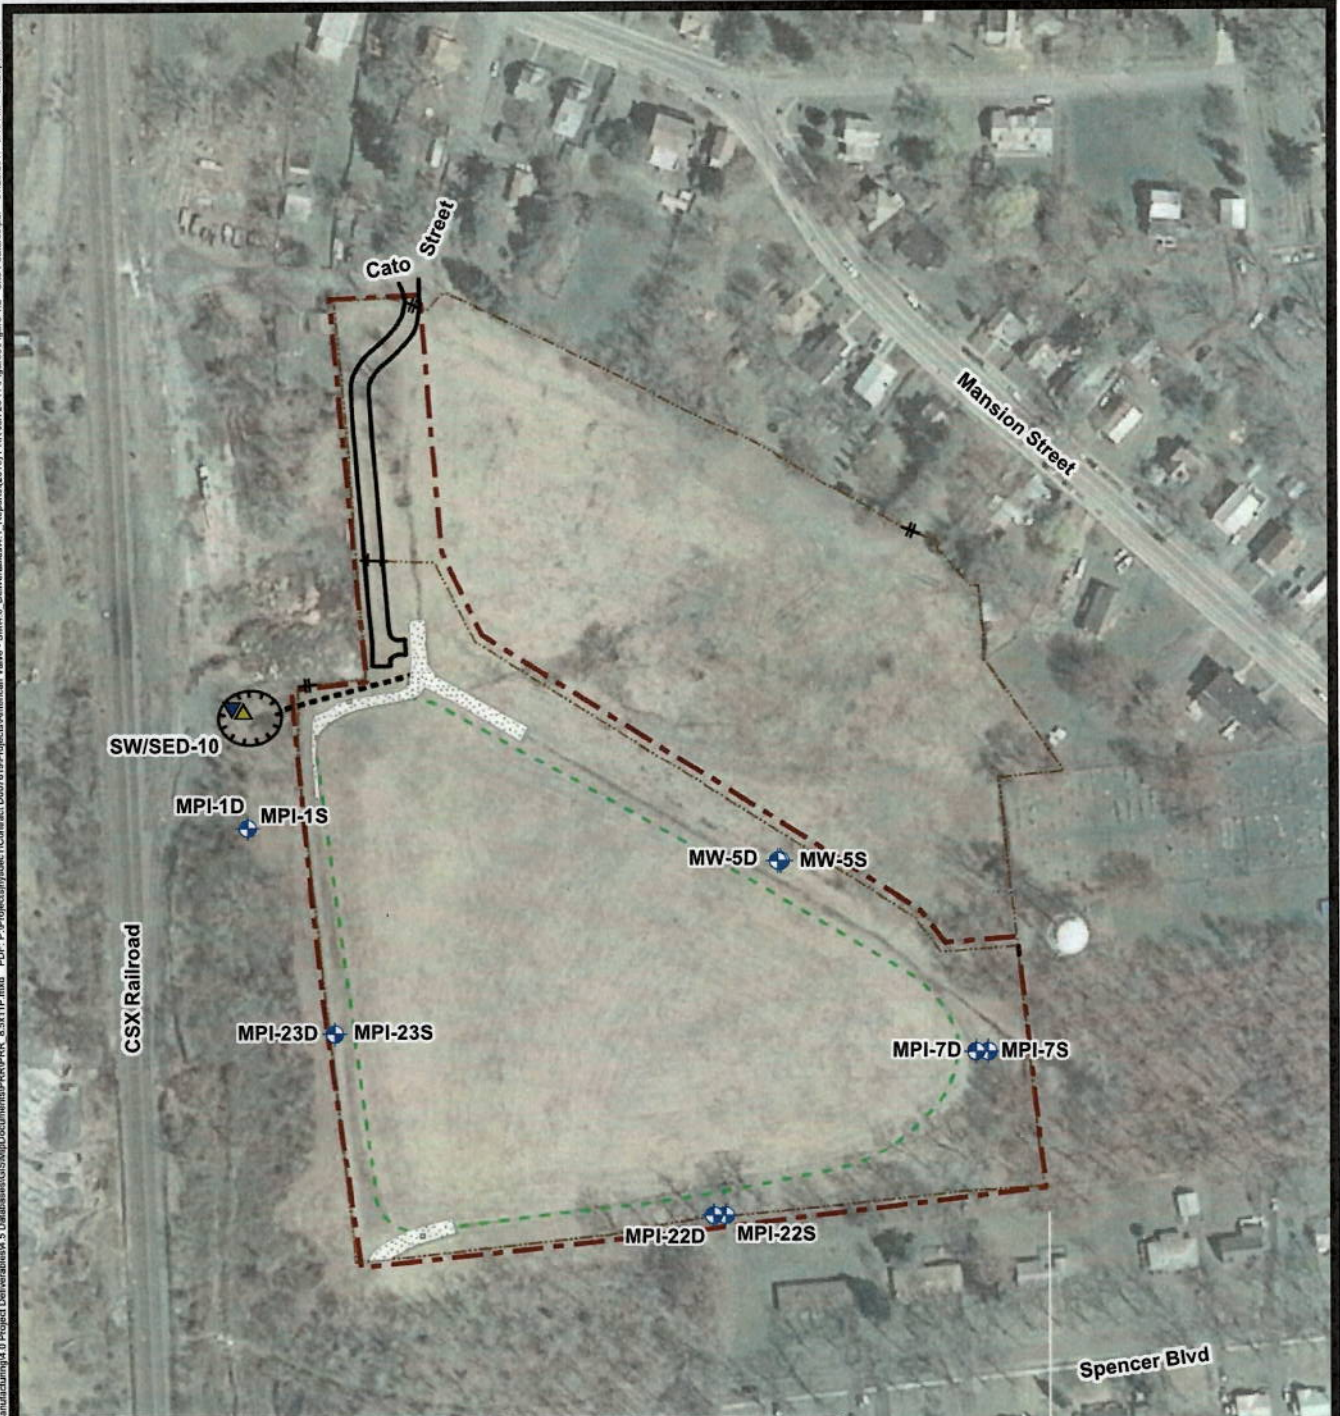
SITE FEATURES  
Project 361212252 Figure 1.2

Figure 1.2 shows the current Site features.

SM requirements as described in the SMP are outlined in Table 2.1. These include semi-annual inspection of institutional/engineering controls (IC/EC) at the Site, as well as LTM which includes analysis of groundwater, surface water, and sediment samples from existing monitoring locations (Figure 1.2). Existing shallow and deep wells are monitored to evaluate contaminant concentrations in groundwater as compared to the Site cleanup goals (New York State (NYS) Class GA Standards [6 New York Codes, Rules and Regulations Parts 700-705] for lead and VOCs) (NYS, 1999). Surface water sample results are monitored for comparison to site cleanup goals for lead and VOCs (Technical and Operational Guidance Series 1.1.1, "Ambient Water Quality Standards and Guidance Values and Groundwater Effluent Limitations" [NYSDEC, 1998]). Sediment sample results are compared to Technical Guidance for Screening Contaminated Sediments, 1999 for VOCs, semi-VOCs and lead (NYSDEC, 1999b).

The LTM program described in the SMP includes groundwater elevation monitoring, monitoring well inventory and repair, groundwater sampling and analysis, and surface water/sediment sampling and analysis. Since January 2008, monitoring locations have been sampled at 15-month intervals (Table 2.1). Results of the LTM conducted in December 2017 are discussed below. The LTM locations are shown on Figure 1.2. Table 2.2 summarizes the sampling and analysis plan for all Site monitoring locations.

Surface water/sediment samples were scheduled to be collected in December 2017 in accordance with the SMP, at locations SW-10 and SED-10 from the drainage basin adjacent to the Site and railroad (Figure 1.2). Samples were to be analyzed for VOCs and lead. Sample locations SW-10 and SED-10 were frozen during the December sampling event and therefore no samples were collected.

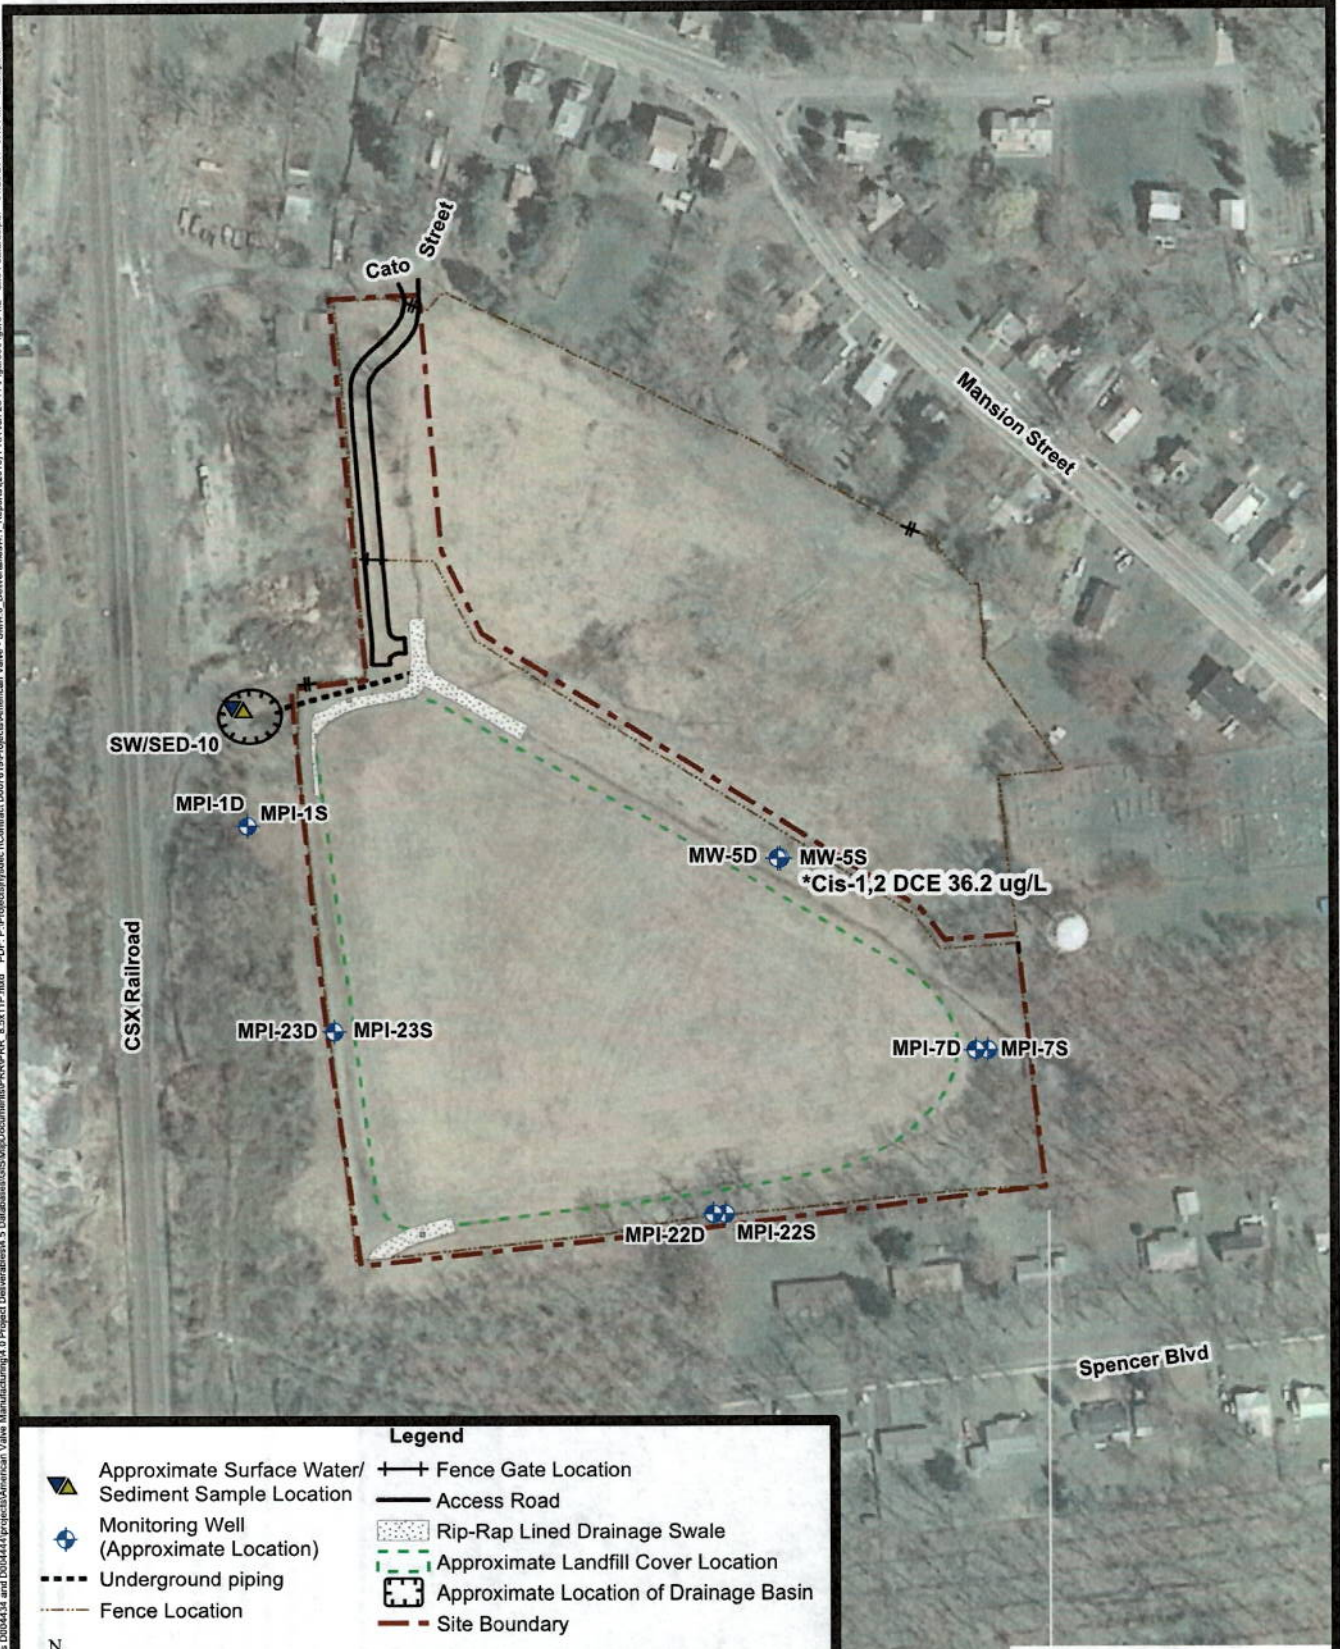
LONG TERM MONITORING RESULTS  
 Project 3612122252 Figure 2.2

Groundwater samples were analyzed for VOCs by the United States Environmental Protection Agency (USEPA) Method 8260 and lead by the USEPA Method 6010B. VOCs were detected at concentrations above SCGs in one of the nine monitoring wells. Figure 2.2 shows the most recent analytical results that exceeded SCGs.
