August 31, 2011

SUBJECT: Field Activities Plan
AL Tech Specialty Steel: NYSDEC Site # 401003
Interim Remedial Measure Addressing PCB Contaminants in South Lagoon
Landfill Cap Repairs and Maintenance in Waste Management Area
MACTEC Engineering and Consulting, Inc. Project No. 3612112193

NYSDEC
AI Tech Specialty Steel
Colonie, New York

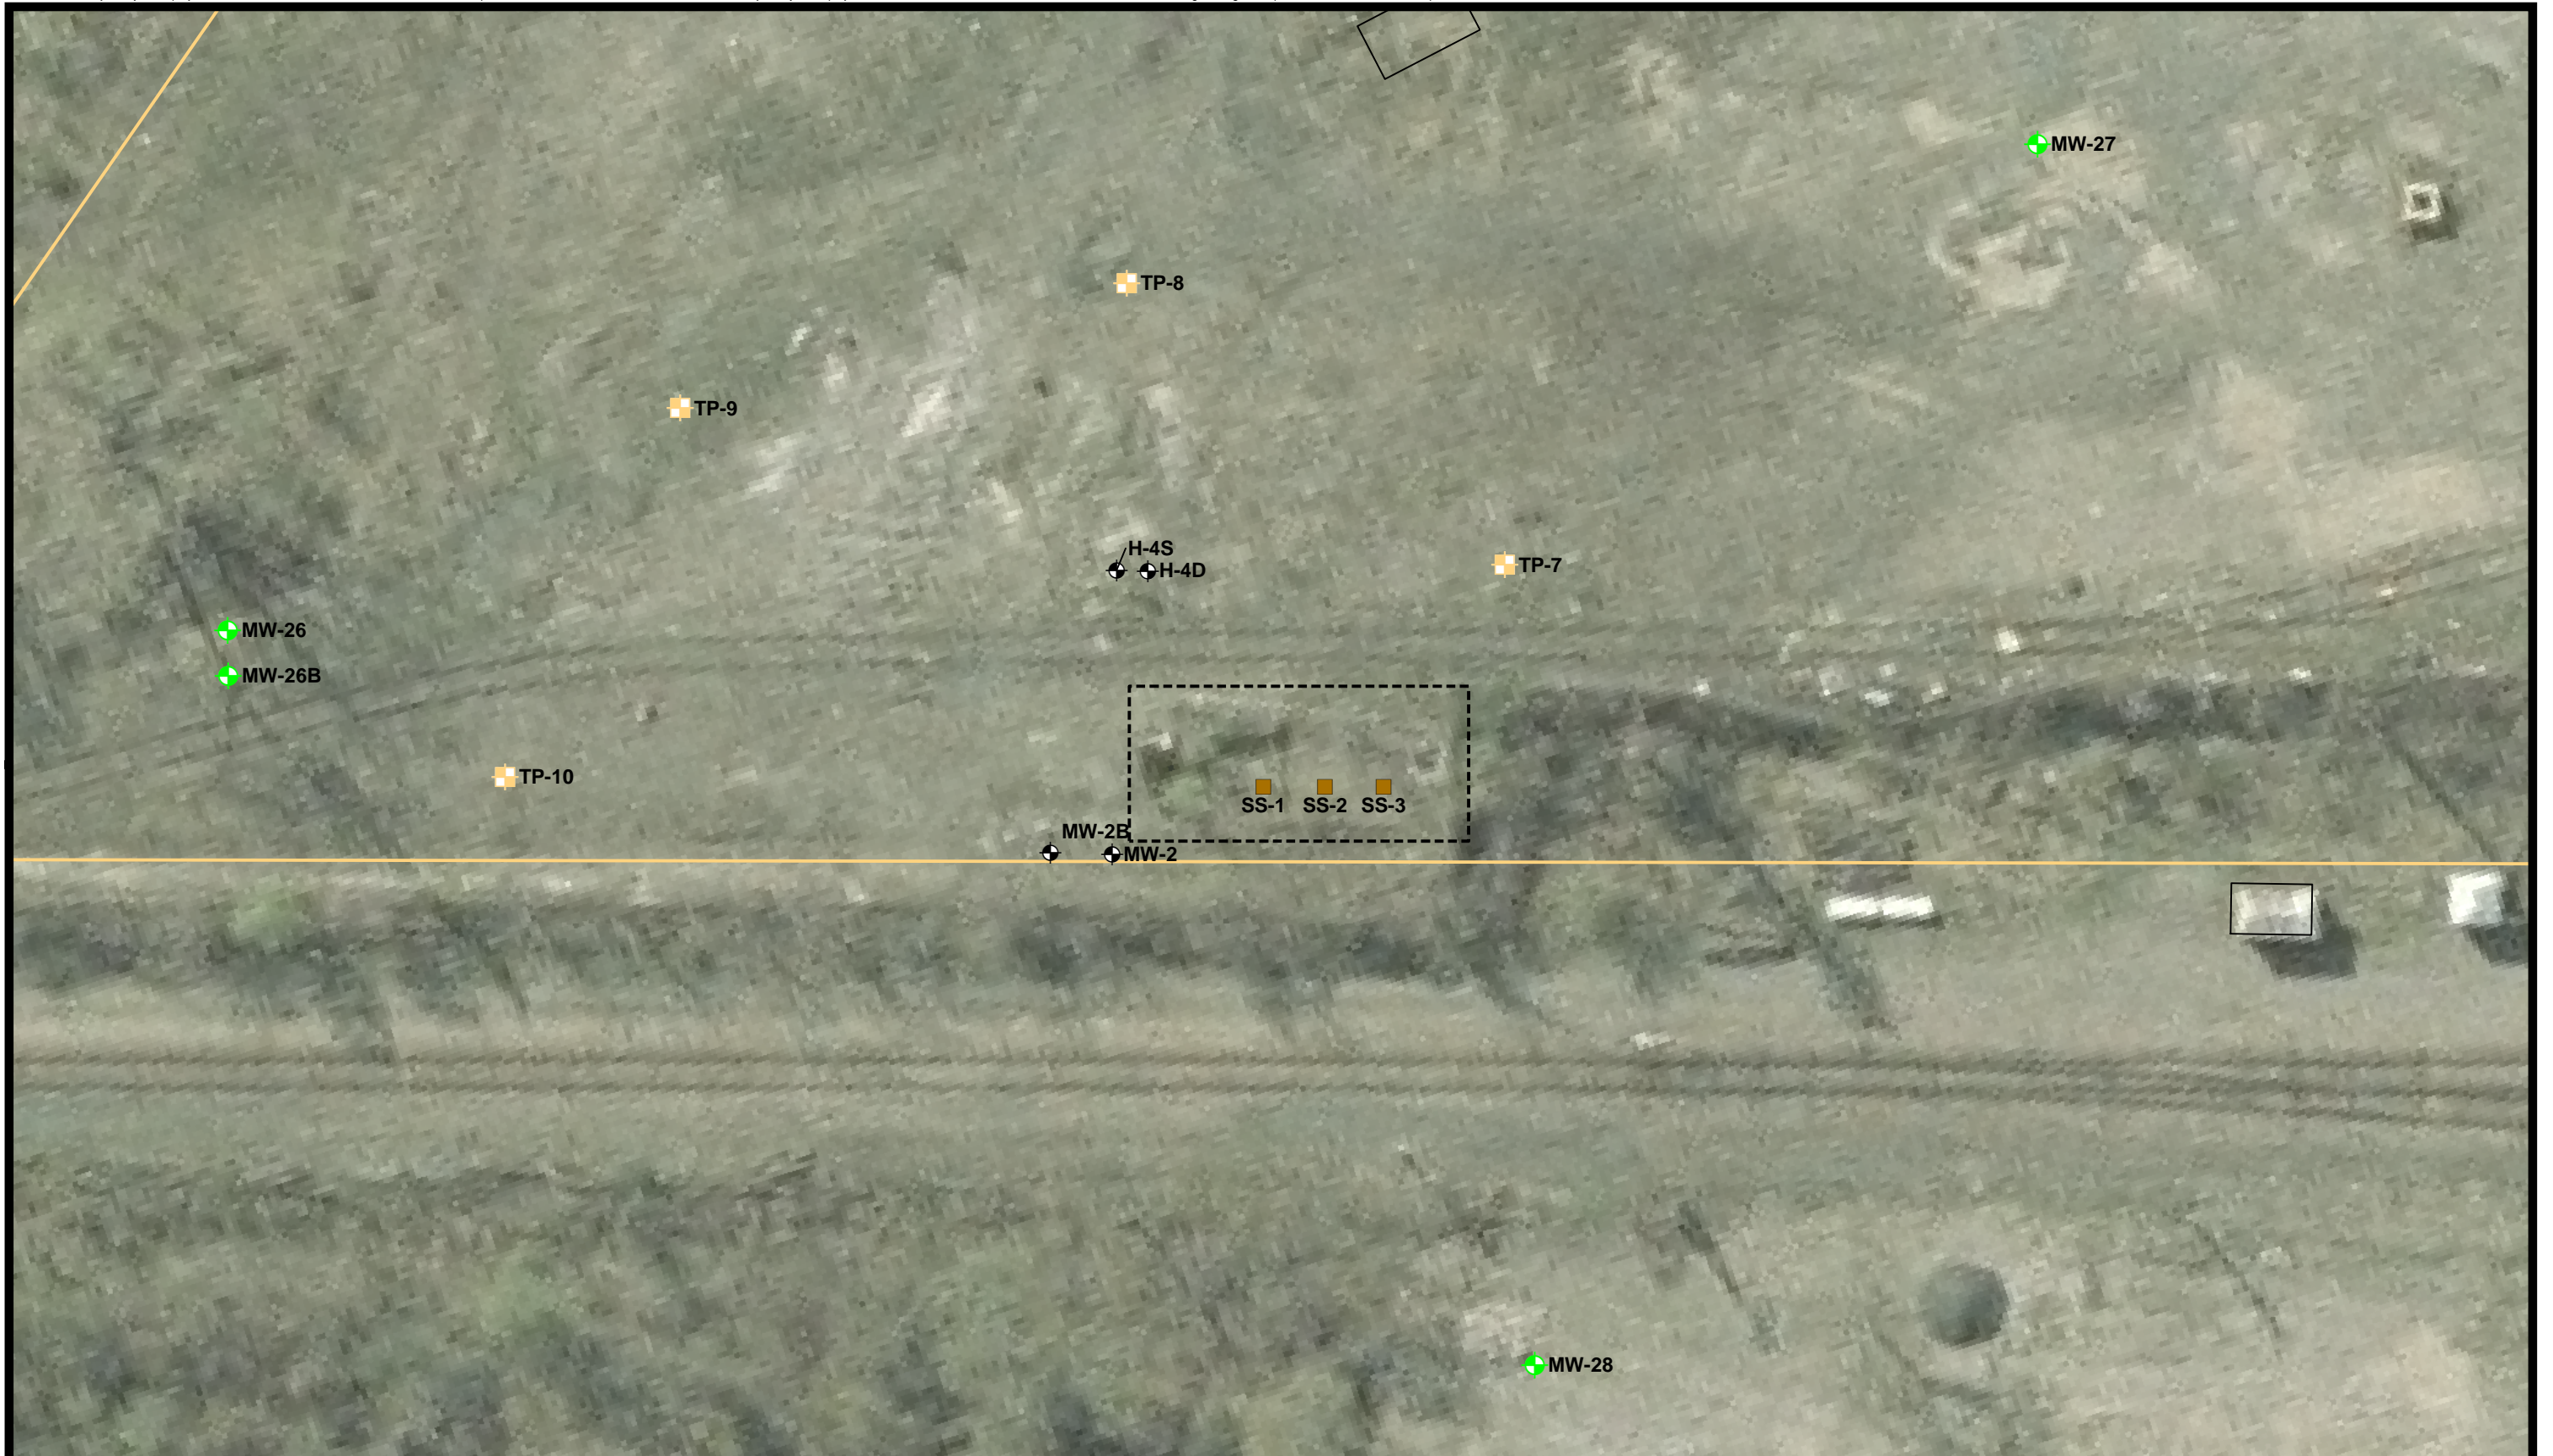
Figure 2

Proposed Surface Soil Samples	Initial Test Pit Locations	Estimated Location of South Lagoon
Proposed SMSA GW Wells	Existing SMSA GW Wells

Proposed Locations
South Lagoon Area
Project 3612-06-2060
