Site #4130003 Amphenol Corporation - B.C.O.

Hill Site Area - Assesment of Remedial Technologies

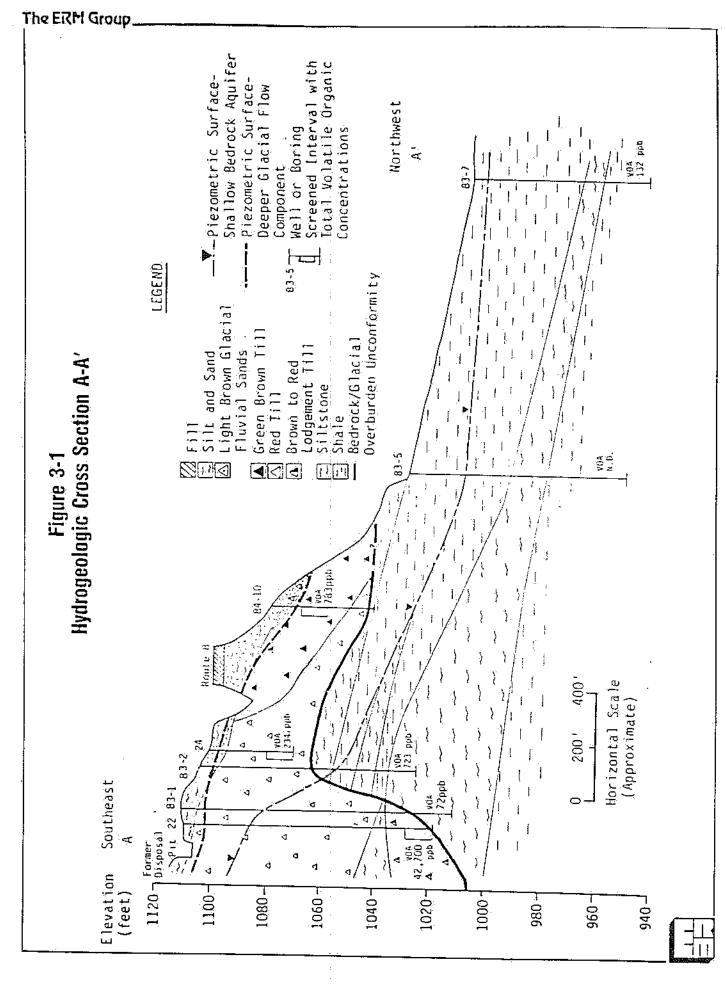
Attachments: Figure 3-1, Combined ground water contour map for the

Hill Site and Route 8 Site

The site geology consists of unconsolidated glacial till overlying Devonian aged shale and siltstone bedrock. The glacial till was deposited directly from glacial ice without significant sorting by water. This process created a poorly sorted, very dense till with low primary permeability. The thickness of the glacial till above the bedrock ranges from 38 to 110 feet, with the greatest thickness seen nearer the former disposal pit. A representative cross section of the site (Figure 3-1 from the 1985 Remedial Investigation Report) is included as an attachment to this letter.
