Subject: **2018 Annual Report**  
**American Valve Manufacturing, Site 420002**  
**MACTEC Engineering and Consulting, P.C., Project No. 3612122252**

MACTEC Engineering and Consulting, P.C., (MACTEC), under contract to the New York State Department of Environmental Conservation (NYSDEC) is submitting this letter report describing the 2018 site activities completed and observations noted at the former American Valve Manufacturing site (Site) (NYSDEC Site 420002) in the village of Coxsackie, New York (Figure 1). This report presents the following:

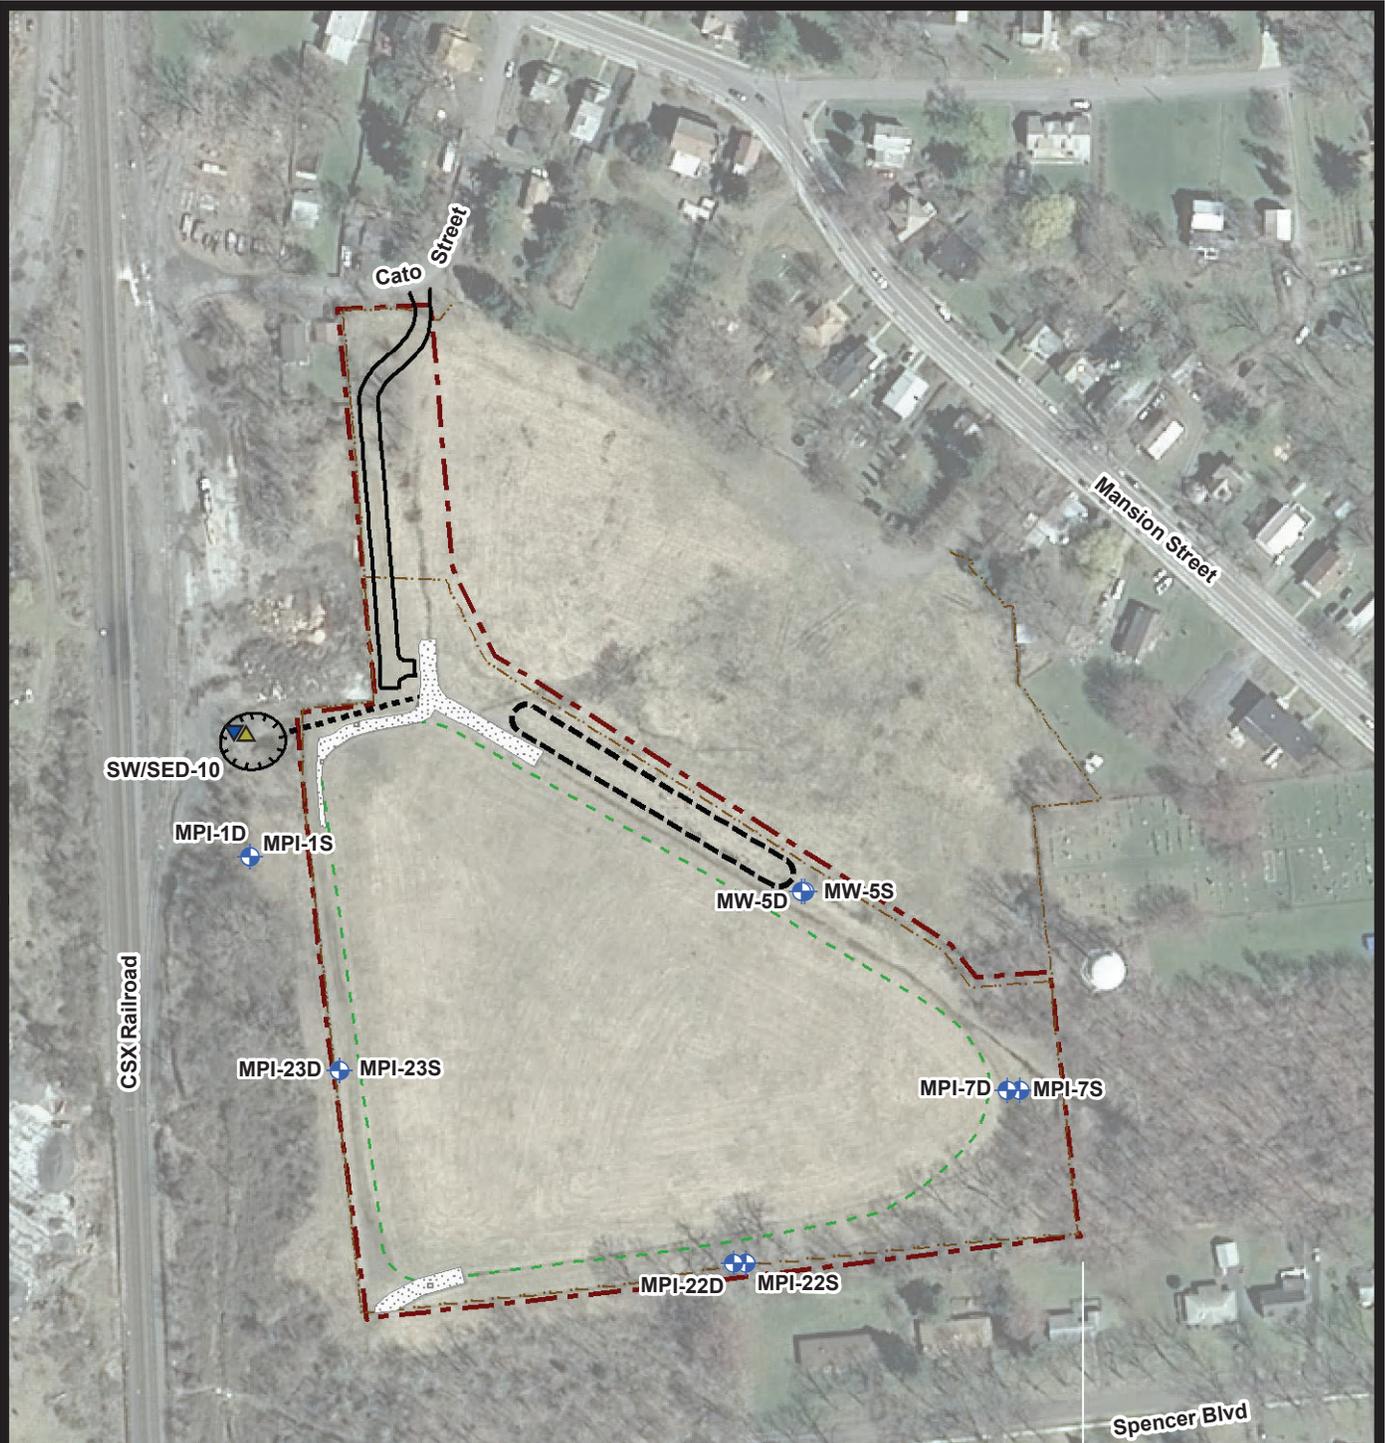
SITE FEATURES  
 Project 3612122252  
 Figure 2

The Site is located at 170 Mansion Avenue in the Village of Coxsackie, Greene County, New York, and is currently identified as Section 56.14 Block 2 and Lot 37 on the Greene County Tax Map. The original Site was 12.5 acres in size when the Records of Decision (RODs) were signed in 1997 and 1999 (NYSDEC, 1997; NYSDEC 1999). In 2017 the NYSDEC modified the Site boundary and reduced the area of the Site to 9.8 acres, which includes the landfill and associated features (i.e. fence, drainage swales, access road). The Site no longer includes the Northern Parcel. The Site is bounded by undeveloped property (the Northern Parcel) to the north, residential properties and Spencer Boulevard to the south, the village water tower to the east, and CSX railroad to the west. Figure 2 shows the current Site features.

The storm water collection and drainage system, access road, and monitoring well and gas vent network were inspected and observed to be in good condition during the May and October 2018 Site inspections, similar to previous events (MACTEC, 2018a and 2018b). Animal burrows in the landfill cap which were identified during the fall 2017 inspection were repaired in May as described in the following section. However, in October one animal burrow was identified along the western flank of the landfill, and an animal tunnel was observed under the western portion of the fence. Tire marks associated with tree removal were identified during the May inspection, however they were observed to be filling in naturally with soil and vegetation during the October inspection (MACTEC, 2018b). Trees that were cut down during the May 2018 fence repair were still located on the southern portion of the landfill during the October inspection (MACTEC, 2018b).
