We respectfully request your review and approval of the attached package developed under the provisions of 42 U.S.C. §9620(h)(3)(C) of the Comprehensive Environmental Response, Compensation and Liability Act of 1980, as amended (CERCLA), for the "early transfer" of real property at the former Plattsburgh Air Force Base (AFB), New York, a Federal facility listed on the National Priorities List.

# REVISED SUPPLEMENTAL ENVIRONMENTAL BASELINE SURVEY (SEBS) FOR CENTRAL AIRFIELD Former Plattsburgh Air Force Base (AFB), New York March 2012

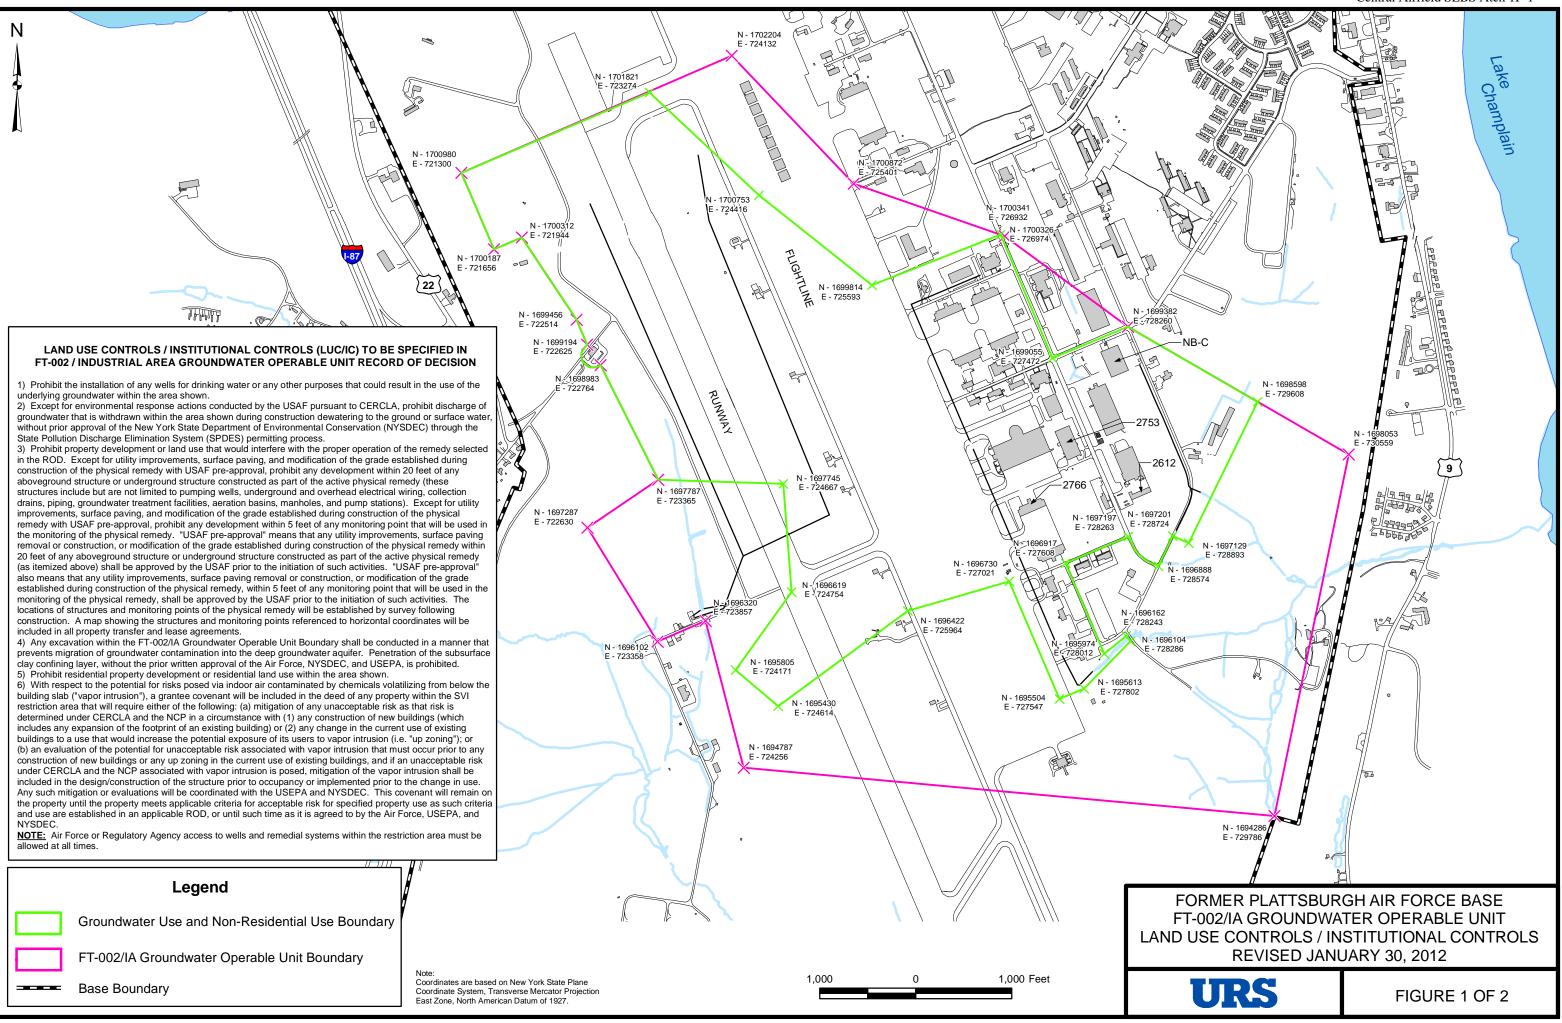
## Central Airfield SEBS Atch 1F-1

Attachments: 1A. Location Plans 1B-D. Site Plan 1E. IRP Site FT-002 Source OU LUC/ICs 1F-1/2. IRP Site FT-002 Groundwater OU LUC/ICs 1G. IRP Site FT-002 Groundwater OU Plumes 1H. IRP Site SS-005 LUC/ICs 1I. IRP Site SS-006 LUC/ICs 1J. IRP Site LF-022 LUC/ICs 1K. IRP Site LF-023 LUC/ICs 1L. Mobil Gas Station Plume LUC/ICs 1M. Former Fuel Distribution System 1N. Location of areas requiring FOST/FOSET 1O-1/2/3 FOSET Parcel and Restrictions Central Airfield SEBS Atch 1A
