**SUBJECT: Final Interim Remedial Measure Work Plan
Cayadutta Creek Bank Restoration
Johnstown (N. Market St.) Former MGP Site (#518020)**

FINAL INTERIM REMEDIAL MEASURE WORK PLAN

CAYADUTTA CREEK BANK RESTORATION

JOHNSTOWN (N. MARKET STREET) FORMER MANUFACTURED GAS PLANT
105 N. MARKET STREET
JOHNSTOWN, FULTON COUNTY, NEW YORK
SITE #5-18-020

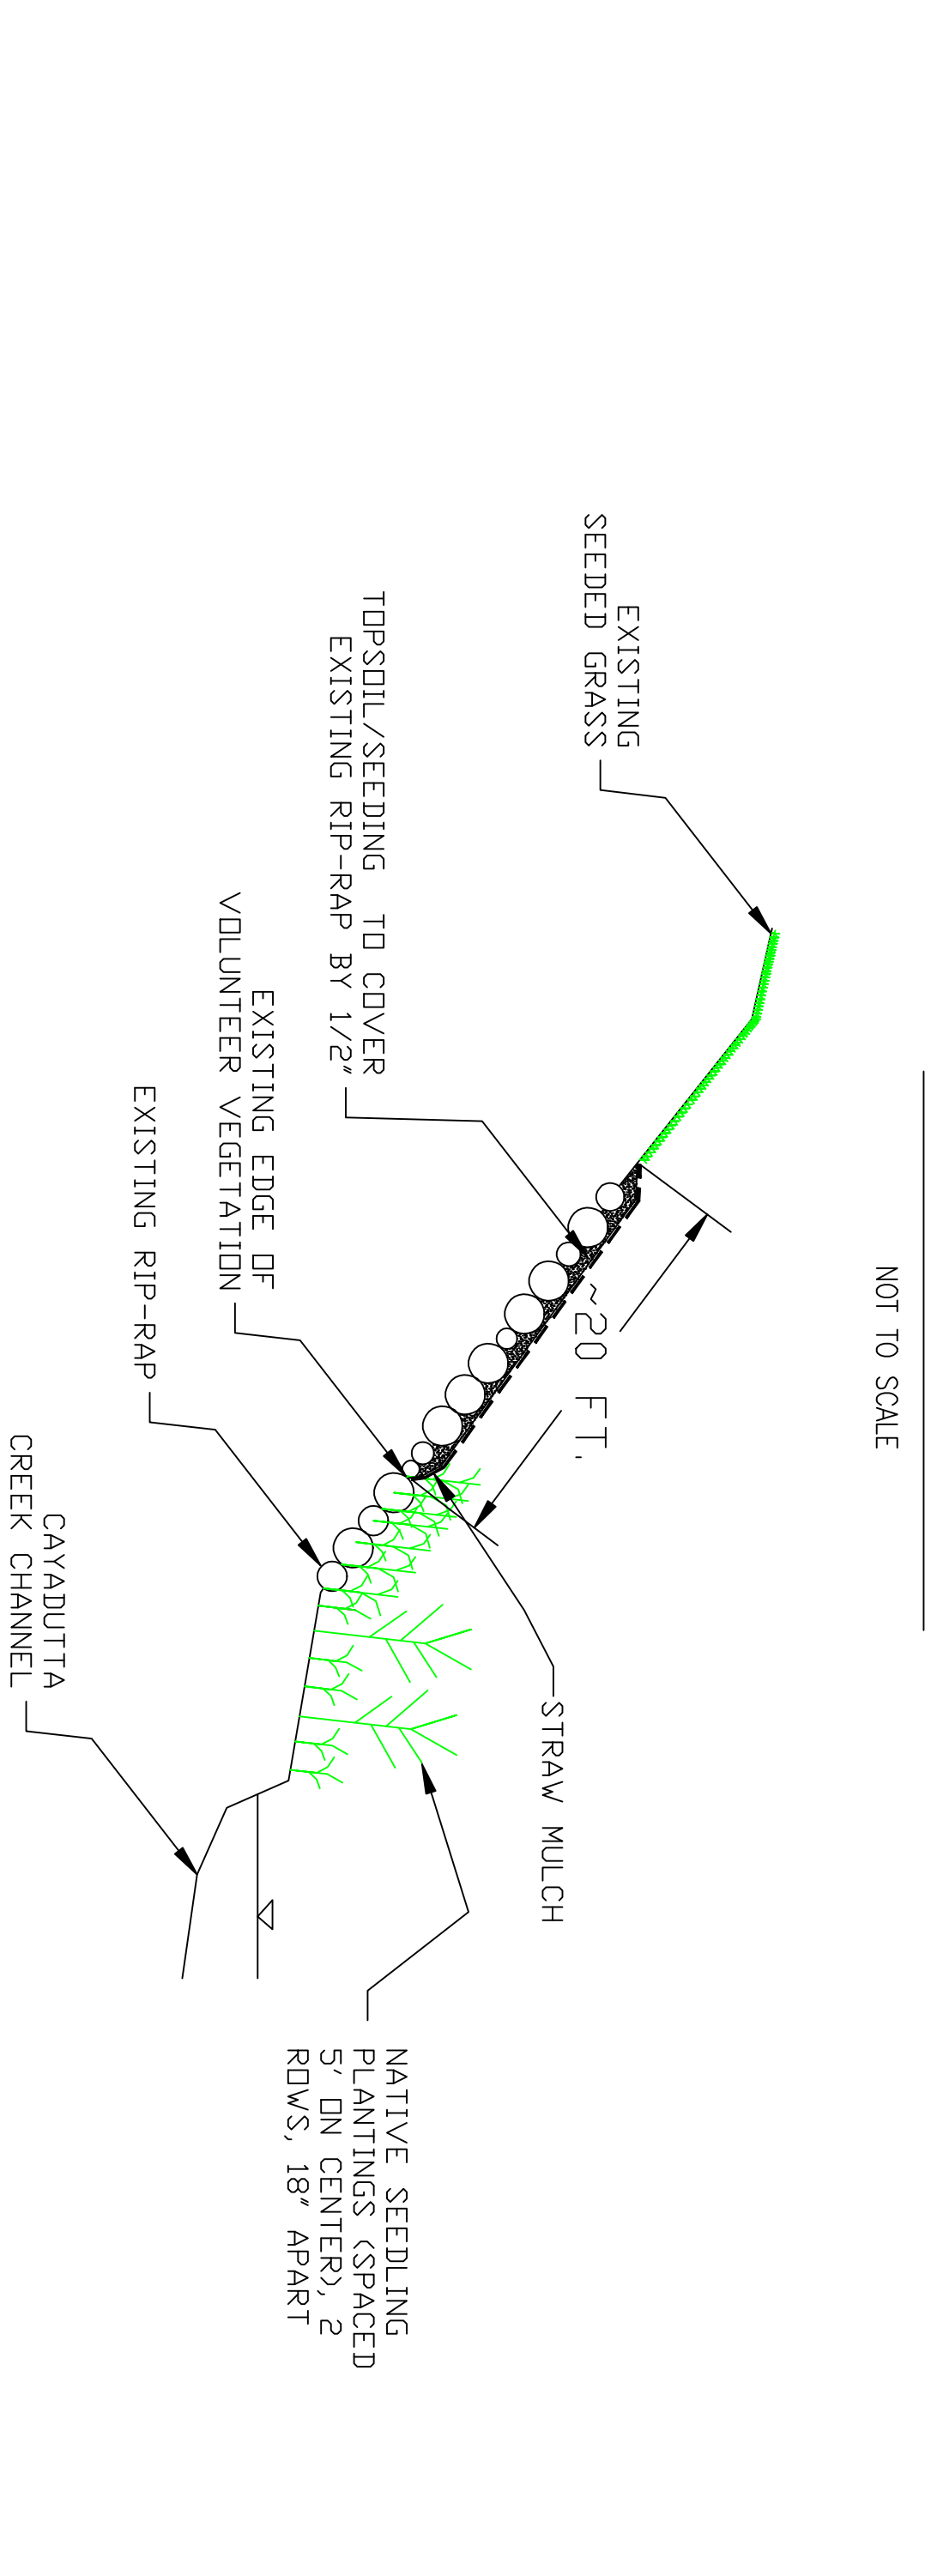
DWN: EAG	DATE: 06/22/09	PROJECT NO.: 106-2907.0004
CHKD: MO/RC	REV.: 1	FIGURE NO.: 4
DES: MO	APPD:

1. Mobilize at Site.
2. Install temporary silt fence and construction straw bale barriers.
3. Place soil/temp into riprap crevices.
4. Seed, place straw mulch, and plant seedlings.
5. Install temporary straw bale barriers for growing season.
6. Remove construction straw bale barriers.

1. All erosion and sediment control practices will be checked for stability and operation following every runoff-producing rainfall but in no case less than once every week. Any needed repairs will be made immediately to maintain all practices as designed and installed for their appropriate phase of the project.
2. Sediment will be removed from behind the silt fence and straw bale barriers when it becomes about 0.5 ft deep at the barrier. The silt fence and straw bale barriers will be repaired as necessary to maintain a barrier.
