Feasibility Study

"Van Raalte Knitting Mill"
Saratoga Springs, Saratoga County, New York
Site No. 546036

Prepared by:
NYSDEC
Region 5

May 1997

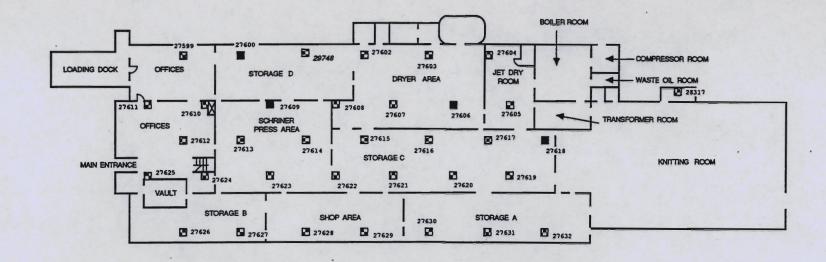
FIGURE 5

PLAIN TEXT DENOTES SAMPLES TAKEN IN 2/94

ITALIC TEXT DENOTES SAMPLES TAKEN IN 6/94 (after cleaning general area)

WIPE SAMPLE LOCATION - FLOOR SURFACES (PCB) BELOW 1 ug/100cm2

BUILDING PLAN - FIRST FLOOR

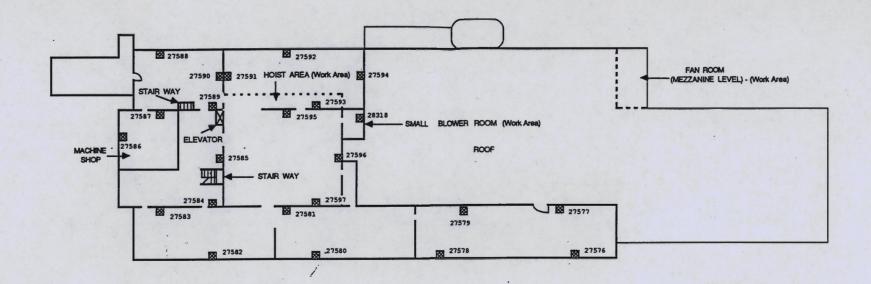
FIGURE 5
BUILDING PLAN - SECOND FLOOR

WIPE SAMPLE
LOCATION - WALL
SURFACES (PCB)

WIPE SAMPLE LOCATION - WALL SURFACES (PCB) ABOVE 1 ug/100cm2 P. T. & L. ENVIRONMENTAL CONSULTANTS, INC. 1 KALISA WAY, SUITE 105, PARAMUS, NEW JERSEY

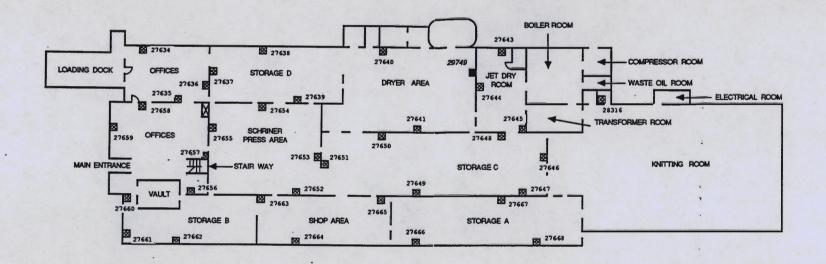
FIGURE 5
BUILDING PLAN - FIRST FLOOR

PLAIN TEXT DENOTES SAMPLES TAKEN IN 2/94

ITALIC TEXT DENOTES SAMPLE TAKEN IN 6/94 (after cleaning general area)

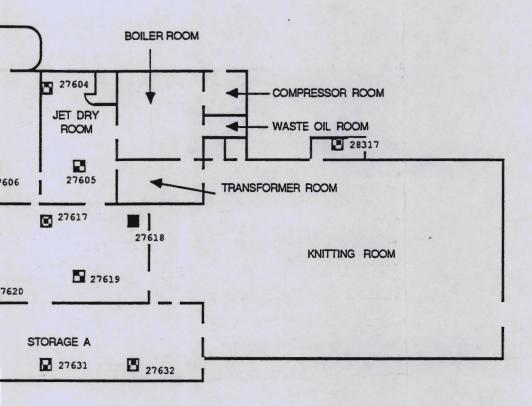
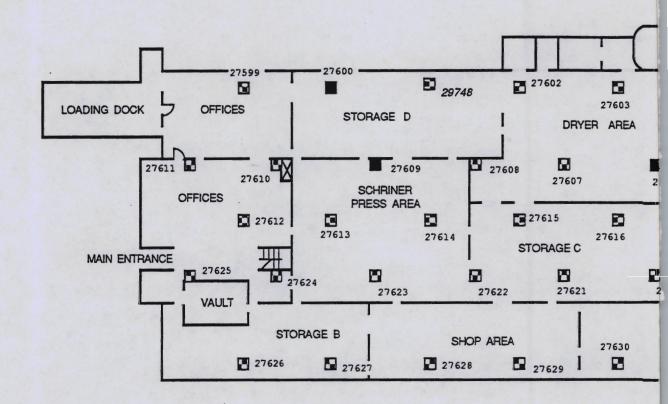
FIGURE 5

PLAIN TEXT DENOTES SAMPLES TAKEN IN 2/94

ITALIC TEXT DENOTES SAMPLES TAKEN IN 6/94 (after cleaning general area)

WIPE SAMPLE LOCATION - FLOOR SURFACES (PCB) BELOW 1 ug/100cm2

> WIPE SAMPLE LOCATION - FLOOR SURFACES (PCB) ABOVE 1 ug/100cm2

PCB WIPE SAMPLING NON WORK AREAS-FLOOR SURFACES

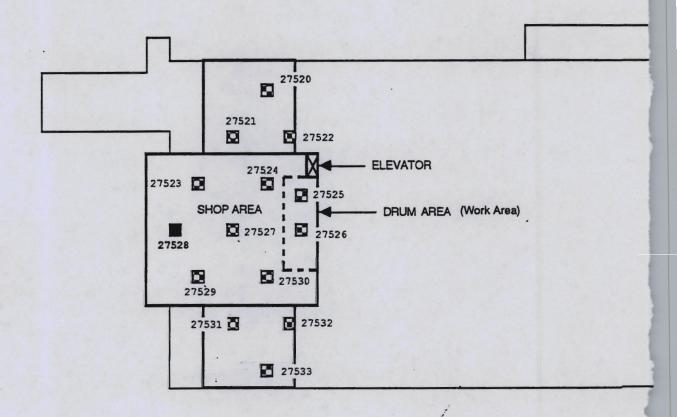
FIGURE 5

WIPE SAMPLE
LOCATION - FLOOR
SURFACES (PCB)

WIPE SAMPLE LOCATION - FLOOR SURFACES (PCB) ABOVE 1 ug/100cm2

PCB WIPE SAMPLING NON WORK AREAS-FLOOR SURFACES
