Subject:  
Transloading Area Restoration Plan (Revised)  
NYSEG Court Street Former Manufactured Gas Plant Site  
NYSDEC Site No. 7-04-031

On behalf of NYSEG, this letter presents the revised restoration plan (Restoration Plan) for the transloading area that was constructed to support the ongoing remedial activities at the NYSEG Court Street Former Manufactured Gas Plant (MGP) Site, Operable Unit No. 2 (OU-2) located in Binghamton, New York.

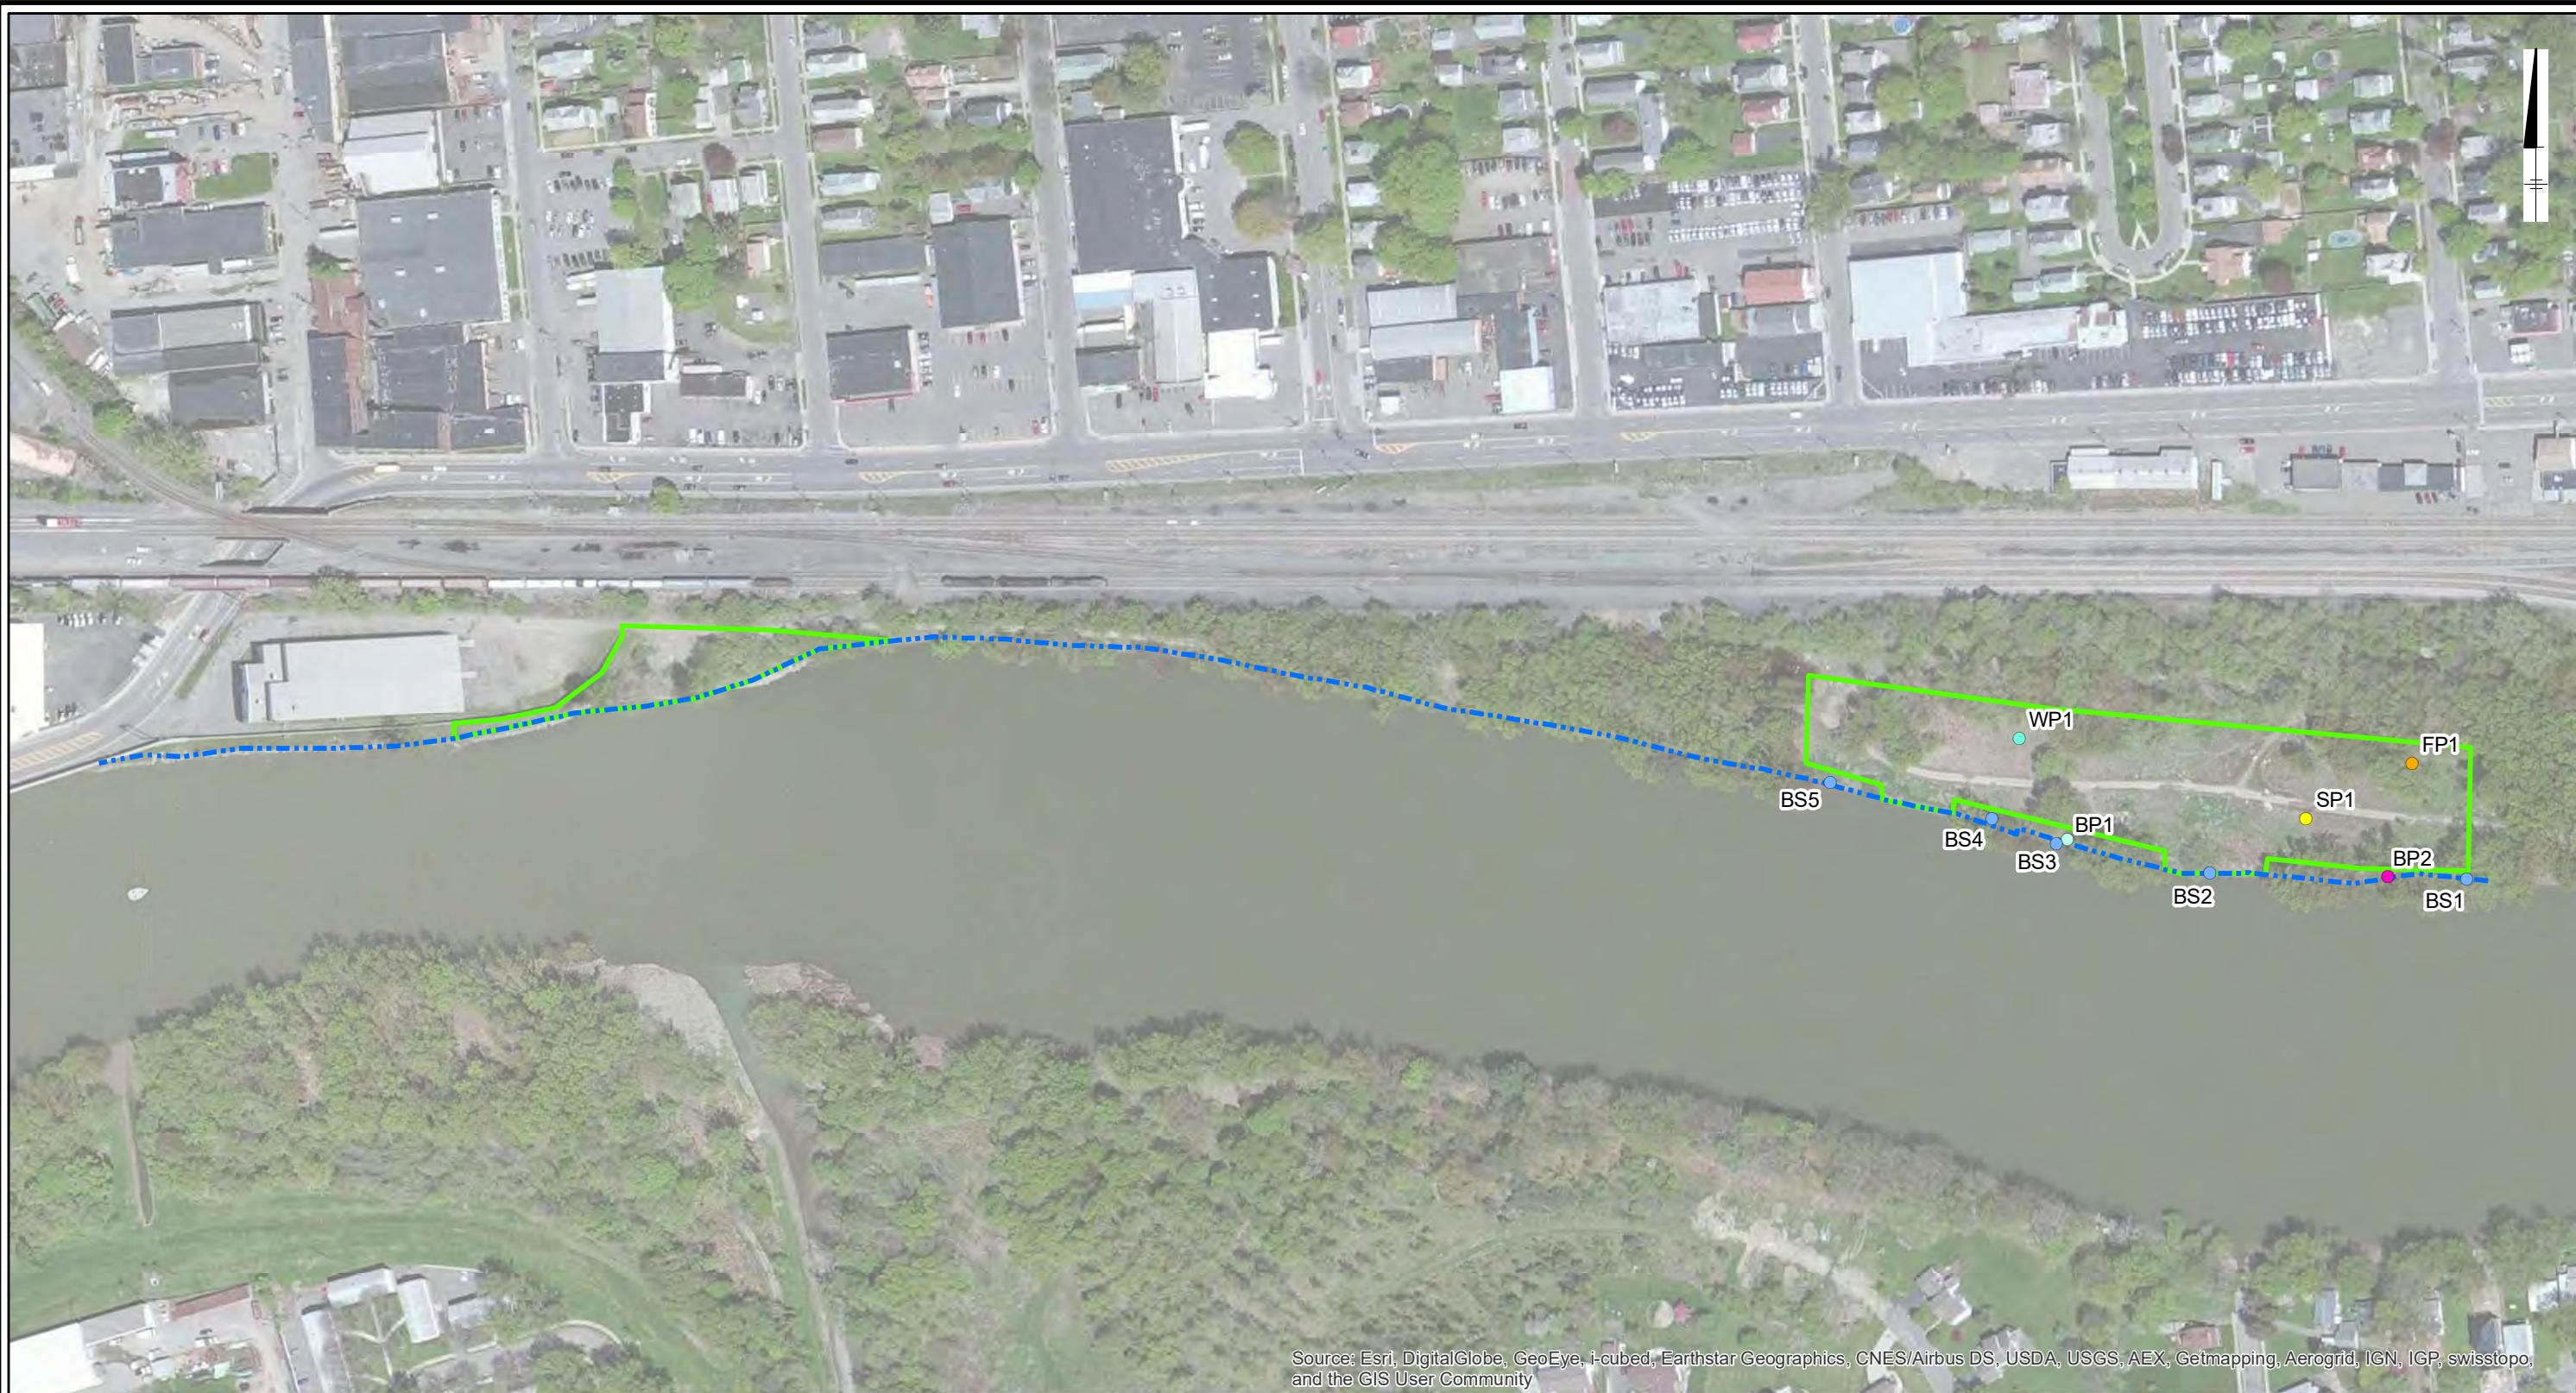
FIGURE  
2

- SUCCESSIONAL FIELD
- FORESTED FLOODPLAIN
- WET MEADOW WETLAND
- RIVERBANK - DISTURBED
- RIVERBANK - NATURAL
- RIVERBANK ASSESSMENT AREA
- MEAN HIGH WATER LEVEL
- POTENTIAL TRANSLOADING AREA

Within the surveyed area, five distinct vegetative communities were observed, including successional field, forested floodplain, wet meadow wetland, and two types of vegetated banks. Surveyed plot areas are indicated on Figure 2 and a summary of the dominant vegetation species and relative percent cover observed within each vegetative stratum is presented in Table 2. Canopies found within most of the areas were dominated by red maple and silver maple. As noted above, potential hybridization of red maple and silver maple were observed within this floodplain area. Several invasive plant and shrub species were observed within these habitats, including Japanese knotweed, purple loosestrife, and Tartarian honeysuckle. Additionally, ten silver maple trees with potential northern long-eared bat summer roosting habitat (e.g., cavities, exfoliated bark) were identified throughout the surveyed area.

A total of 38 approximate OHWM / MHWL locations were assessed throughout the transloading area and slightly downstream. The identified OHWM / MHWL is shown on Figure 2.

A general bank assessment was performed at five representative areas, as shown on Figure 2. At location BS1, an approximately 30% slope was observed and was likely the most accessible area to set up near-shore transloading of materials and equipment. Other areas assessed included a gas pipeline crossing (BS2), high cut bank with erosion (BS3), steep slope (60-70%) at BS4, and highly eroded bank (BS5). A representative photo log showing examples of the vegetative communities, potential roost trees, OHWM / MHWLs and existing banks is provided as Attachment 1.

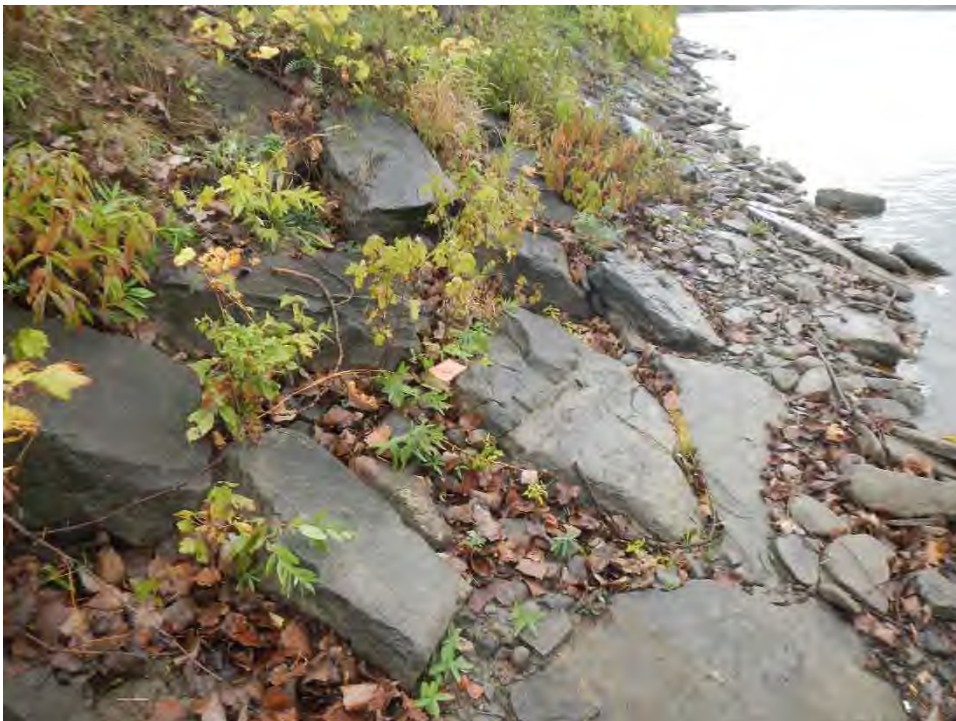
**Photograph: 8**

**Description:**  
OHWM – rock staining  
and vegetation break

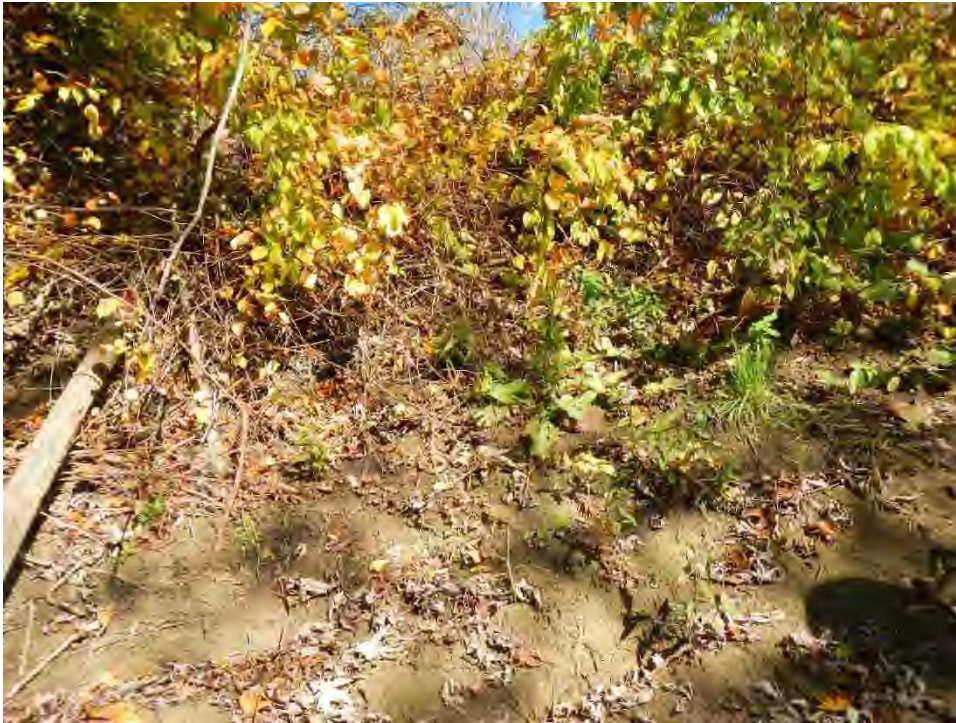
**Photograph: 15**

**Description:**  
Bank assessment area

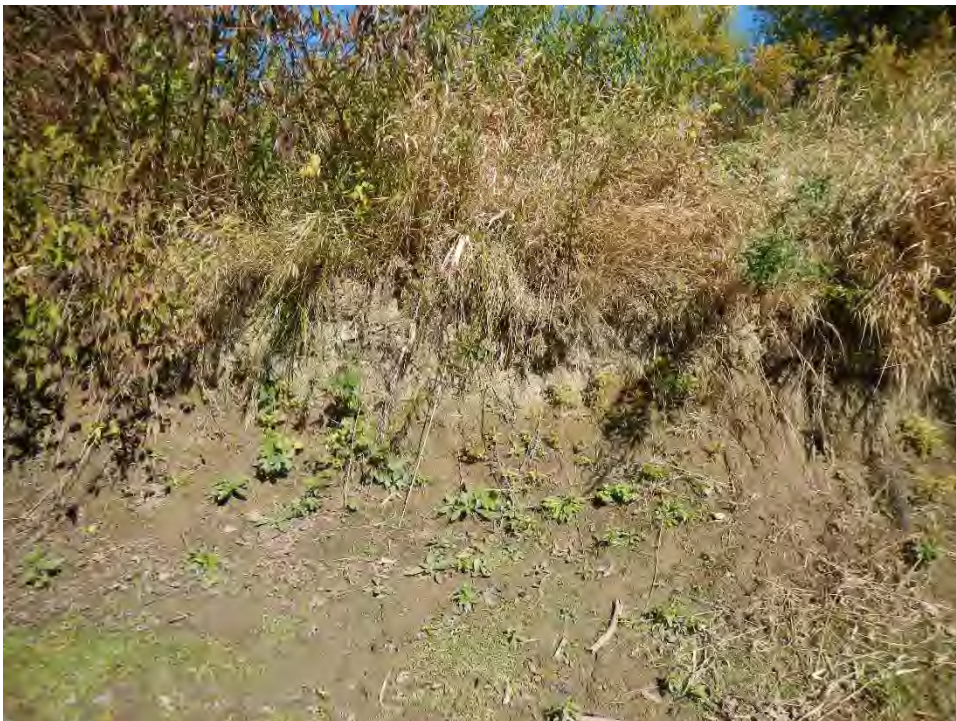
**Photograph: 16**

**Description:**  
Bank assessment area
