## CORTLAND COUNTY LANDFILL REMEDIAL ACTION LANDFILL CLOSURE

TOWNLINE ROAD CORTLAND COUNTY, NEW YORK

# CONSTRUCTION CERTIFICATION REPORT

**VOLUME I OF III**

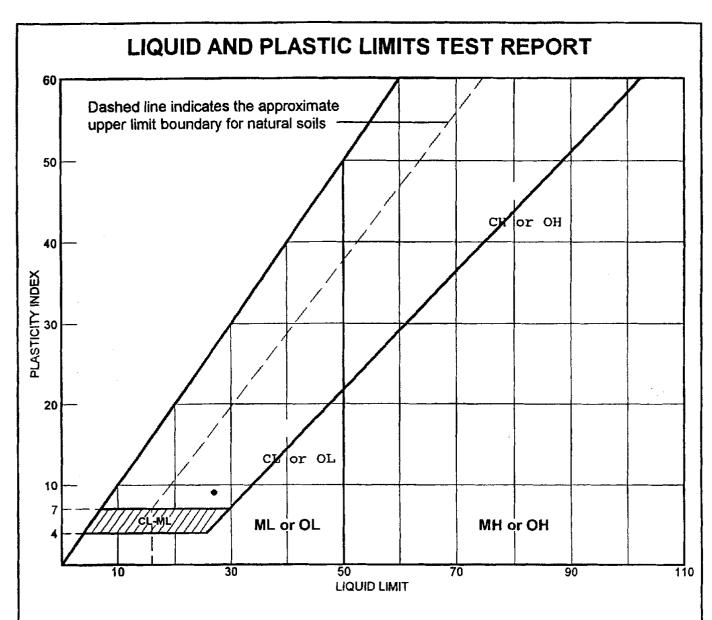
SOIL DATA								
SYMBOL	SOURCE	SAMPLE NO.	DEPTH (ft.)	NATURAL WATER CONTENT (%)	PLASTIC LIMIT (%)	LIQUID LIMIT (%)	PLASTICITY INDEX (%)	USCS	
•	Common Fill	209, CF-2			18	27	9	GC

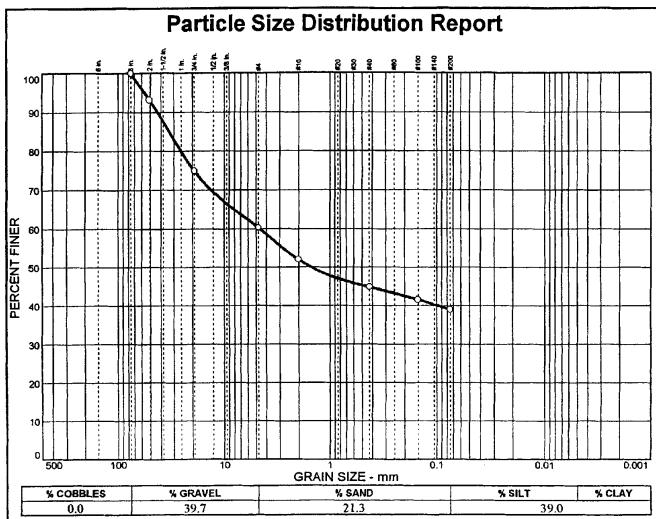
% COBBLES	% GRAVEL	% SAND	% SILT	% CLAY
0.0	39.7	21.3	39.0	
<u> </u>			· · · · · · · · · · · · · · · · · · ·

SIEVE	PERCENT	SPEC.*	PASS?
SIZE	FINER	PERCENT	(X≃NO)
3 in. 2 in. .75 in. #4 #10 #40 #100 #200	100.0 93.2 74.9 60.3 52.0 44.8 41.5 39.0		(2.89)

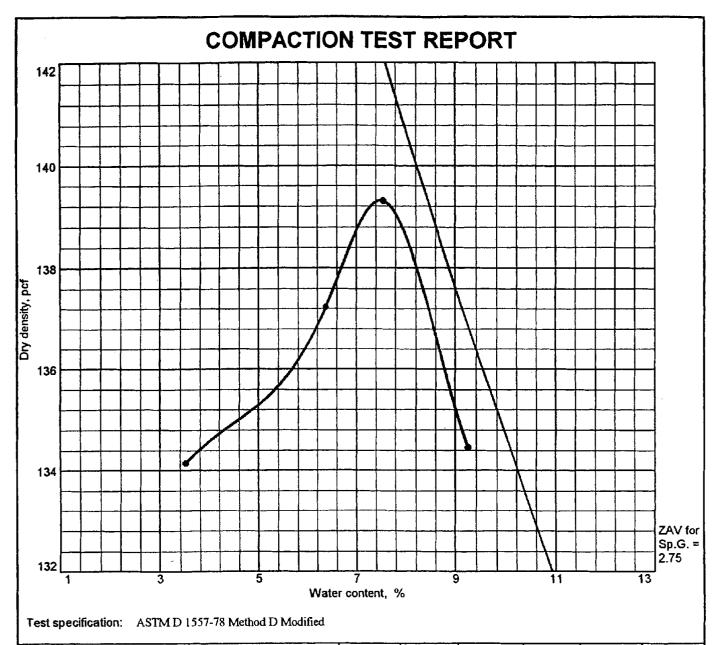
Elev/	Classi	fication	Nat.	Sp.G.	LL	Pi	% >	% <
Depth	USCS	AASHTO	Moist.	Sp.G.	-	Pi	3/4 in.	No.200
	GC				27	a	25.1	39.0
1	300		<u> </u>		21		25.1	37.0

Optimum moisture = 7.5 %

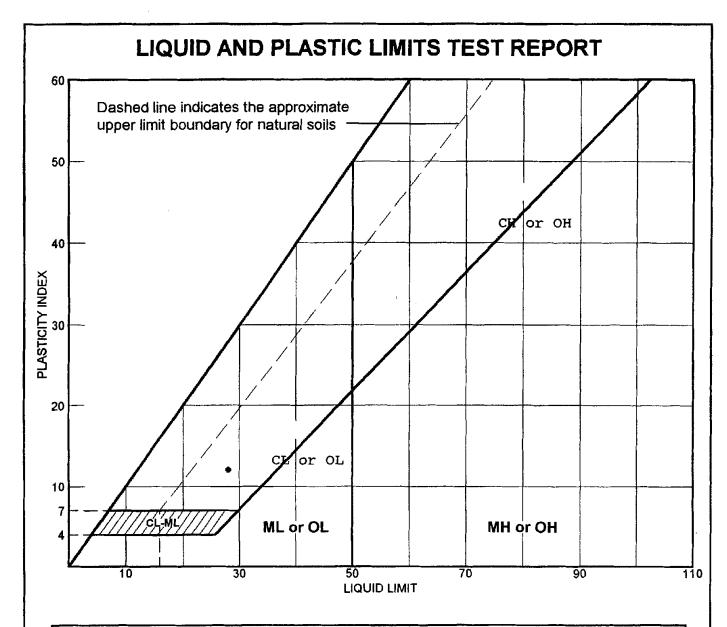
SOIL DATA								
SYMBOL	SOURCE	SAMPLE NO.	DEPTH (ft.)	NATURAL WATER CONTENT (%)	PLASTIC LIMIT (%)	LIQUID LIMIT (%)	PLASTICITY INDEX (%)	USCS	
•	Common Fill	217, CF-3			16	28	12	SC

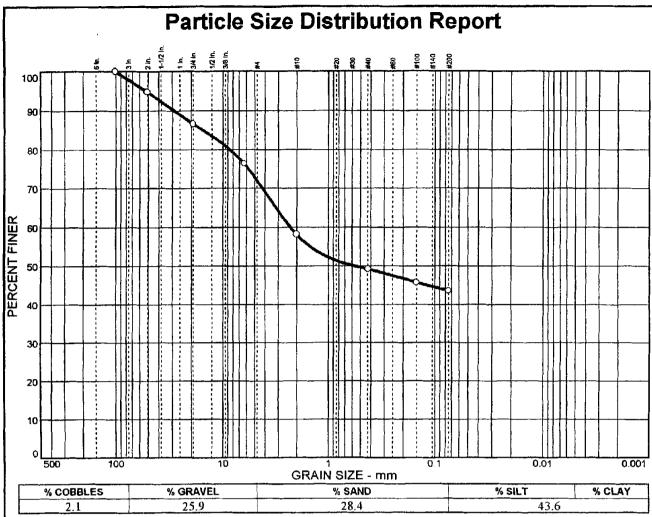
SIEVE	PERCENT	SPEC.*	PASS?
SIZE	FINER	PERCENT	(X=NO)
4 in. 2 in. .75 in. .25 in. #10 #100 #200	100.0 94.8 86.6 76.4 58.2 49.2 45.8 43.6

Clayey sand with	Soil Description Clayey sand with gravel Retest of CF #1								
PL= 16	Atterberg Limit	<u>s</u> Pl= 12							
D <sub>85</sub> = 15.5 D <sub>30</sub> = C <sub>u</sub> =	Coefficients D60= 2.28 D15= Cc=	D <sub>50</sub> = 0.565 D <sub>10</sub> =							
USCS= SC	<u>Classification</u> AASH								
	Remarks

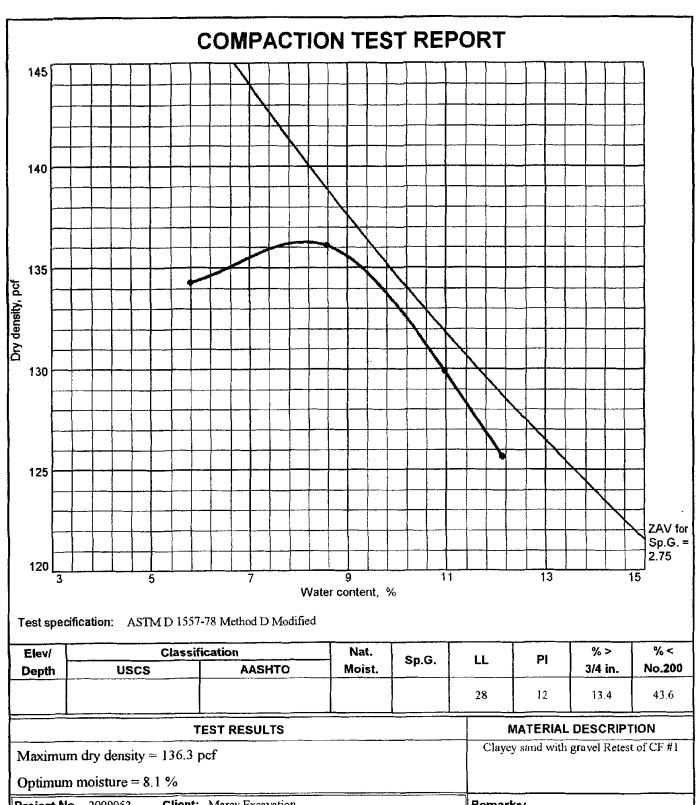
TEST RESULTS	MATERIAL DESCRIPTION
Maximum dry density = 136.3 pcf	Clayey sand with gravel Retest of CF #1
Optimum moisture = 8.1 %	
Project No. 2009053 Client: Marcy Excavation	Remarks:
Project: Cortland Landfill Cover	
● Location: Pile #3	
COMPACTION TEST REPORT	
SJB SERVICES, INC.	Plate

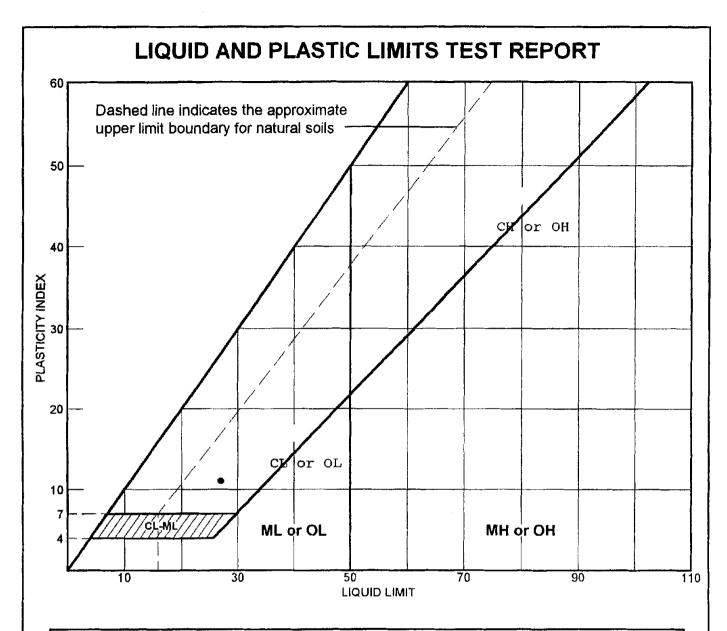
SOIL DATA								
SYMBOL	SOURCE	SAMPLE NO.	DEPTH (ft.)	NATURAL WATER CONTENT (%)	PLASTIC LIMIT (%)	LIQUID LIMIT (%)	PLASTICITY INDEX (%)	USCS	
•	Common Fill	225, CF-4			16	27	11	GC

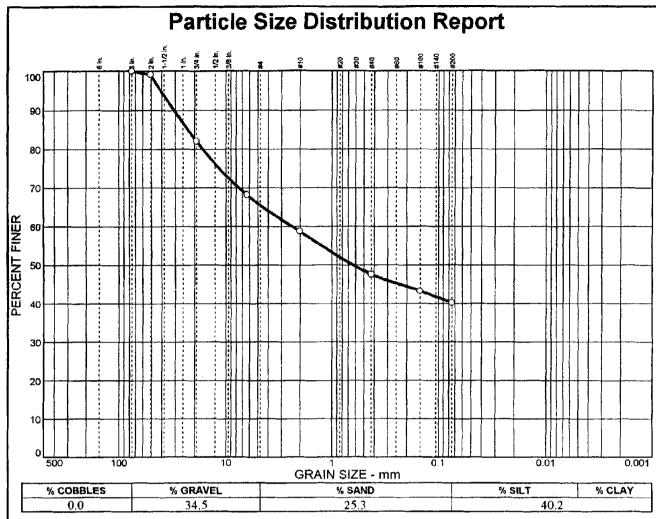
SIEVE	PERCENT	SPEC.*	PASS?
SIZE	FINER	PERCENT	(X=NO)
3 in. 2 in. .75 in. .25 in. #10 #100 #200	100.0 99.2 82.1 68.2 58.7 47.6 43.3 40.2

Soil Description	
Clayey gravel wi Common Fill	th sand	
<b>PL=</b> 16	Atterberg Limits	PI= 11
D85= 22.8 D30= Cu=	Coefficients D60= 2.37 D15= Cc=	D <sub>50</sub> = 0.633 D <sub>10</sub> =
USCS= GC	Classification AASHT	·O=
	<u>Remarks</u>

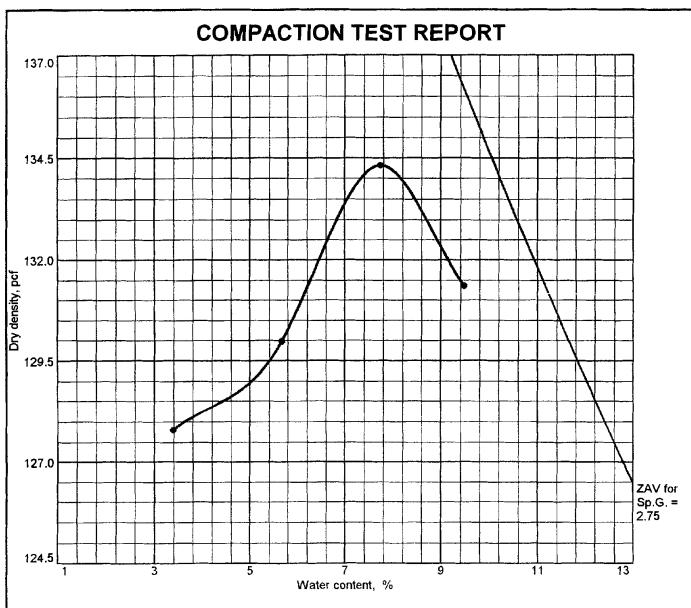
Test specification: ASTM D 1557-78 Method D Modified

Elev/	Classification		Nat.	5-0		Б	% >	% <
Depth	USCS	AASHTO	Moist.	Sp.G.	LL.	Pi	3/4 in.	No.200
	GC				27	11	17.9	40.2

TEST RESULTS	MATERIAL DESCRIPTION
Maximum dry density = 134.3 pcf	Clayey gravel with sand Common Fill
Optimum moisture = 7.7 %	
Project No. 2009053 Client: Marcy Excavation	Remarks:
Project: Cortland Landfill Cover	
• Location: 5/10/01, S-1	
COMPACTION TEST REPORT	
SJB SERVICES, INC.	Plate

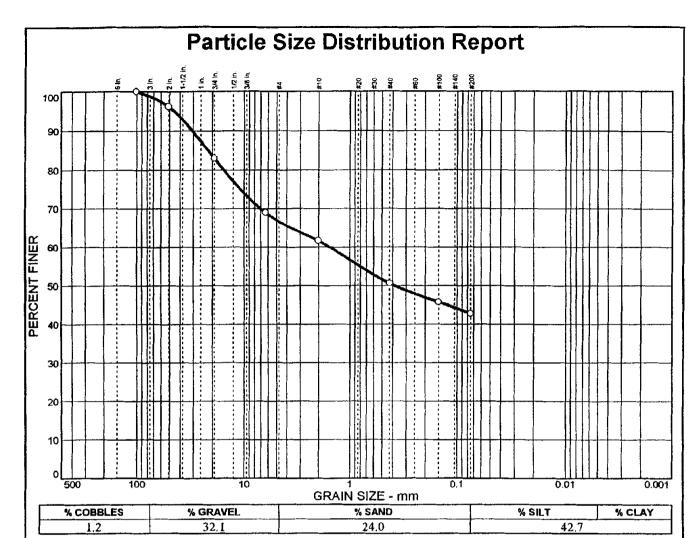
SIEVE	PERCENT FINER	SPEC.* PERCENT	PASS? (X=NO)
4 in. 2 in. 75 in. 25 in. #10 #40 #100 #200	100.0 96.1 83.0 69.0 61.6 50.6 45.8 42.7

Soil Description	)
Common Fill, 51 Clayey gravel wi		
PL= 16	Atterberg Limits	<u>s</u> Pl≃ 12
D <sub>85</sub> = 21.7 D <sub>30</sub> = C <sub>u</sub> =	Coefficients D <sub>60</sub> = 1.57 D <sub>15</sub> = C <sub>c</sub> =	D <sub>50</sub> = 0.382 D <sub>10</sub> =
USCS= GC	Classification AASH	TO≃
	<u>Remarks</u>

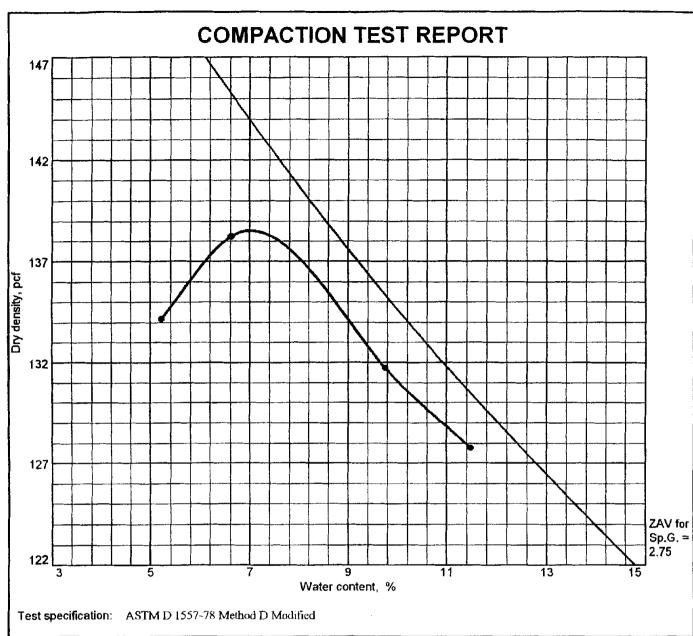
Elev/	Classification		Nat.	E - C		DI DI	% >	% <
Depth	USCS	AASHTO	Moist.	Sp.G.	LL	PI	3/4 in.	No.200
	GC				28	12	33.3	42.7
ļ	1						55.5	]

TEST RESULTS	MATERIAL DESCRIPTION
Maximum dry density = 138.5 pcf	Common Fill, 5K Clayey gravel with sand
Optimum moisture = 7.0 %	
Project No. 2009053 Client: Marcy Excavation	Remarks:
Project: Cortland Landfill Cover	
♦ Location: Pile 5, Sampled on 5/17/01	
COMPACTION TEST REPORT	
SJB SERVICES, INC.	Plate

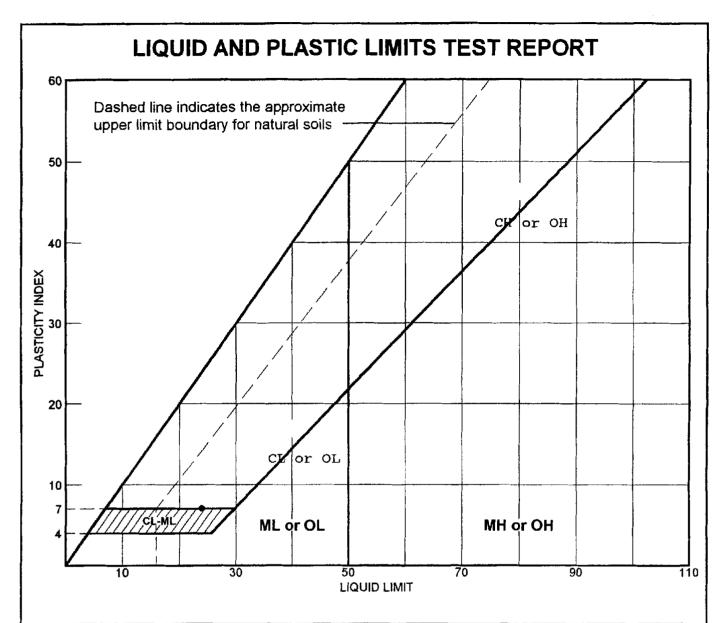
SOIL DATA									
SYMBOL	SOURCE	SAMPLE NO.	DEPTH (ft.)	NATURAL WATER CONTENT (%)	PLASTIC LIMIT (%)	LIQUID LIMIT (%)	PLASTICITY INDEX (%)	USCS		
•	Common Fill	252, CF #6	Loc, B-74		17	24	7	CL-MIL

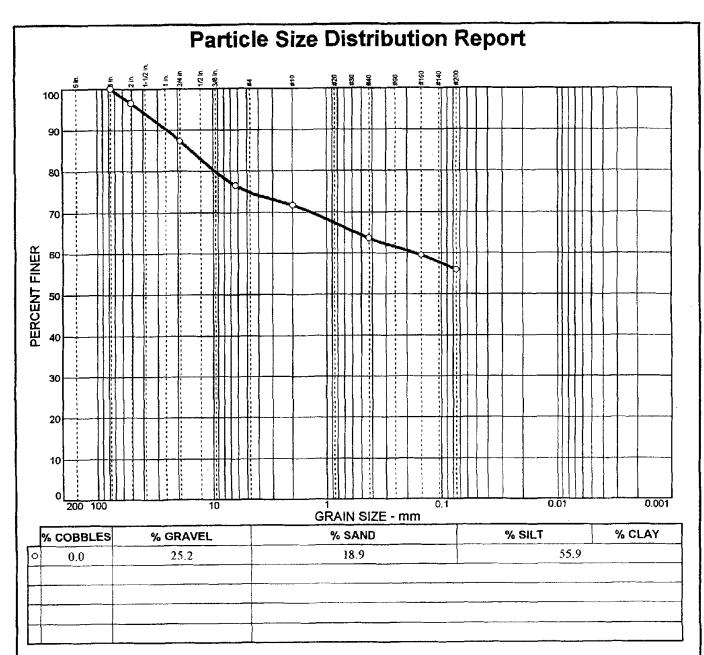
SOIL DATA						
SYMBOL SOURCE SAMPLE NO.			DEPTH (ft.)	DESCRIPTION	uscs	
0	Common Fill	252, CF #6	Loc. B-74	Common Fill, Gravelly silty clay with sand	CL-ML	
				B-74, Sampled on 5/25/01

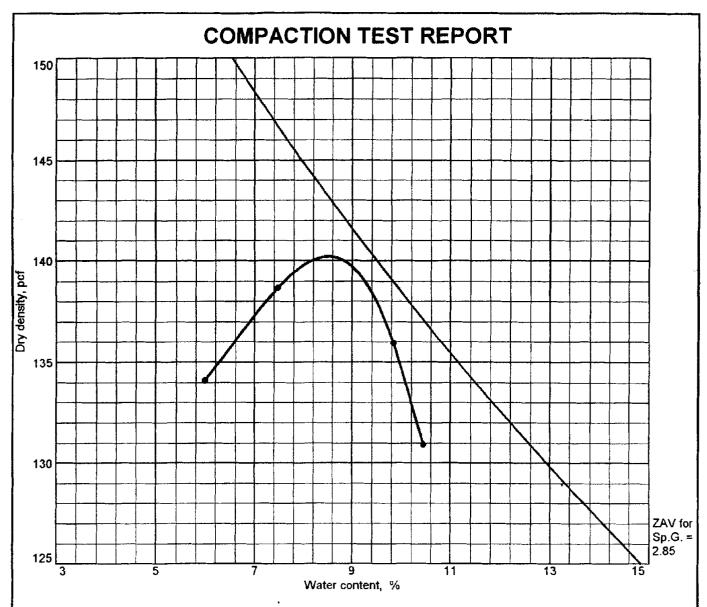
Test specification: ASTM D 1557-78 Method D Modified

Elev/ Classification	ication	Nat.	Sp.G.		DI	%>	% <	
Depth	USCS	AASHTO	Moist.	5p.G.	LL	PI	3/4 in.	No.200
	CL-ML				24	7	25.2	55.9

TEST RESULTS	MATERIAL DESCRIPTION
Maximum dry density = 140.2 pcf	Common Fill, Gravelly silty clay with sand B-74, Sampled on 5/25/01
Optimum moisture = 8.5 %	
Project No. 2009053 Client: Marcy Excavation	Remarks:
Project: Cortland Landfill Cover	
● Location: 5-10K cy, B-74	
COMPACTION TEST REPORT	
SJB SERVICES, INC.	Plate

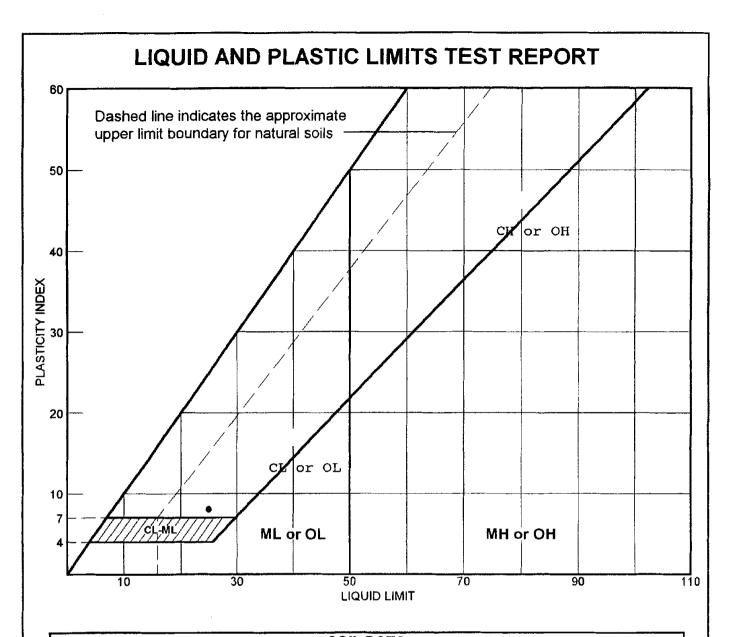
SOIL DATA								
SYMBOL	SOURCE	SAMPLE NO.	DEPTH (ft.)	NATURAL WATER CONTENT (%)	PLASTIC LIMIT (%)	LIQUID LIMIT (%)	PLASTICITY INDEX (%)	USCS	
•	Common Fill	256			17	25	8	GC

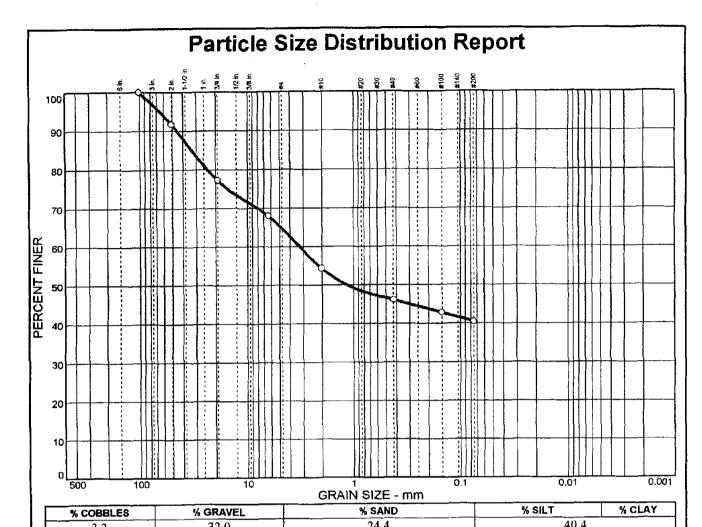
IEVE	PERCENT	SPEC."	PASS?
SIZE	FINER	PERCENT	(X≂NO)
4 in. 2 in. 5 in. 5 in. #10 #100 #200	100.0 91.7 77.2 68.0 54.3 46.1 42.8 40.4

<u> </u>	40.4				
Conumon Fill, Sa Clayey gravel wi					
<b>PL</b> = 17	Atterberg Limits LL= 25	PI= 8			
D85= 32.8 D30= C <sub>u</sub> =	Coefficients D60= 3.24 D15= C <sub>c</sub> =	D <sub>50</sub> ≂ 1.16 D <sub>10</sub> =			
USCS= GC	Classification AASHT	D=			
F.M.=0.80	Remarks

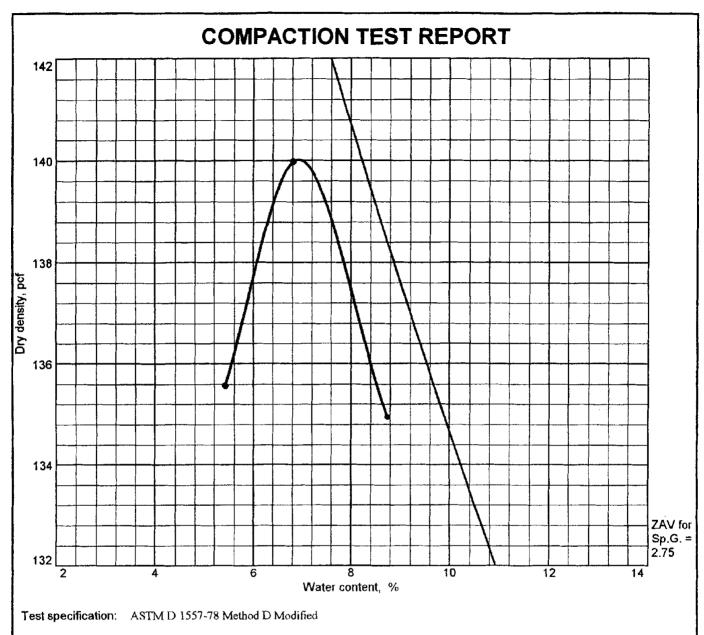
Elev/	Classification		Nat.	Nat.	Nat. S-C		DI	% >	% <
Depth	USCS	AASHTO	Moist.	Sp.G.	LL	PI	3/4 in.	No.200	
	.GC				25	8	22.8	40.4

TEST RESULTS	MATERIAL DESCRIPTION
Maximum dry density = 140.0 pcf	Common Fill, Sampled 6/1/01 Clayey gravel with sand
Optimum moisture = 6.9 %	
Project No. 2009053 Client: Marcy Excavation	Remarks:
Project: Cortland Landfill Cover	
• Location: CF-7, BGV 97, 15K	
COMPACTION TEST REPORT	
SJB SERVICES, INC.	Plate

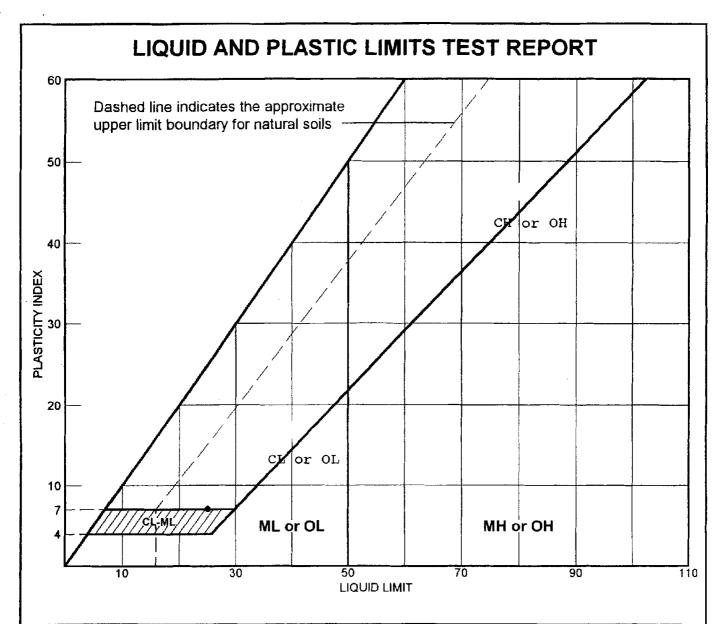
SOIL DATA								
SYMBOL	SOURCE	SAMPLE NO.	DEPTH (ft.)	NATURAL WATER CONTENT (%)	PLASTIC LIMIT (%)	LIQUID LIMIT (%)	PLASTICITY INDEX (%)	uscs
•	Common Fill	266, CF-8			18	25	7	GC-GM

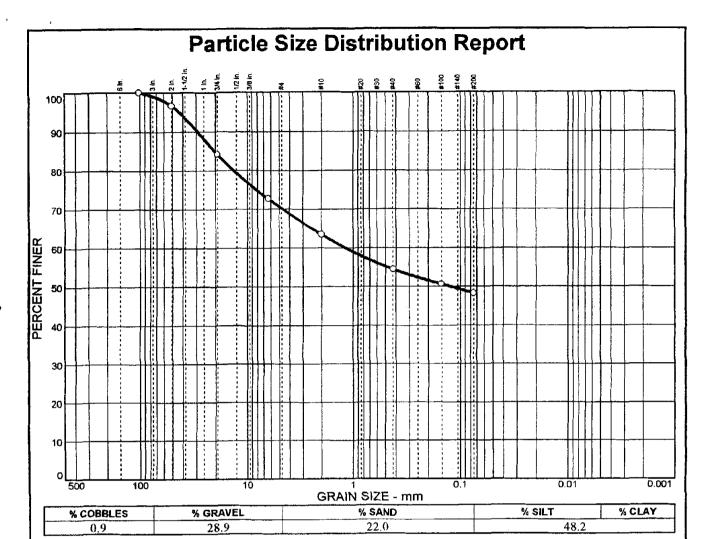
SIEVE	PERCENT	SPEC.*	PASS?
SIZE	FINER	PERCENT	(X=NO)
4 in. 2 in. .75 in. .25 in. #10 #40 #100 #200	100.0 96.7 84.2 72.7 63.5 54.5 50.6 48.2

Soil Description  Common Fill CF-8, @ AV-10, Sampled 6-6-01  Silty clayey gravel with sand.					
PL= 18	Atterberg Limits LL= 25	Pi= 7				
D <sub>85</sub> = 20.2 D <sub>30</sub> = C <sub>u</sub> =	Coefficients D60= 1.19 D15= C <sub>c</sub> =	D <sub>50</sub> = 0.126 D <sub>10</sub> =				
USCS≈ GC-G	Classification AASHT	O=				
F.M.=0.65	Remarks					
	_ <del>.</del>

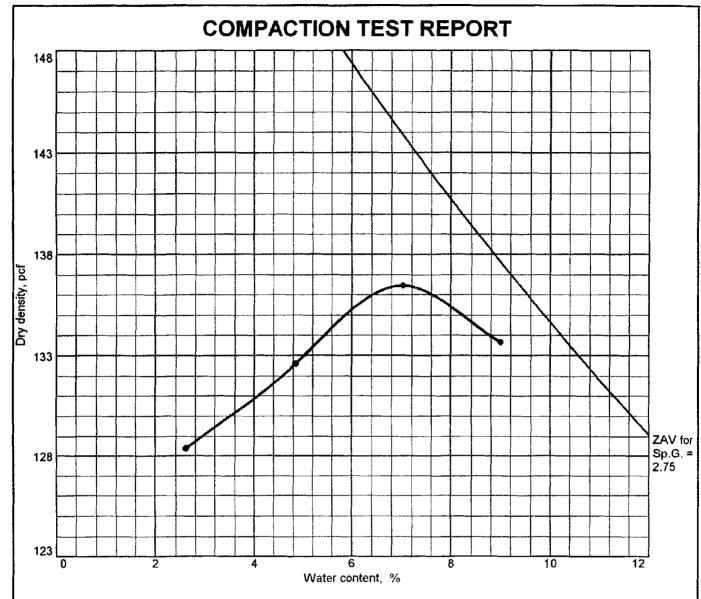
Test specification: ASTM D 1557-78 Method C Modified

Elev/	Classi	fication	Nat.		1.1	DI.	% >	% <
Depth	USCS	AASHTO	Moist.	Sp.G.	LL	PI	3/4 in.	No.200
	GC-GM				25	7	15.8	48.2

TEST RESULTS	MATERIAL DESCRIPTION
Maximum dry density = 136.4 pcf	Common Fill CF-8, @ AV-10, Sampled 6-6-
Optimum moisture = 7.0 %	Silty clayey gravel with sand.
Project No. 2009053 Client: Marcy Excavation	Remarks:
Project: Cortland Landfill Cover	Common Fill CF-8, @ AV-10, Sampled 6-6-01.
• Location: AV-10, 20K	
COMPACTION TEST REPORT	
SJB SERVICES, INC.	Plate

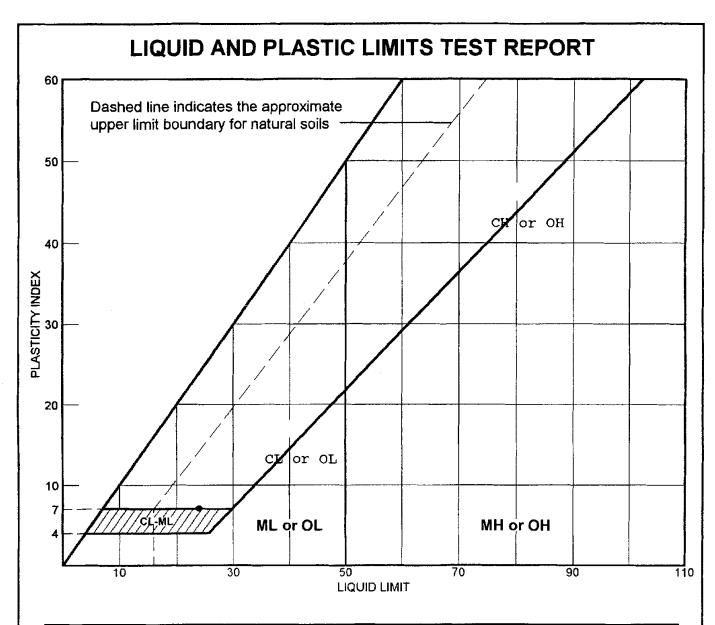
SOIL DATA							
SYMBOL	SOURCE	SAMPLE NO.	DEPTH (ff.)	NATURAL WATER CONTENT (%)	PLASTIC LIMIT (%)	LIQUID LIMIT (%)	PLASTICITY INDEX (%)	USCS
•	Common Fill	267, CF-9			17	24	7	GC-GM

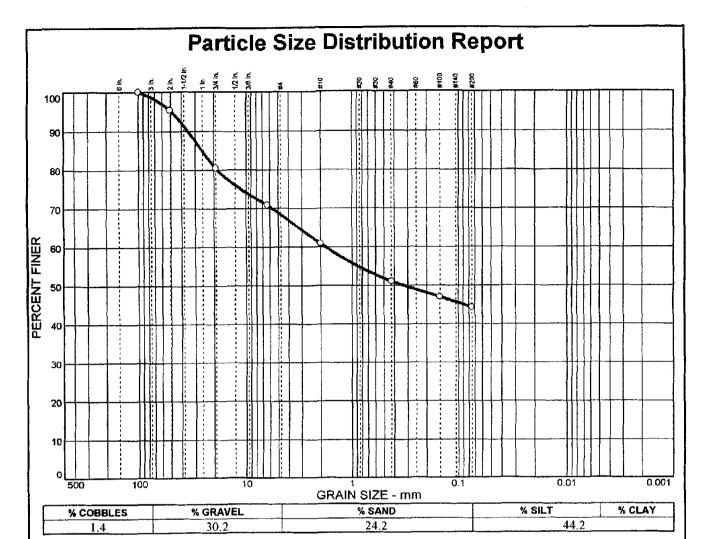
SIEVE	PERCENT	SPEC.*	PASS?
SIZE	FINER	PERCENT	(X=NO)
4 in. 2 in.	100.0 95.4		
.75 in.	80.5		
.25 in. #10	70.8 60.9		
#40	51.1		
#100	47.0		
#200	44.3		
}			
1			
1			
		1	<u> </u>

Soil Description  Common Fill, CF-9, 25K, Sampled 6/7/01  Silty clayey gravel with sand					
PL= 17	Atterberg Limits	<u>s</u> Pi= 7				
D <sub>85</sub> = 25.6 D <sub>30</sub> = C <sub>u</sub> =	<u>Coefficients</u> D <sub>60</sub> = 1.79 D <sub>15</sub> = C <sub>c</sub> =	D <sub>50</sub> = 0.329 D <sub>10</sub> =				
USCS= GC-C	Classification AASH	TO=				
F.M.=0.73	<u>Remarks</u>

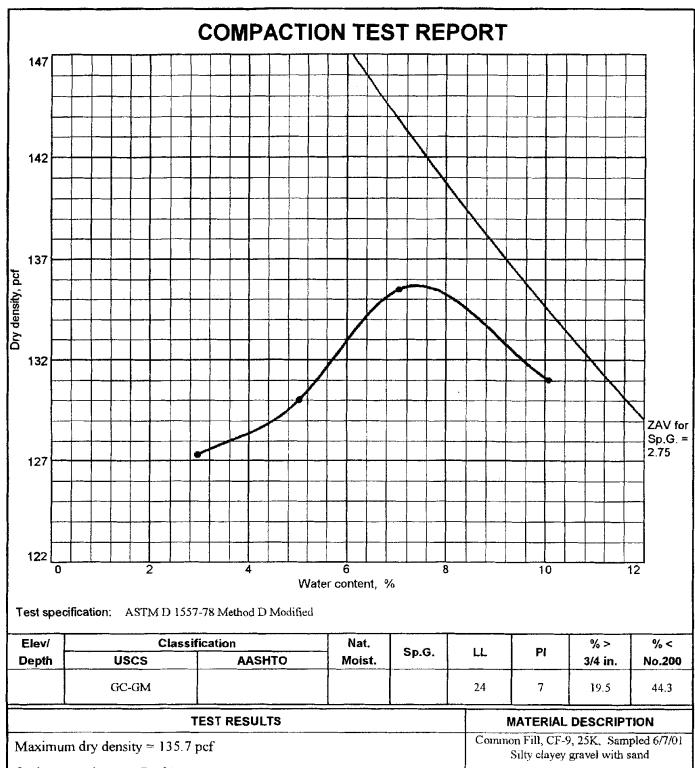
TEST RESULTS	MATERIAL DESCRIPTION
Maximum dry density = 135.7 pcf	Common Fill, CF-9, 25K, Sampled 6/7/01 Silty clayey gravel with sand
Optimum moisture = 7.4 %	
Project No. 2009053 Client: Marcy Excavation	Remarks:
Project: Cortland Landfill Cover	
Location: 25K	
COMPACTION TEST REPORT	
SJB SERVICES, INC.	Plate

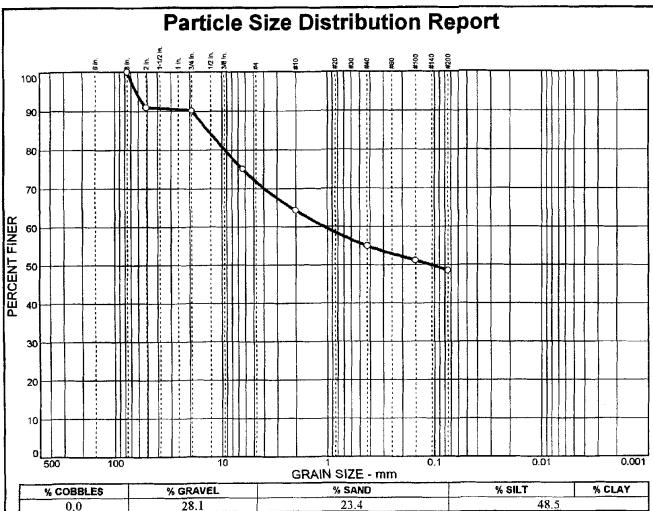
SIEVE SIZE	PERCENT	SPEC.* PERCENT	PASS? (X=NO)
3 in. 2 in. 75 in. 25 in. #10 #40 #100 #200	100.0 90.9 90.1 75.1 64.3 54.9 51.1 48.5

Common Fill, 1	Soil Description  N. Garage #3 P	
PL=	Atterberg Limits	PI=
D <sub>85</sub> = 13.4 D <sub>30</sub> = C <sub>u</sub> =	Coefficients D60= 1.09 D15= Cc=	D50= 0.111 D <sub>10</sub> =
USCS= GC-G	Classification GM AASHT	O=
Performed Grain F.M.=0.59	Remarks n Size only.

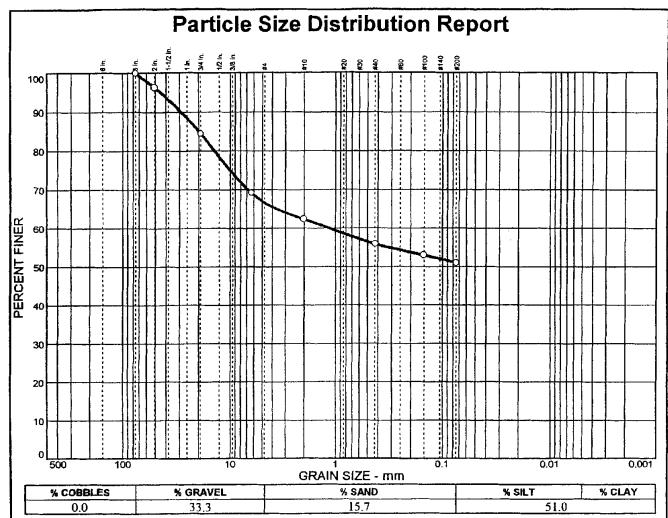
SIEVE	PERCENT	SPEC.*	PASS?
SIZE	FINER	PERCENT	{X=NO}
3 in. 2 in. 75 in. 25 in. #10 #40 #100 #200	100.0 96.3 84.5 69.2 62.4 55.9 53.0 51.0

Common Fill, C	Soil Description	<u>n</u>
Gravelly silt with	n sand	
PL= NP	Atterberg Limit	<u>s</u> PI= NP
D <sub>85</sub> = 19.7 D <sub>30</sub> = C <sub>u</sub> =	Coefficients D <sub>60</sub> = 1.15 D <sub>15</sub> = C <sub>c</sub> =	D <sub>50</sub> ≠ D <sub>10</sub> =
USCS= ML	Classification AASH	ITO=
	<u>Remarks</u>

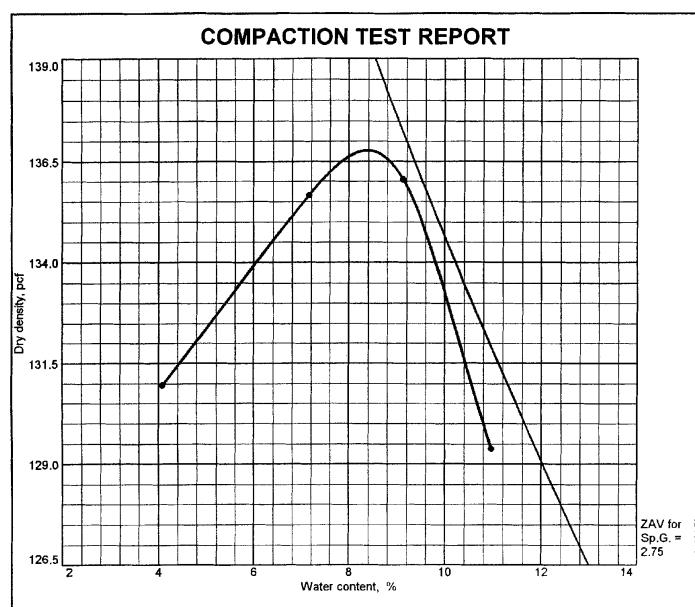
Test specification: ASTM D 1557-78 Method D Modified

Elev/	Classif	ication	Nat.	6-6	Nat.	1.1	D.	% >	% <
Depth	USCS	AASHTO	Moist.	Sp.G.	LL	PI	3/4 in.	No.200	
	ML				12	NP	33.3	51.0

Maximum dry density = 136.8 pcf
Optimum moisture = 8.4 %

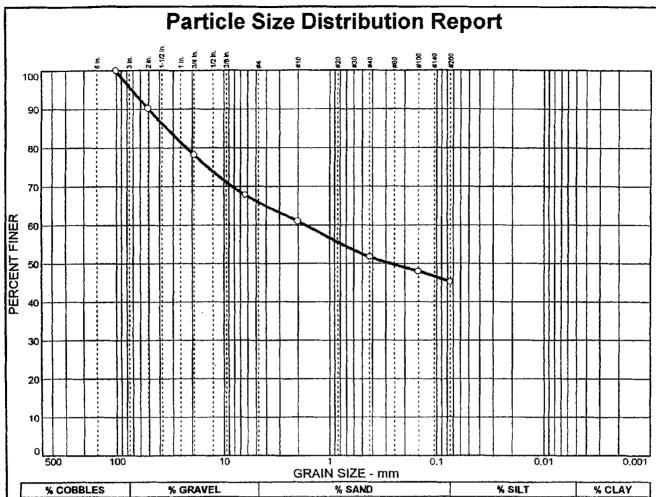
% COBBLES	% GRAVEL	% SAND	% SILT	% CLAY
4.1	30.0	20.7	45.2

SIEVE	PERCENT	SPEC.*	PASS?
SIZE	FINER	PERCENT	(X=NO)
4 in. 2 in. .75 in. .25 in. #10 #40 #100 #200	100.0 90.2 78.2 67.8 61.0 51.7 48.0 45.2		
<u> </u>	<u> </u>	<u> </u>

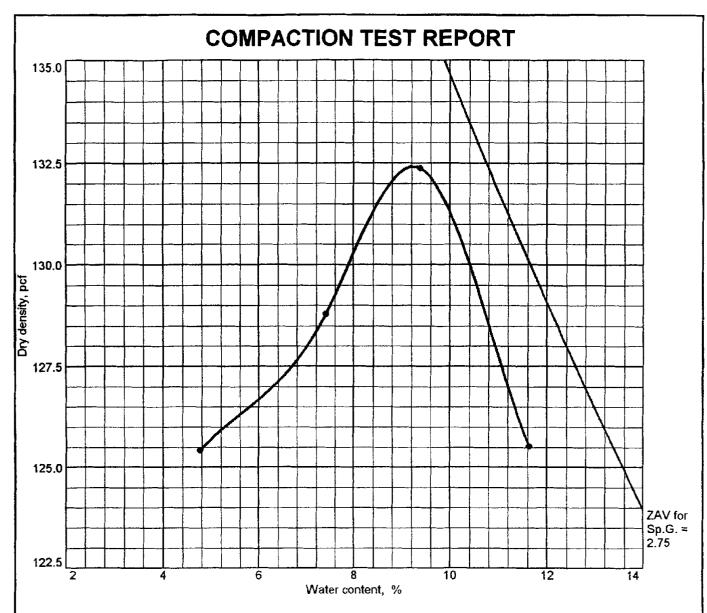
Test specification: ASTM D 1557-78 Method D Modified

Elev/	Class	ification	Nat.	Nat.	<u> 1</u>		% >	% <
Depth	USCS	AASHTO	Moist.	Sp.G.	LL	PI	3/4 in.	No.200
1	GC				29	8	21.8	45.2

TEST RESULTS	MATERIAL DESCRIPTION
Maximum dry density = 132.4 pcf	Common Fill, CF-12 Clayey gravel with sand
Optimum moisture = 9.2 %	
Project No. 2009053 Client: Marcy Excavation	Remarks:
Project: Cortland Landfill Cover	
• Location: B55, 35K Sample	8
COMPACTION TEST REPORT	
SJB SERVICES, INC.

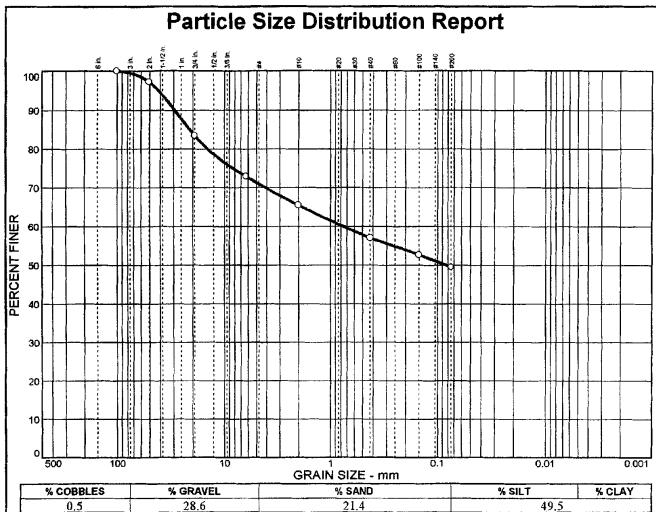
SIZE FINE	R PERCENT	1 00 000
SIZE FINE		(X=NO)
4 in. 100.0 2 in. 97 75 in. 83 25 in. 72 #10 65 #100 57. #100 52 #200 49	3 5 9 1 7

21.4	······	47.7				
Soil Description						
Common Fill, CF-13						
Clayey gravel wit	th sand					
Atterberg Limits						
PL= 22	LL= 30	PI= 8				
	Coefficients					
D <sub>85</sub> = 21.1	D <sub>60</sub> = 0.763	D <sub>50</sub> = 0.0833				
D30=	D <sub>15</sub> =	D <sub>10</sub> =				
D30= Cu=	Cc≟	10				
	Classification					
USCS= GC	AASHTO=					
	<u>Remarks</u>

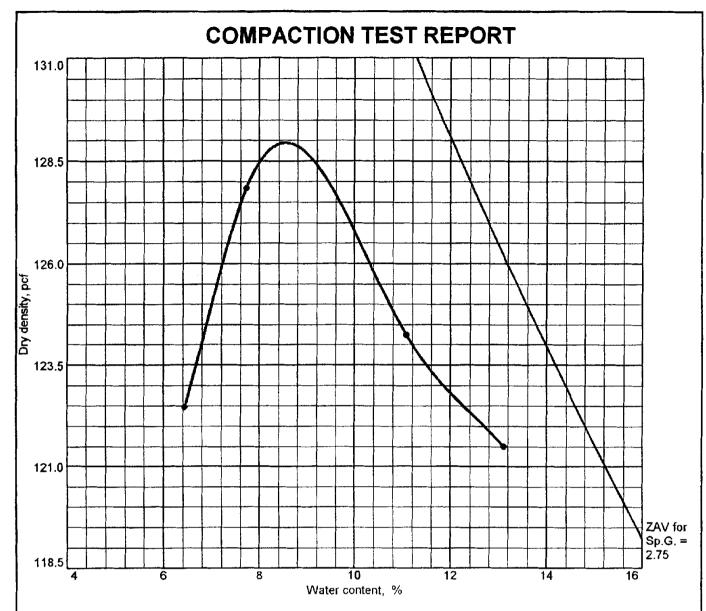
Test specification: ASTM D 1557-78 Method D Modified

Elev/	Classification		Nat.	C= C		-	% >	% <
Depth	USCS	AASHTO	Moist.	Sp.G.	LL	PI	3/4 in.	No.200
	GC				30	8	16.5	49.5
-	GC				30	8	16.5

TEST RESULTS	MATERIAL DESCRIPTION
Maximum dry density = 128.9 pcf	Common Fill, CF-13 Clayey gravel with sand
Optimum moisture = 8.5 %	
Project No. 2009053 Client: Marcy Excavation	Remarks:
Project: Cortland Landfill Cover	
● Location: B65, 40K Sample	
COMPACTION TEST REPORT	
SJB SERVICES, INC.	Plate

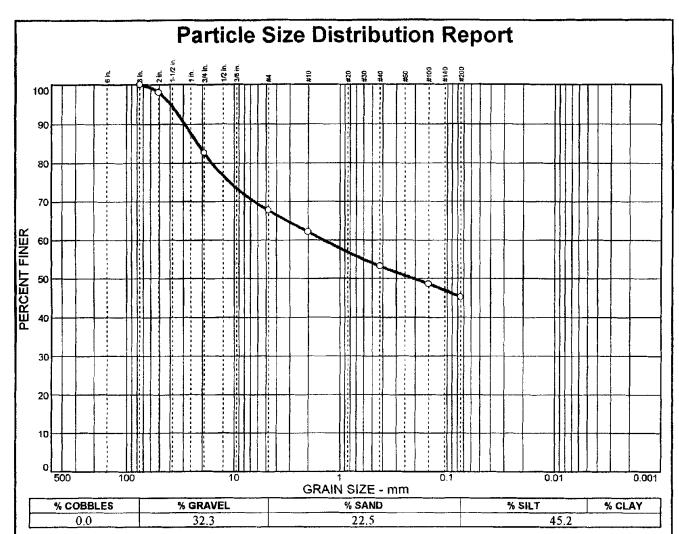
SIEVE	PERCENT	SPEC.*	PASS?
SIZE	FINER	PERCENT	(X=NO)
3 in. 2 in. .75 in. #4 #10 #40 #100 #200	100.0 98.1 82.6 67.7 62.1 53.2 48.6 45.2		(x no)

Soil Descriptio	<u>n</u>
Clayey gravel wi	th sand	
	Atterberg Limit	:S
PL= 20	LL= 28	PI≈ 8
_	Coefficients	
D <sub>85</sub> ≈ 21.9	D <sub>60</sub> = 1.42 D <sub>15</sub> =	D <sub>50</sub> = 0.206 D <sub>10</sub> =
D30= C <sub>u</sub> =	$C_{12}^{c}$	210
	Classification	
USCS= GC	AASH	ITO≃
	<u>Remarks</u>	
Sampled on 7/25	5/01

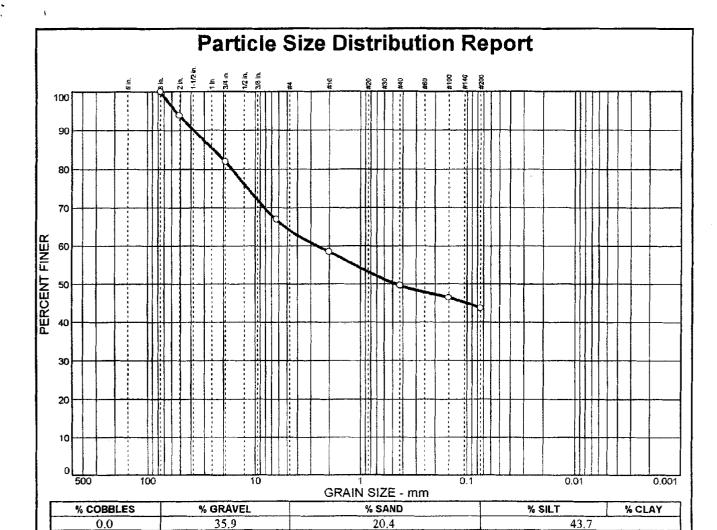
SIEVE	PERCENT	SPEC.*	PASS?
SIZE	FINER	PERCENT	(X≃NO)
3 in. 2 in. 75 in. 75 in. 125 in. #10 #40 #100 #200	100.0 93.9 81.9 66.9 58.5 49.6 46.4 43.7

Soil Description				
Silty clayey gravel with sand					
PL= 17	Atterberg Limits	PI= 7			
PL- 17	LL- 24	P)- /			
D <sub>85</sub> = 24.5	Coefficients D <sub>60</sub> = 2.59	D <sub>50</sub> = 0,467			
D <sub>30</sub> = C <sub>u</sub> =	D <sub>60</sub> - 2.39	D <sub>10</sub> = 0,407			
C <sub>u</sub> =	C <sub>c</sub> =				
	<u>Classification</u>				
USCS≃ GC-C	M AASHT	O=			
	<u>Remarks</u>

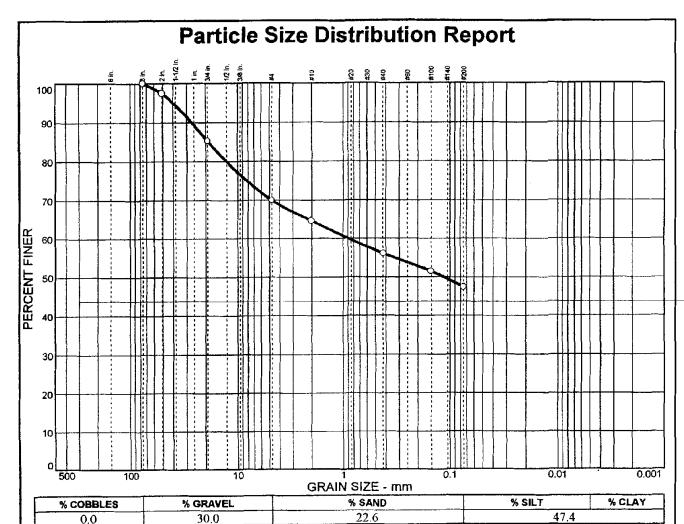
SIEVE	PERCENT	SPEC.*	PASS?
SIZE	FINER	PERCENT	(X=NO)
3 in. 2 in. 75 in. #4 #10 #40 #100 #200	100.0 97.5 85.3 70.0 64.6 56.1 51.4 47.4

<del>1 </del>	Soil Description	
Silty clayey grav	vel with sand	
	Atterberg Limits	
PL= 20	LL= 27	PI= 7
	Coefficients	
$D_{85} = 18.6$	$D_{60} = 0.895$	$D_{50} = 0.116$
D <sub>85</sub> = 18.6 D <sub>30</sub> = C <sub>u</sub> =	D15=	D <sub>10</sub> =
∪u-	O <sub>C</sub> -	
11 <b>55</b> 0 000	Classification	_
USCS= GC-C	M AASHT	O=
	<b>Remarks</b>	
Sampled on 7/2	5/01

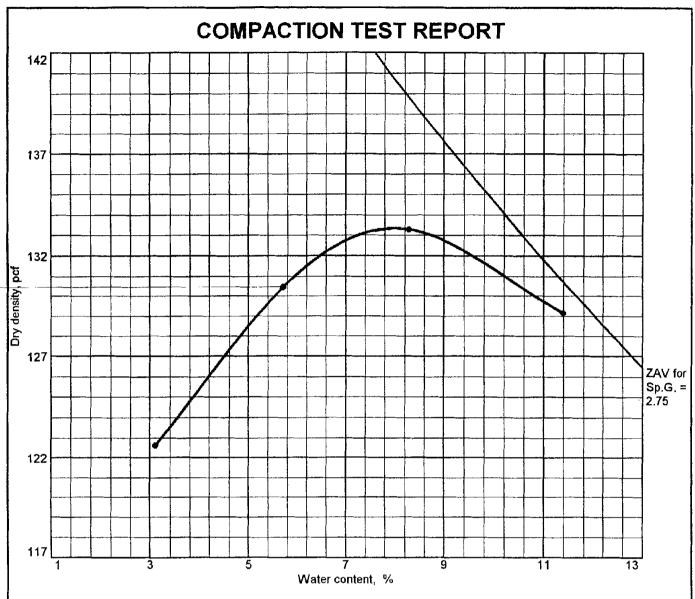
Elev/	Classification		Nat.	C C		DI	% >	% <
Depth	USCS	AASHTO	Moist.	Sp.G.	LL	PI	3/4 in.	No.200
	GC-GM				27	7	14.7	47.4

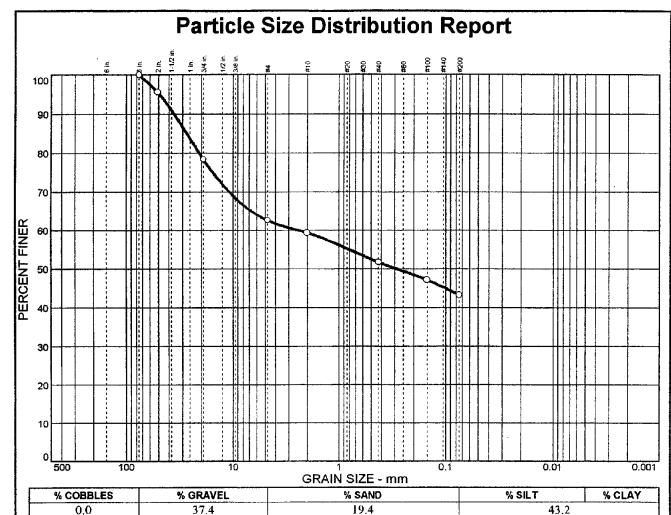
SIEVE	PERCENT	SPEC.*	PASS?
SIZE	FINER	PERCENT	(X=NO)
3 in. 2 in. .75 in. #4 #10 #40 #100 #200	100.0 95.6 78.4 62.6 59.3 51.7 47.1 43.2

19,4		43.2
Common fill 65k Silty gravel with	=	
PL= 17	Atterberg Limits LL= 25	PI= 8
D <sub>85</sub> = 27.2 D <sub>30</sub> = C <sub>u</sub> =	Coefficients D <sub>60</sub> = 2.46 D <sub>15</sub> = C <sub>c</sub> =	D <sub>50</sub> = 0.289 D <sub>10</sub> =
USCS≃ GC	Classification AASHT	'O=
	<u>Remarks</u>

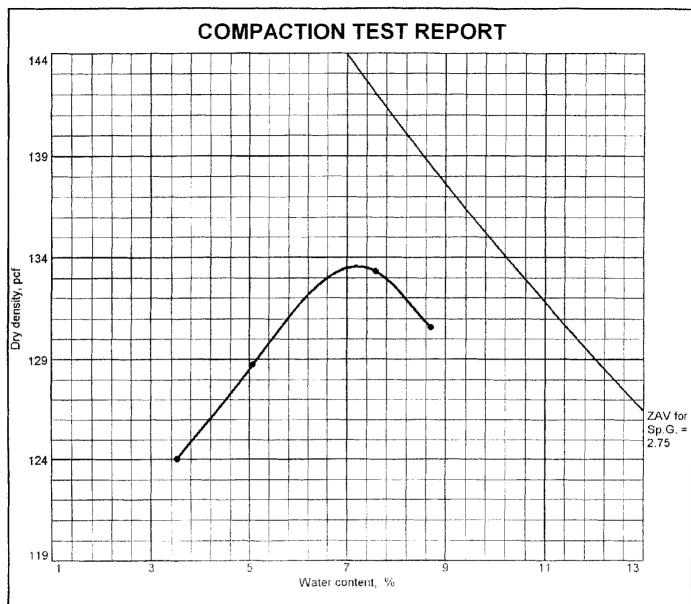
Elev/	Elev/ Classification	fication	Nat. Sp.G.		nı	% >	% <	
Depth	USCS	AASHTO	Moist.	δρ.G.	LL	PI	3/4 in.	No.200
	GC				25	· ·	21.6	.12.3
i	l GC				23		21.0	43.2

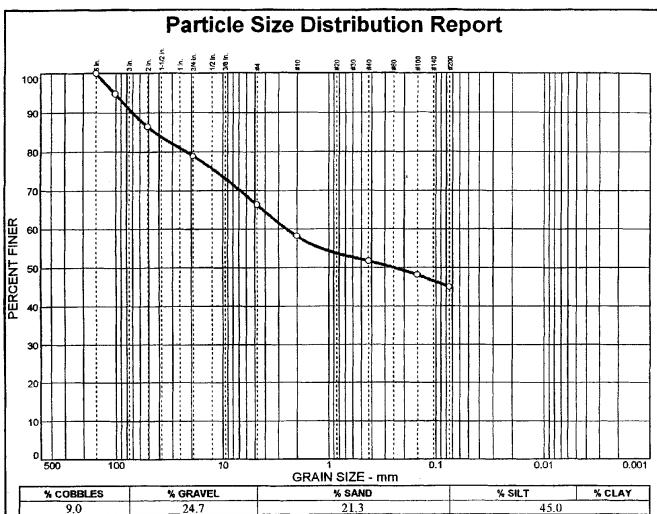
SIEVE	PERCENT	SPEC.*	PASS?
SIZE	FINER	PERCENT	(X=NO)
6 in. 4 in. 2 in. 75 in. #4 #10 #40 #100 #200	100.0 94.7 86.4 78.9 66.3 58.1 51.7 48.1 45.0

21,3		43.0
Silty clayey gra	Soil Description vel with sand	
PL= 18	Atterberg Limits LL= 24	PI= 6
D <sub>85</sub> = 43.7 D <sub>30</sub> = C <sub>u</sub> =	Coefficients D60= 2.52 D15= Cc=	D <sub>50</sub> = 0.247 D <sub>10</sub> =
USCS= GC-0		O=
	Remarks

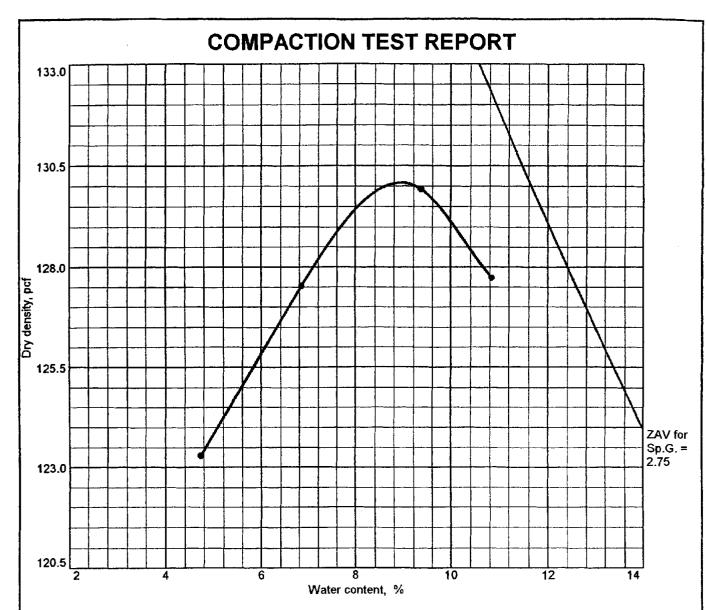
Elev/	Classi	fication	Nat.	Sp.G.	1.1	PI	%>	<b>%</b> <
Depth	USCS	AASHTO	Moist.	Sp.G.	LL	Fi	3/4 in.	No.200
	GC-GM /				24	6	21.1	45.0

TEST RESULTS	MATERIAL DESCRIPTION			
Maximum dry density = 130.1 pcf	Silty clayey gravel with sand			
Optimum moisture = 8.9 %				
Project No. 2009053 Client: Marcy Excavation	Remarks:			
Project: Cortland Landfill Cover				
• Location: Common Fill, 70 K Sample N106E91				
COMPACTION TEST REPORT				
SJB SERVICES, INC.

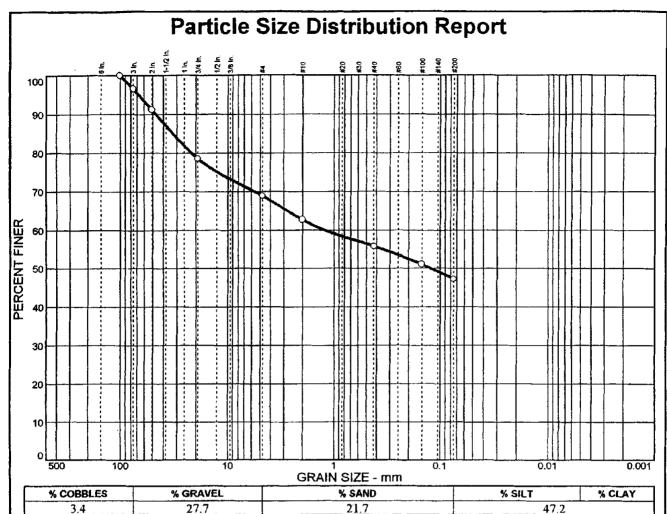
SIEVE	PERCENT	SPEC.*	PASS?
SIZE	FINER	PERCENT	(X=NO)
4 in. 3 in. 2 in. 75 in. #10 #100 #200	100.0 96.6 91.2 78.6 68.9 62.7 55.8 51.0 47.2

Soil Description		
Silty clayey gra	Soil Description Silty clayey gravel with sand		
PL= 18	Atterberg Limits LL= 23	PI= 5	
D <sub>85</sub> = 32.4 D <sub>30</sub> = C <sub>U</sub> =	Coefficients D <sub>60</sub> = 1.22 D <sub>15</sub> = C <sub>c</sub> =	D <sub>50</sub> = 0.124 D <sub>10</sub> =	
USCS= GC-G	Classification GM AASHT	O=	
	<u>Remarks</u>

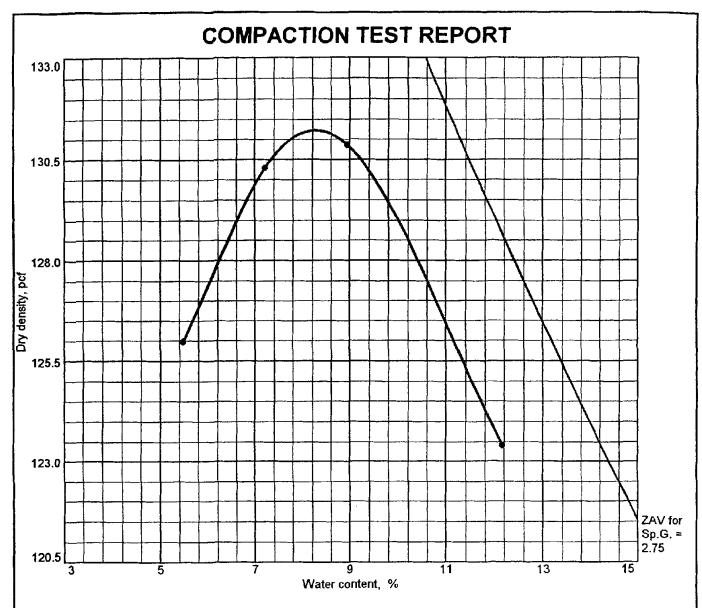
Elev/	Class	ification	Nat,	Sp.G.		PI	% >	% <
Depth	USCS	AASHTO	Moist.	Sp.G.	LL	P1	3/4 in.	No.200
	GC-GM				23	5	21.4	47.2

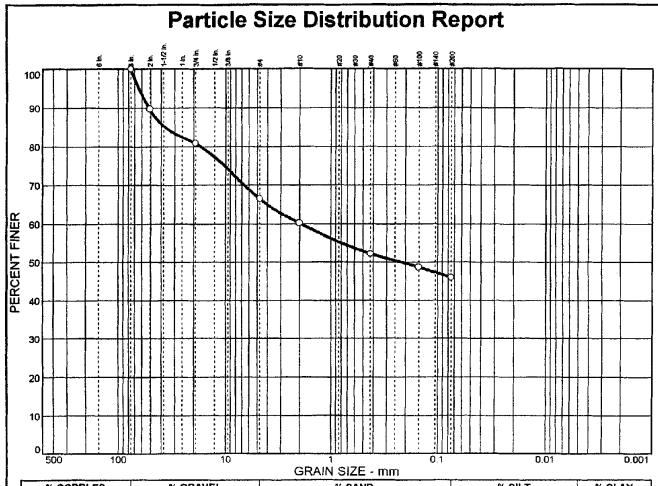
% COBBLES	% GRAVEL	% SAND	% SILT	% CLAY
0.0	33.5	20.5	46.0

i	SIEVE	PERCENT	SPEC.*	PASS?
	SIZE	FINER	PERCENT	(X=NO)
	3 in. 2 in. .75 in. #4 #10 #40 #100 #200	100.0 89.7 80.8 66.5 60.2 52.2 48.7 46.0		
	Ī		l

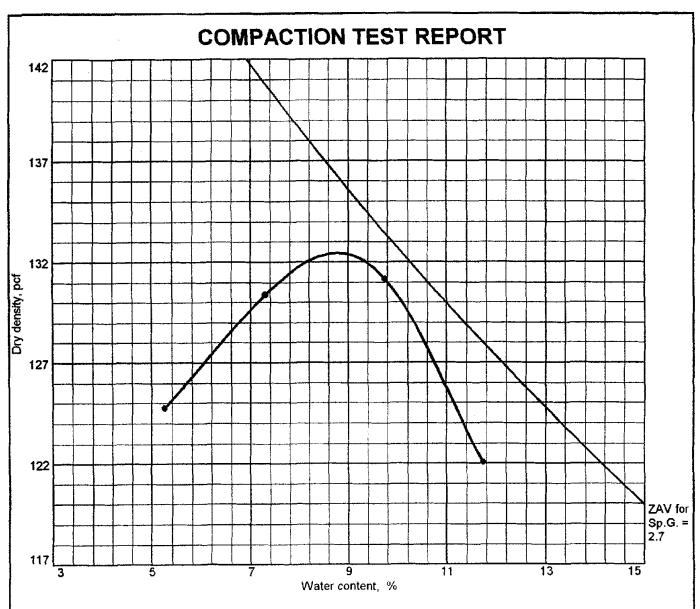
Elev/	Classit	fication	Nat.	Sp.G.	L,L	PI	% >	% <
Depth	uscs	AASHTO	Moist.	3p.0.	Bay Bay	• •	3/4 in.	No.200
	GC-GM			2.7	24	7	19.2	46.0

TEST RESULTS	MATERIAL DESCRIPTION
Maximum dry density = 132.4 pcf	80K N98 E 8 2 Silty clayey gravel with sand
Optimum moisture = 8.8 %	
Project No. 2009053 Client: Marcy Excavation	Remarks:
Project: Cortland Landfill Cover	
Source: Common Fill     Sample No	: 452
COMPACTION TEST REPOR	Т
SJB SERVICES,	INC. 452

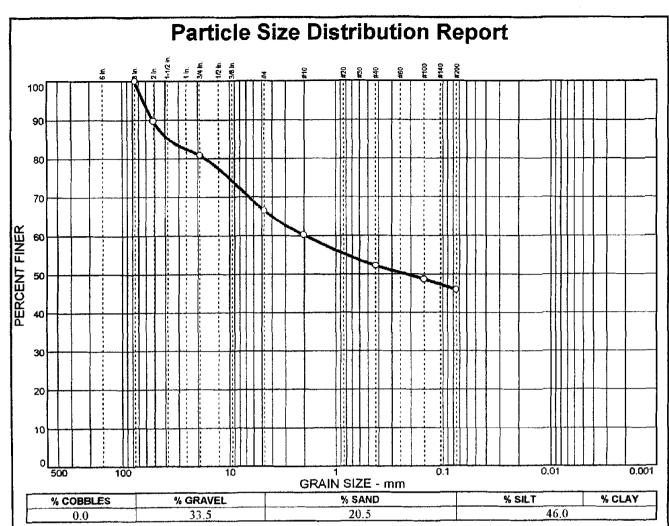
SIEVE	PERCENT	SPEC.*	PASS?
SIZE	FINER	PERCENT	(X=NO)
3 in. 2 in. 75 in. #44 #100 #200	100.0 89.7 80.8 66.5 60.2 52.2 48.7 46.0

Soil Description		
80K N98 E 8 2	Silty clayey gravel wi	th sand	
	Atterberg Limits		
PL= 17	LL= 24	PI= 7	
D <sub>85</sub> = 36.8 D <sub>30</sub> = C <sub>u</sub> =	Coefficients D60= 1.93 D15= Cc=	D <sub>50</sub> = 0.222 D <sub>10</sub> =	
USCS= GC-G	Classification  AASHI	O=	
	<b>Remarks</b>

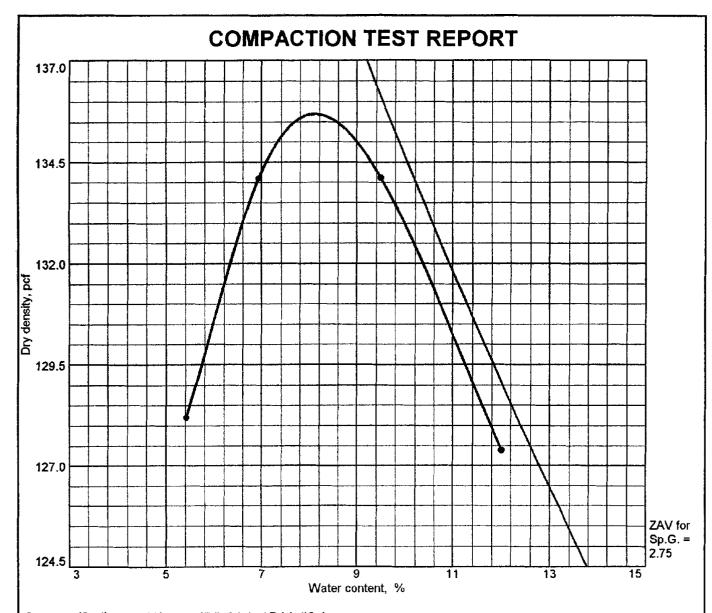
Elev/	Classification		Nat.	e- c	1 1	Pi	% >	% <
Depth	USCS	AASHTO	Moist.	Sp.G.	LL		3/4 in.	No.200
	GC-GM			2.75	25	7	27.4	42.9

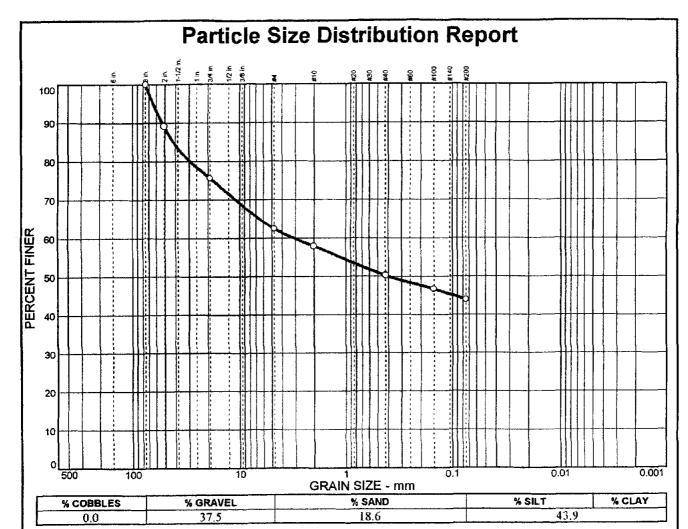
SIEVE	PERCENT	SPEC.*	PASS?
SIZE	FINER	PERCENT	(X=NO)
3 in. 2 in. 75 in. #4 #10 #40 #100 #200	100.0 89.1 75.6 62.5 57.9 50.2 46.7 43.9

Soil Description	1
90K N95 E84		
Silty clayey grav	el with sand	
PL= 17	Atterberg Limits	<u>s</u> PI= 6
D <sub>85</sub> = 41.5 D <sub>30</sub> = C <sub>u</sub> =	Coefficients D60= 3.10 D15= Cc=	D <sub>50</sub> = 0.404 D <sub>10</sub> =
USCS= GC-G	Classification  AASH	TO=
•	<b>Remarks</b>
