## CORTLAND COUNTY LANDFILL REMEDIAL ACTION LANDFILL CLOSURE

TOWNLINE ROAD CORTLAND COUNTY, NEW YORK

# CONSTRUCTION CERTIFICATION REPORT

**VOLUME I OF III**

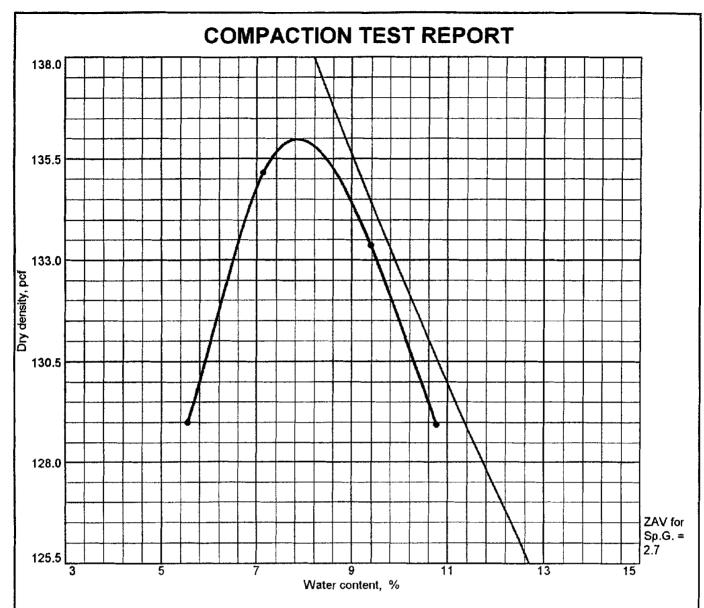
Elev/	Classification		Nat.	Sp.G.	1	PI	% >	% <
Depth	USCS	AASHTO	Moist.	3p.G.	LL	PI	3/4 in.	No.200
	GC-GM			2.7	23	6	24.4	43.9

TEST RESULTS	MATERIAL DESCRIPTION
Maximum dry density = 136.0 pcf	90K N95 E84 Silty clayey gravel with sand
Optimum moisture = 7.9 %	
Project No. 2009053 Client: Marcy Excavation	Remarks:
Project: Cortland Landfill Cover	
Source: Common Fill     Sample No.: 454	
COMPACTION TEST REPORT	
SJB SERVICES, INC.	454

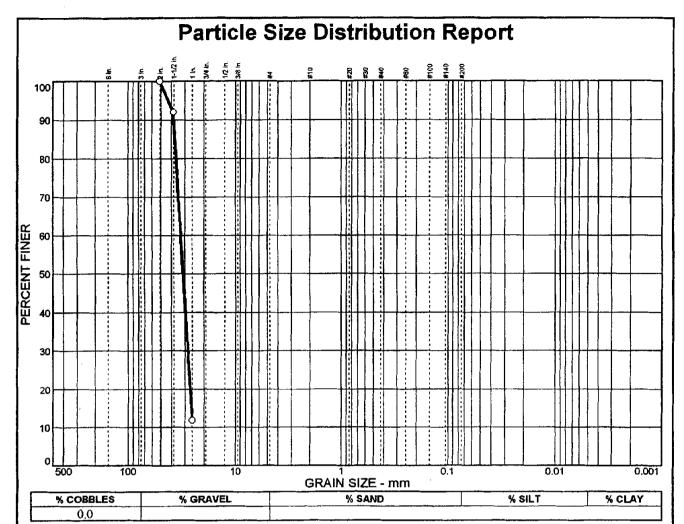
SIEVE	PERCENT	SPEC.*	PASS?
SIZE	FINER	PERCENT	(X=NO)
2 in. 1.5 in. 1 in.	100.0 92.0 11.8

Soil Description	
Gravel Aggregate	е	
PL=	Atterberg Limits	PI=
D <sub>85</sub> = 36.8 D <sub>30</sub> = 27.8 C <sub>u</sub> =	Coefficients D60= 32.4 D15= 25.8 Cc=	D <sub>50</sub> = 30.8 D <sub>10</sub> =
USCS= GP	Classification AASH	ro=
#200 Wash: 0.7%	Remarks

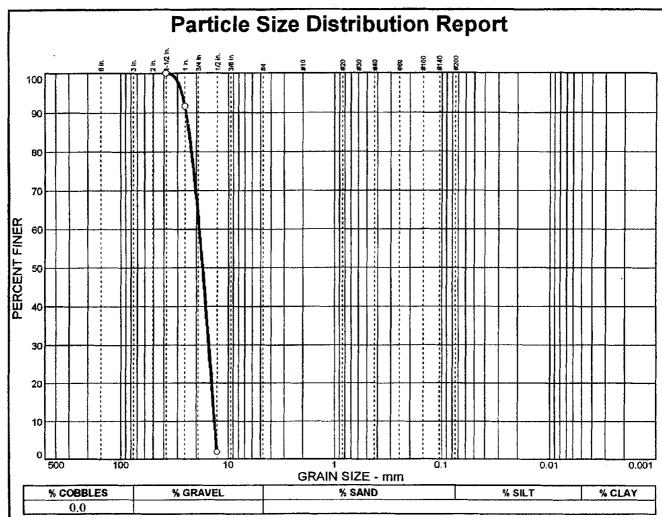
SIEVE	PERCENT	SPEC.*	PASS?
SIZE	FINER	PERCENT	(X=NO)
1.5 in. 1 in. .5 in.	100.0 91.6 1.9		[K. Ito]

Gravel Aggregat	Soil Description	
Giaron rippingar	•	
PL=	Atterberg Limits	PI=
D <sub>85</sub> = 23.2 D <sub>30</sub> = 15.1 C <sub>u</sub> = 1.39	Coefficients D60= 18.5 D15= 13.8 C <sub>C</sub> = 0.92	D <sub>50</sub> = 17.3 D <sub>10</sub> = 13.3
USCS= GP	Classification AASHT	O≃
#200 Wash: 0.39	<u>Remarks</u>

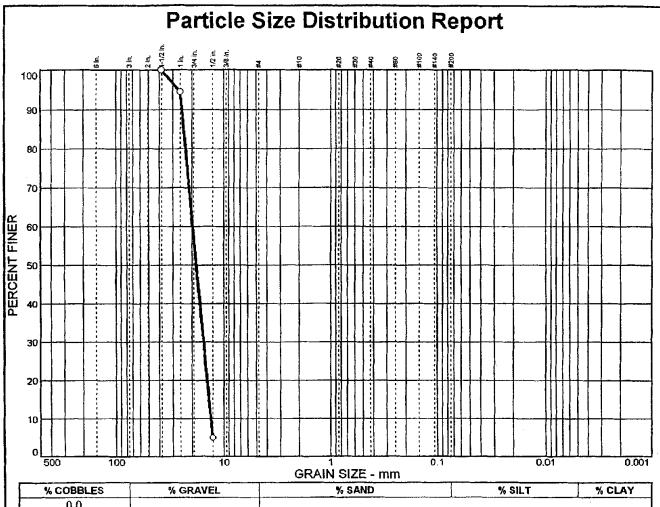
010111110100		
% COBBLES	% GRAVEL	% SAND	% SILT	% CLAY
0.0

SIEVE	PERCENT	SPEC.*	PASS?
SIZE	FINER	PERCENT	(X=NO)
1.5 in. 1 in. .5 in.	100.0 94.5 5.0		ĮX KGJ
•

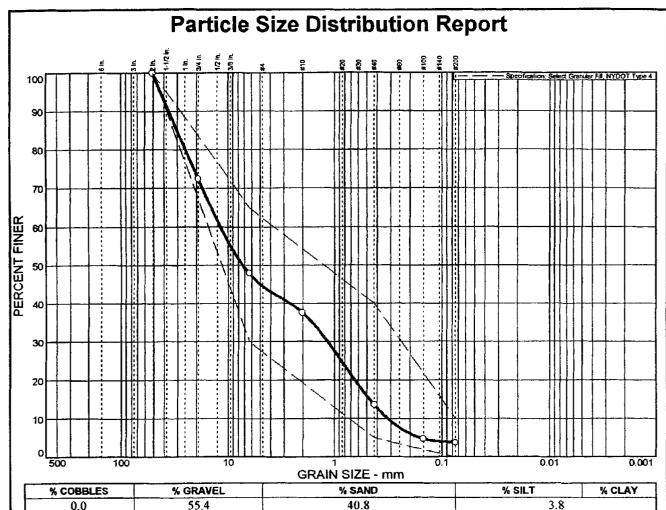
Granular Fill Prequalification Test Results

SIEVE	PERCENT	SPEC.*	PASS?
SIZE	FINER	PERCENT	(X=NO)
2 in. .75 in. .25 in. #10 #40 #100 #200	100.0 72.4 47.9 37.6 13.6 4 8 3 8	100 - 100.0 30.0 - 65.0 5.0 - 40.0 0.0 - 10.0	
Select	Granular Fill NY	DOT Type 4

Soil Description  Granular Fill  Poorly graded gravel with sand				
PL=	Atterberg Limits LL=	PI=		
D <sub>85</sub> = 30.0 D <sub>30</sub> = 1.16 C <sub>u</sub> = 37.31	D <sub>60</sub> = 11.8 D <sub>15</sub> = 0.469 C <sub>c</sub> = 0.36	D <sub>50</sub> = 7.27 D <sub>10</sub> = 0.316		
USC\$= GP	Classification AASHT	*O=		
Granular Fill	Remarks

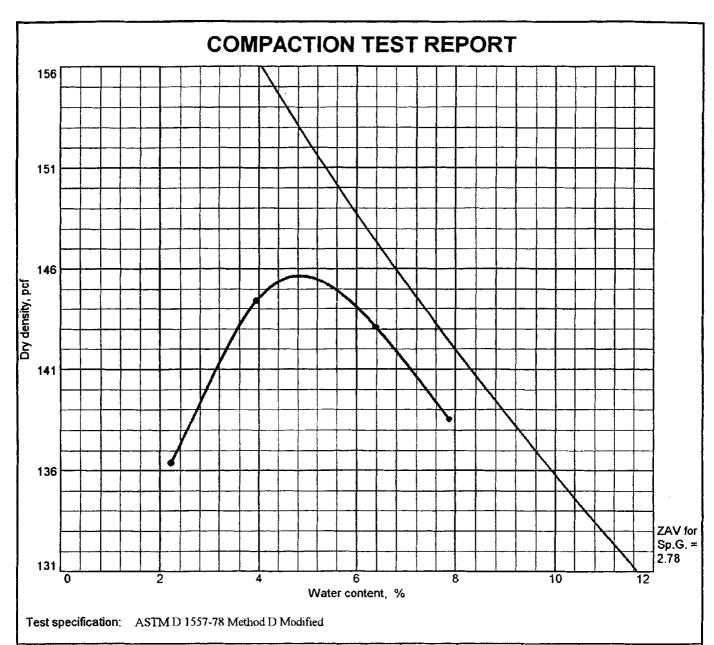
Elev/	Classi	fication	Nat.	l Sp.G. l	Nat.	0-0	% >	% <
Depth	USCS	AASHTO	Moist.		LL	PI	3/4 in.	No.200
	GP						27.6	3.8
1		1	1

TEST RESULTS	MATERIAL DESCRIPTION
Maximum dry density = 145.6 pcf	Granular Fill Poorly graded gravel with sand
Optimum moisture = 4.8 %	
Project No. 2009053 Client: Marcy Excavation	Remarks:
Project: Cortland Landfill Cover	
Location: Suite Kote	
COMPACTION TEST REPORT	
SJB SERVICES, INC	Plate
