RE: Response to NYSDEC Comments
2011 PCB Pollutant Minimization Plan (PMP) Annual Report
SPDES Permit No. NY0001163

Response to NYSDEC Comments Made on March 22, 2012
RE: 2011 Annual PMP Report, February 1, 2012

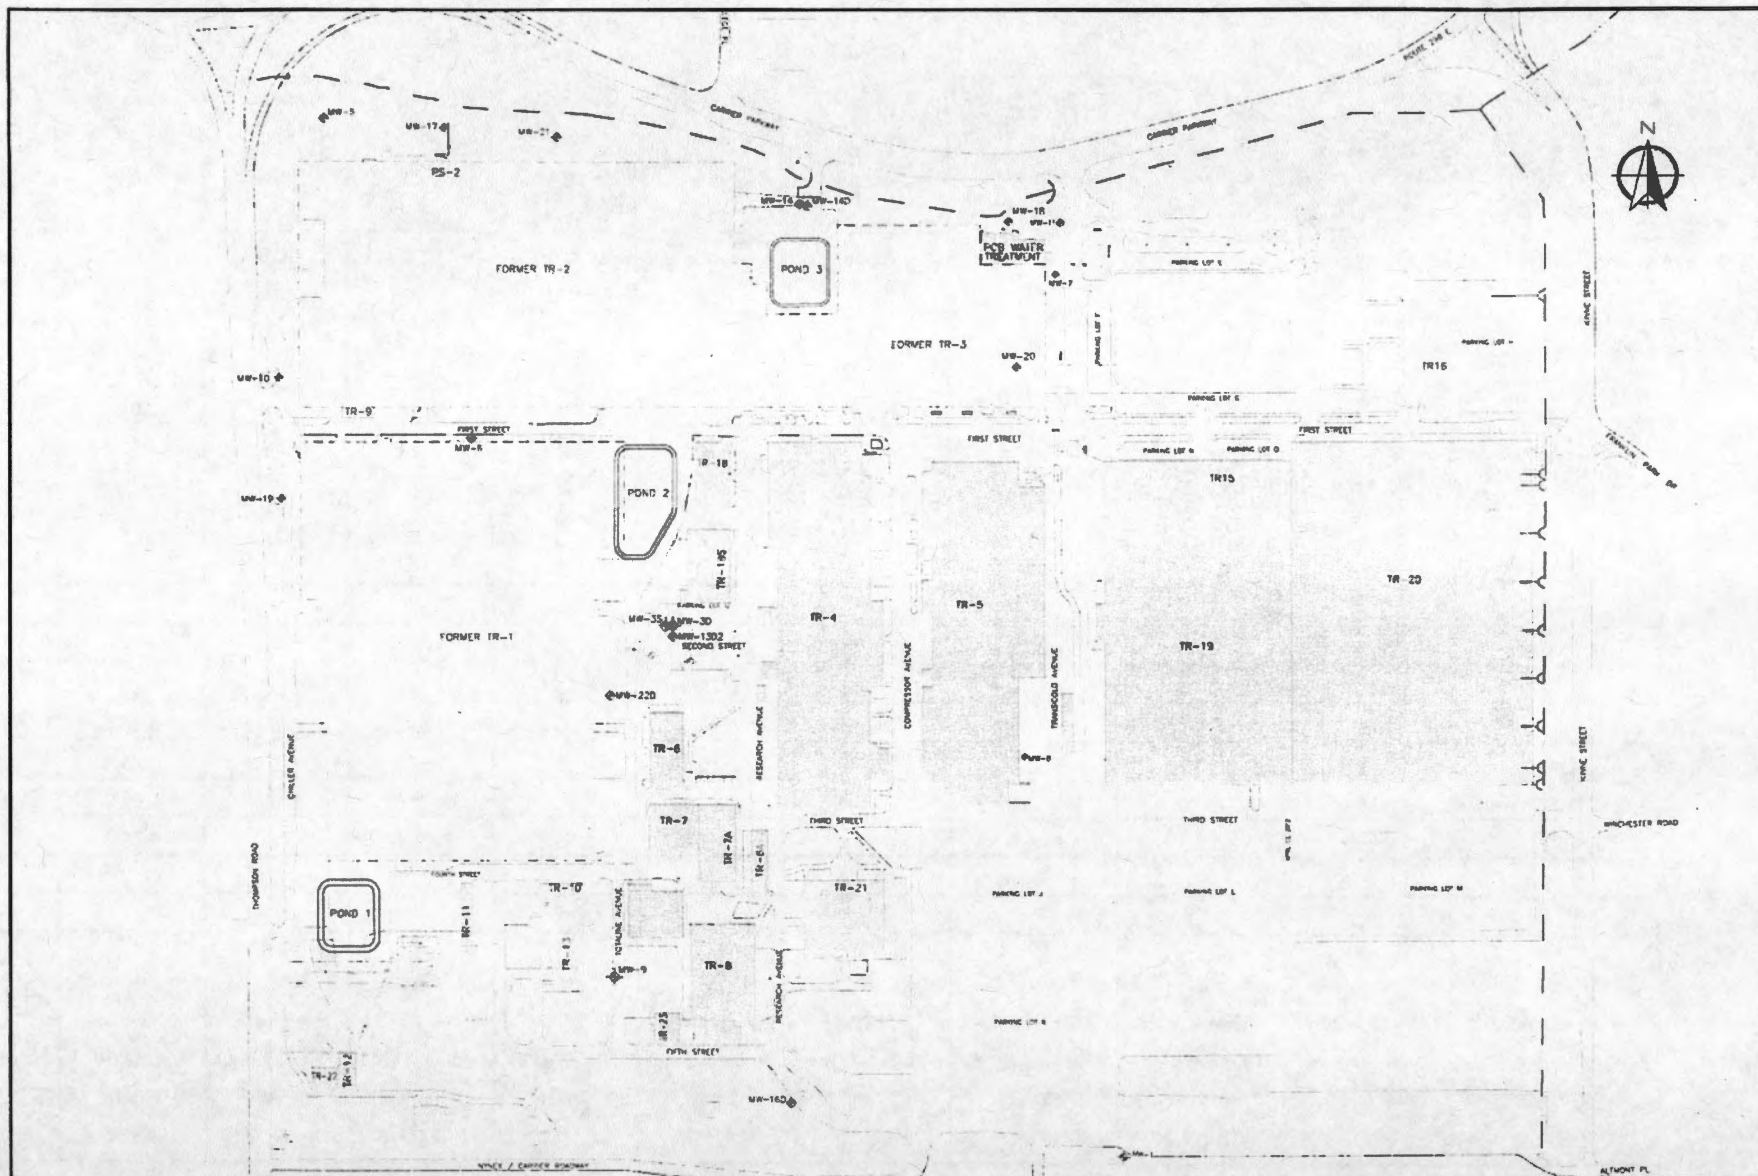
ELEVATIONS REFERRED TO CITY OF SYRACUSE DATUM
ADD 362.00 FEET TO OBTAIN USGS DATUM OF 1929
BENCHMARKS (NOT SHOWN)
BM 164 (ELEV.=42.68)
IRON BOLT AT NORTHEAST CORNER OF CONCRETE SLAB,
APPROX. 80 FEET NORTH AND APPROX. 30 FEET EAST
OF THE SOUTHEAST CORNER OF BUILDING TR-4
BM 500 (ELEV.=44.87)
CHISELED CROSS ON EAST NUT OF POSITION INDICATION
VALVE, APPROX. 75 FEET NORTHWEST OF THE
SOUTHWEST CORNER OF BUILDING TR-7 AND APPROX
90 FEET NORTHEAST OF THE SOUTHEAST CORNER OF
BUILDING TR-1.
