Prepared For: United Technologies Corp. Shared Remediation Services Farmington, CT Prepared by: AECOM Latham, NY 60340856 January 2016

SANDERS CREEK UTC/CARRIER SITE THOMPSON ROAD, SYRACUSE, NY Sampling and Analysis Plan

Corrective Action Order - Index CO 7-20051118-4 NYSDEC Site Registry #734043

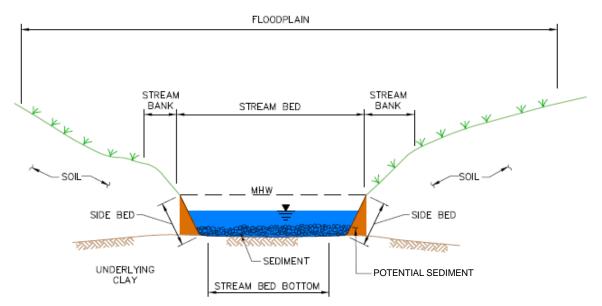
Conceptual Site Model Cross-Section

- Potential Sediment For purposes of this SAP, the potential sediment cross-sectional area is defined by the vertical line drawn from MHW down to underlying clay, the horizontal line along the top of the underlying clay to the toe-of-slope of the side bed and along the slope of the side bed back to the MHW. As depicted below, this cross-sectional area is triangular in shape and consists of material that falls within the stream bed, below MHW down to the underlying clay. The degree to which this material is actually sediment depends on its composition which will be assessed during upcoming sampling activities. The presence of sediment will be assessed by advancing a sampler 2 feet into the bank, perpendicular to the Side Bed. Materials will be logged and classified by a New York State-licensed geologist.

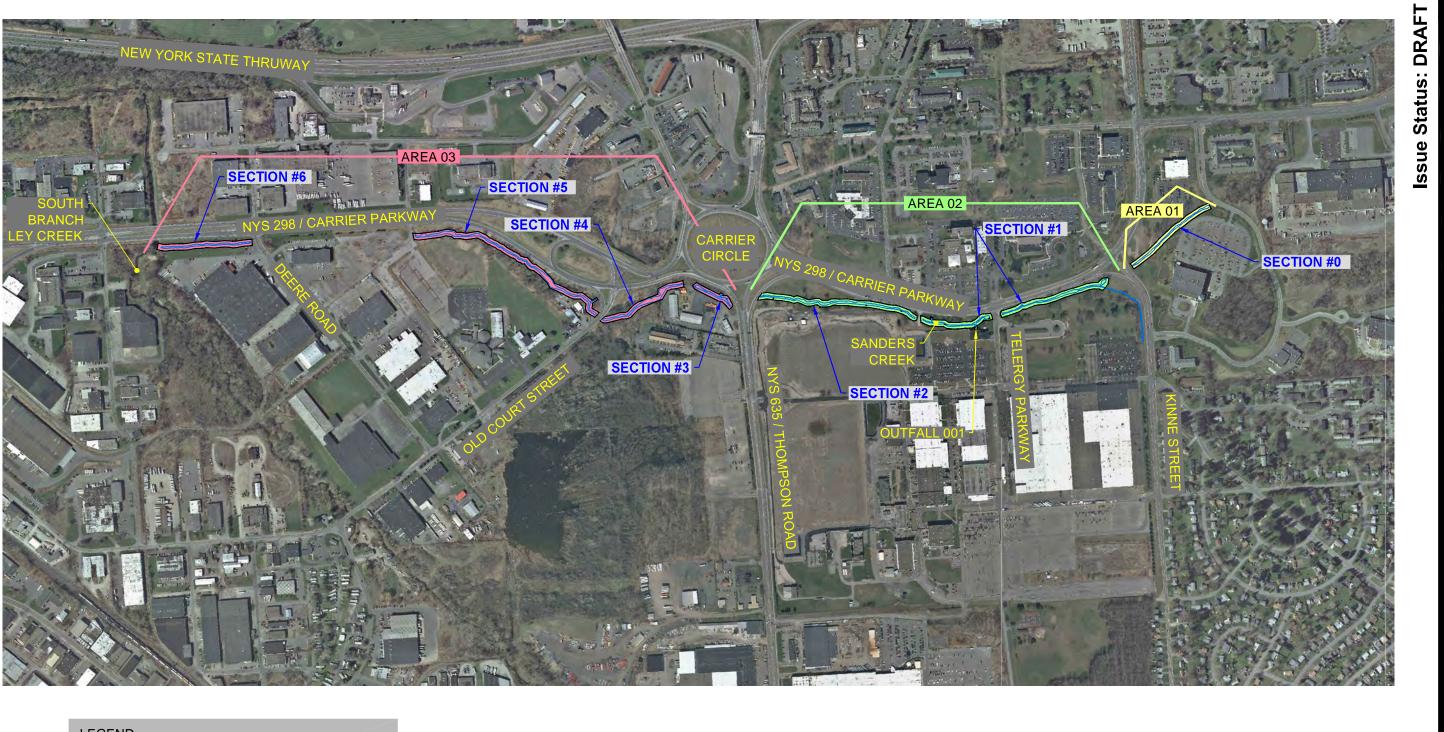
ATCOM Figure: 2.3

SANDERS CREEK INVESTIGATION AREAS

The Site is located in the Town of DeWitt, Onondaga County, New York, approximately 1 mile south of the New York State Thruway (**Figure 2.1**). Sanders Creek runs westward for approximately 8,900 feet (ft.) from New Venture Gear Drive northeast of the Carrier facility to the confluence with South Branch of Ley Creek (**Figure 2.2**). The portions of Sanders Creek that define the Site and an upgradient/background section have been described in terms of Sections. These conventions are explained below and shown on **Figure 2.3**.

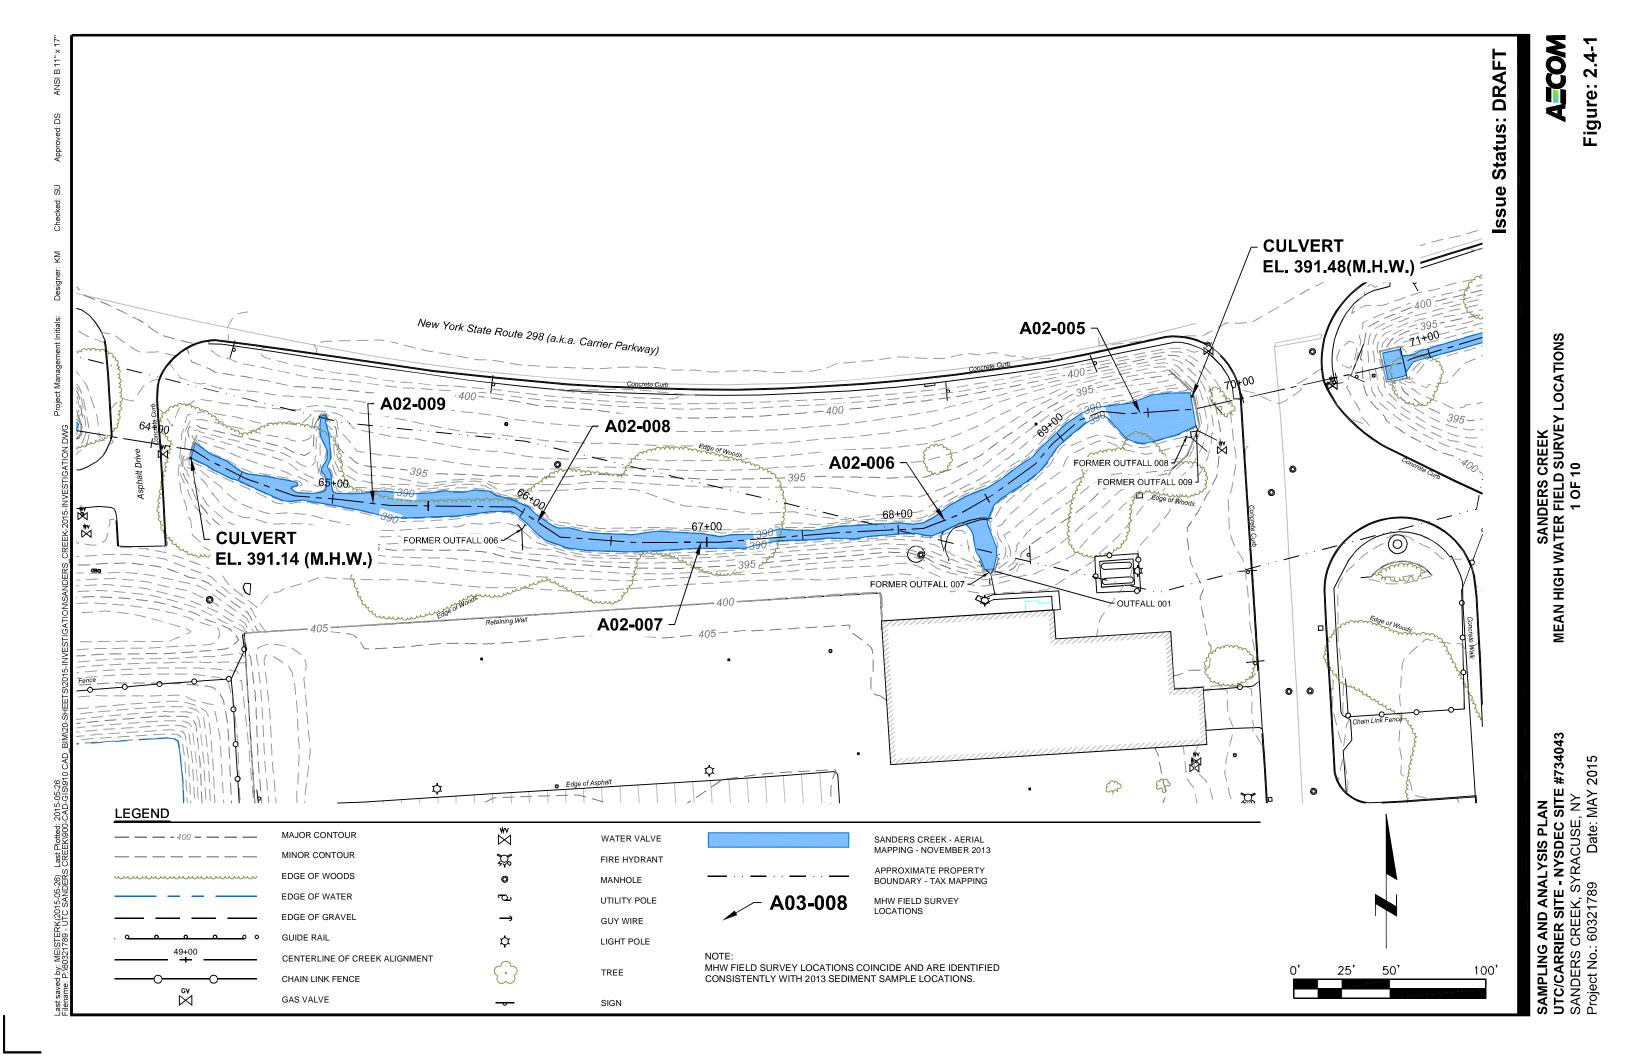
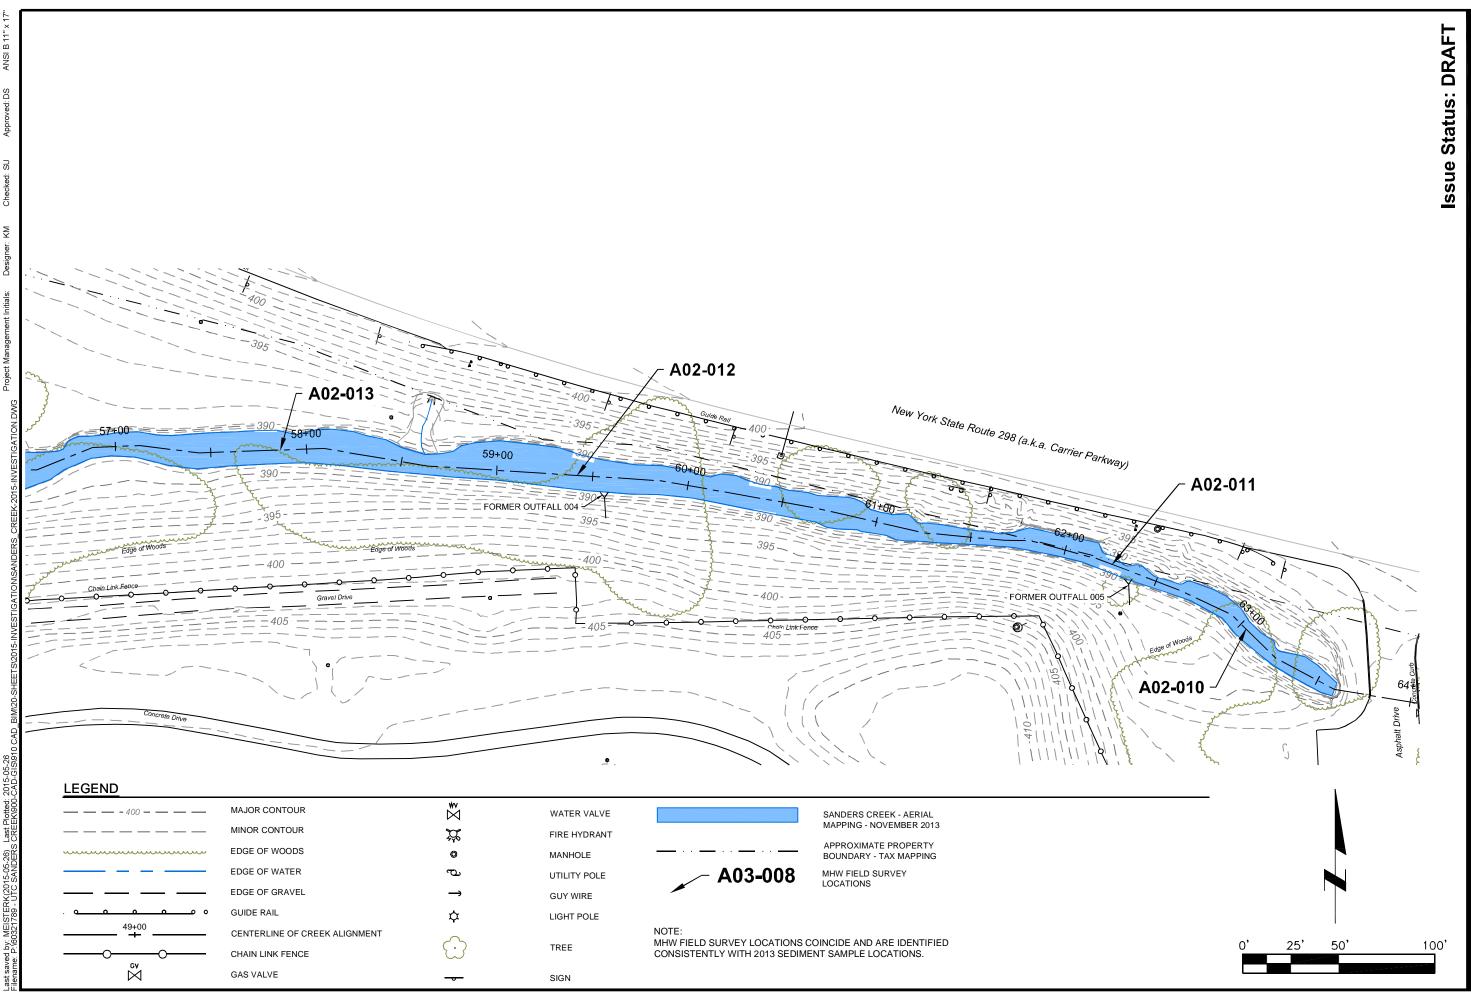
SANDERS CREEK MEAN HIGH WATER FIELD SURVEY LOCATIONS 2 OF 10

The survey was conducted during relatively low flow conditions at the end of a descending limb of a recent rain event as monitored at the United States Geological Survey (USGS) station on Ley Creek. Flow was measured in Sanders Creek each of the two days (2.8 cubic feet per second [cfs] and 1.7 cfs, respectively). At each transect (located by global positioning system [GPS]), both edges of the stream and the MHW were marked and surveyed. The depth to clay was determined at one or both edges of the stream. Measuring the depth of clay at the edge of the stream allowed a visual assessment of the surface material and for GPS survey, as well as improving sample recovery from the core, all of which are made more difficult by standing in turbid water as was present in the middle of the stream. Other ancillary measurements were taken (i.e., stream depth and width, width at MHW, and height of adjacent bank). The MHW was also marked and surveyed at each culvert. The MHW survey locations are presented on **Figures 2.4-1 through 2.4-10** and MHW survey results are shown graphically on **Figure 2.5**.

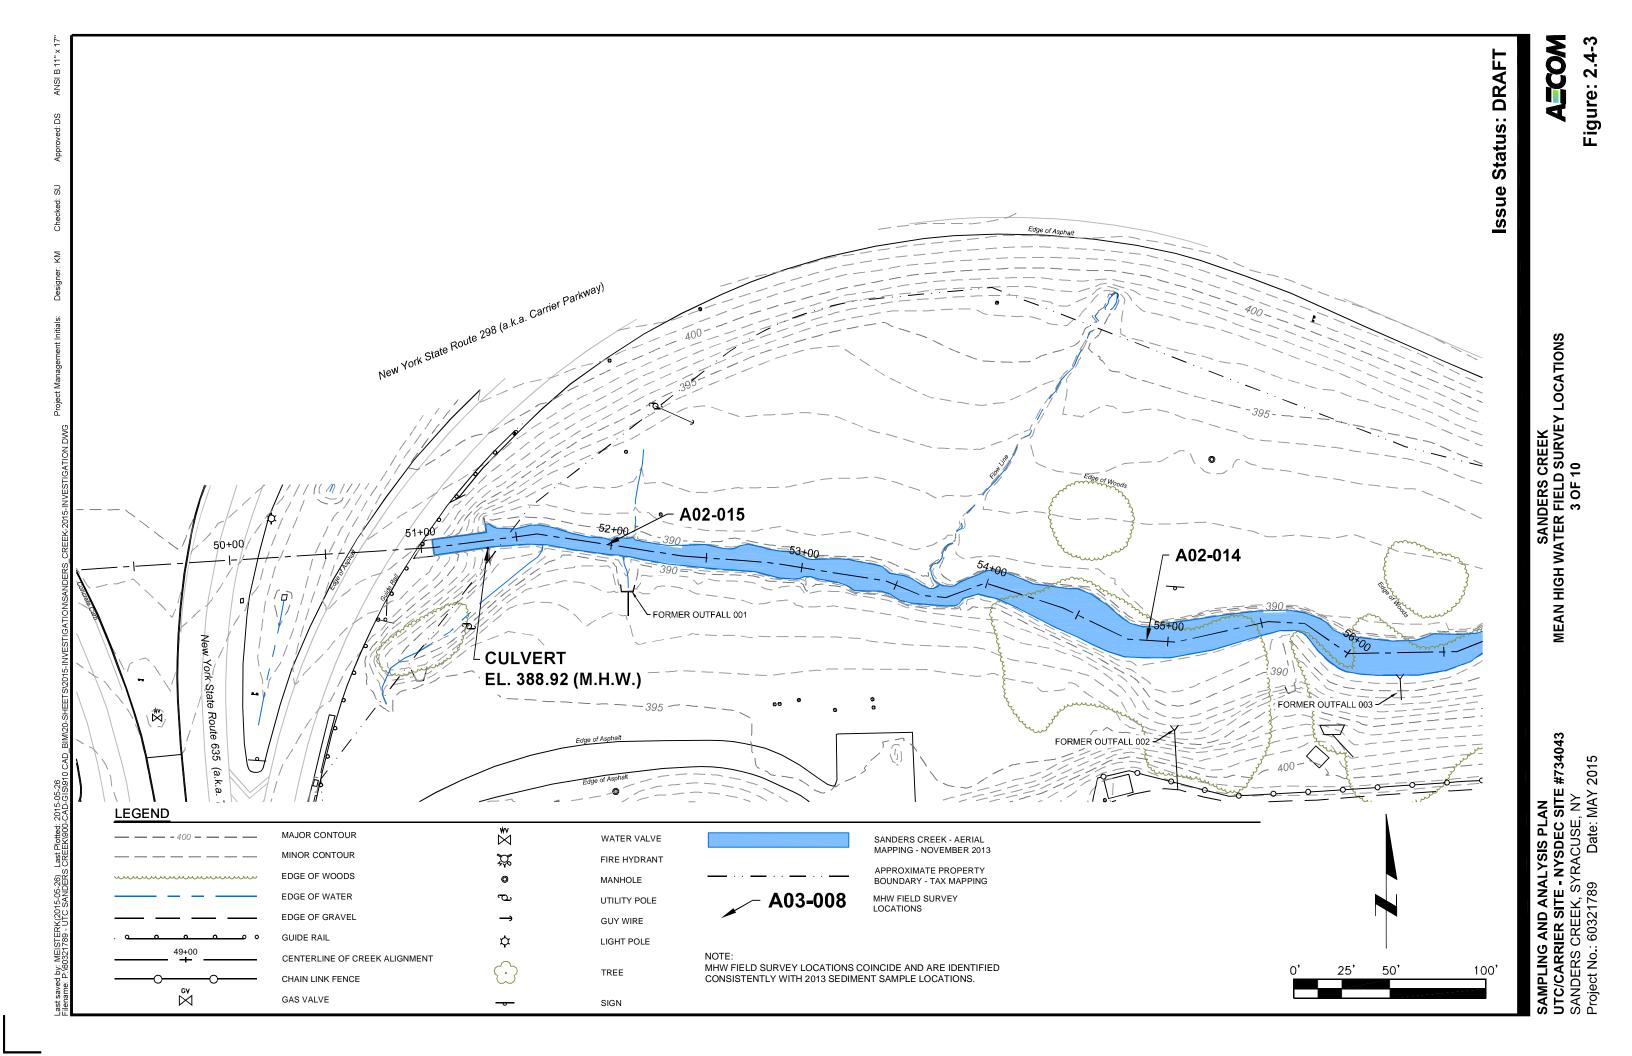
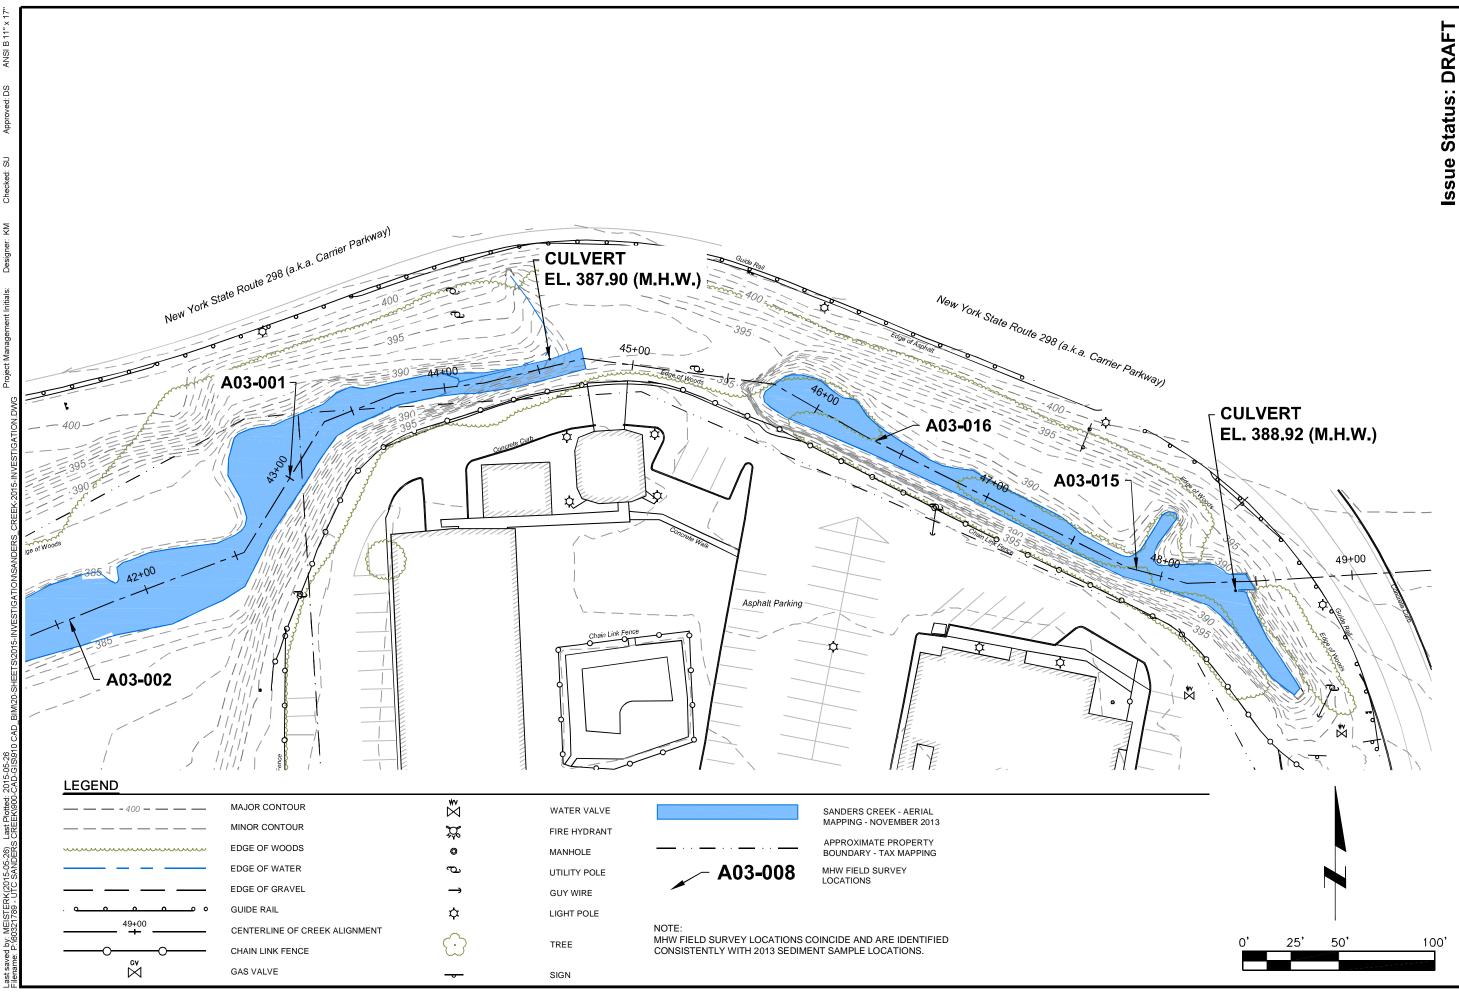
SANDERS CREEK MEAN HIGH WATER FIELD SURVEY LOCATIONS 4 OF 10

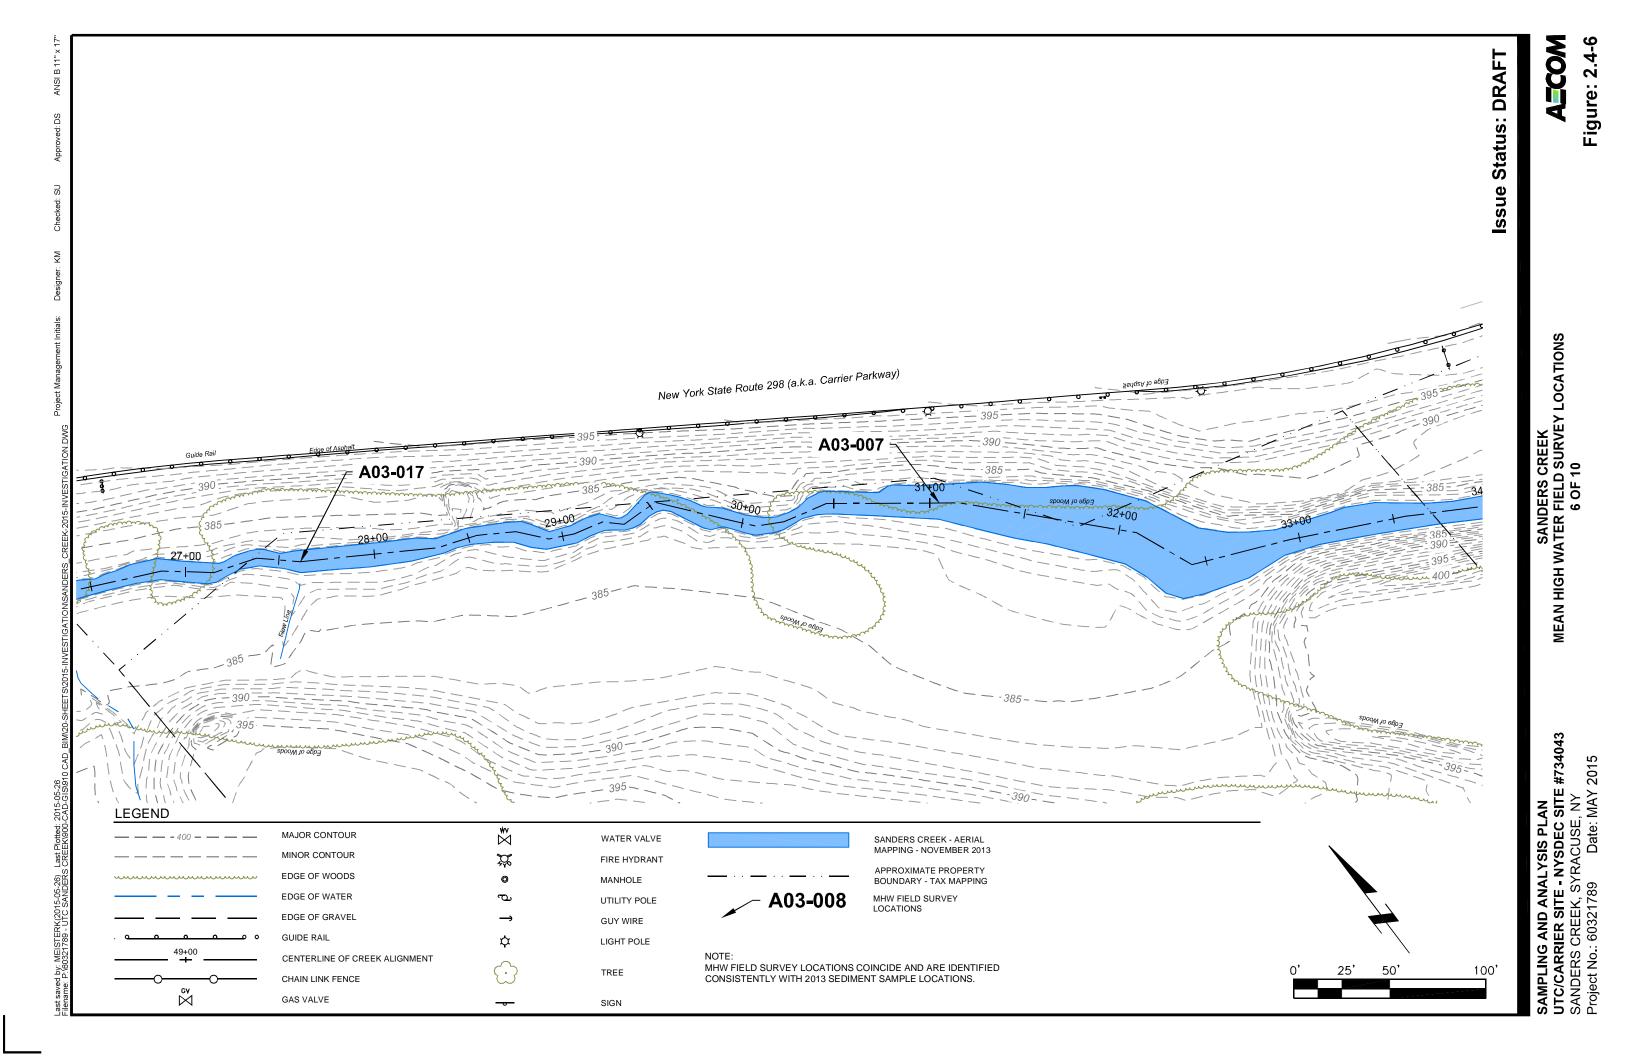
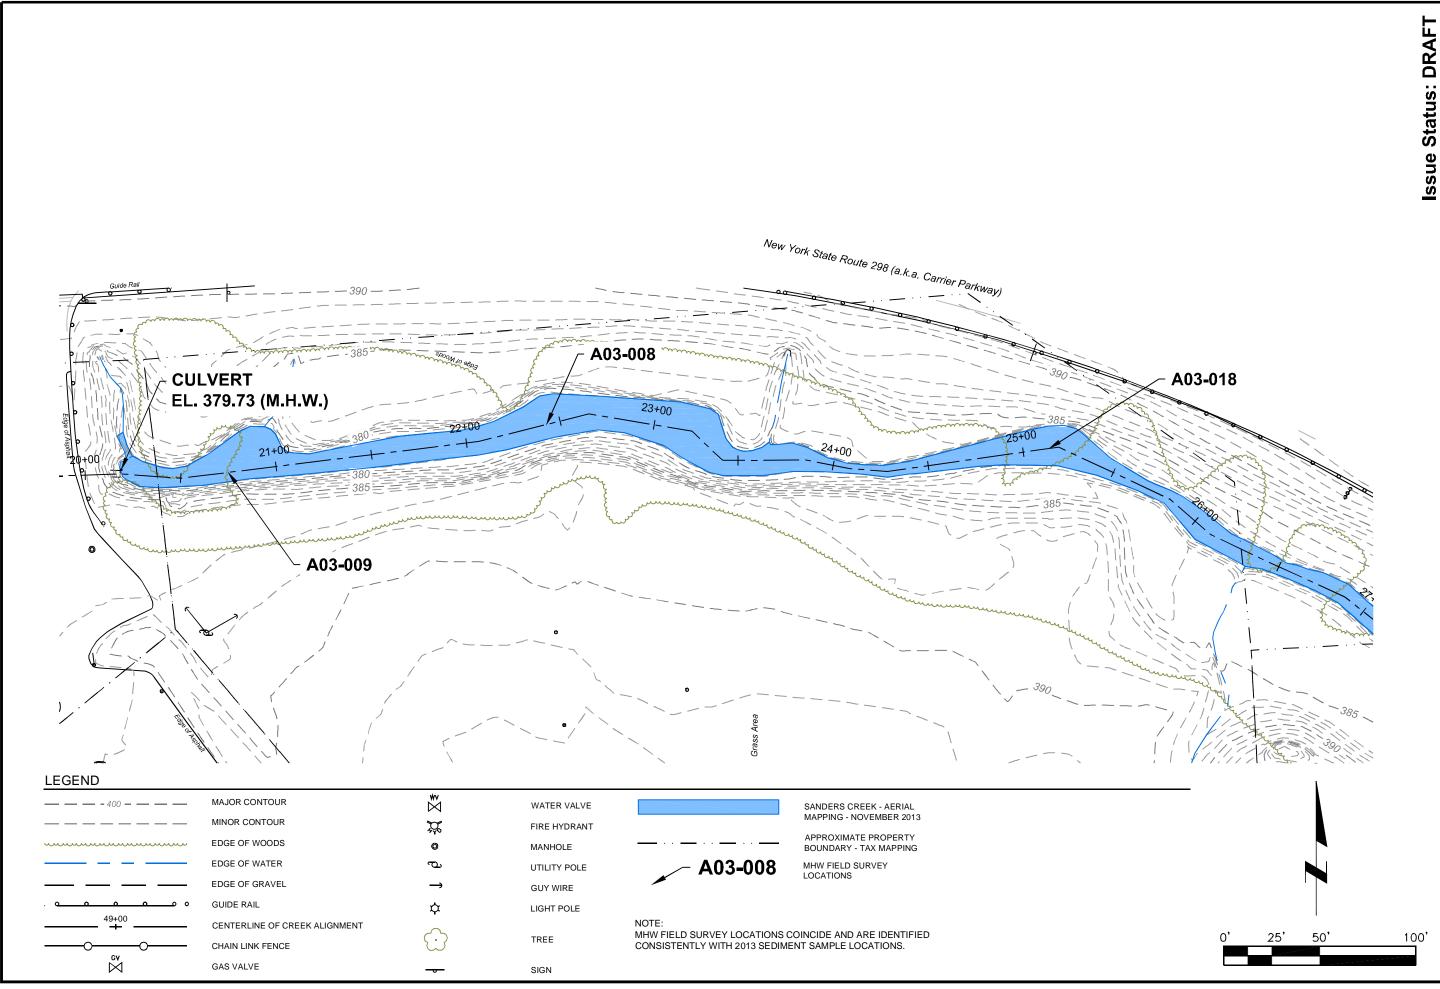
SANDERS CREEK MEAN HIGH WATER FIELD SURVEY LOCATIONS 7 OF 10

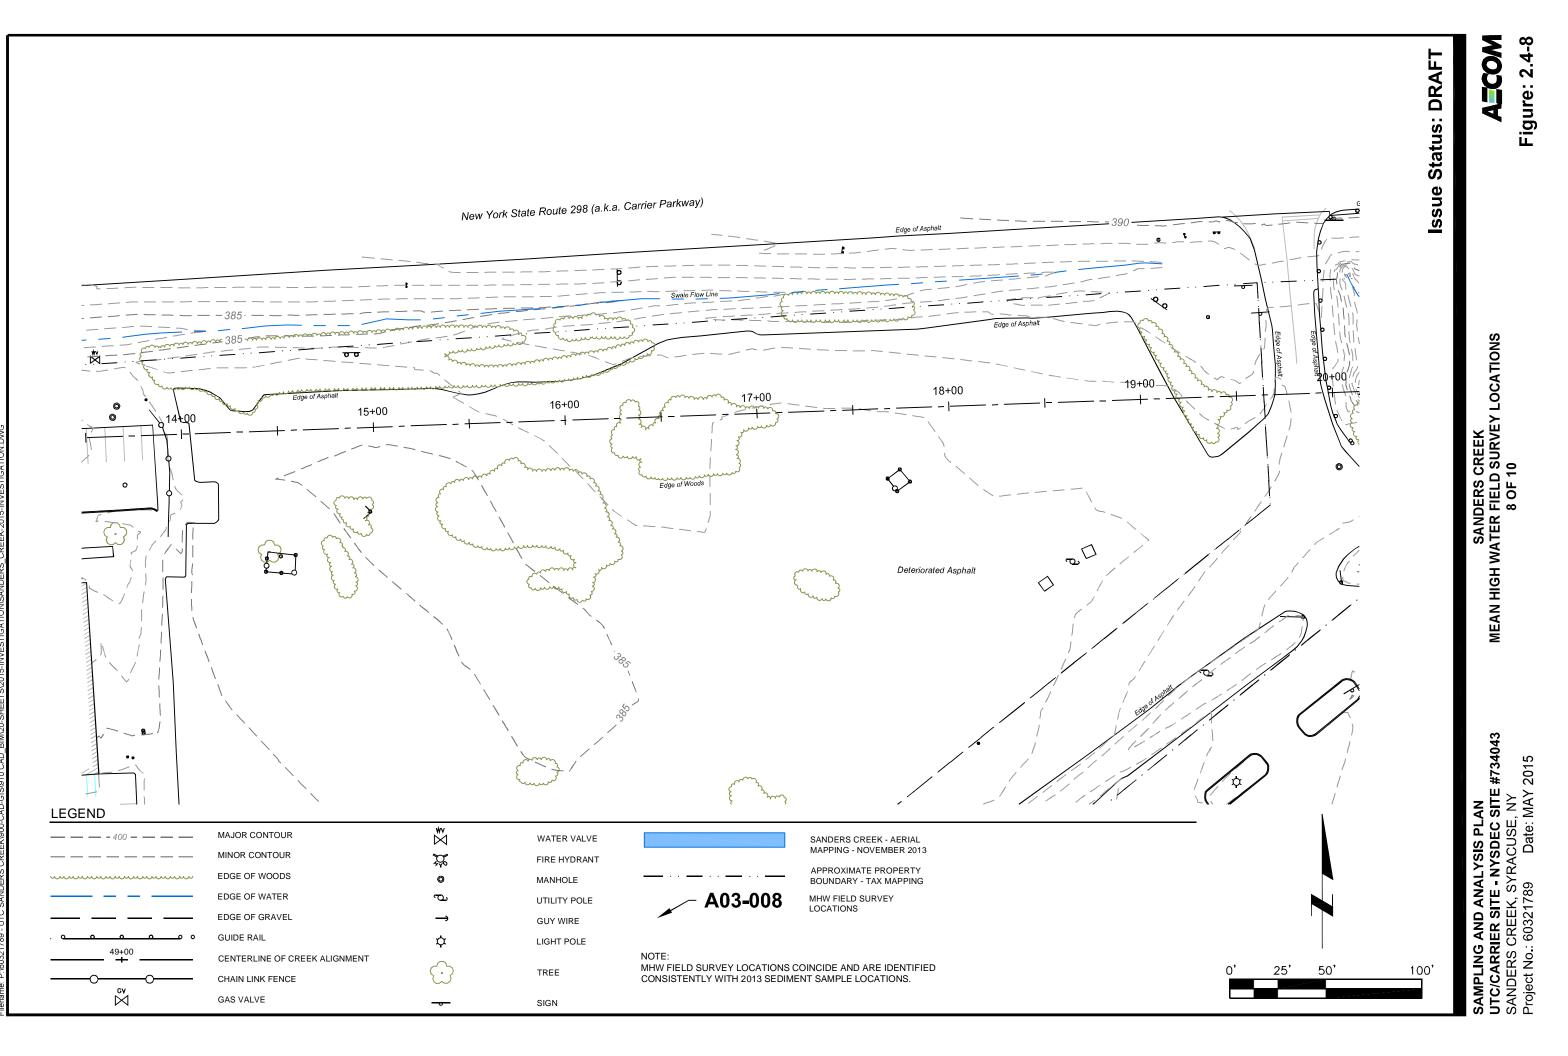
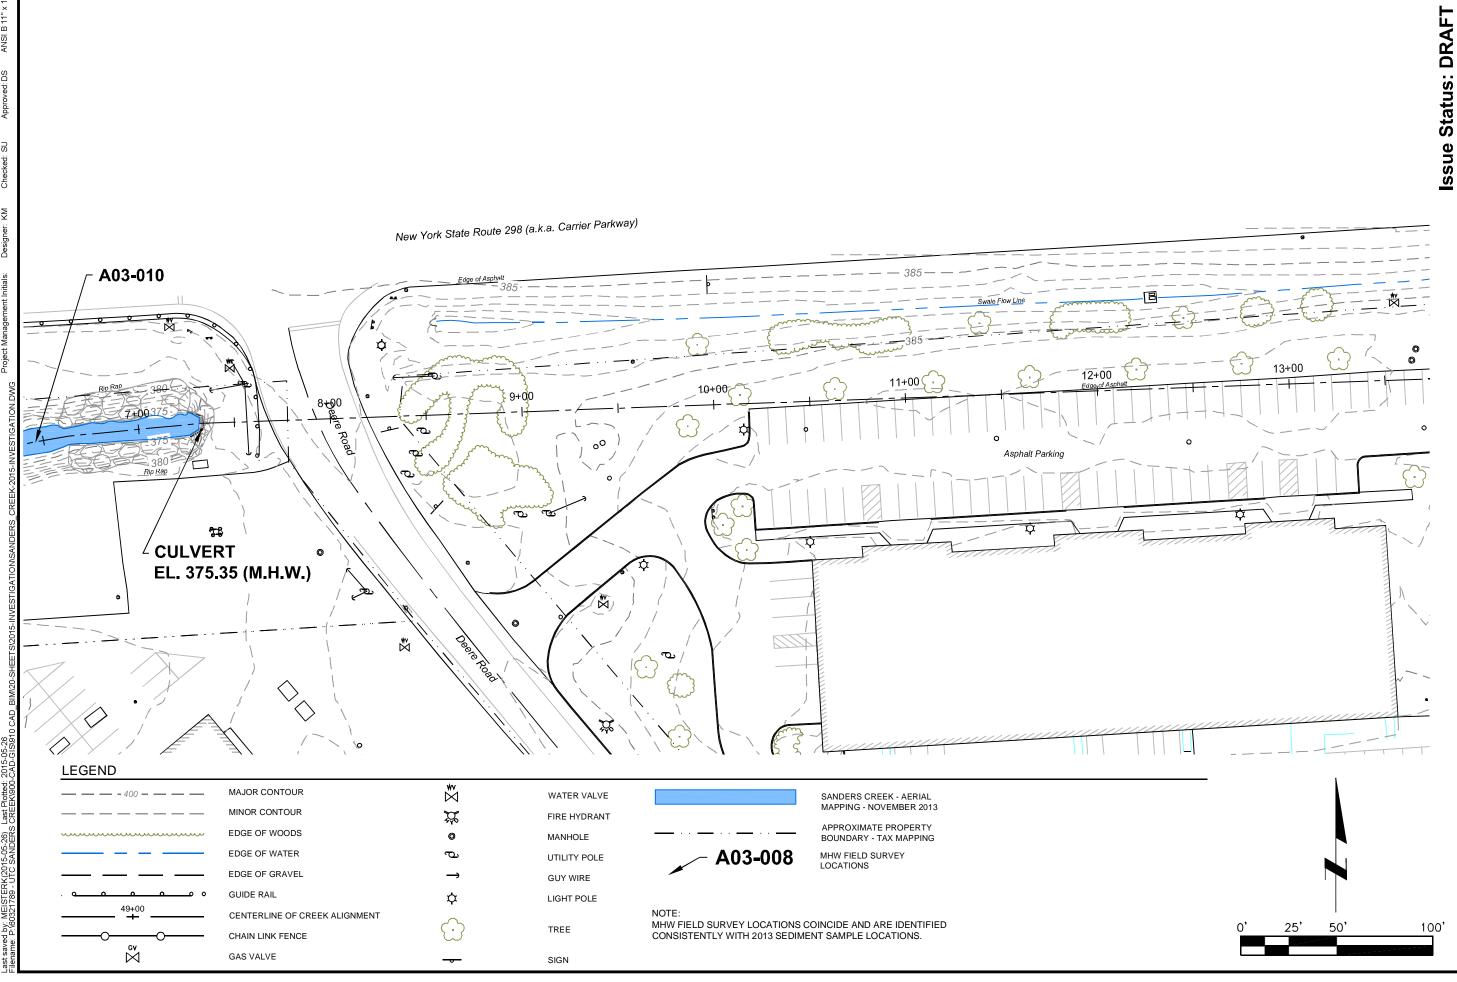
SANDERS CREEK MEAN HIGH WATER FIELD SURVEY LOCATIONS 9 OF 10

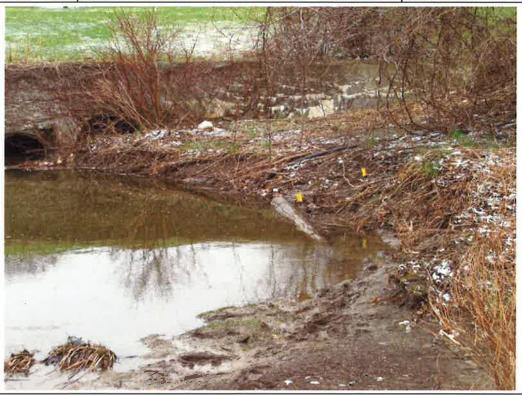
Photo No. 2 Date: 4/23/15 Direction Photo Taken: Downstream

Transect A02-005 b. Lower yellow pin flag at current water elevation; upper yellow pin flag at MHW. Stake with blue flag shows historical sediment sample location. Bankfull bench and undercut banks in distance.

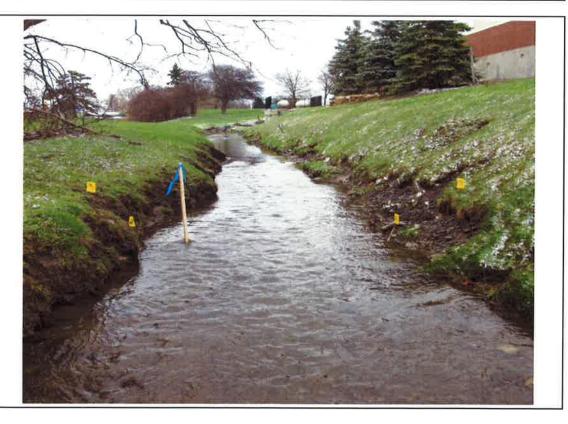
Photo No.Date:44/23/15Direction PhotoTaken:Upstream

Transect A02-007. Two lower yellow pin flags at current water elevation; 2 upper yellow pin flags at MHW. Stake with blue flag shows historical sediment sample location.

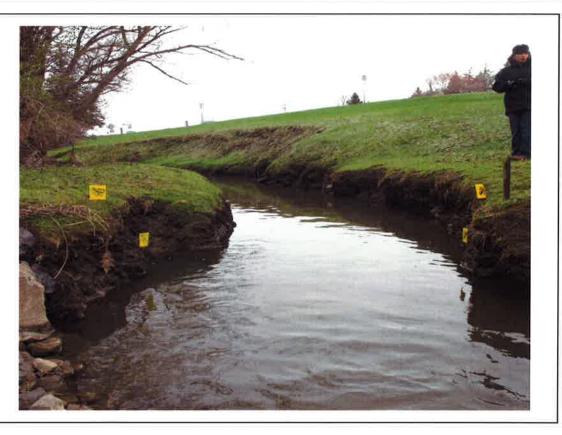
Photo No.Date:64/23/15Direction PhotoTaken:Downstream

Transect A02-008 Two lower yellow pin flags at current water elevation; 2 upper yellow pin flags at MHW.

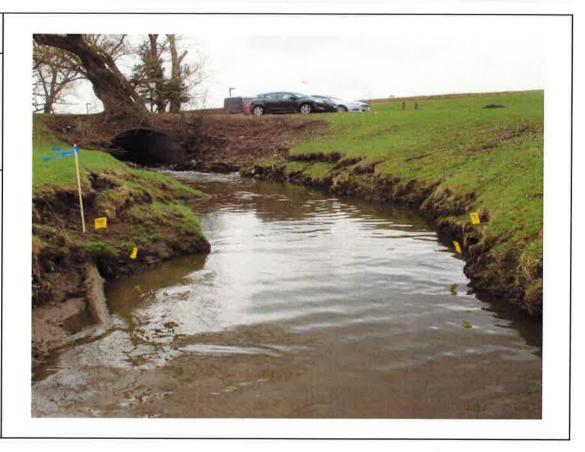
Photo No.

Transect A02-010. Two lower yellow pin flags at current water elevation; 2 upper yellow pin flags at MHW. Stake with blue flag shows historical sediment sample location. Shows upper bank collapsed (left and background) into area below MHW due to undercutting erosion.

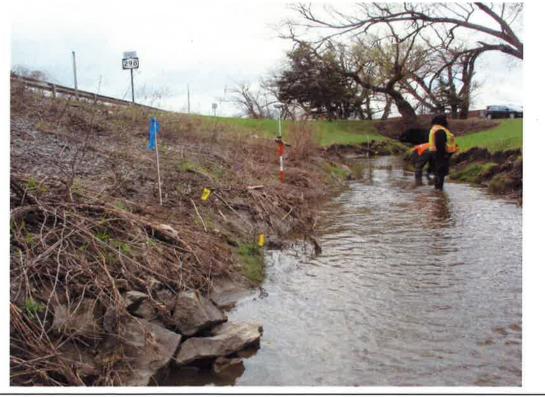
Photo No.
10Date:
4/23/15Direction Photo
Taken:
Upstream

Transect A02-011 b. North bank. Lower yellow pin flag at current water elevation; Upper yellow pin flag at MHW. Stake with blue flag shows historical sediment sample location.

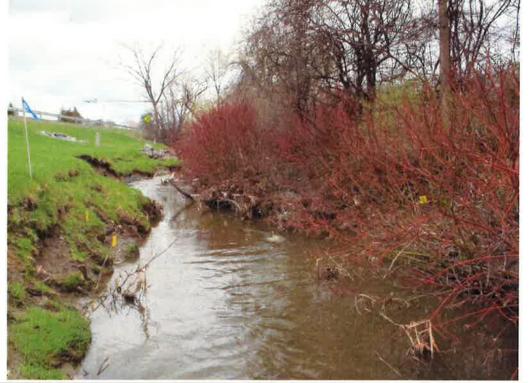
Transect A02-013. Two lower yellow pin flags at current water elevation; 2 upper yellow pin flags at MHW. Stake with blue flag shows historical sediment sample location. Shows upper bank collapsed (left) into area below MHW due to undercutting erosion.

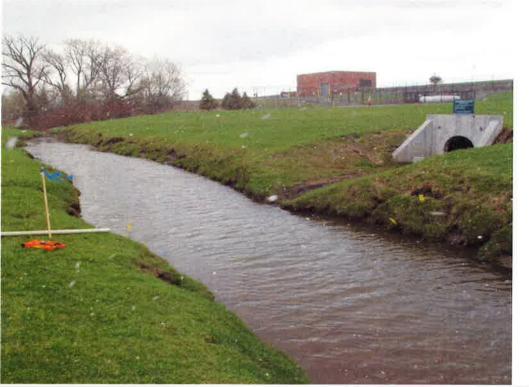
Transect A02-015 a.
Lower yellow pin flag at
current water elevation;
Upper yellow pin flag at
MHW. Stake with blue
flag shows historical
sediment sample
location. Left pin flags
not visible.

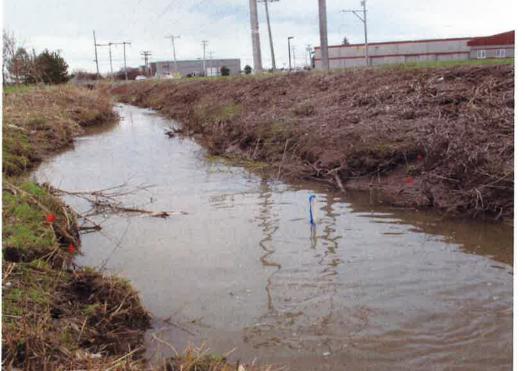
Transect A03-011. Two lower orange pin flags at current water elevation; 2 upper orange pin flags at MHW. Stake with blue flag shows historical sediment sample location. Note slumping of undercut bank (left).

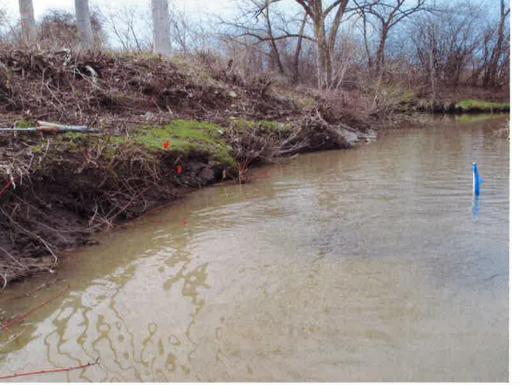
Transect A03-013 left bank. . Lower orange pin flags at current water elevation; upper orange pin flag at MHW. Stake with blue flag shows historical sediment sample location. Near confluence with Ley Creek

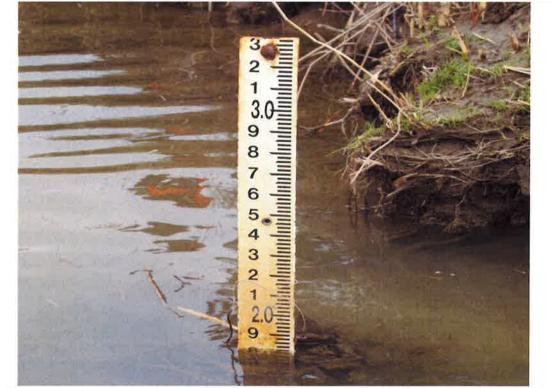
A03-013 Staff Gage wide view showing bank context.

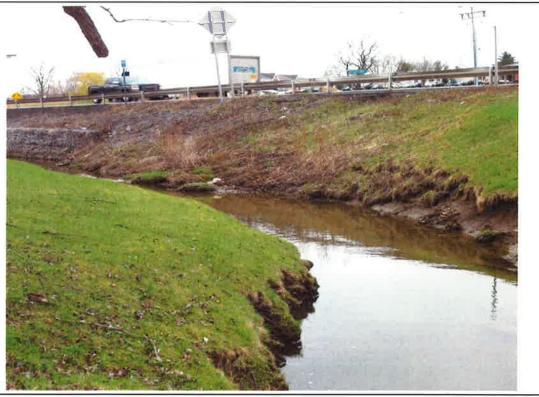
Photo No.Date:424/23/15Direction PhotoTaken:Downstream

Sanders Creek @ Gabion 1- showing grass sod collapsed from undermining at the MHW level

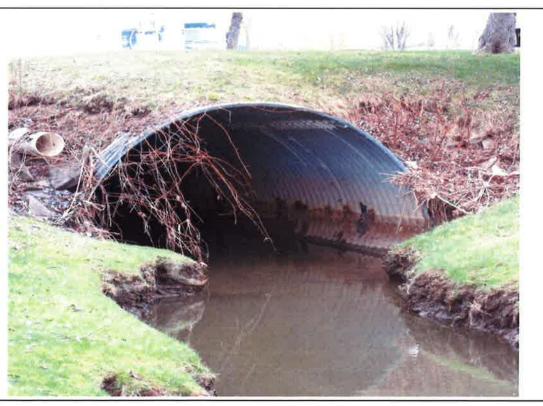
Photo No.Date:464/23/15Direction PhotoTaken:Downstream

UTC Culvert @ pulloff Upstream MHW staining inside culvert. MHW just above bankfull on left and right banks.

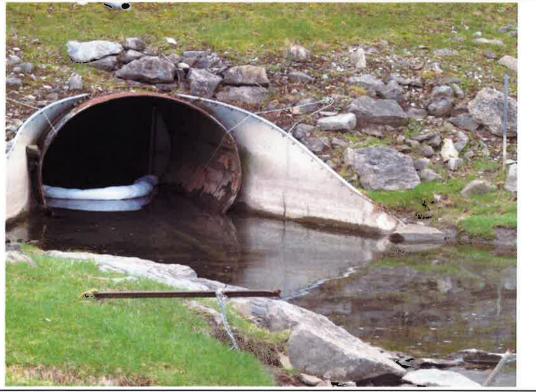
Photo No.Date:564/23/15Direction PhotoTaken:Upstream into outfall.Description:

UTC Outfall 1 Shows boom in place and MHW staining on culvert walls approximately ½ pipe height.
