Re: Annual Landfill Inspection Report (Year 22)  
Syracuse China Landfill  
Town of Salina, Onondaga County, New York  
NYSDEC Site Number 7-34-053

Rocterra, LLC (Rocterra), on behalf of TPC-York Inc. (TPC-York), has prepared this letter report to summarize the required monitoring and maintenance activities completed at the Syracuse China Landfill site located in the Town of Salina, Onondaga County, New York (Site No. 7-34-053). In accordance with New York State Department of Environmental Conservation (NYSDEC) requirements, activities for the twenty second year of Operation, Monitoring and Maintenance (OM&M) were performed at the site. In accordance with the OM&M Plan prepared by Remedial Engineering, PC dated September 25, 2003 and the schedule approved by NYSDEC, the following activities were performed:

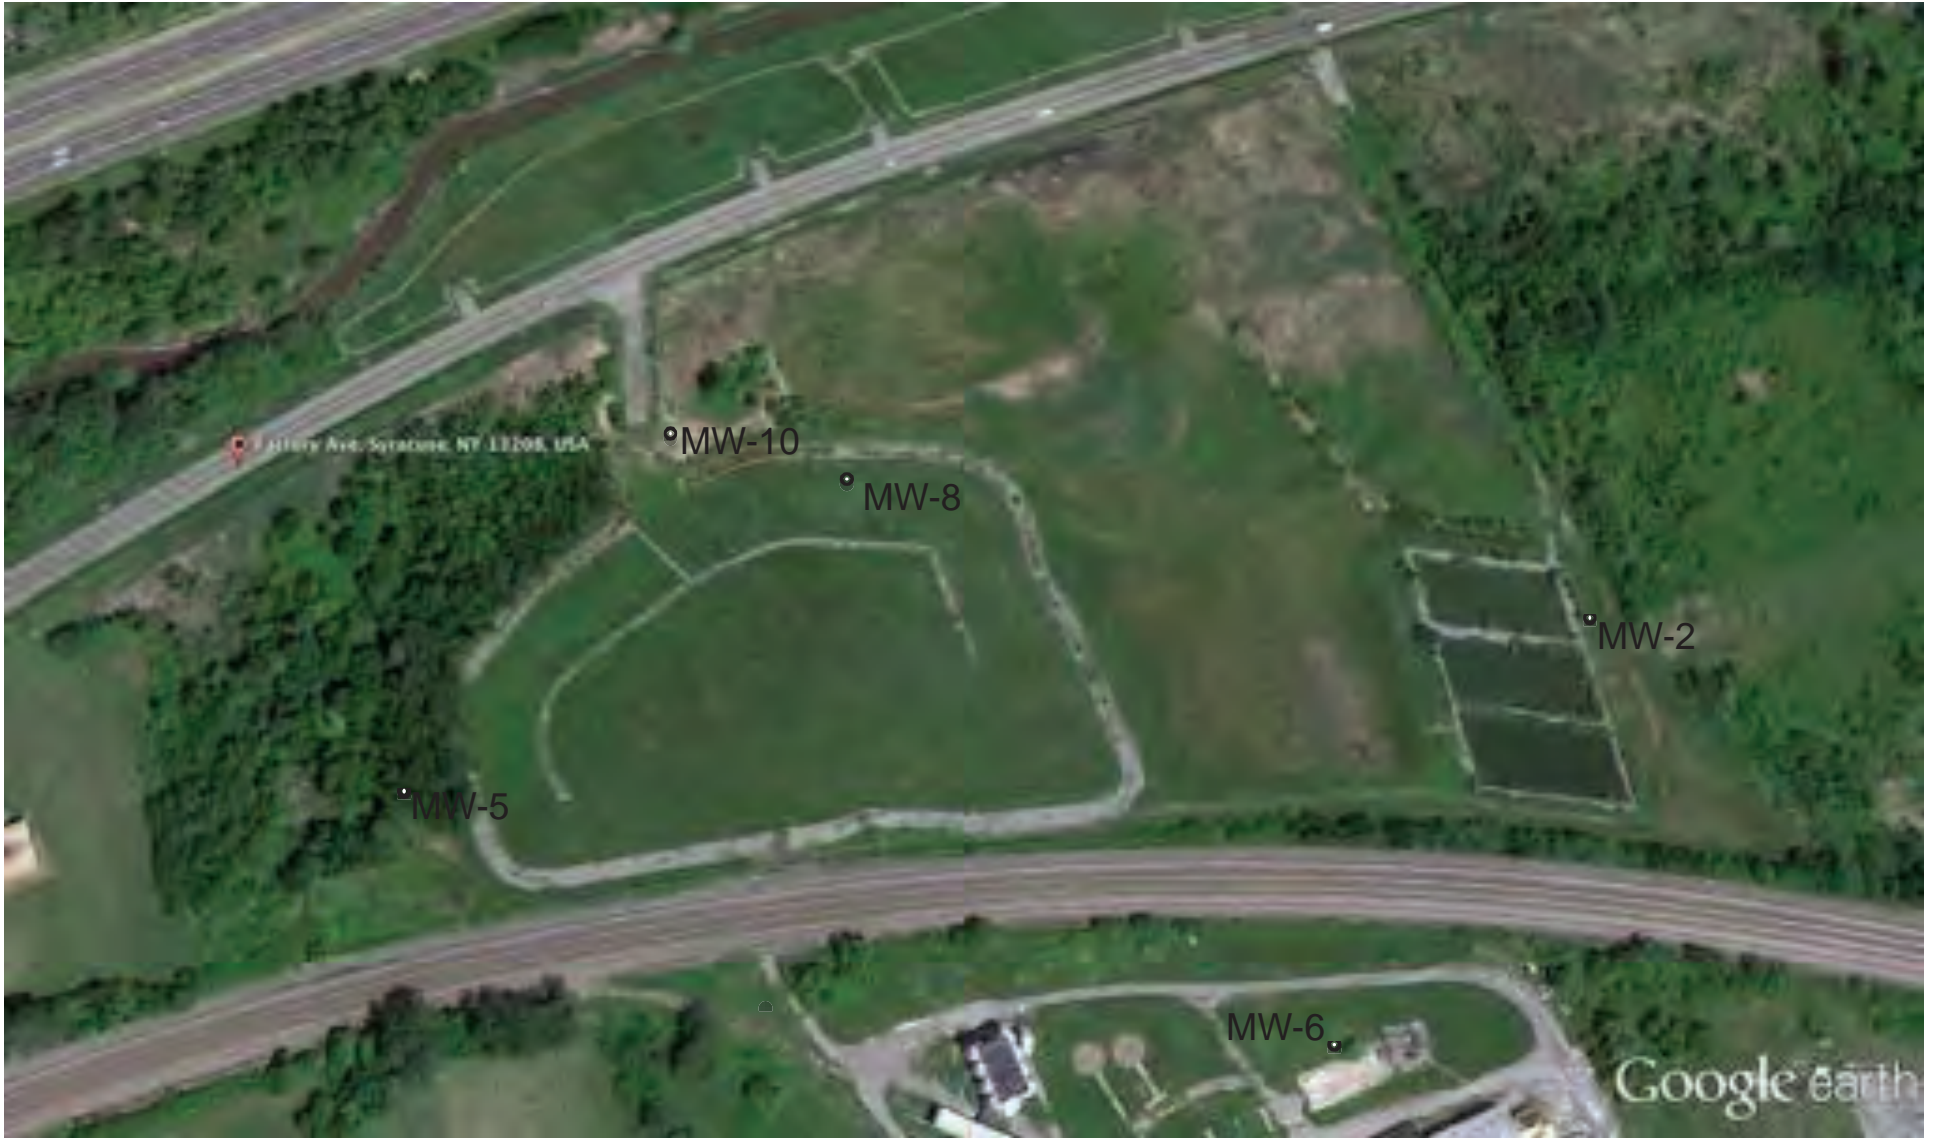
3

Site Feature Location Plan

gas vents GV-1 through GV-7, fencing, access road and Syracuse China signs for erosion, blockage or other damage. The results of Rocterra's inspection activities are summarized in the Site Monitoring, Inspection and Maintenance Forms, provided as Appendix A. Photographs showing the condition of key site features are provided as Appendix B. A site plan showing key site features is provided as Figure 3.
