Crompco LLC  
1815 Gallagher Rd  
Plymouth Meeting, PA 19462

Marones East Avenue ARCO Inc., DBA East Ave Auto  
Location #8-071226

1656 East Avenue  
Rochester, NY 14610  
+1 585-271-7610

W-155039 Visit #157296 7/01/2026

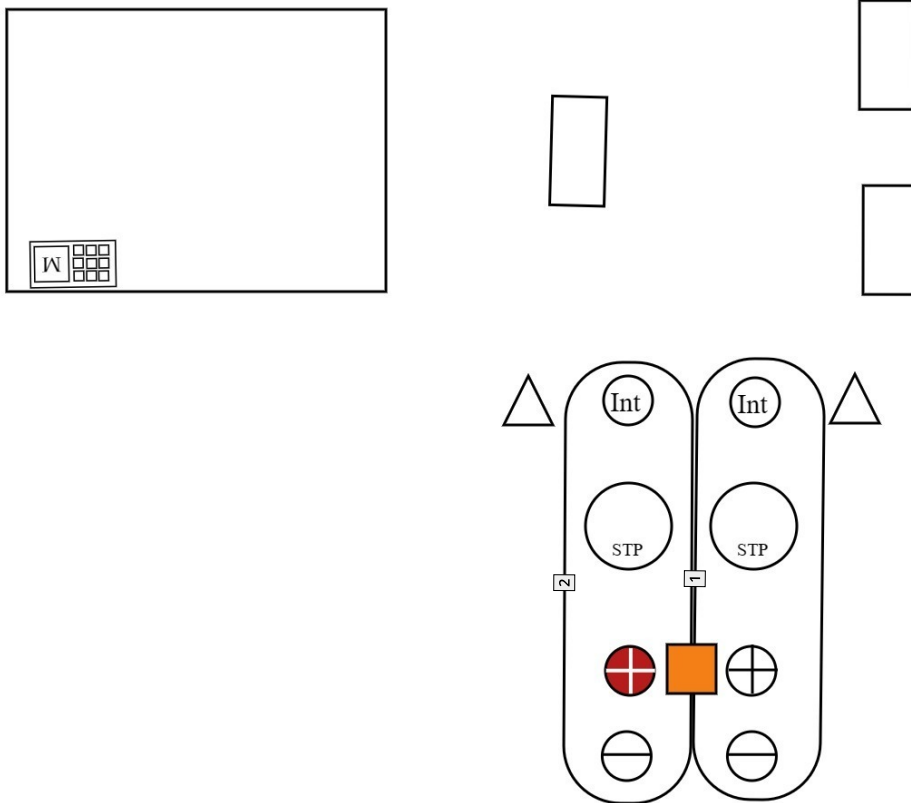
## Diagram - Site Diagram (v2)

1: Fiberglass Tank - 001 Reg 15K

2: Fiberglass Tank - 002 Prem 15K
