## **Introduction**

**STATEMENT OF BASIS  
FOR  
KODAK PARK INVESTIGATION AREA MIA-329**

**MIA-329**  
**CORRECTIVE MEASURES STUDY**  
**SITE LOCATION MAP**

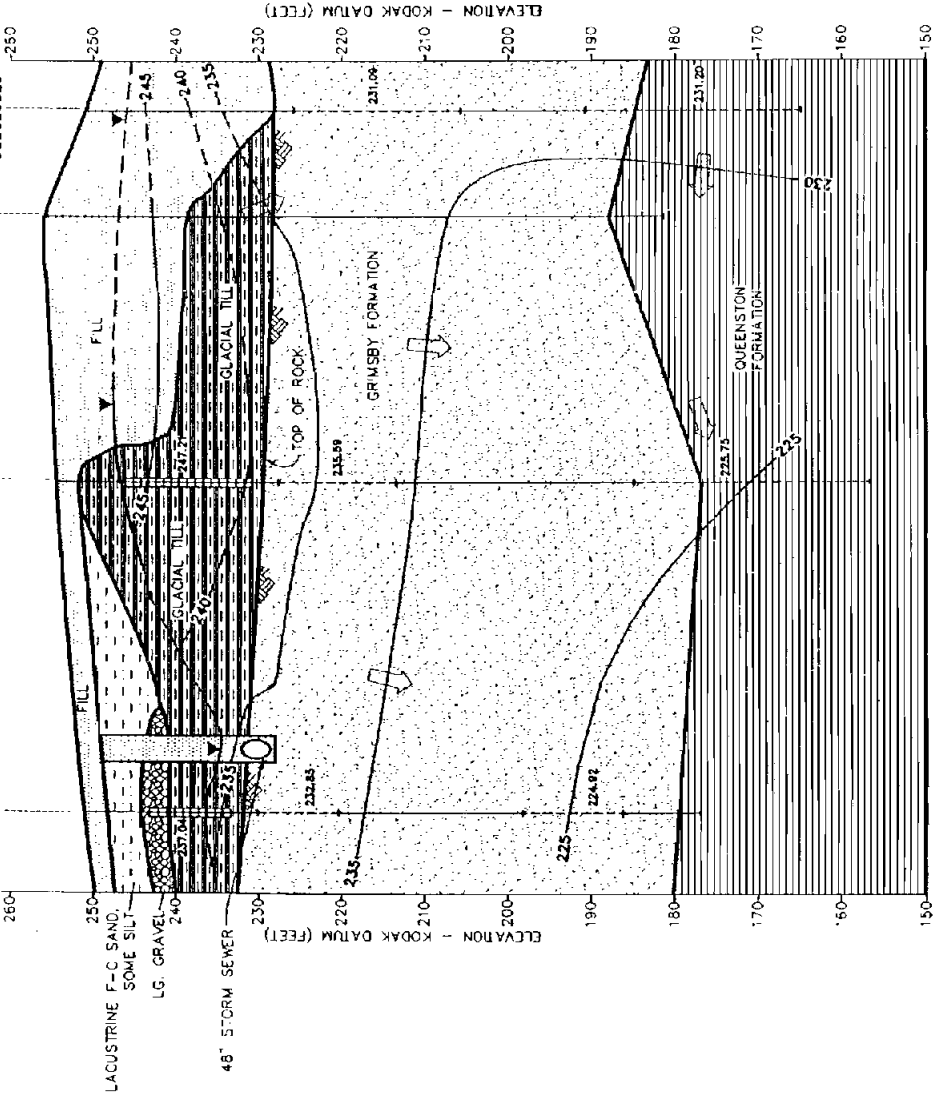
- 230 — GROUNDWATER ELEVATION IN FEET (KODAK DATUM)
- 238.09 — GROUNDWATER ELEVATION IN FEET (KODAK DATUM)
- ▼ WATER TABLE
- ◀ GROUNDWATER FLOW DIRECTION
- FILL MATERIAL
- ▨ SAND AND SILT (LACUSTRINE)
- ▩ GRAVEL
- ▧ GLACIAL TILL
- ▦ SANDSTONE
- ▥ SHALE

GOLDER ASSOCIATES  
CORRECTIVE MEASURES STUDY  
KODAK PARK CORRECTIVE ACTION PROGRAM  
EASTMAN KODAK COMPANY  
ROCHESTER, NEW YORK

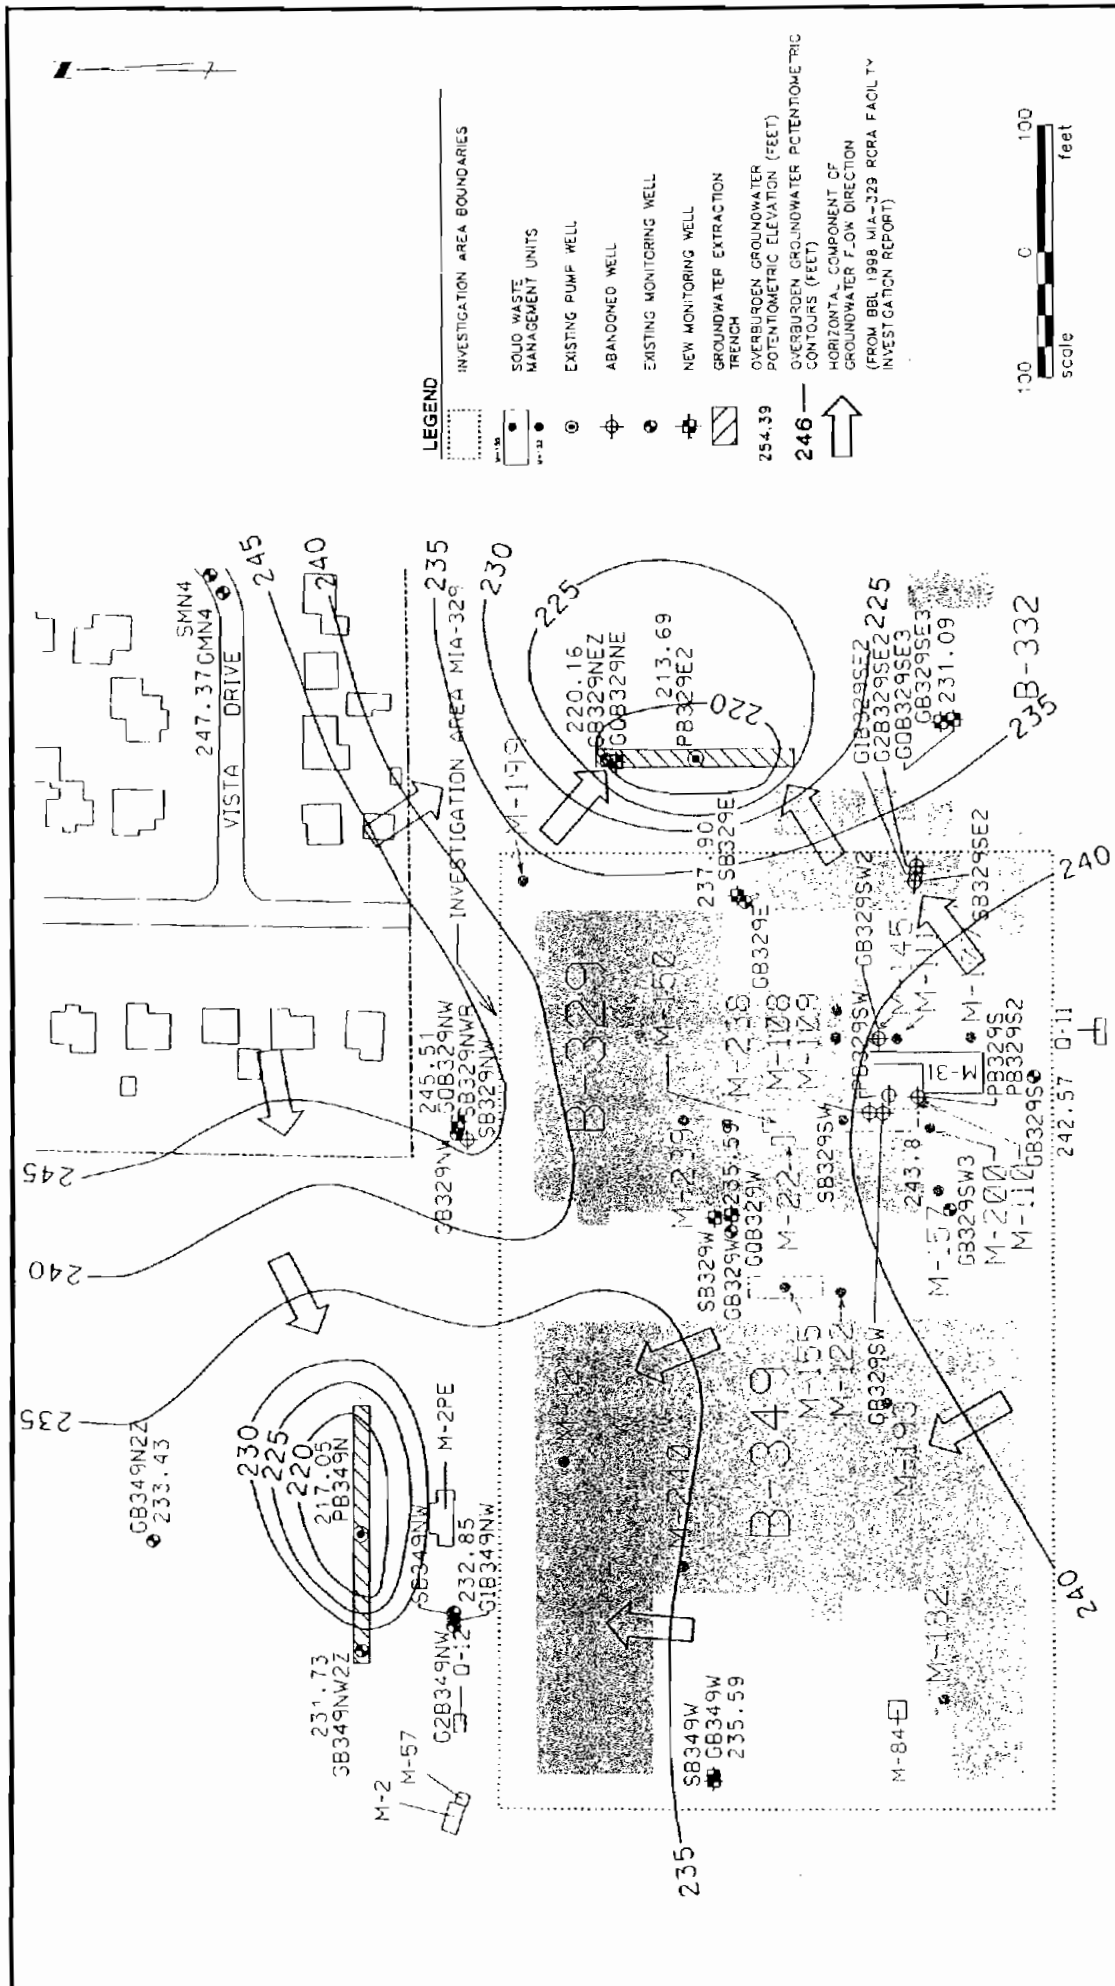
<b>Goldier Associates</b> Buffalo, New York		<b>TOP-OF-ROCK GROUNDWATER POTENTIOMETRIC CONTOUR MAP</b> APRIL 29-30, 1998	
CLIENT/PROJECT	MIA-329 CORRECTIVE MEASURES STUDY	DATE	2/1/00
PROJECT	KODAK PARK CORRECTIVE ACTION PROGRAM	SCALE	AS SHOWN
DESIGNED BY	EASTMAN KODAK COMPANY	FILE NO.	993-9224
CHECKED BY	ROCHESTER, NEW YORK	FIGURE NO.	5
APPROVED BY
