**PHASE I/PHASE II REMEDIAL
INVESTIGATION REPORT**

**Union Road Site
Town of Cheektowaga,
Erie County, New York
(Site Registry No. 9-15-128)**

JUNE 1991

**DVIRKA AND BARTILUCCI
CONSULTING ENGINEERS
SYOSSET, NEW YORK**

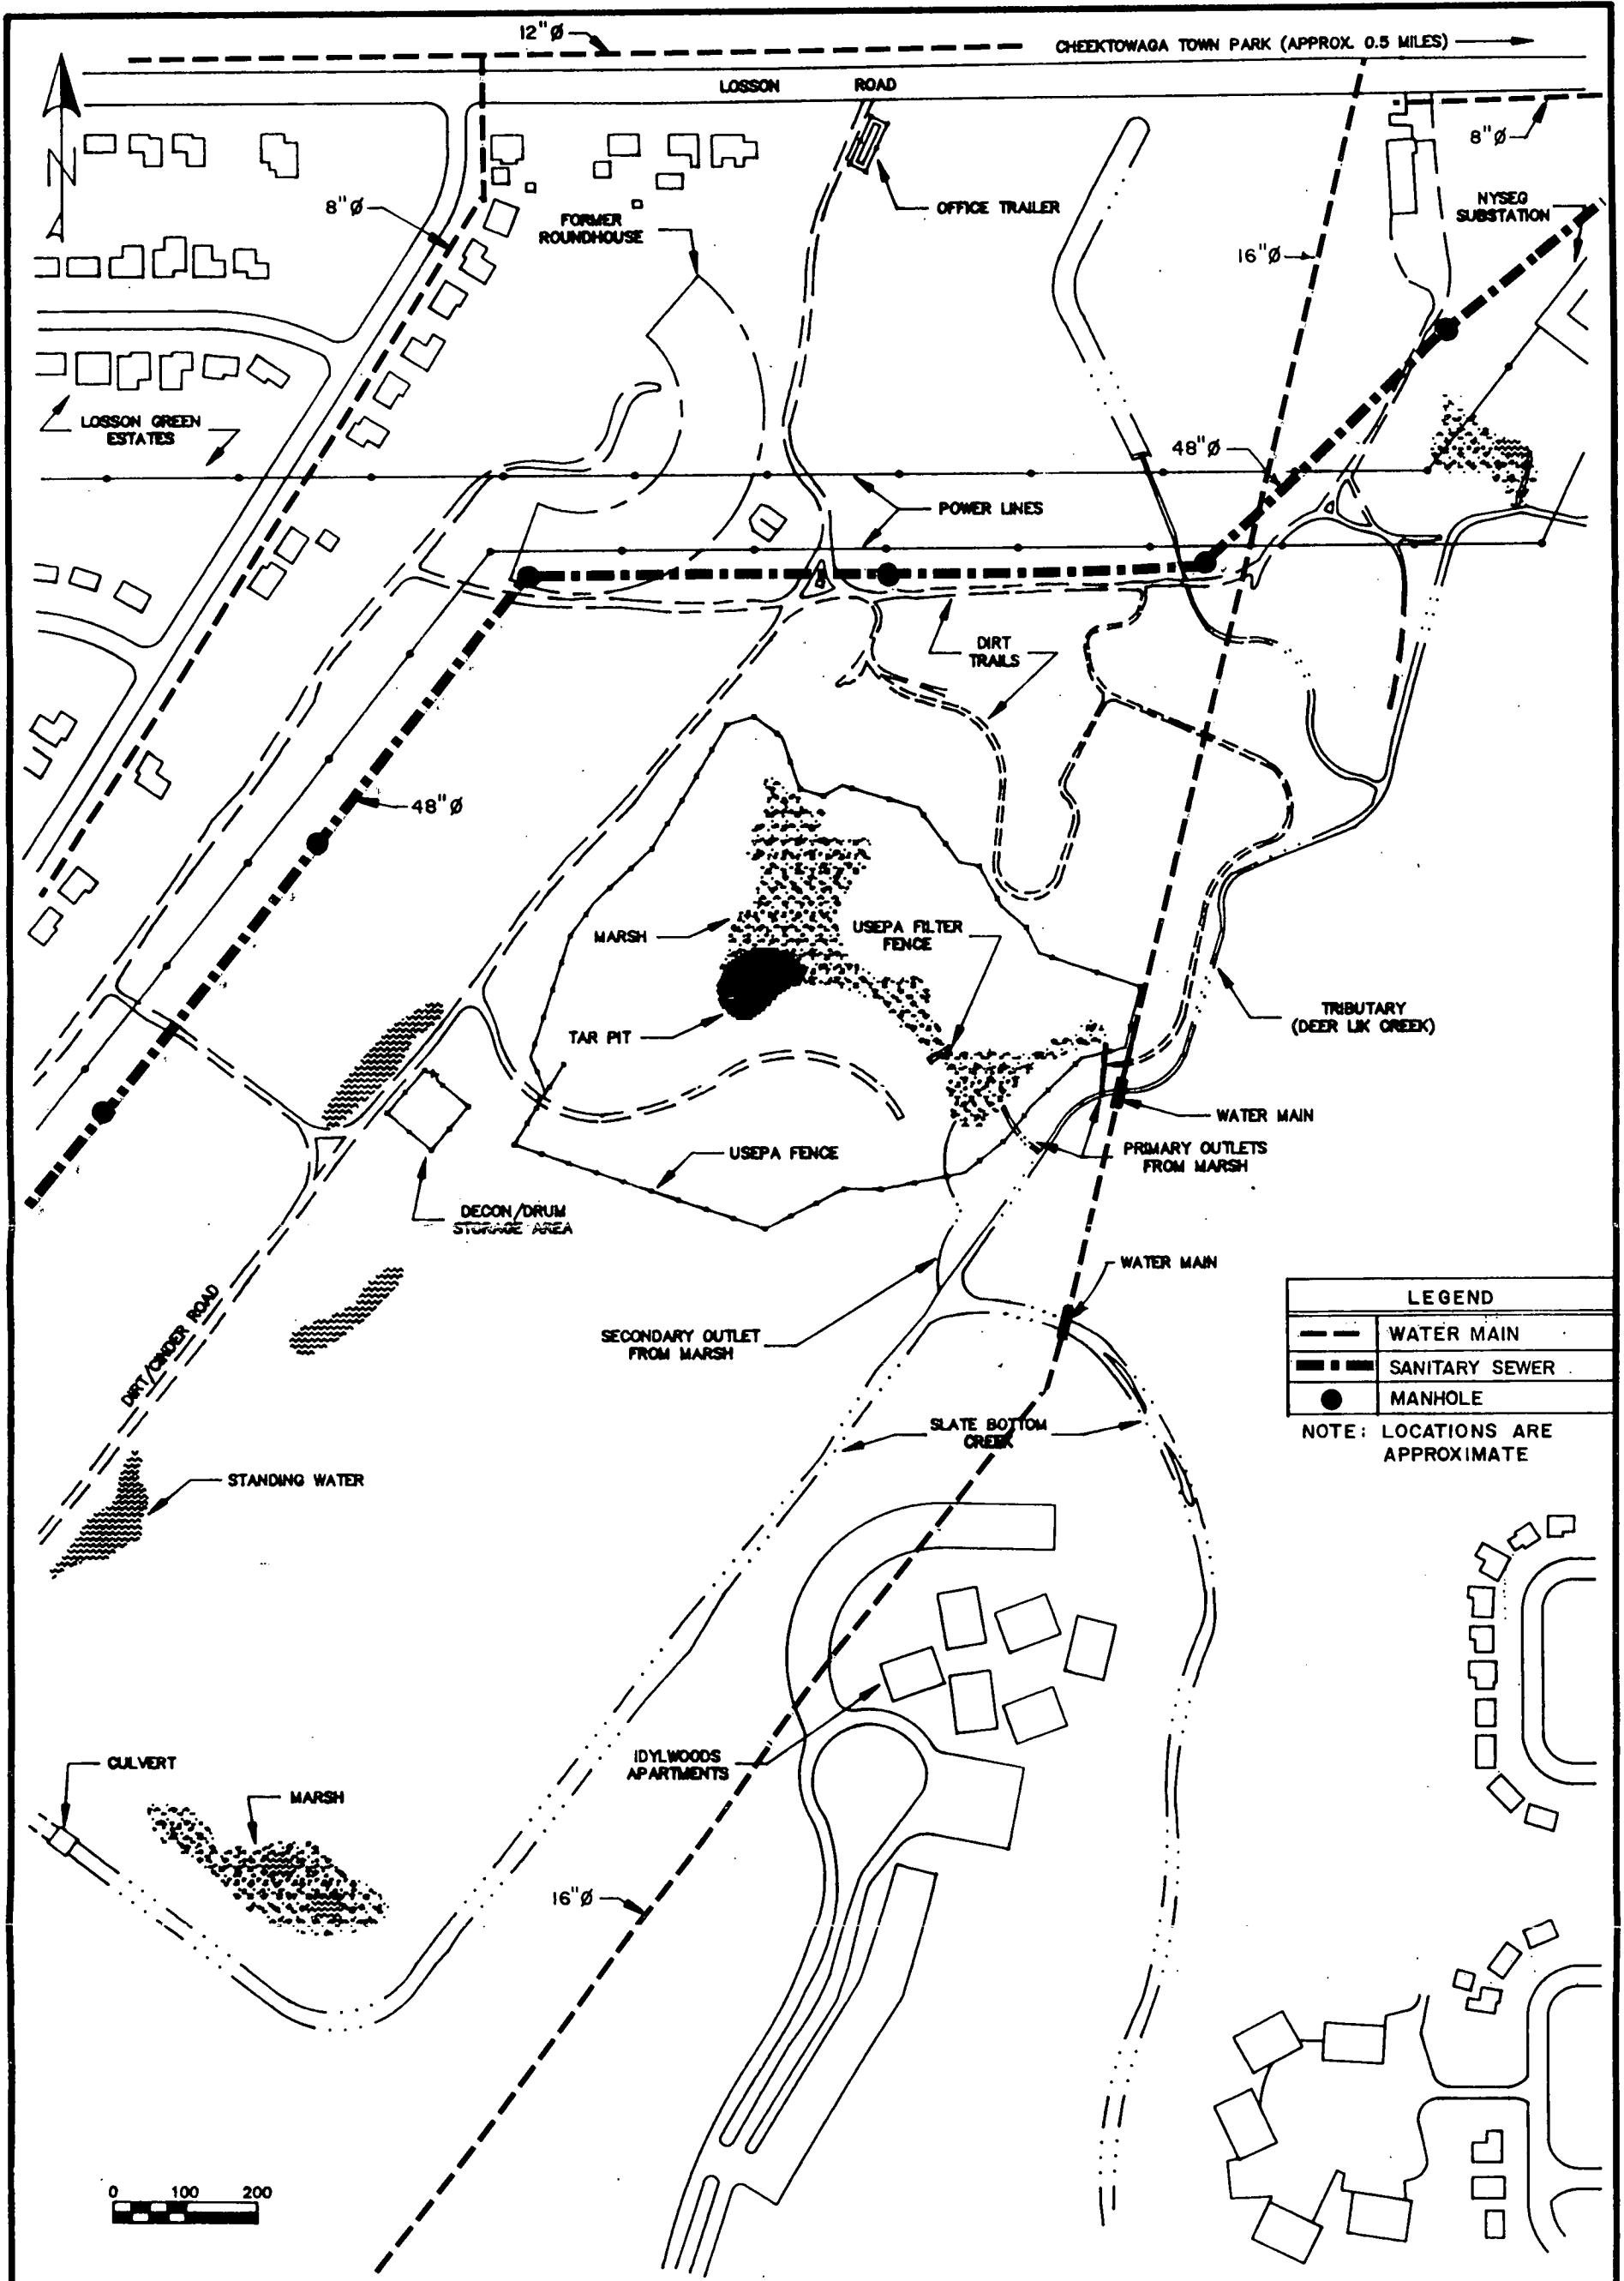
UNION ROAD SITE
 LOCATIONS OF SANITARY SEWER AND WATER MAIN

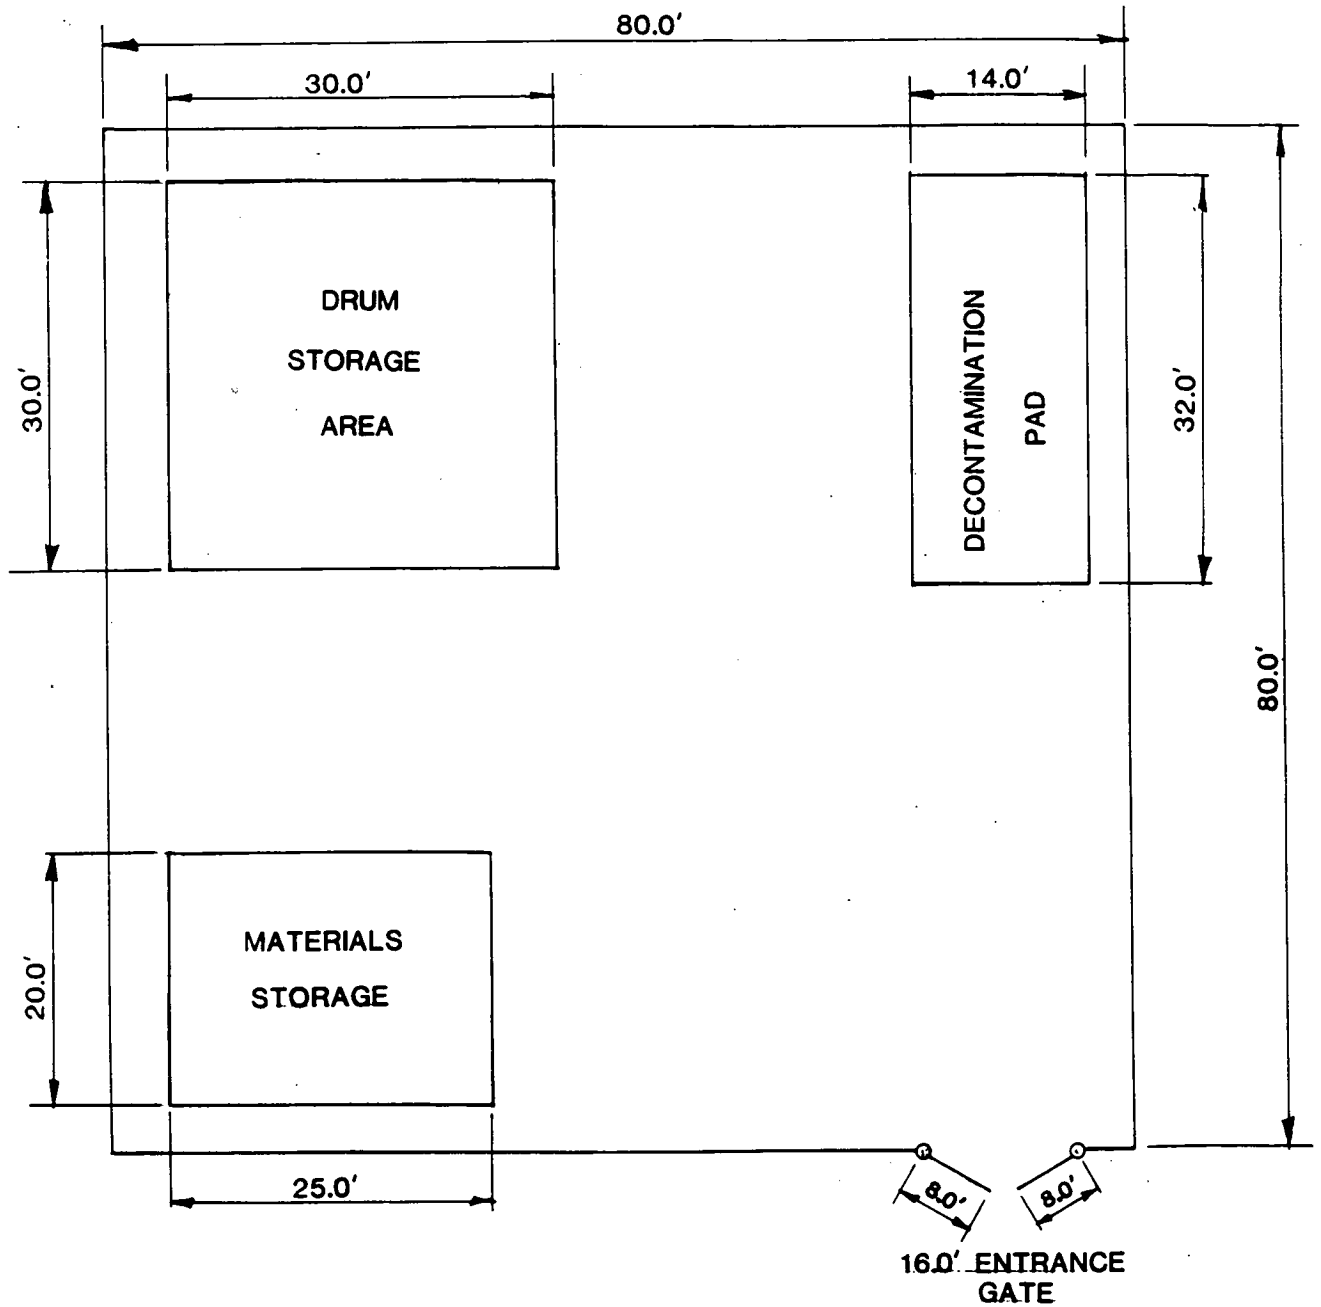
UNION ROAD SITE
**FENCED EQUIPMENT STAGING, DECONTAMINATION PAD
 AND DRUM STORAGE AREA**

The decontamination/storage area was located closer to the center of field activities and away from residences surrounding the site (see Figure No. 2-1). This area, which measures 80 feet by 80 feet, was also enclosed by an 8 foot high chain-link fence and truck gate with barbed wire as is illustrated in Figure No. 2-2. The decontamination pad was constructed of sand covered by a plastic liner and a platform to support vehicles. Wastewater generated as a result of steam cleaning/chemical washing equipment and supplies was diverted to a sump and pumped into drums. A detailed description of the decontamination pad is provided in the project Work Plan.

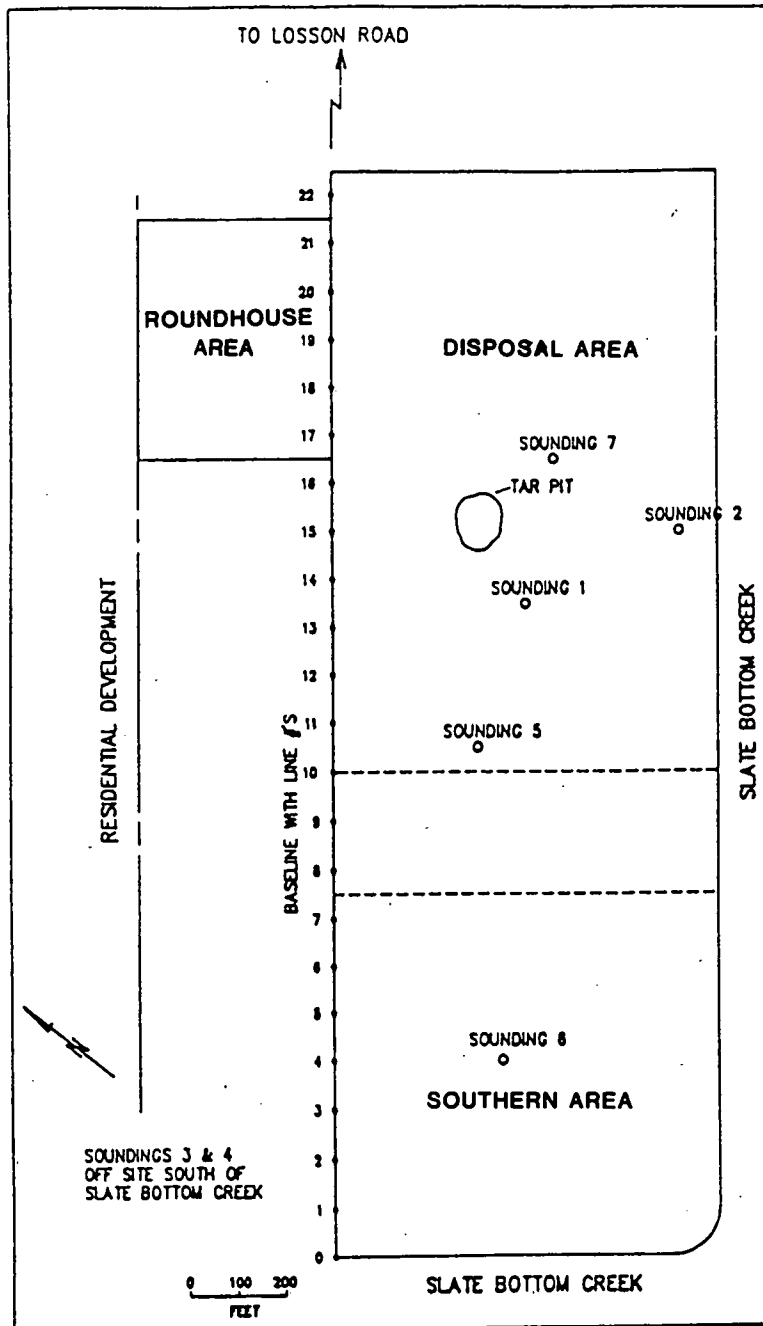
UNION ROAD SITE
LOCATIONS OF RESISTIVITY SOUNDINGS

The objective of the soundings was to determine at what electrode spacing is the apparent resistivity affected by the electrical characteristics of the tar-like waste material. Seven soundings were conducted on the site. As shown in Figure No. 2-5, four soundings were located in the Tar Pit and Disposal Area (two of these near the Tar Pit), one in the Southern Area, and two off-site south of the Slate Bottom Creek. The data from the soundings were then used to select the best electrode spacing for traversing.

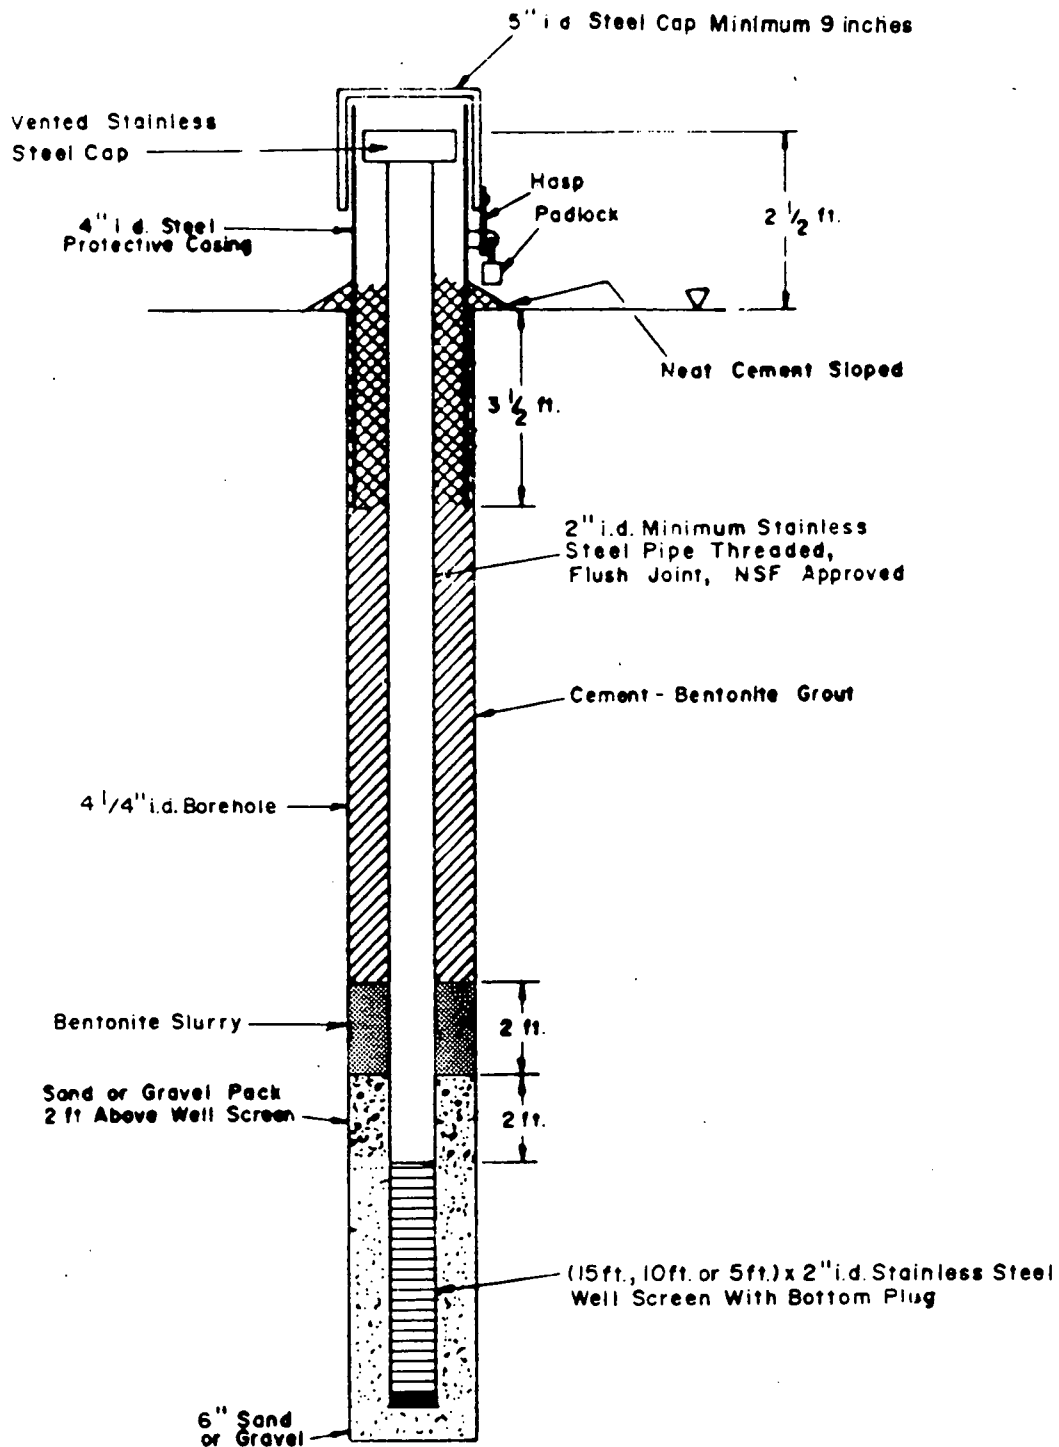
UNION ROAD SITE
**CONSTRUCTION OF
 OVERBURDEN MONITORING WELLS**

All monitoring wells were developed by bailing. Temperature, conductivity, pH and turbidity were periodically monitored during the course of development. Wells were considered developed when turbidity levels reached <50 NTUs and/or the remaining parameters stabilized.

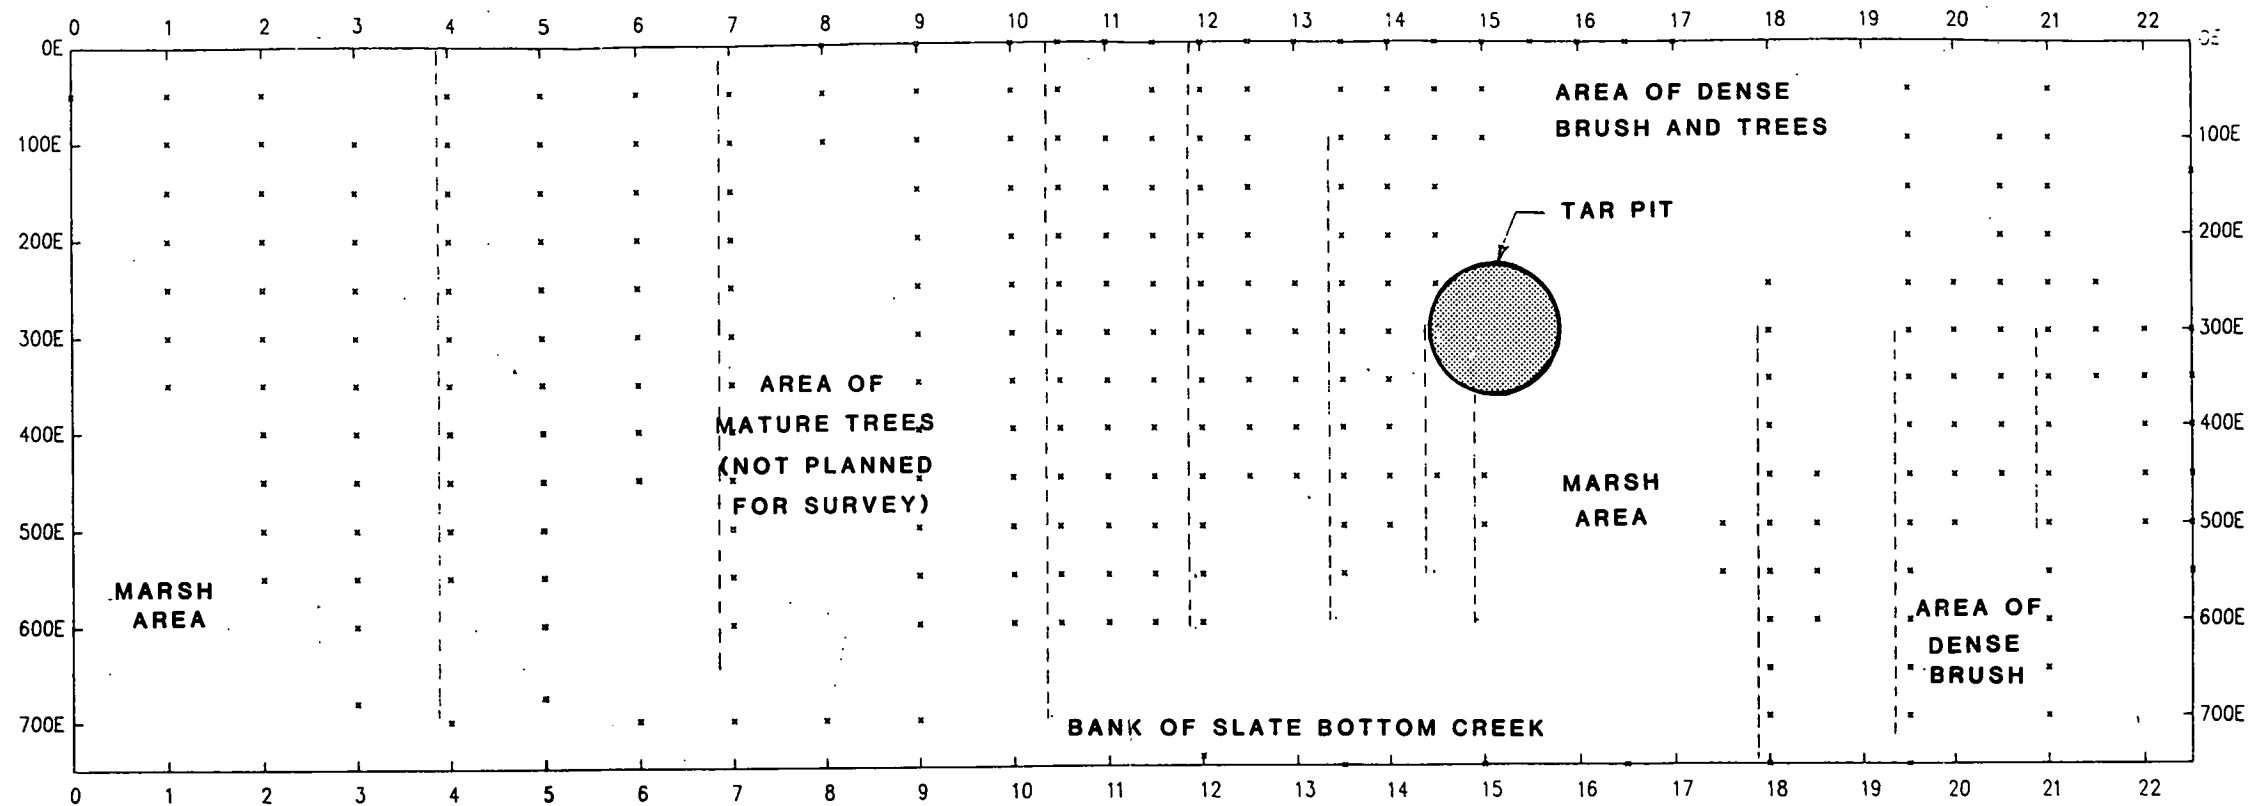
FIGURE NO. 3-3

LEGEND

- x RESISTIVITY
- CONDUCTIVITY

Terrain conductivity profiling results correlated closely with the magnetic and resistivity data in the vicinity of the Tar Pit. The profiles of geophysical lines 1800E and 1950E north of the Tar Pit contain sharp positive and negative (inversion) spikes at about 690E and 760E, respectively (see Figure Nos. 3-6 and 3-7). These spikes generally occur in the vicinity of buried metal objects and correlate in this situation with magnetic anomalies noted in the magnetic survey. The water main running through the site was inferred to occur in areas of the spikes. Reconnaissance terrain conductivity profiles were obtained along lines 700 and 400 in the Southern Area (see Figure Nos. 3-8 and 3-9). The profiles correlate well with the results of the magnetic survey. Terrain conductivity values between the baseline (unpaved road) and about 225E and 250E, respectively, fluctuate and probably reflect scattered metal objects in the area west of the small berm marking the edge of the former railroad yard. To the east of the small berm, the values level off to background levels.

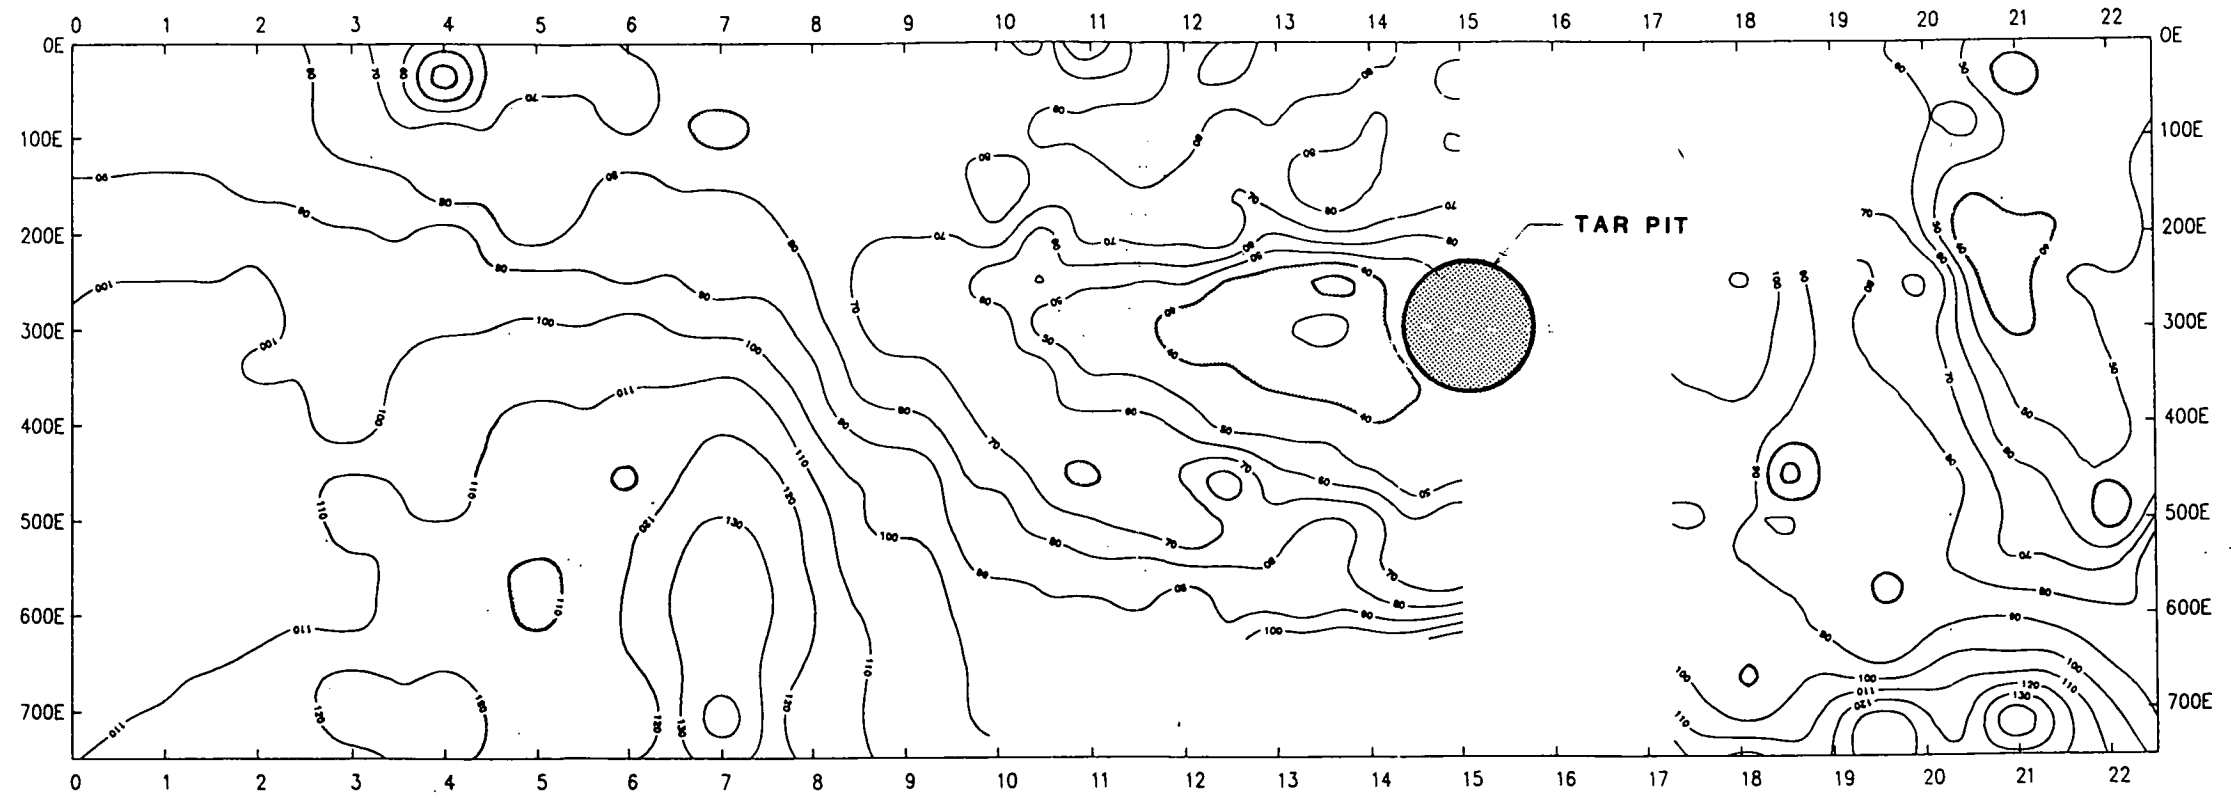
FIGURE NO. 3-5

Source: HAGER-RICHTER GEOSCIENCE, INC.

SCALE: 1" = 200'

Resistivity surveying displayed a prominent low resistivity region south of the Tar Pit, indicating probable southward extension of the tar-like material found in the Tar Pit under the fill area (see Figure No. 3-5). The waste material was estimated to extend for at least 300 feet along the alignment of the former railroad spur. There was no indication of buried waste in the areas north of the Tar Pit. Apparent resistivities increase moving from the Tar Pit through the Southern Area toward Slate Bottom Creek. This trend in a generally level site may reflect changes in the local stratigraphy or bedrock rising closer to ground surface toward the creek or both. Resistivity traversing data was interpreted to indicate that tar-like waste was not disposed in the Southern Area.

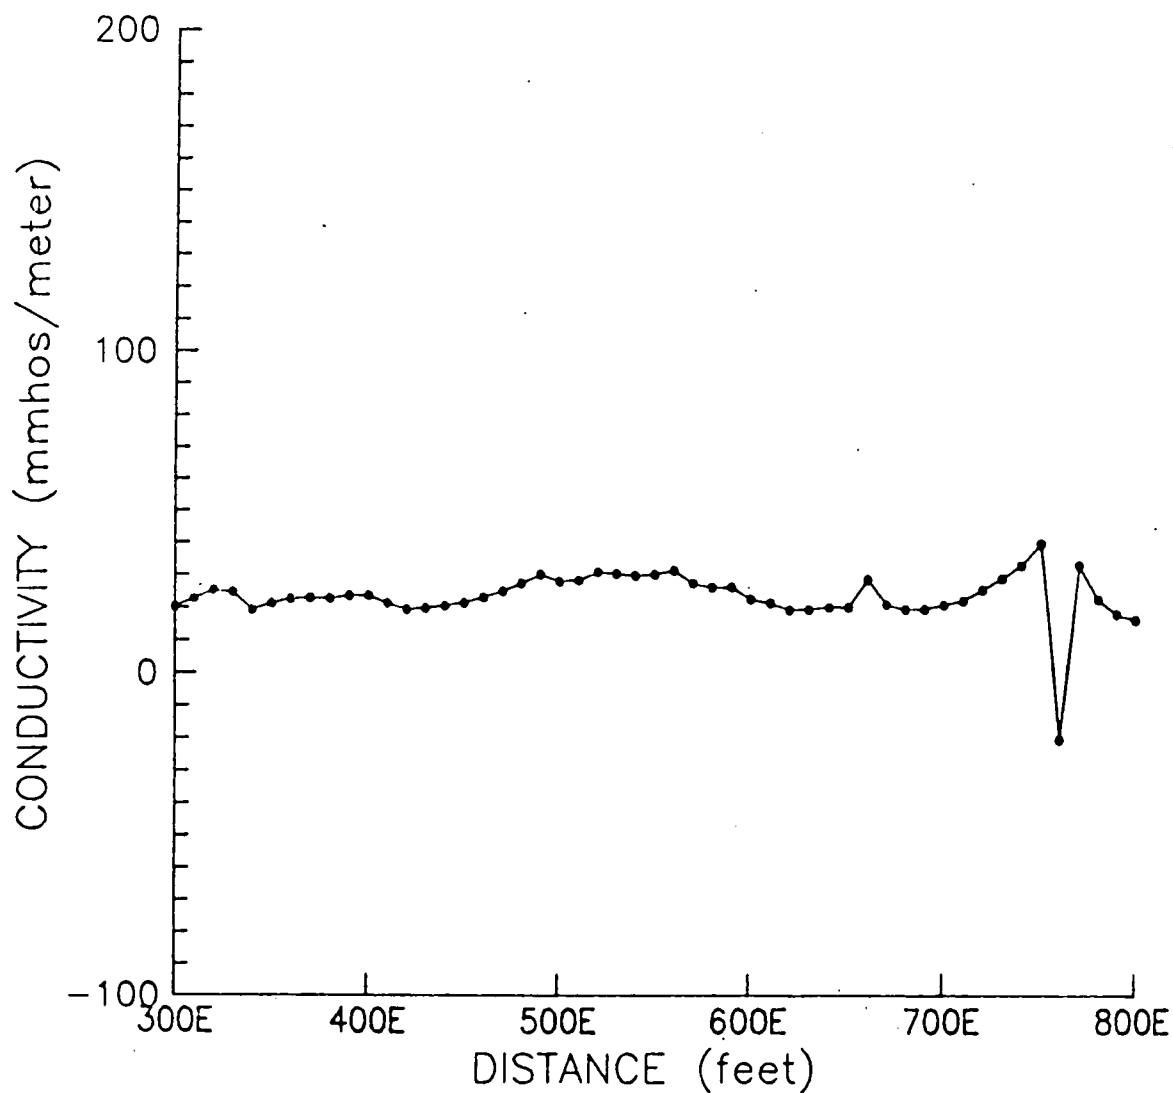
FIGURE NO. 3-6

**PROFILE OF TERRAIN CONDUCTIVITY ALONG LINE 1800E
(DISPOSAL AREA)**

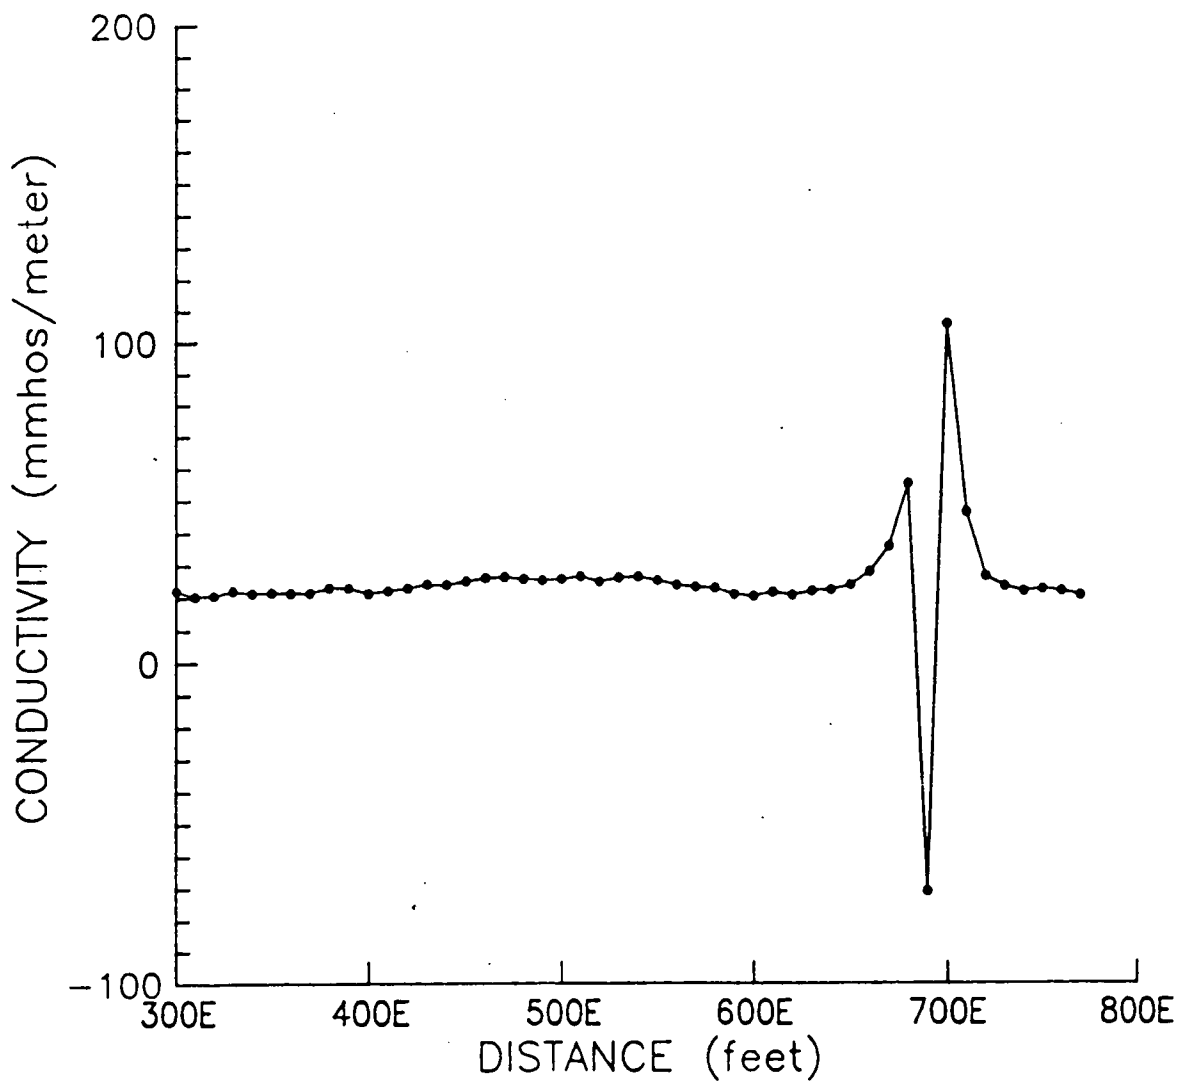
FIGURE NO. 3-7

**PROFILE OF TERRAIN CONDUCTIVITY ALONG LINE 1950E
(DISPOSAL AREA)**

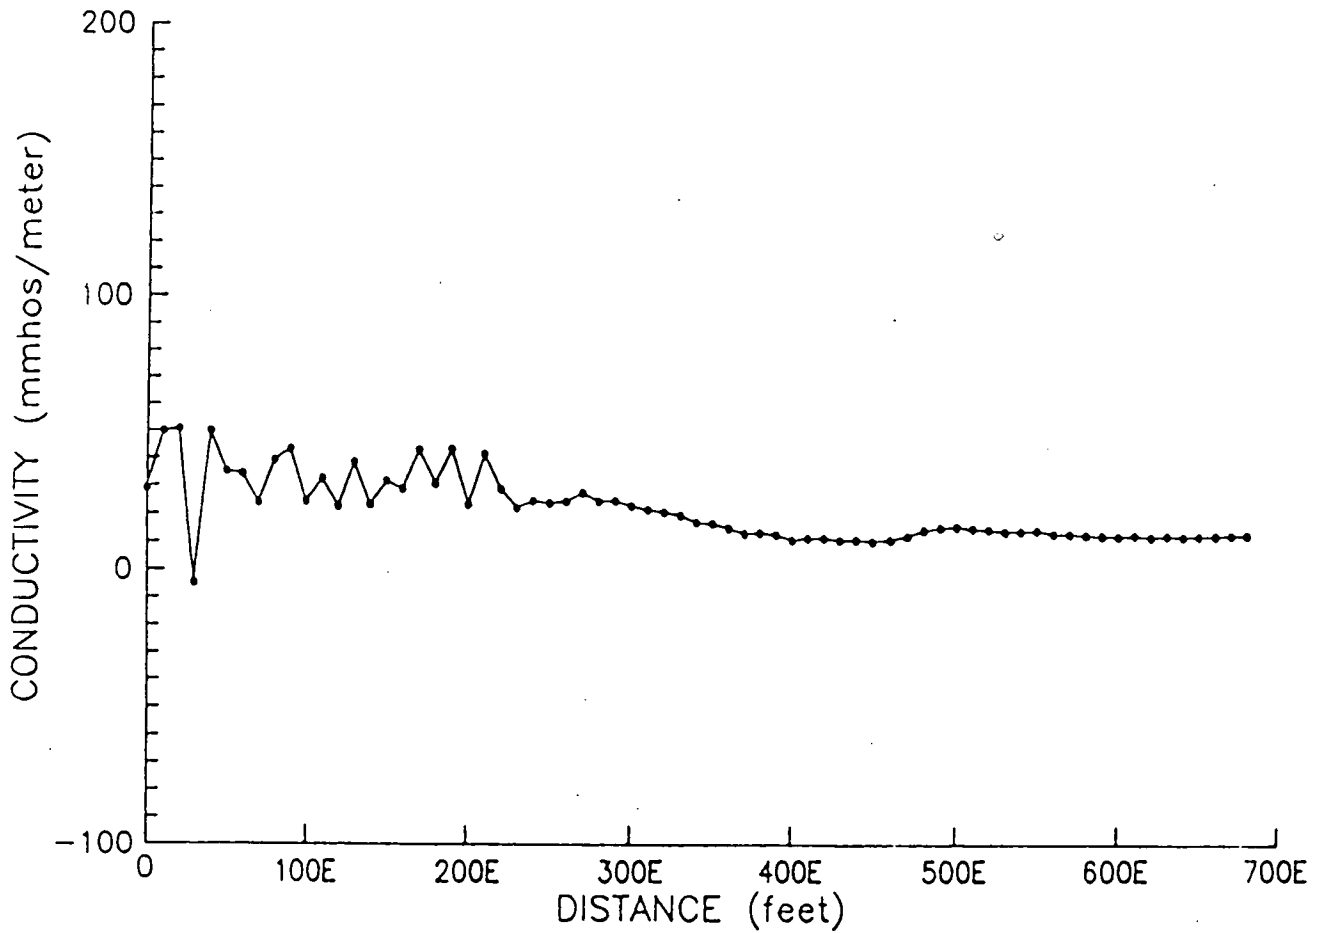
FIGURE NO. 3-8

PROFILE OF TERRAIN CONDUCTIVITY ALONG LINE 700E (SOUTHERN AREA)

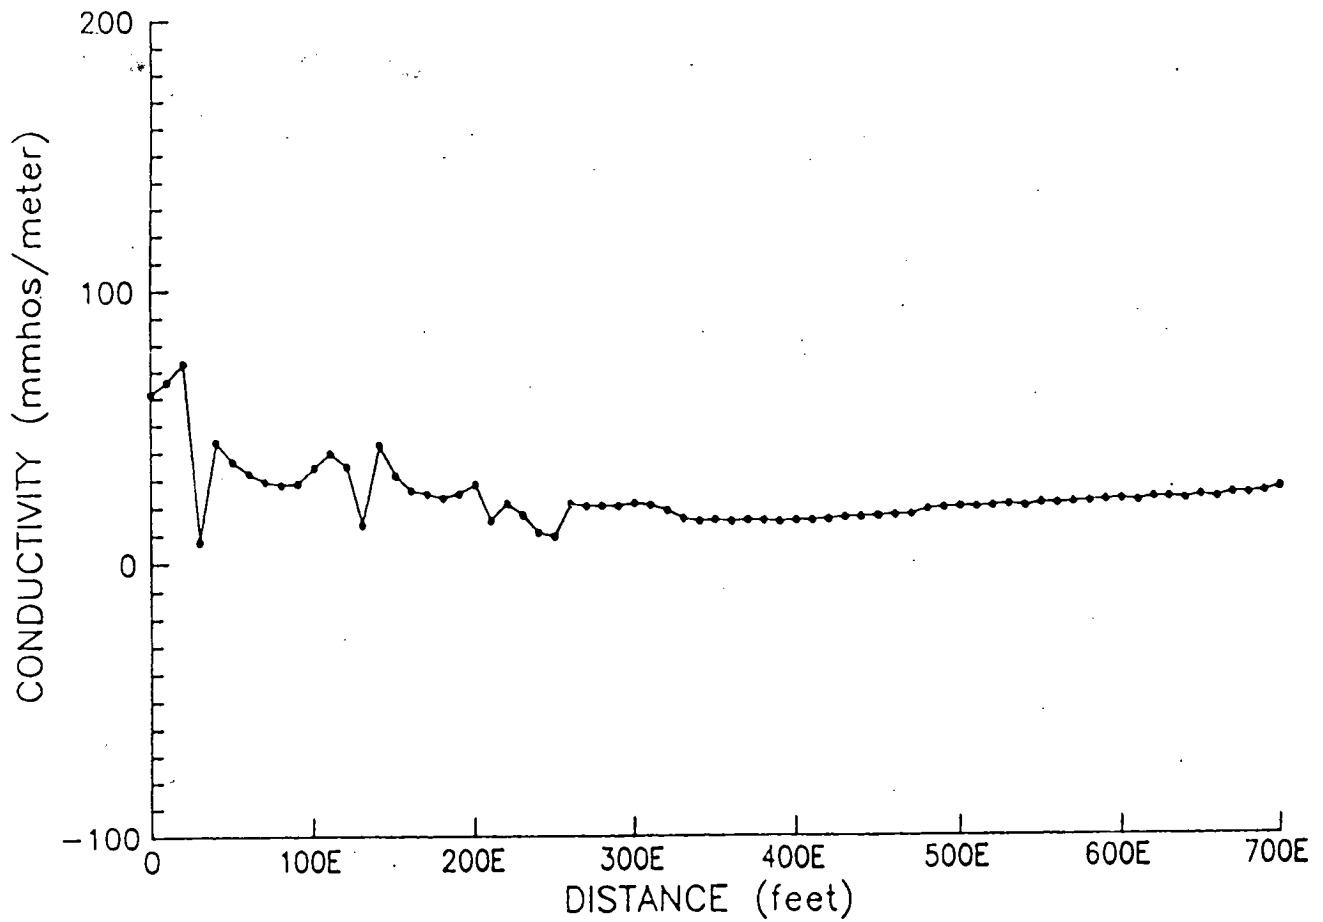
PROFILE OF TERRAIN CONDUCTIVITY ALONG LINE 400E

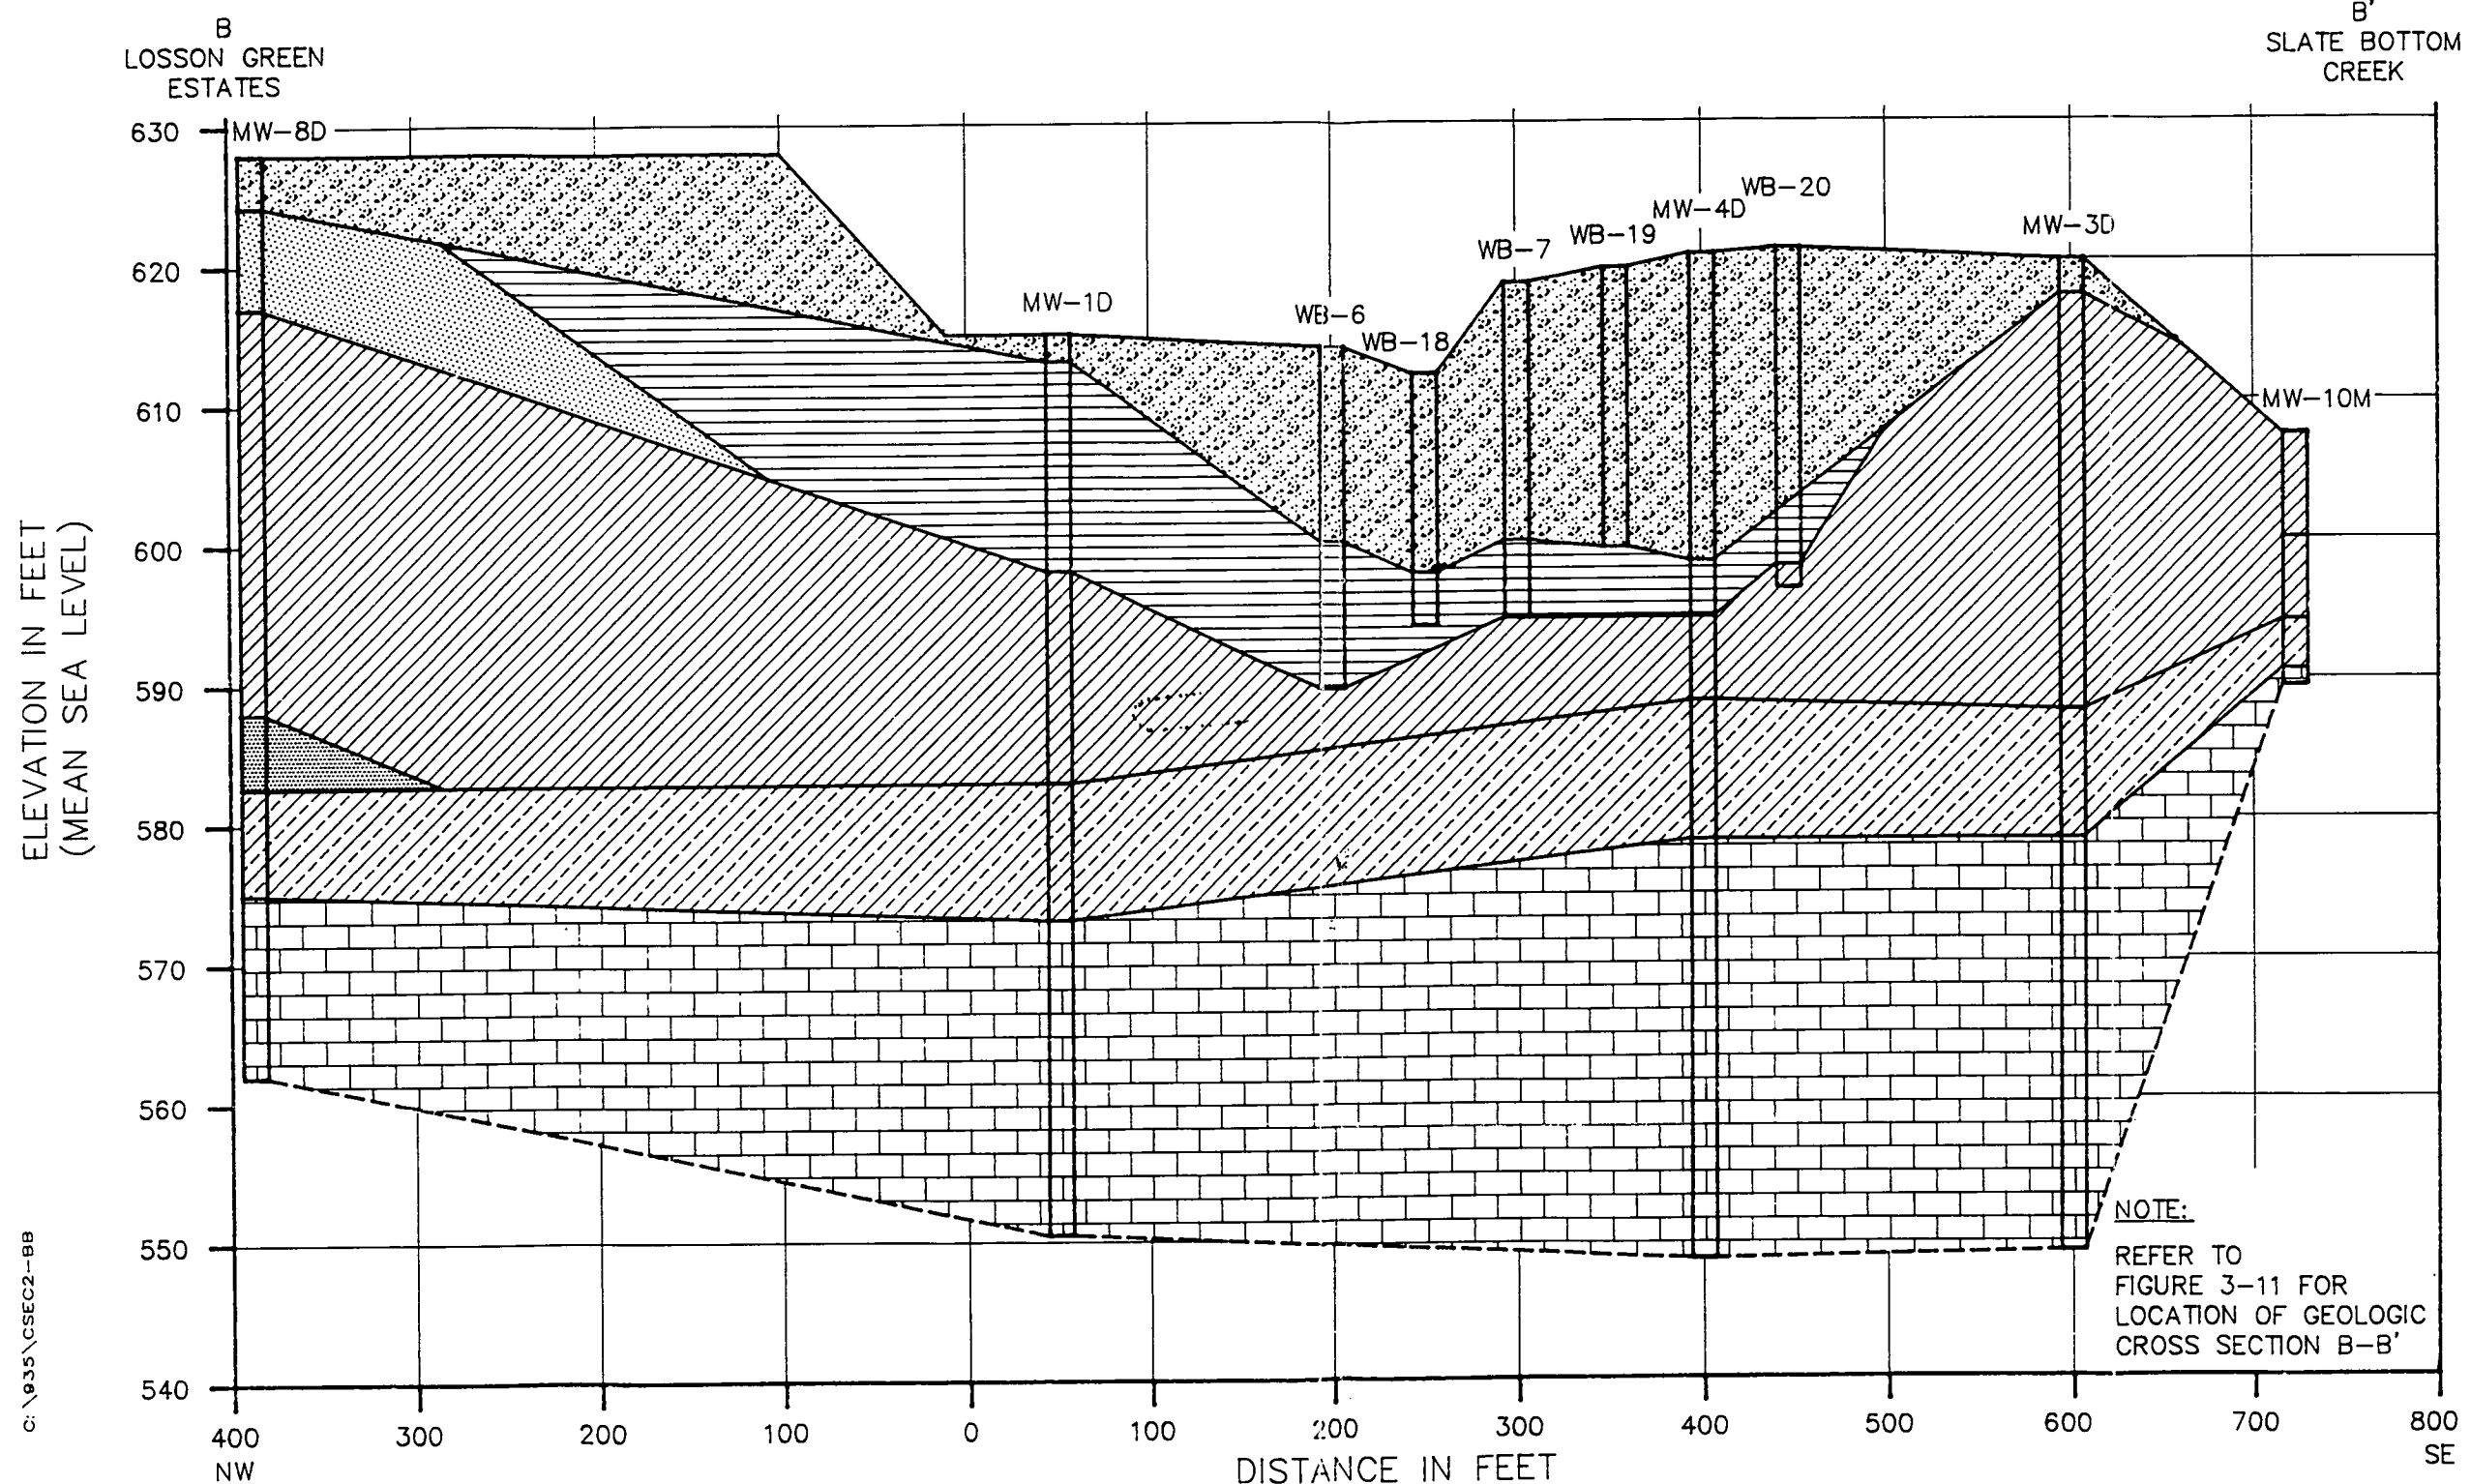
-----: LOWER EXTENT OF BEDROCK INTERSECTED AT MW-8D, MW-1D, MW-4D, MW-3D AND MW-10M

NOTE:
REFER TO
FIGURE 3-11 FOR
LOCATION OF GEOLOGIC
CROSS SECTION B-B'

UNION ROAD SITE
GEOLOGIC CROSS-SECTION B-B'

A total of eight cross sections were prepared for the Union Road Site based on stratigraphic data gathered from both monitoring well and waste borings. Two of the cross sections show geologic units solely and the remaining six illustrate the extent of buried waste material/contaminated soil in addition to the geology. The location of the geologic cross sections are illustrated in Figure No. 3-11 and the location of the buried waste cross sections are shown in Figure No. 3-12. The following discussion on site stratigraphy was derived from these cross sections (Figure Nos. 3-13, 3-14, 3-15, 3-16, 3-17, 3-18, 3-19, and 3-20).
