**PHASE I/PHASE II REMEDIAL
INVESTIGATION REPORT**

**Union Road Site
Town of Cheektowaga,
Erie County, New York
(Site Registry No. 9-15-128)**

JUNE 1991

**DVIRKA AND BARTILUCCI
CONSULTING ENGINEERS
SYOSSET, NEW YORK**

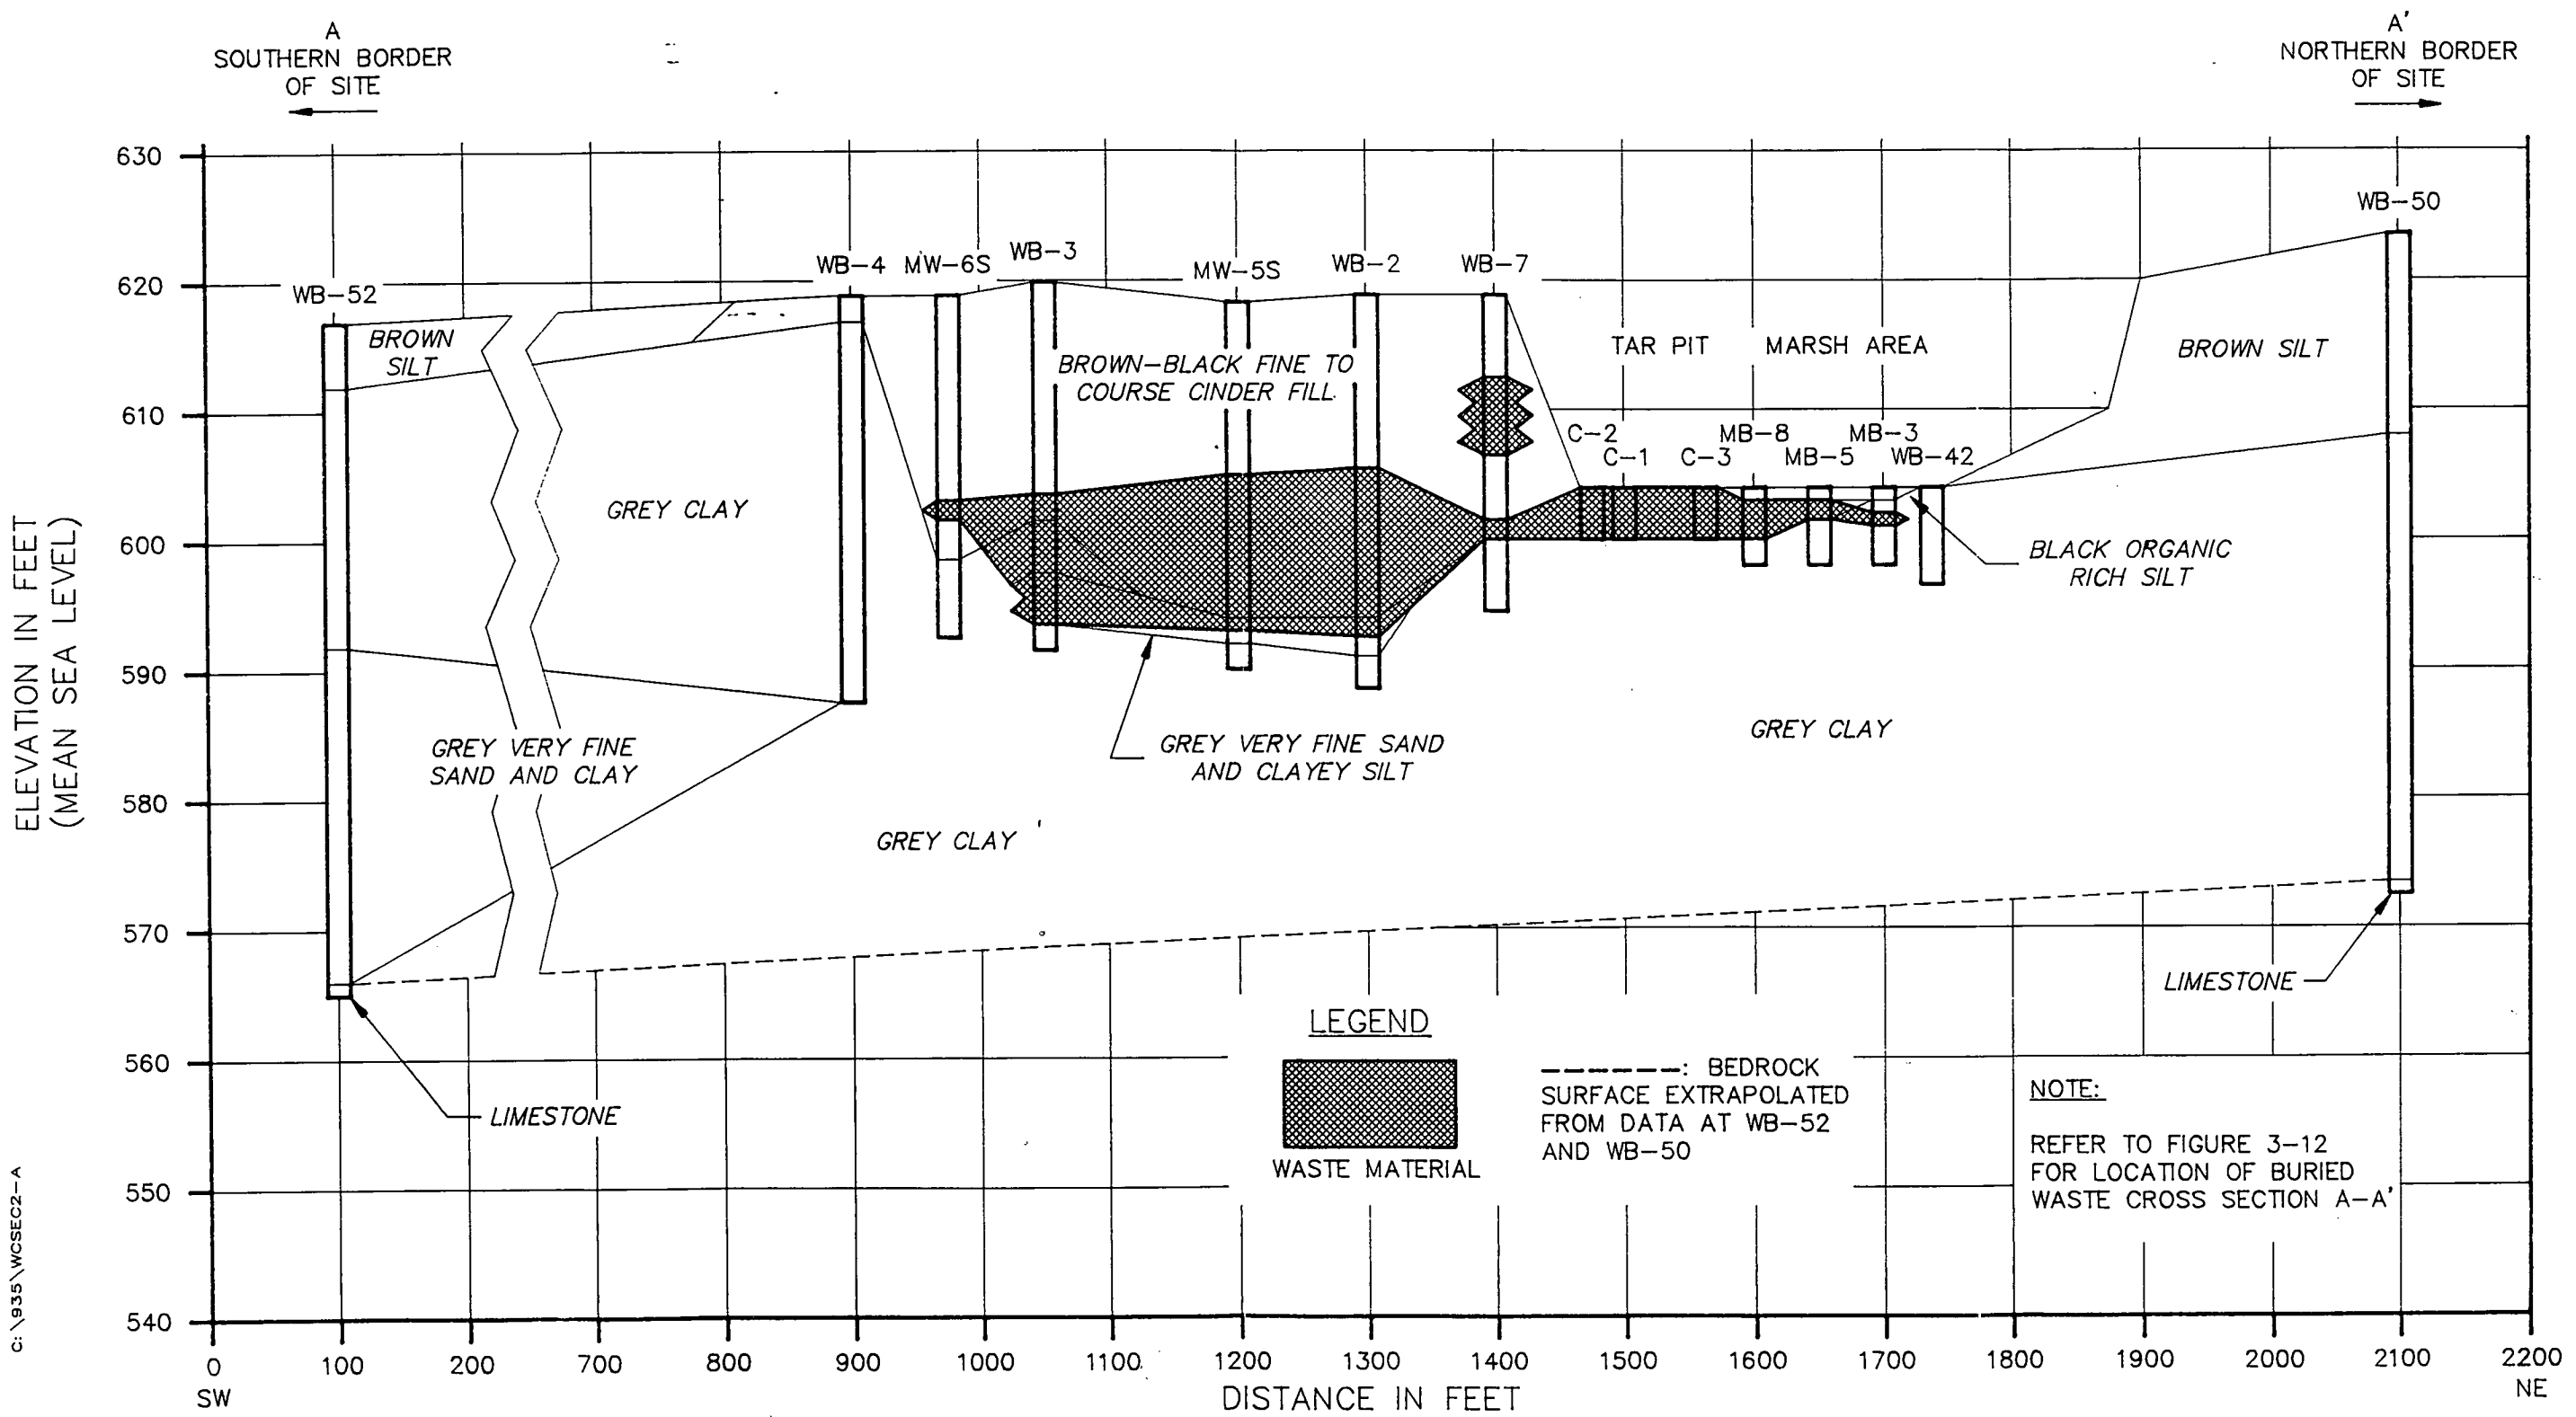
UNION ROAD SITE
BURIED WASTE CROSS SECTION A-A'

A total of eight cross sections were prepared for the Union Road Site based on stratigraphic data gathered from both monitoring well and waste borings. Two of the cross sections show geologic units solely and the remaining six illustrate the extent of buried waste material/contaminated soil in addition to the geology. The location of the geologic cross sections are illustrated in Figure No. 3-11 and the location of the buried waste cross sections are shown in Figure No. 3-12. The following discussion on site stratigraphy was derived from these cross sections (Figure Nos. 3-13, 3-14, 3-15, 3-16, 3-17, 3-18, 3-19, and 3-20).

Drilling into the bluff located immediately to the east of the Tar Pit revealed a relatively continuous zone containing a black soot-like material which was approximately 15 feet in thickness at the WB-23 location and thinned to the east where it was also observed at locations WB-24, 25, 26 and 27. A narrow strand-like deposit of fine to medium red sands was found at locations WB-16 and 20, as well as in test pit Nos. TP-7 and 13. Similar to the black soot-like deposits, the fine to medium red sands were not observed other than at the above mentioned locations.

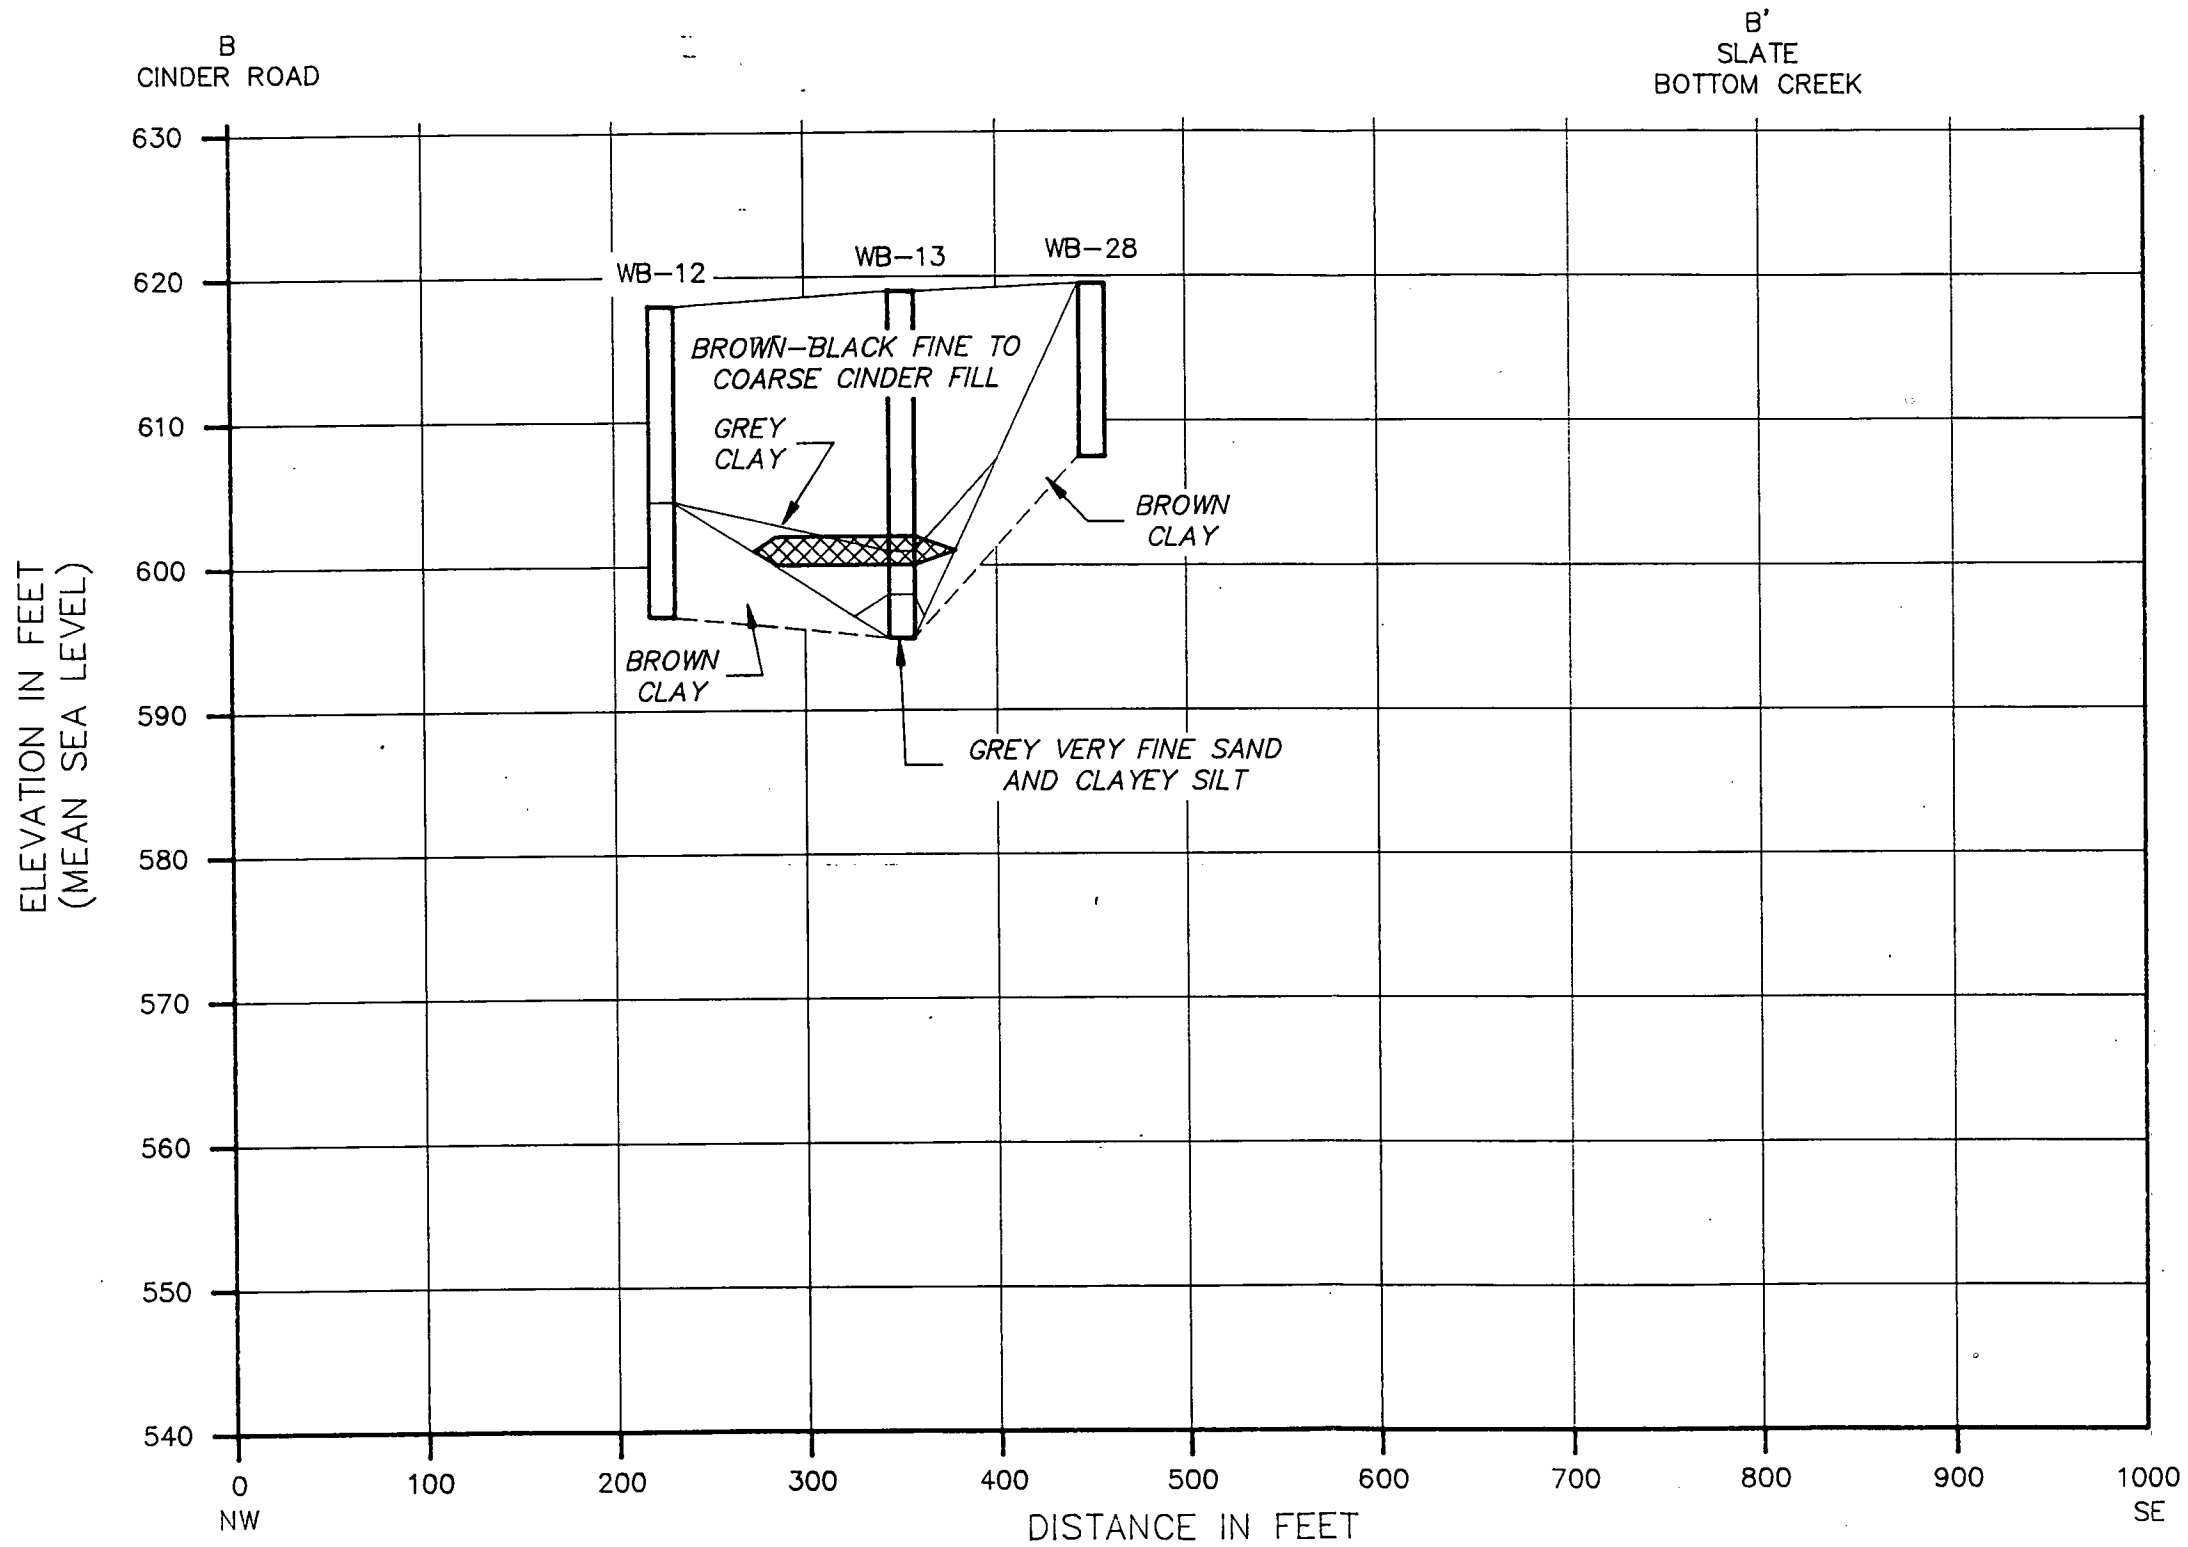
**UNION ROAD SITE
BURIED WASTE CROSS SECTION B-B'**

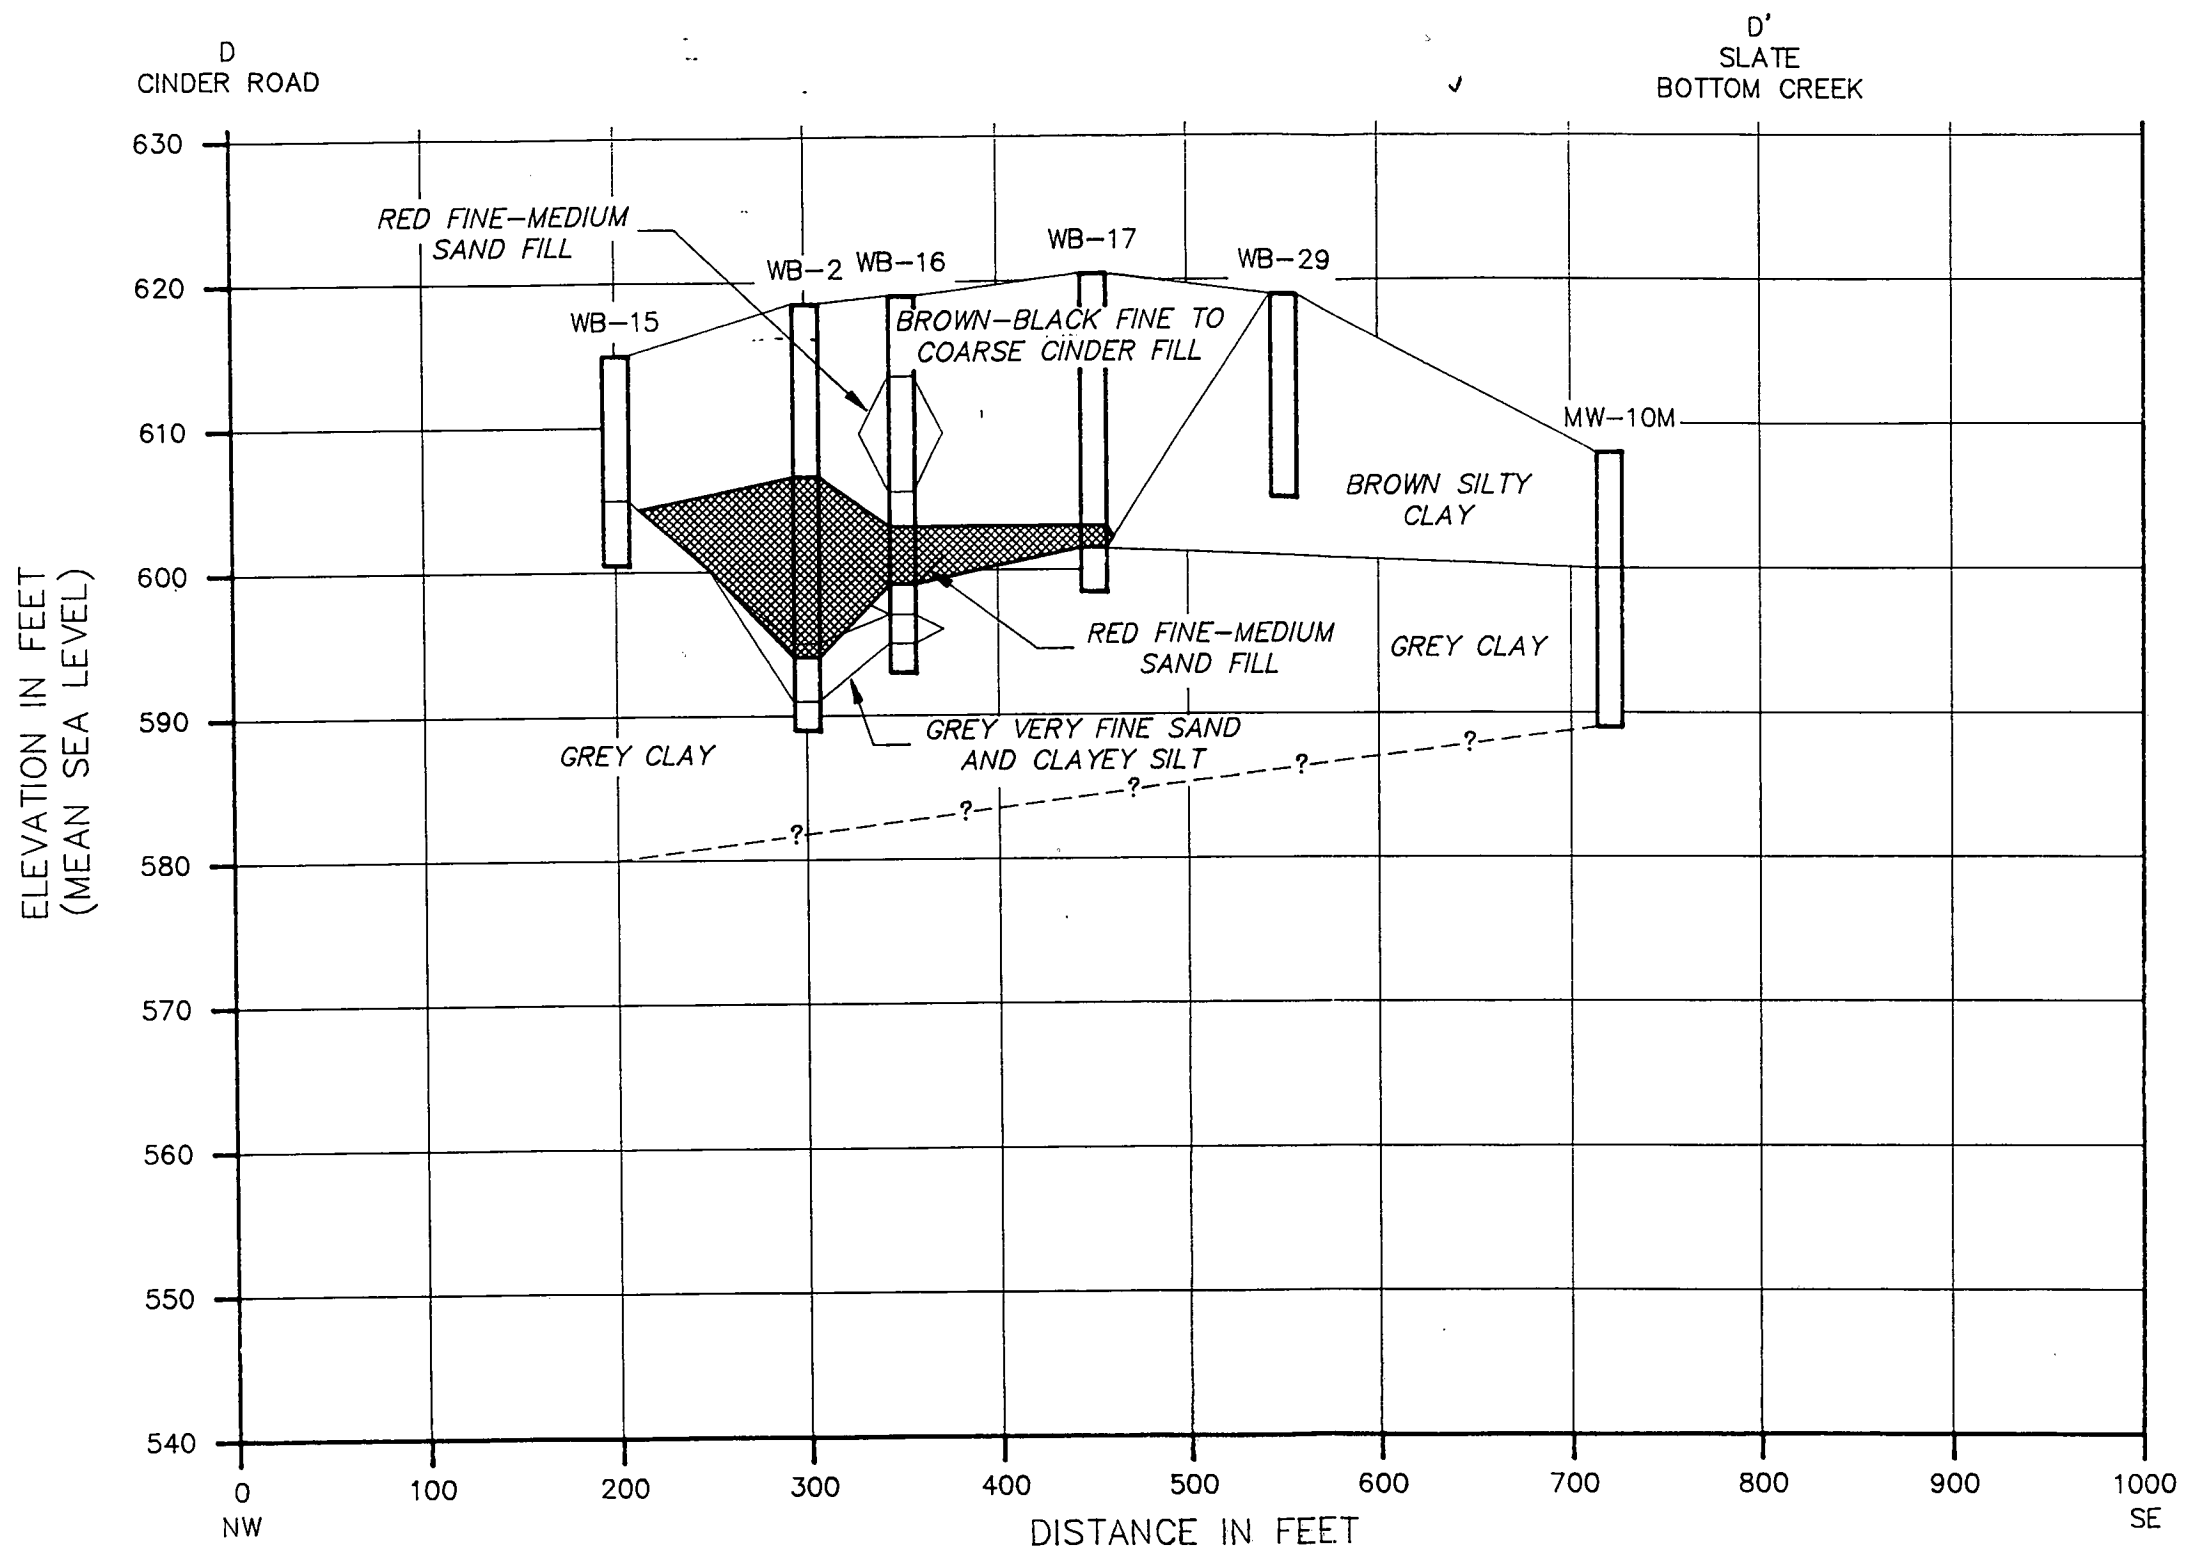
UNION ROAD SITE
BURIED WASTE CROSS SECTION D-D'

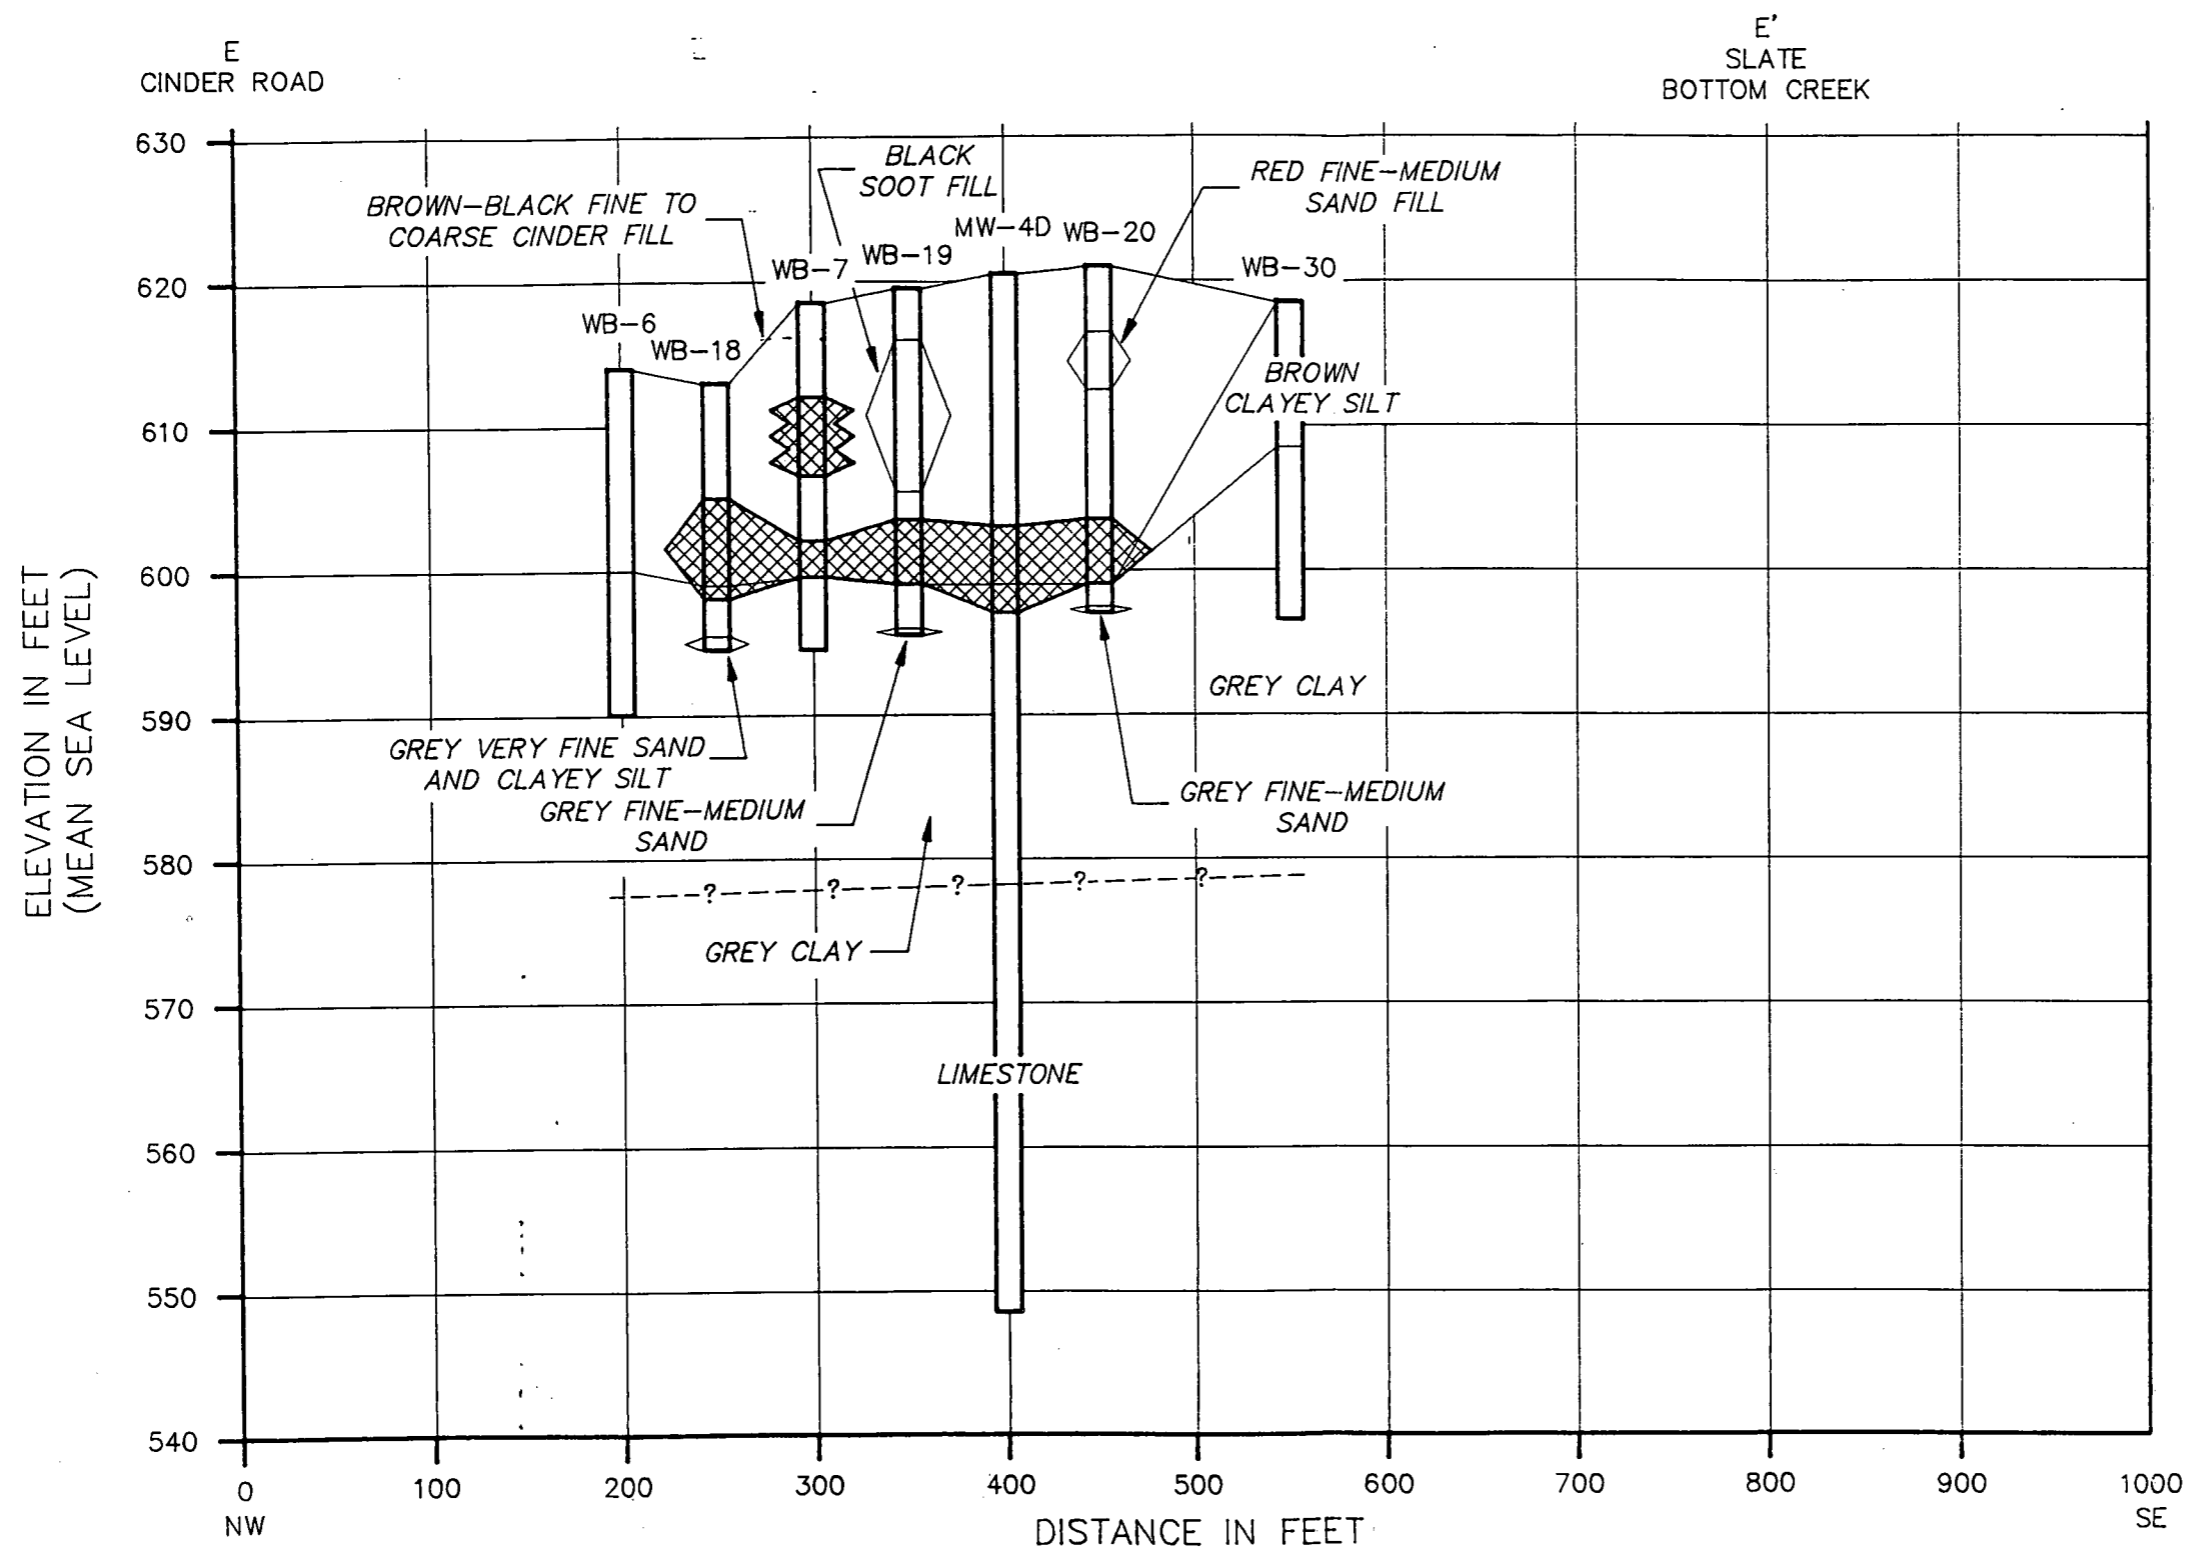
UNION ROAD SITE
BURIED WASTE CROSS SECTION E-E'

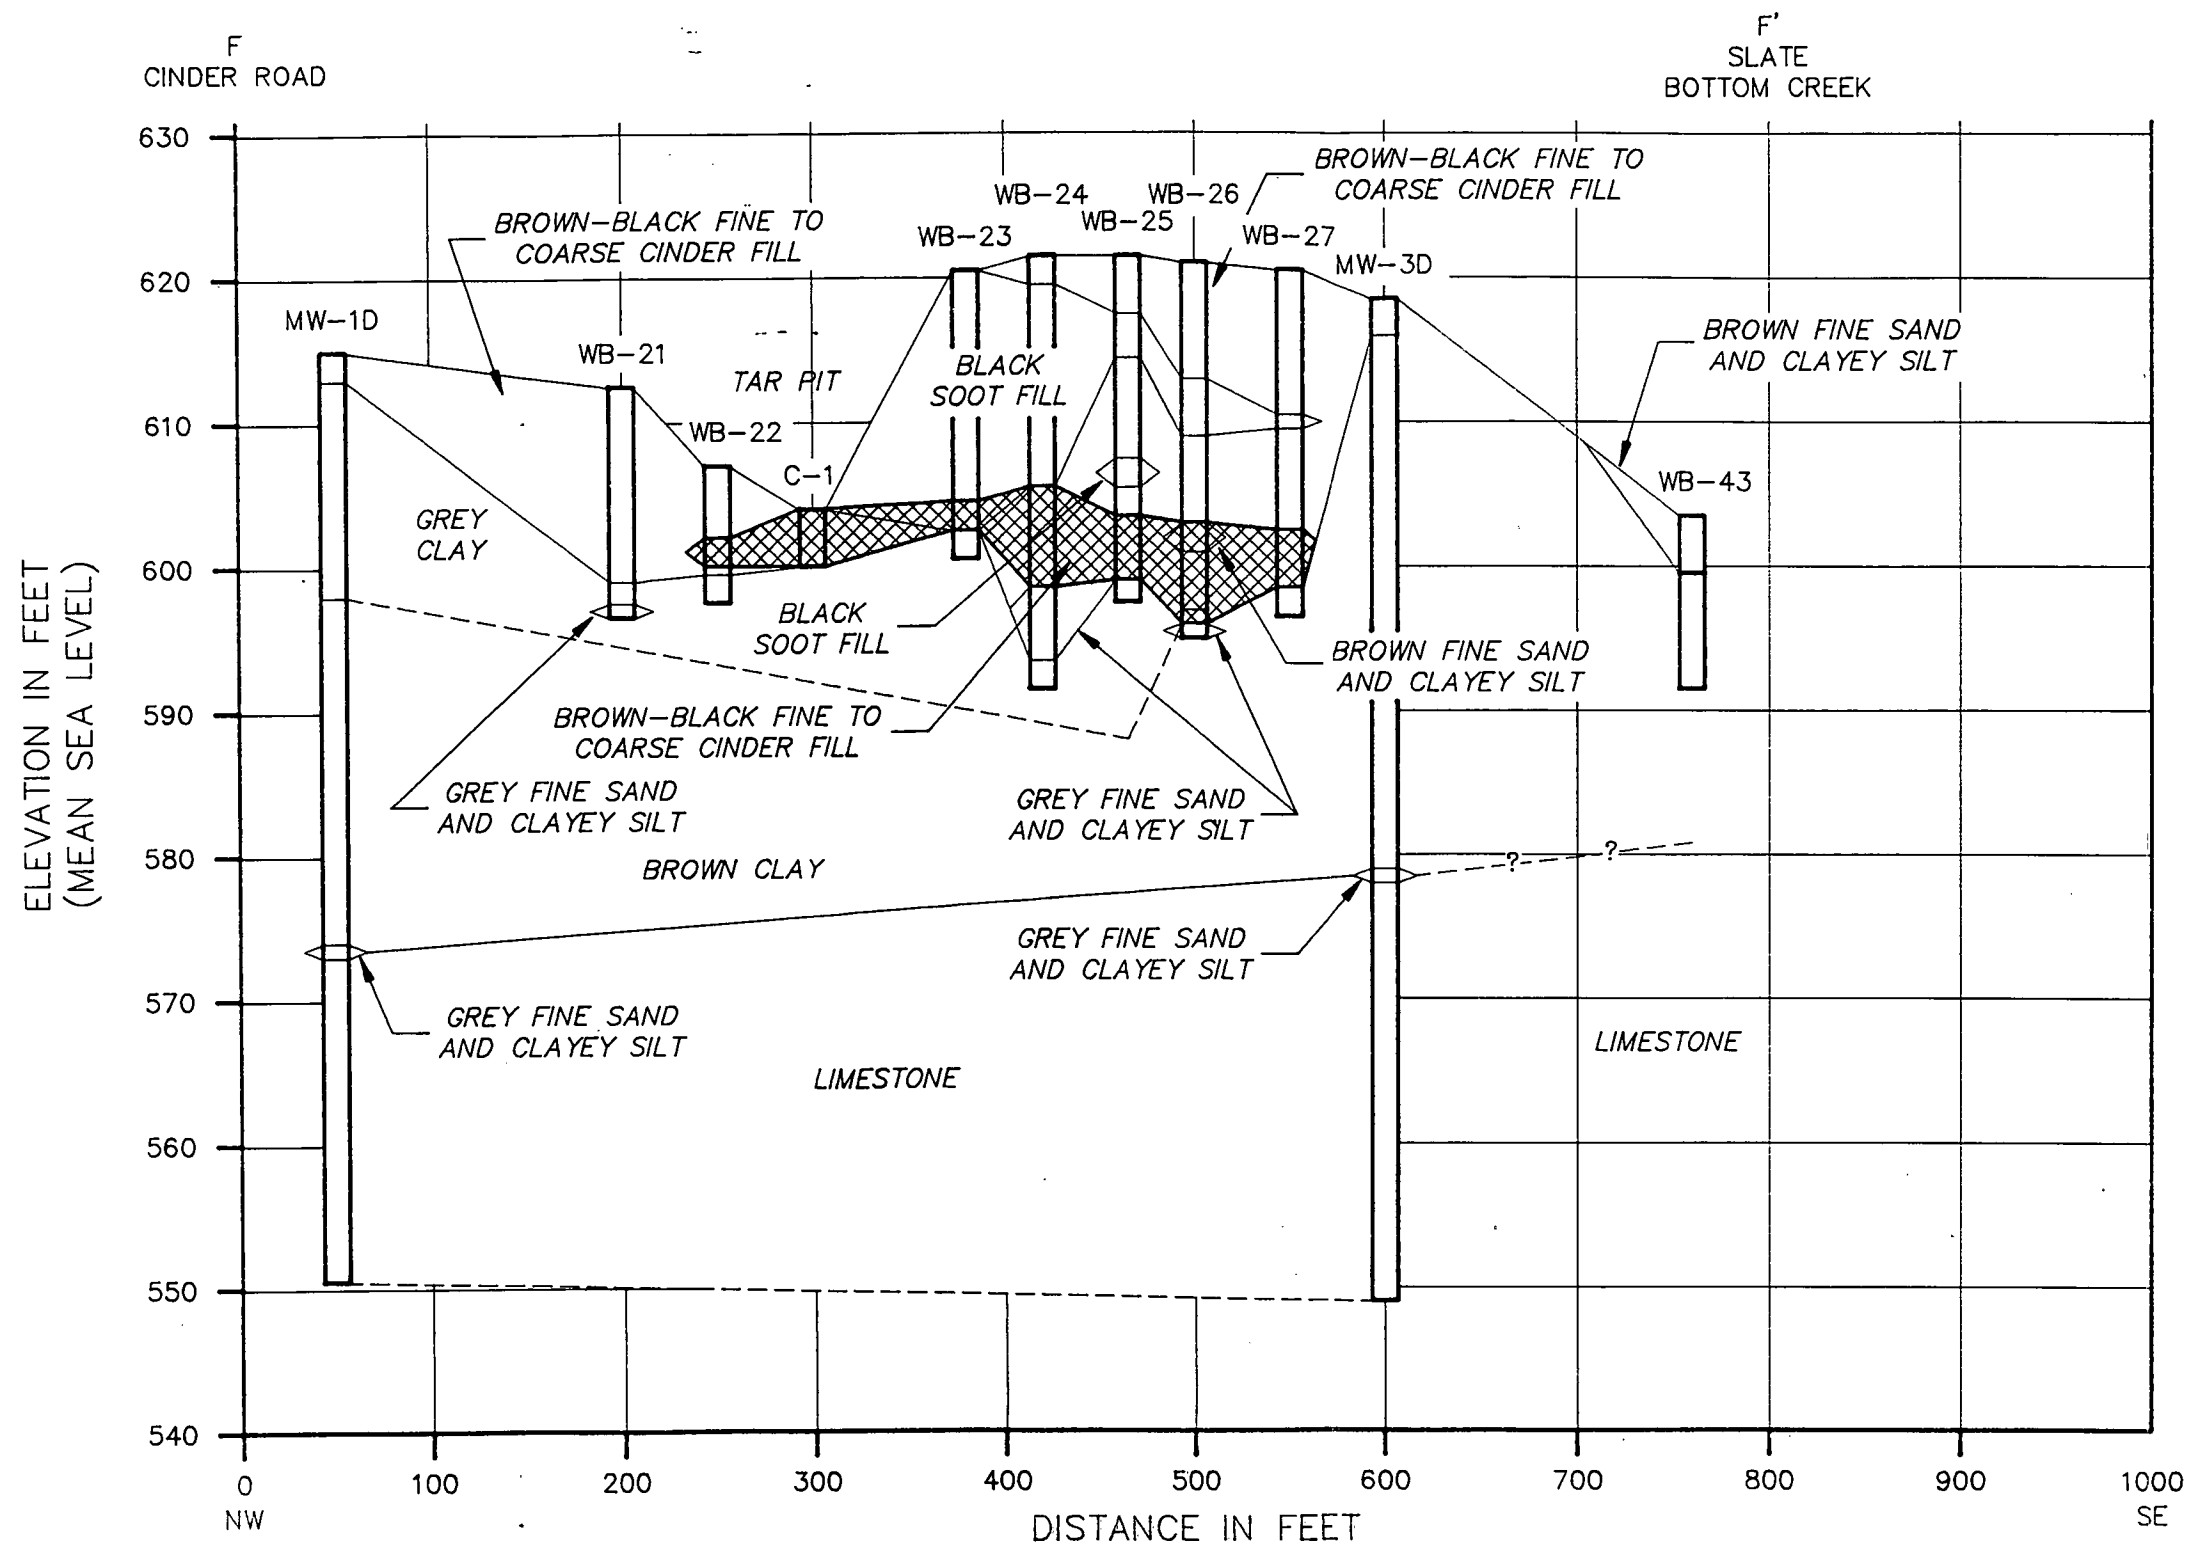
UNION ROAD SITE
BURIED WASTE CROSS SECTION F-F'

poorly sorted. The thickness of the till unit ranges from a minimum of approximately 5 feet at the MW-10M location to a maximum of approximately 23 feet at the MW-7D location. In general, the thicker sections appear to be associated with coarser deposits.
