2008 Periodic Review Report Mr. C's Dry Cleaners Site NYSDEC Site No. 9-15-157 Village of East Aurora Erie County, New York

June 2009

NEW YORK STATE DEPARTMENT OF ENVIRONMENTAL CONSERVATION DIVISION OF ENVIRONMENTAL REMEDIATION

ECOLOGY AND ENVIRONMENT ENGINEERING, P.C.

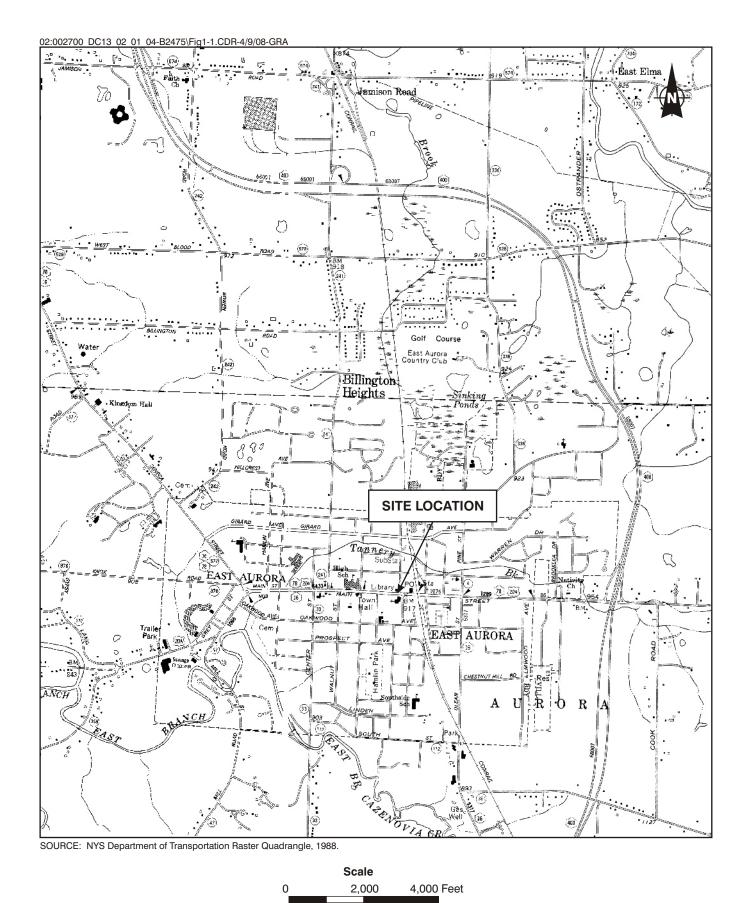
Figure 1-1 General Site Location Map

The Mr. C's Dry Cleaners site (New York State Superfund Site 9-15-157) is located at 586 Main Street in the village of East Aurora, Erie County, New York (see Figure 1-1). The site is located on an approximately 0.5-acre parcel in a mixed-use area of residential, municipal, and light-commercial properties. Mr. C's Dry Cleaners is located in a one-story building on a concrete slab foundation with an adjacent paved parking lot. Mr. C's Dry Cleaners occupies the front portion of the building. Other commercial businesses occupy other parts of the building.

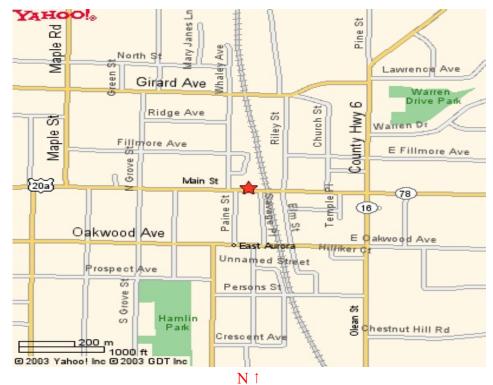
Mr. C's Site Location Map 586 Main Street, East Aurora, County of Erie F-3

The Mr. C's Site (site) is located at 586 Main Street in the Village of East Aurora (see map below). The cleanup was necessary to address groundwater beneath the site that has been contaminated with a common dry cleaning chemical known as tetrachloroethene (perchloroethene or PCE). PCE is a volatile organic compound (VOC). VOCs are chemicals that can evaporate easily, such as ingredients in paint thinners, gasoline and solvents. Although residents in the area are served by the Erie County Water Authority with potable water, cleanup is proceeding to prevent the potential for incidental ingestion or the inhalation of vapor phase chemicals from the groundwater.
