**CMS Property Associates Site**  
**ERIE COUNTY, NEW YORK**

**Site Management Plan**

**NYSDEC Site Number: 915168**

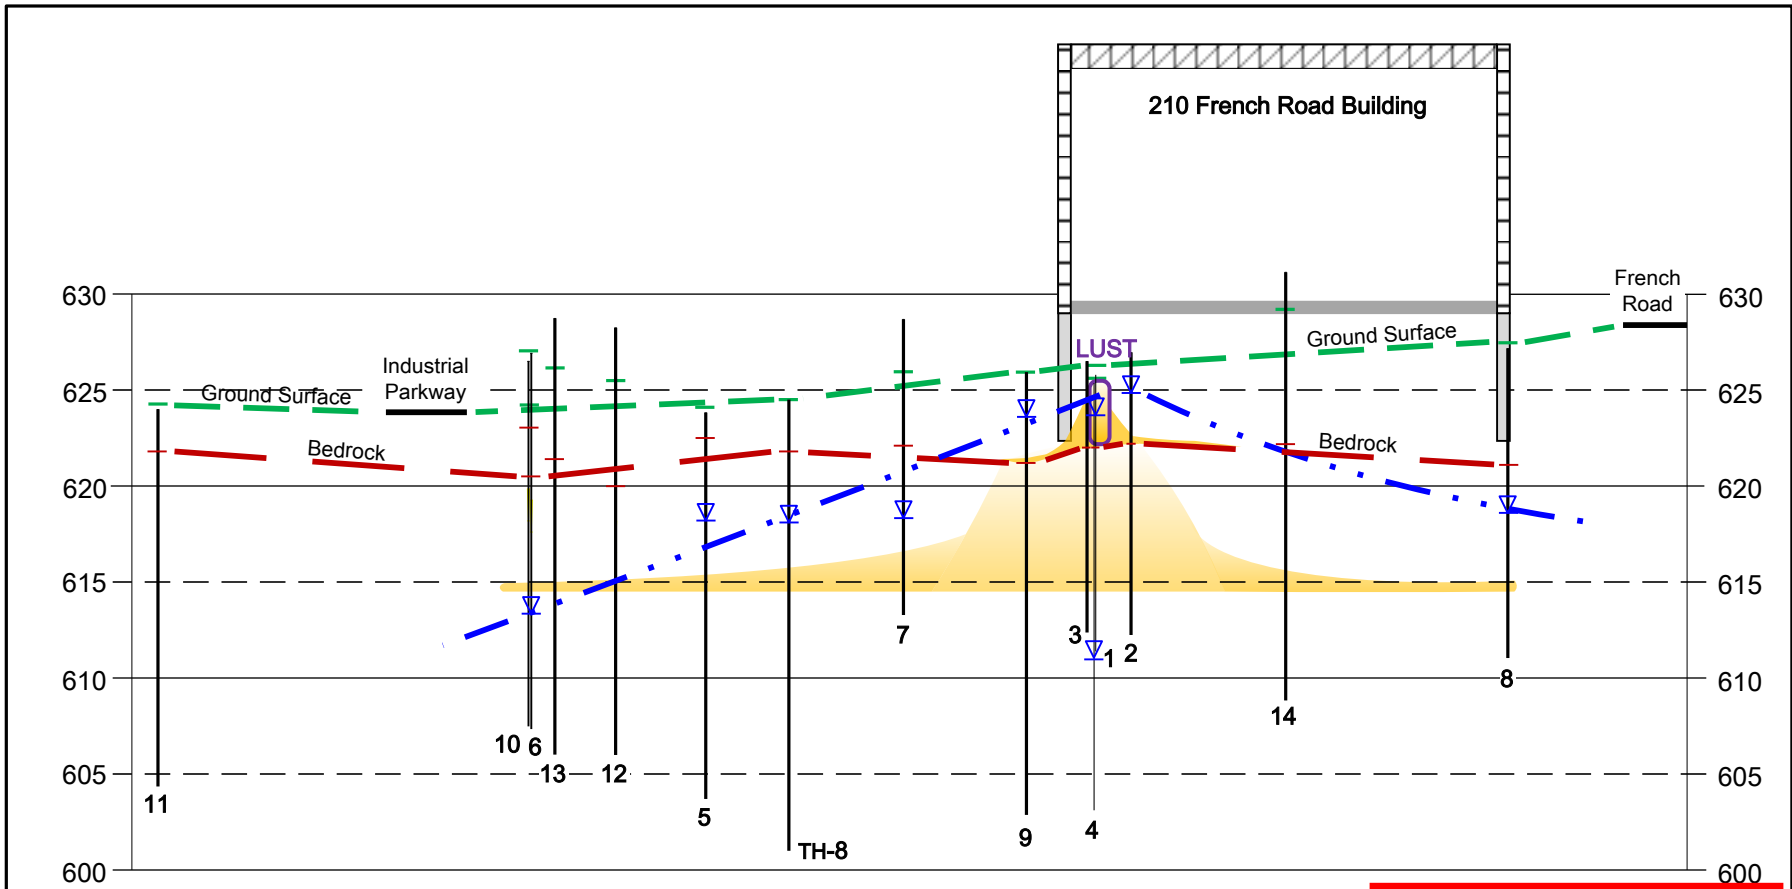
**FIGURE 2  
Conceptual Site  
Model**

CMS Associates Remediation Site Annual Summary Report
<b>Figure 10</b>
<b>Conceptual Site Model</b>
Ken W. Kloeber Consulting Engineers

Figure 2 shows a cross section of the site from French Road at the south to Industrial Parkway at the north, and depicts the micro-variability of the top of bedrock elevation (from monitoring well installations and recent hand probes to refusal.) Monitoring well logs show that the top limestone and shale formations slope downward slightly from east to west and from north to south. Figure 3 depicts the top of bedrock elevations developed from available historic information. An additional monitoring well (see Appendix H) is scheduled for 2015 and this SMP will be updated with the findings of that boring.

Figure 2 is a cross section that shows the depths of all monitoring wells, and their spacing, relative to a north-south baseline through MW-1 (the near-middle of the Site.) Geologic cross sections had not been prepared during the Remedial Investigation, but new studies scheduled for 2015 and 2016 will concentrate on Site hydrogeology and this SMP will be revised with those findings.
