RCRA Facility Assessment Report  
Preliminary Review

General Electric Company

Buffalo Service Shop  
Tonawanda, New York

July 1987

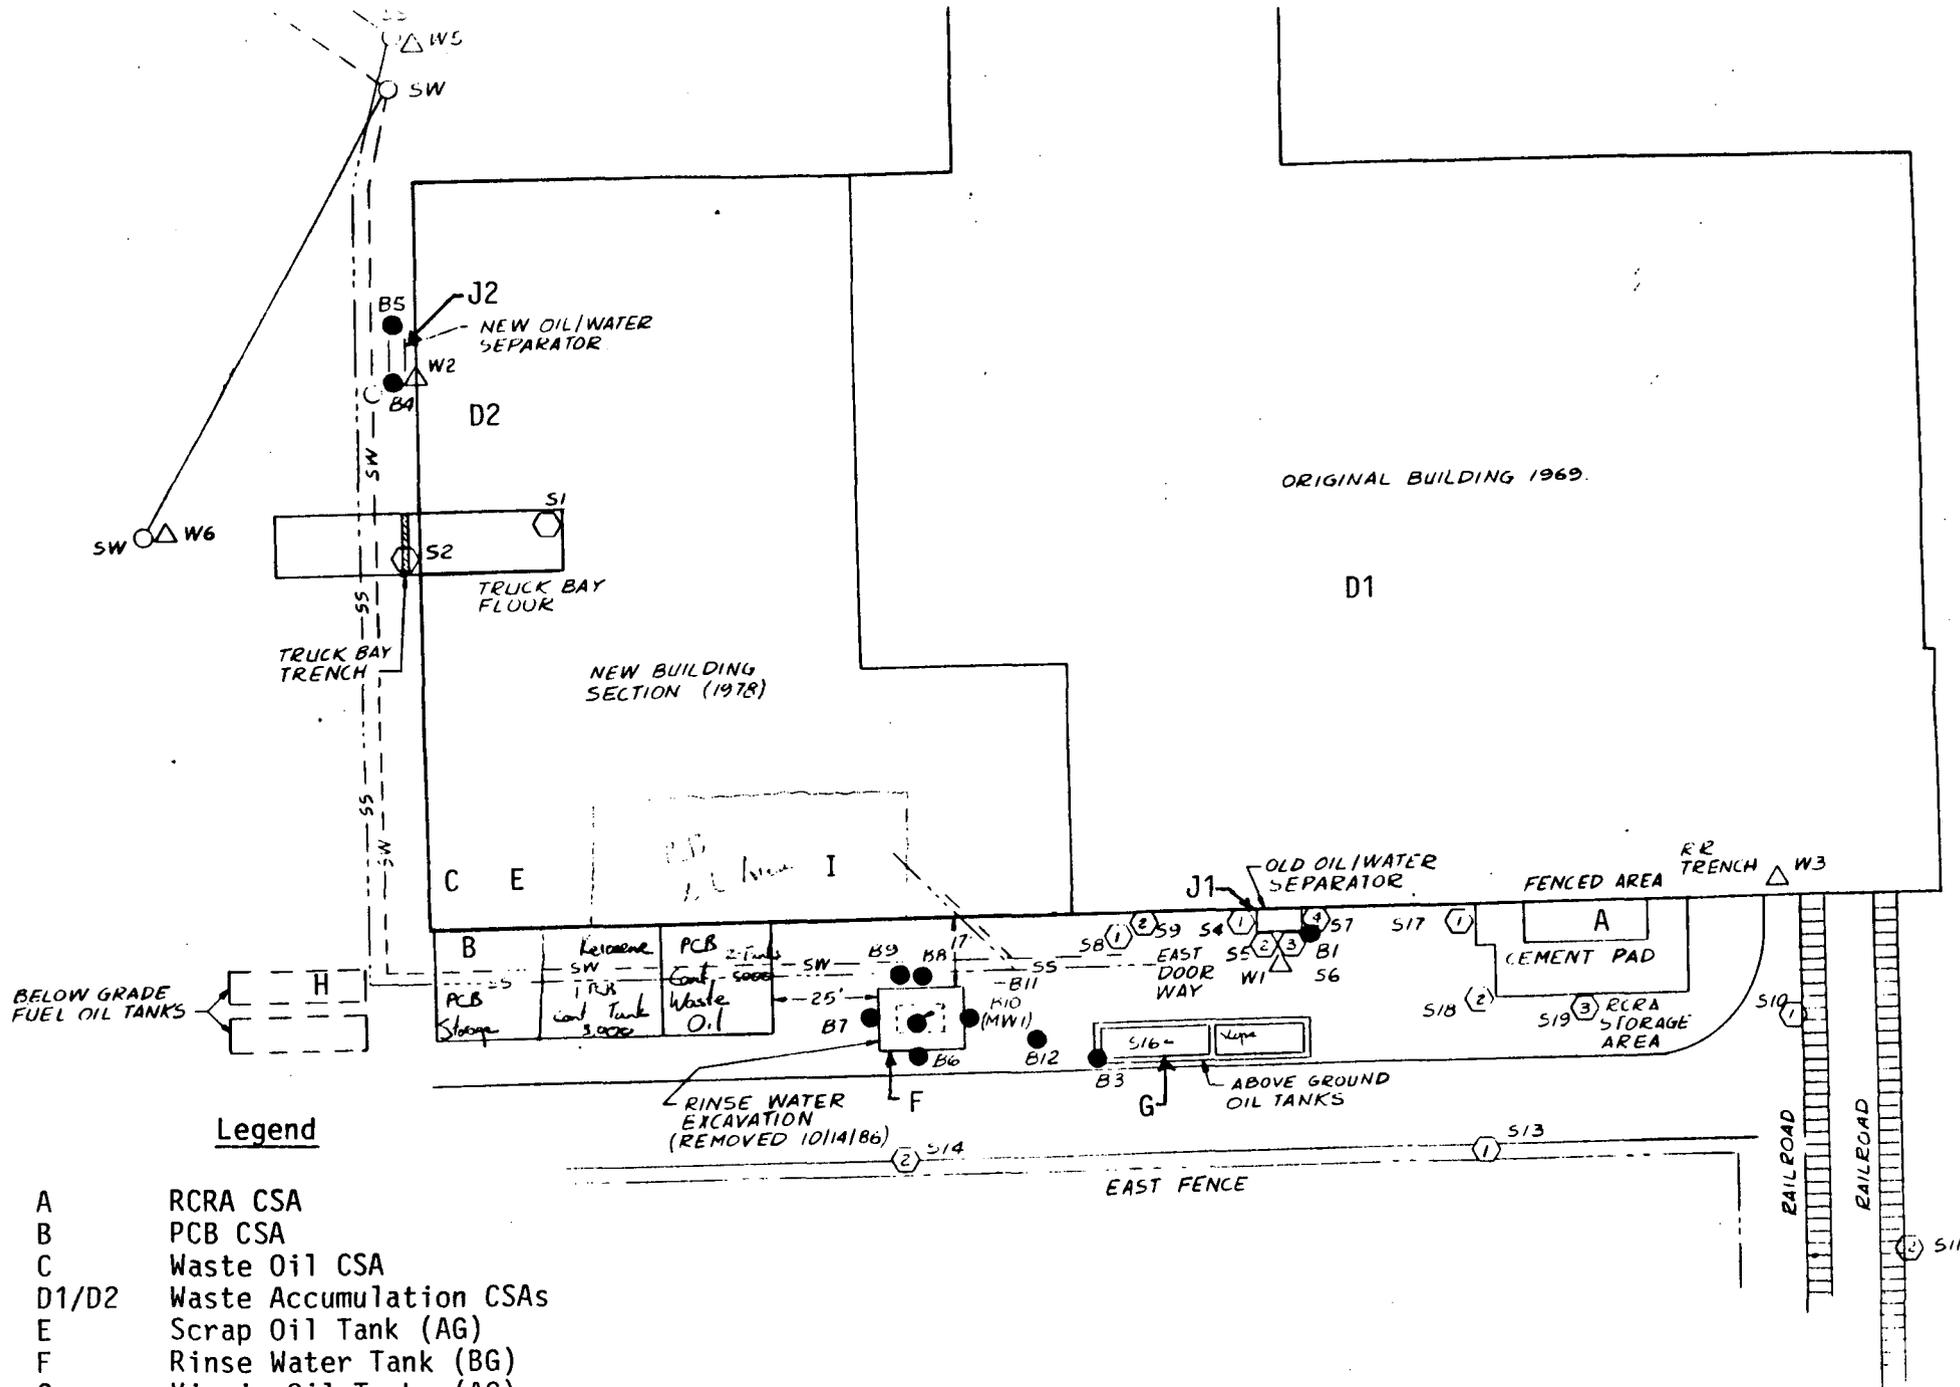
**Legend**

- A RCRA CSA
- B PCB CSA
- C Waste Oil CSA
- D1/D2 Waste Accumulation CSAs
- E Scrap Oil Tank (AG)
- F Rinse Water Tank (BG)
- G Virgin Oil Tanks (AG)
- H Fuel Oil Tanks (BG)
- I PCB Work Area
- J1/J2 Oil/Water Separators

\*\*See Attached Facility Map

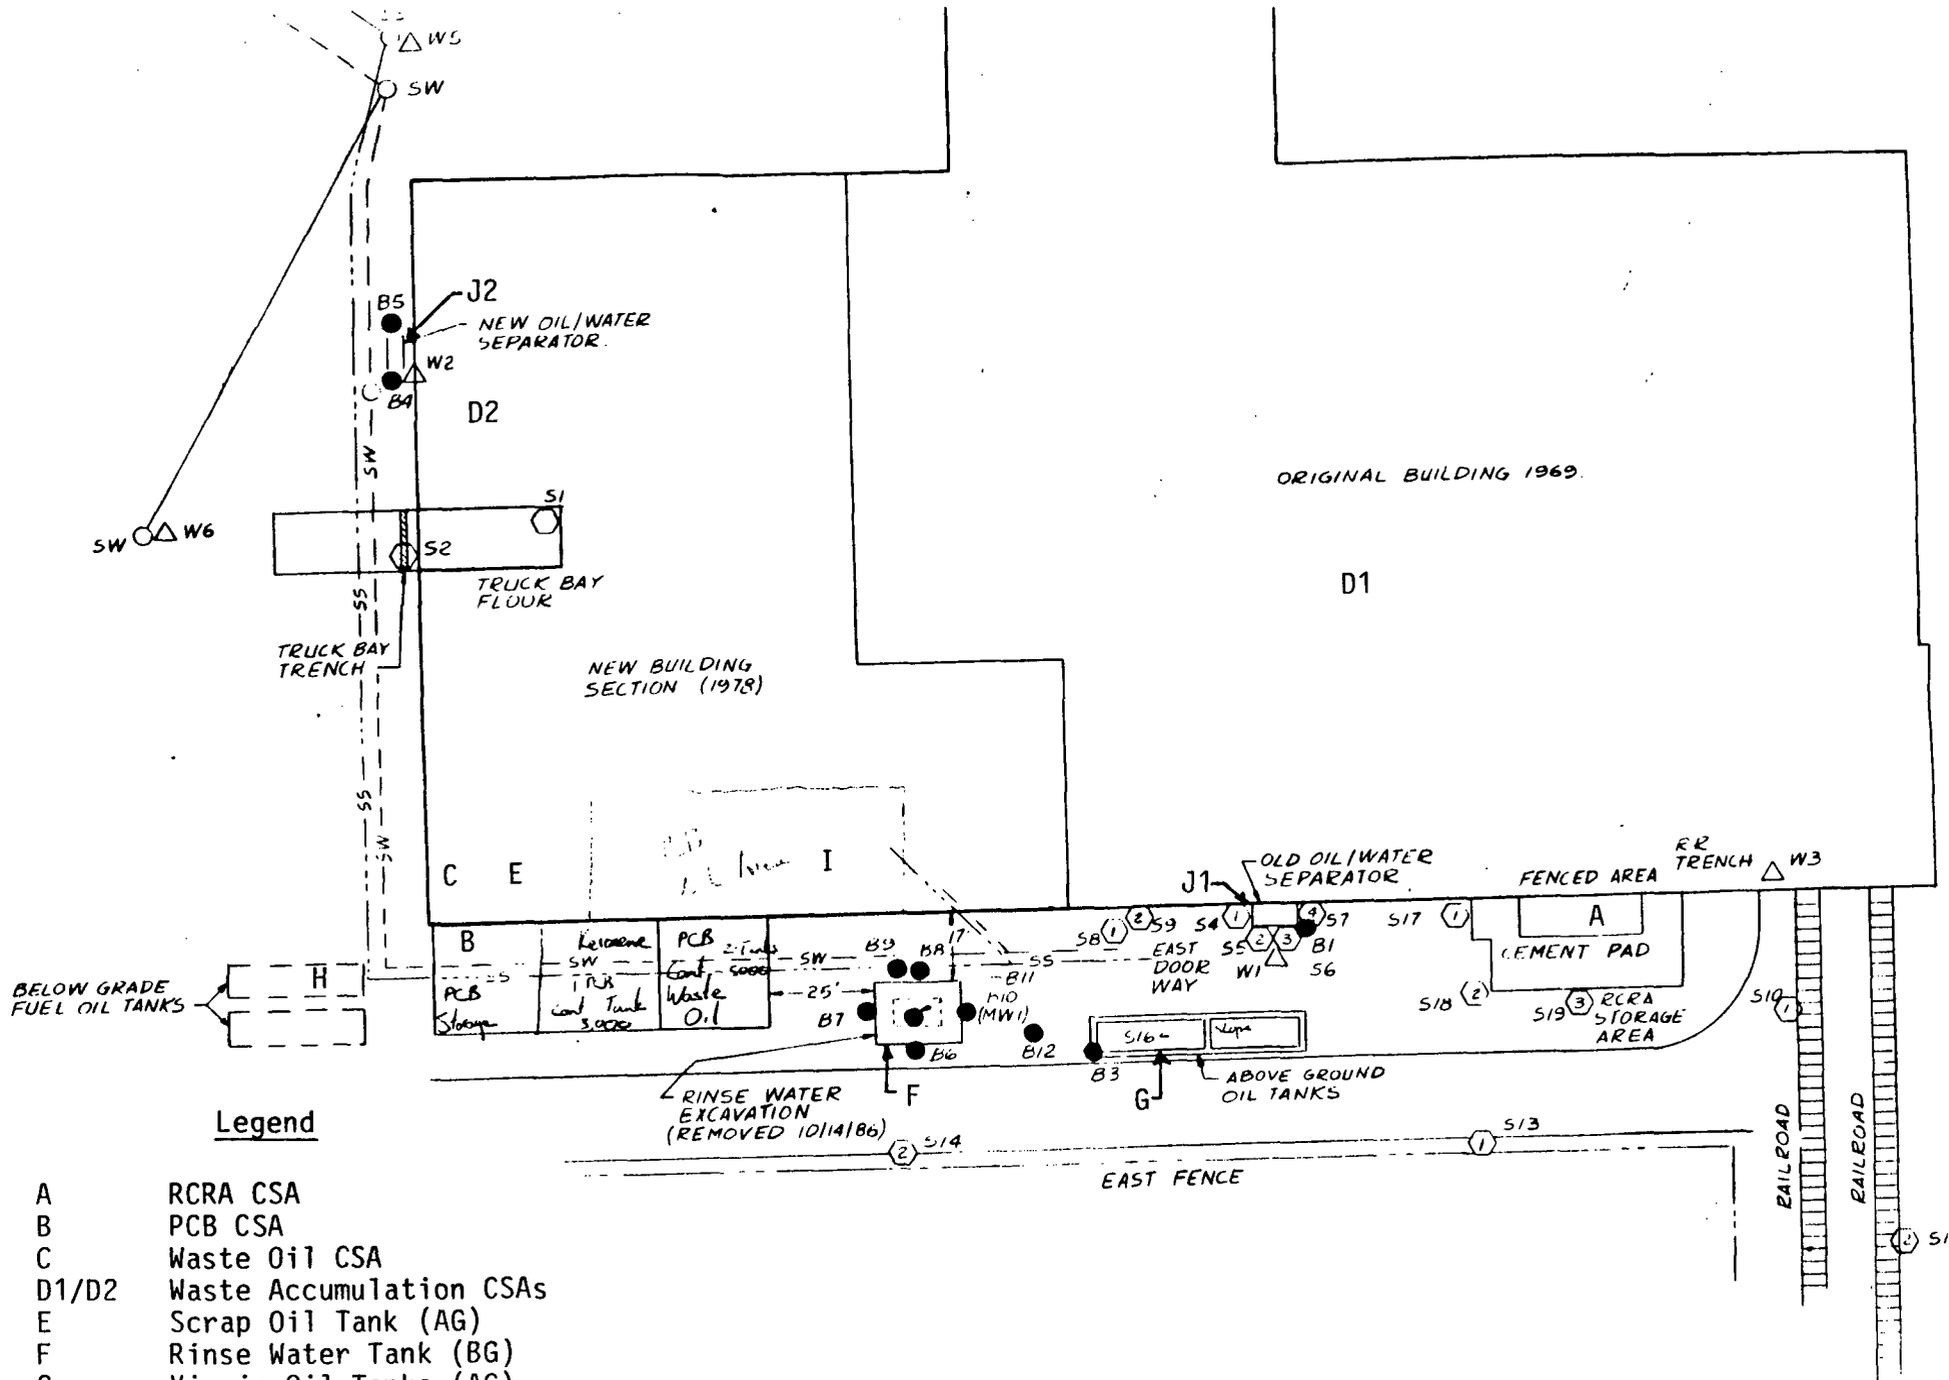
**Legend**

- A RCRA CSA
- B PCB CSA
- C Waste Oil CSA
- D1/D2 Waste Accumulation CSAs
- E Scrap Oil Tank (AG)
- F Rinse Water Tank (BG)
- G Virgin Oil Tanks (AG)
- H Fuel Oil Tanks (BG)
- I PCB Work Area
- J1/J2 Oil/Water Separators

Unit	Sample Location	Collection Procedure	Sample Matrix/Type	Number of Samples	Parameters	Analytical Method from SW-846
RCRA CSA	South Side of concrete pad	hollow stem auger	core/soil	3	halogenated volatile organics	8010
					nonhalogenated volatile organics	8015
					aromatic volatile organics	8020
PCB CSA	Southeast corner	stainless steel scoop	surface/soil	1	Organochlorine Pesticides & PCBs	8080
Virgin Oil Tanks	next to dike drain	hollow stem auger	core/soil	4	*	*
Rail Spur	See diagram	Stainless steel scoop	Surface/soil	6	Organochlorine Pesticides & PCBs	8080

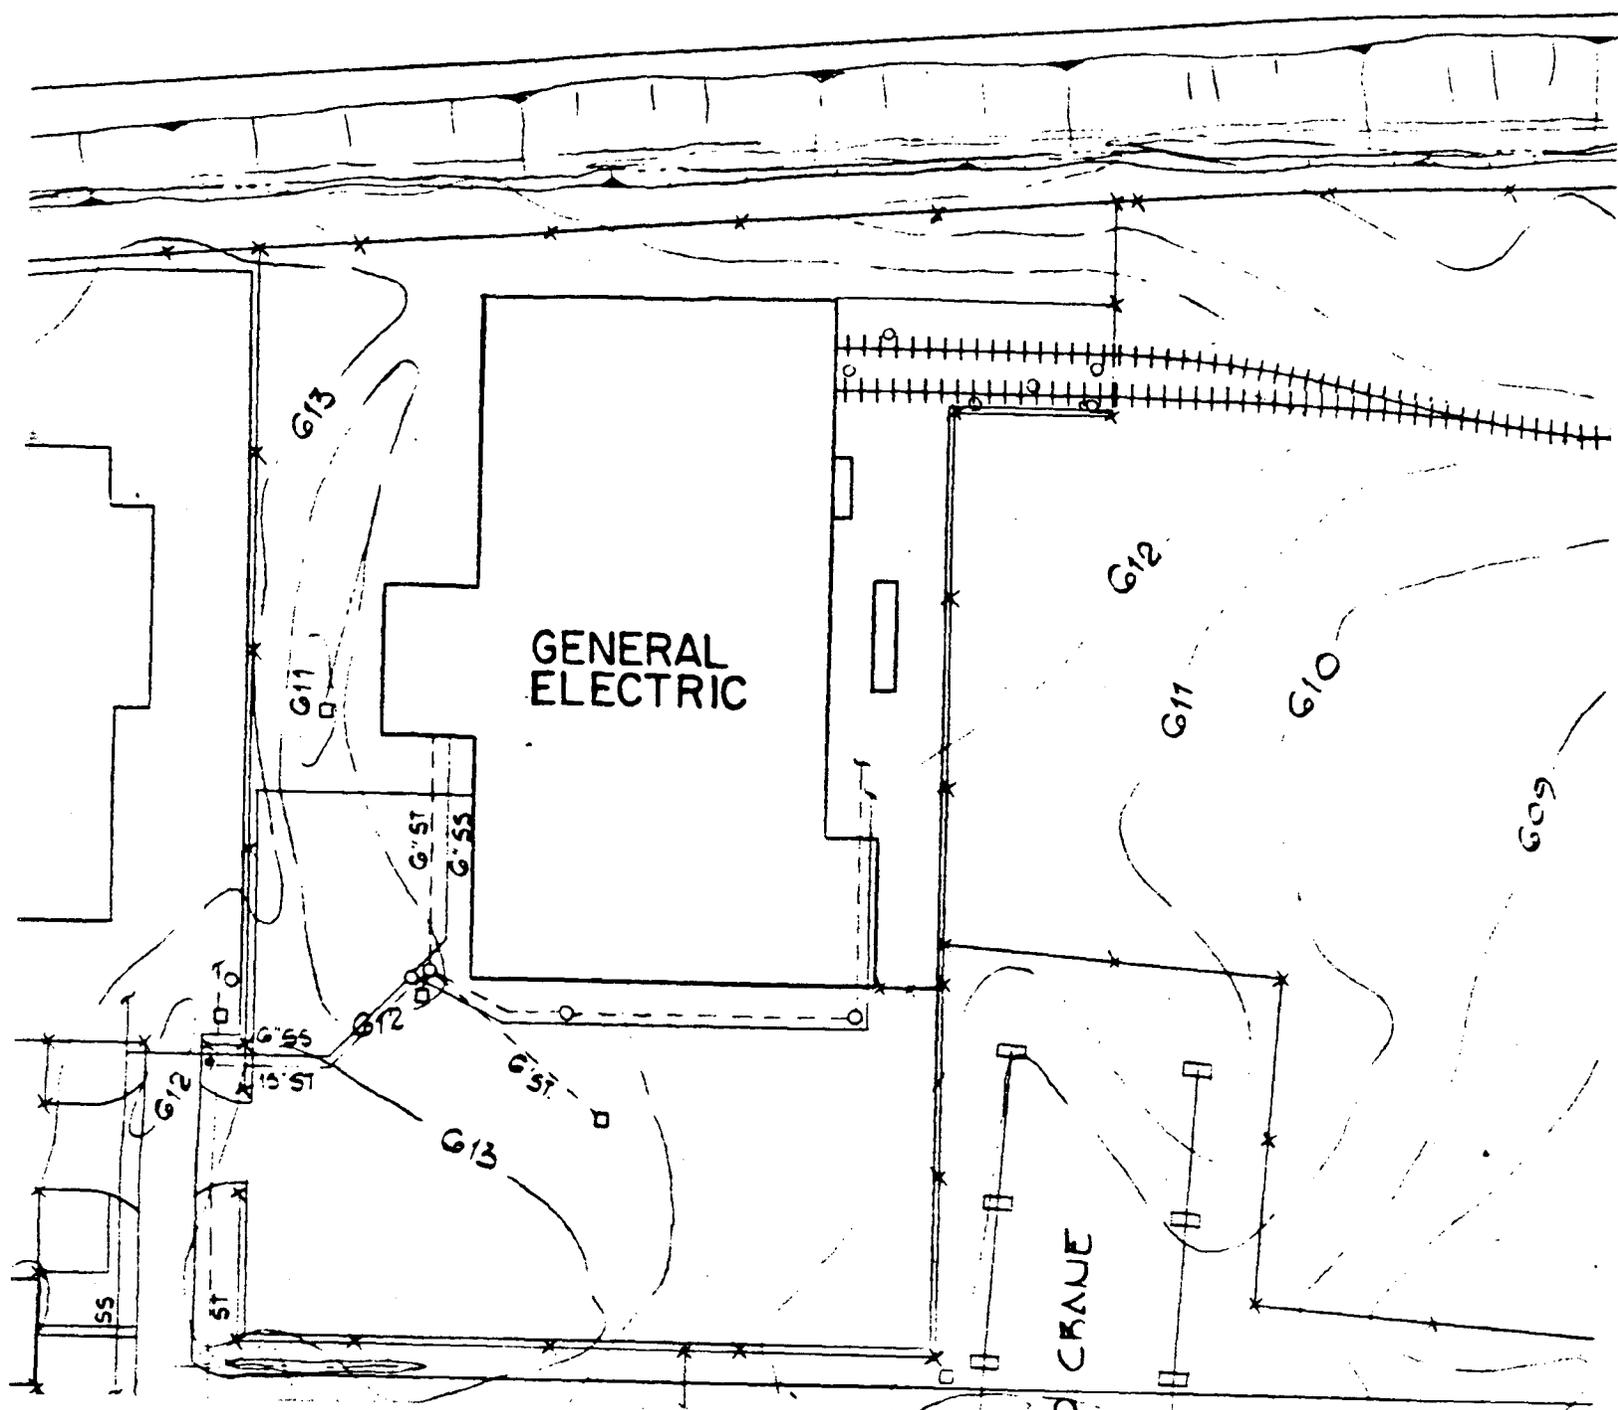
## Legend

◦ Sampling Location
