NYSDEC ID NUMBER: 9-1464-00044
PARTS AND REPAIR SERVICE CENTER
GENERAL ELECTRIC INTERNATIONAL, INC.
175 MILENS ROAD
TONAWANDA, NEW YORK

CORRECTIVE MEASURE IMPLEMENTATION PLAN

OCTOBER 2, 2012

URS

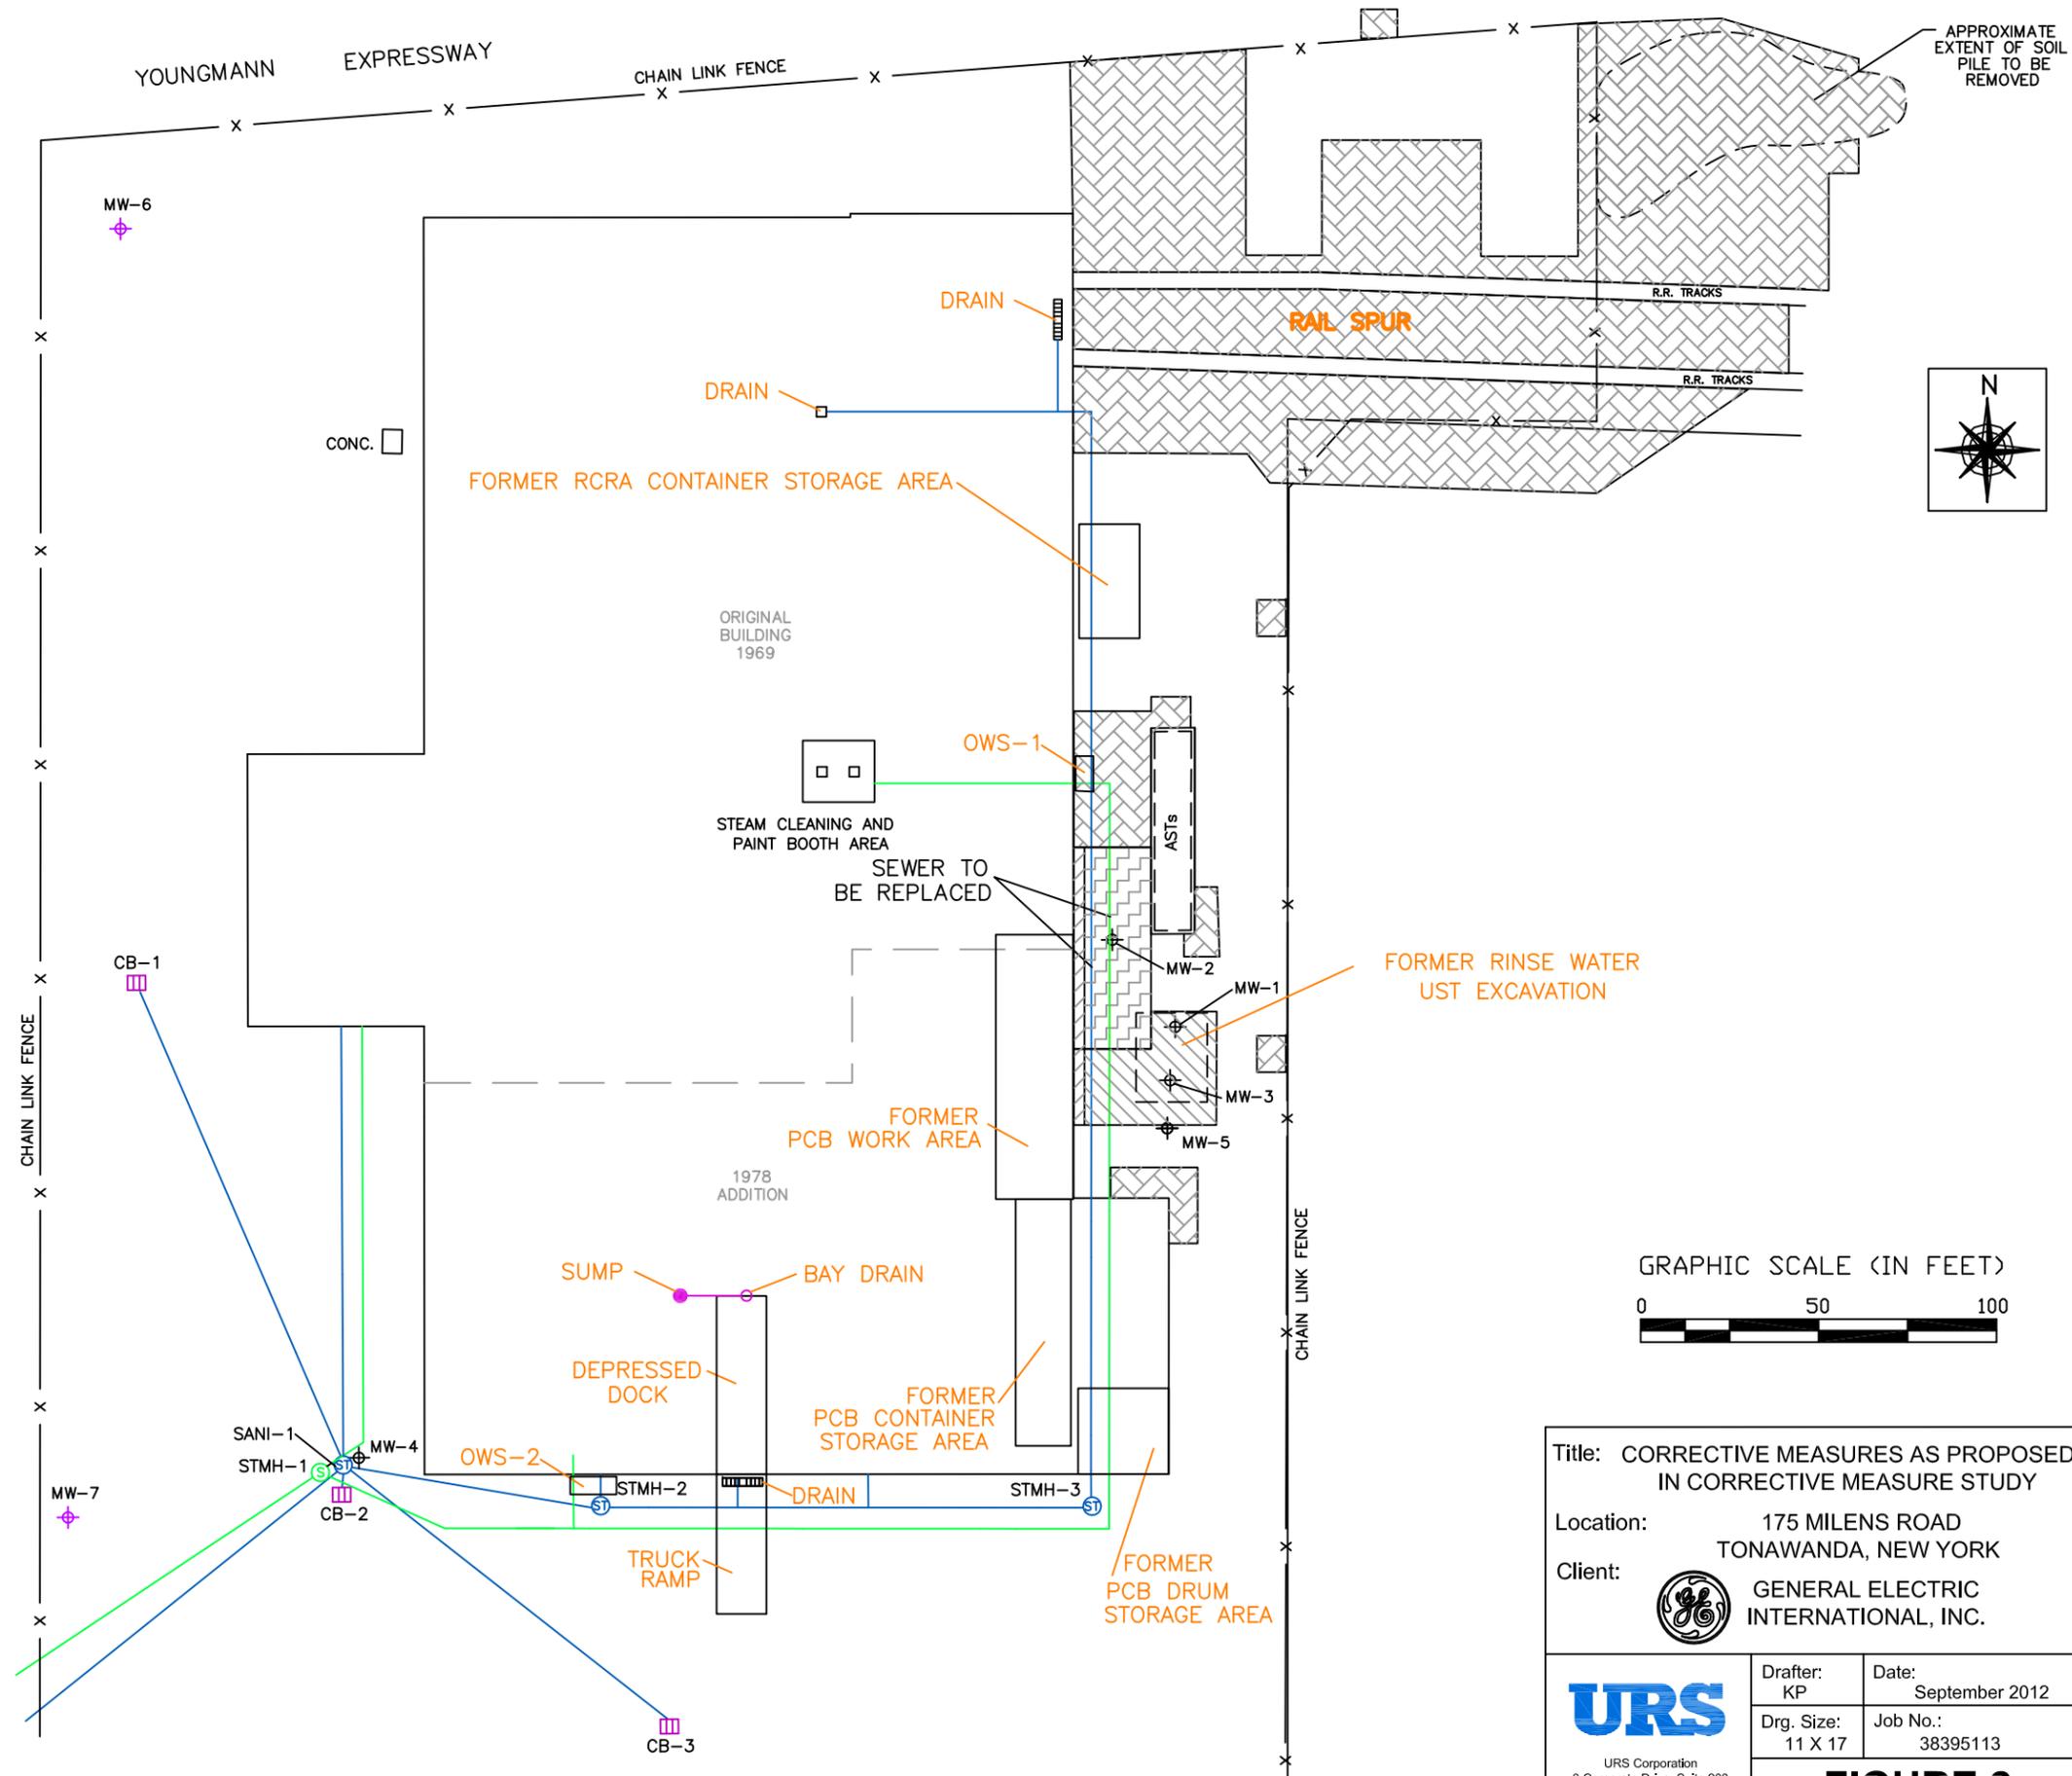
Title: CORRECTIVE MEASURES AS PROPOSED IN CORRECTIVE MEASURE STUDY
 Location: 175 MILENS ROAD TONAWANDA, NEW YORK
 Client:

- 8 INCH STORM SEWER TO BE REPLACED
-

- 4 INCH SANITARY SEWER TO BE REPLACED
-

- NEW MONITORING WELL

MILENS ROAD STORM SEWER:
CLEAN APPROX. 1,340 FT
OF LINE AND MANHOLES
MH-1 THROUGH MH-4

- Replacement of the storm sewer line that passes through the subsurface excavation areas on the east side of the building.

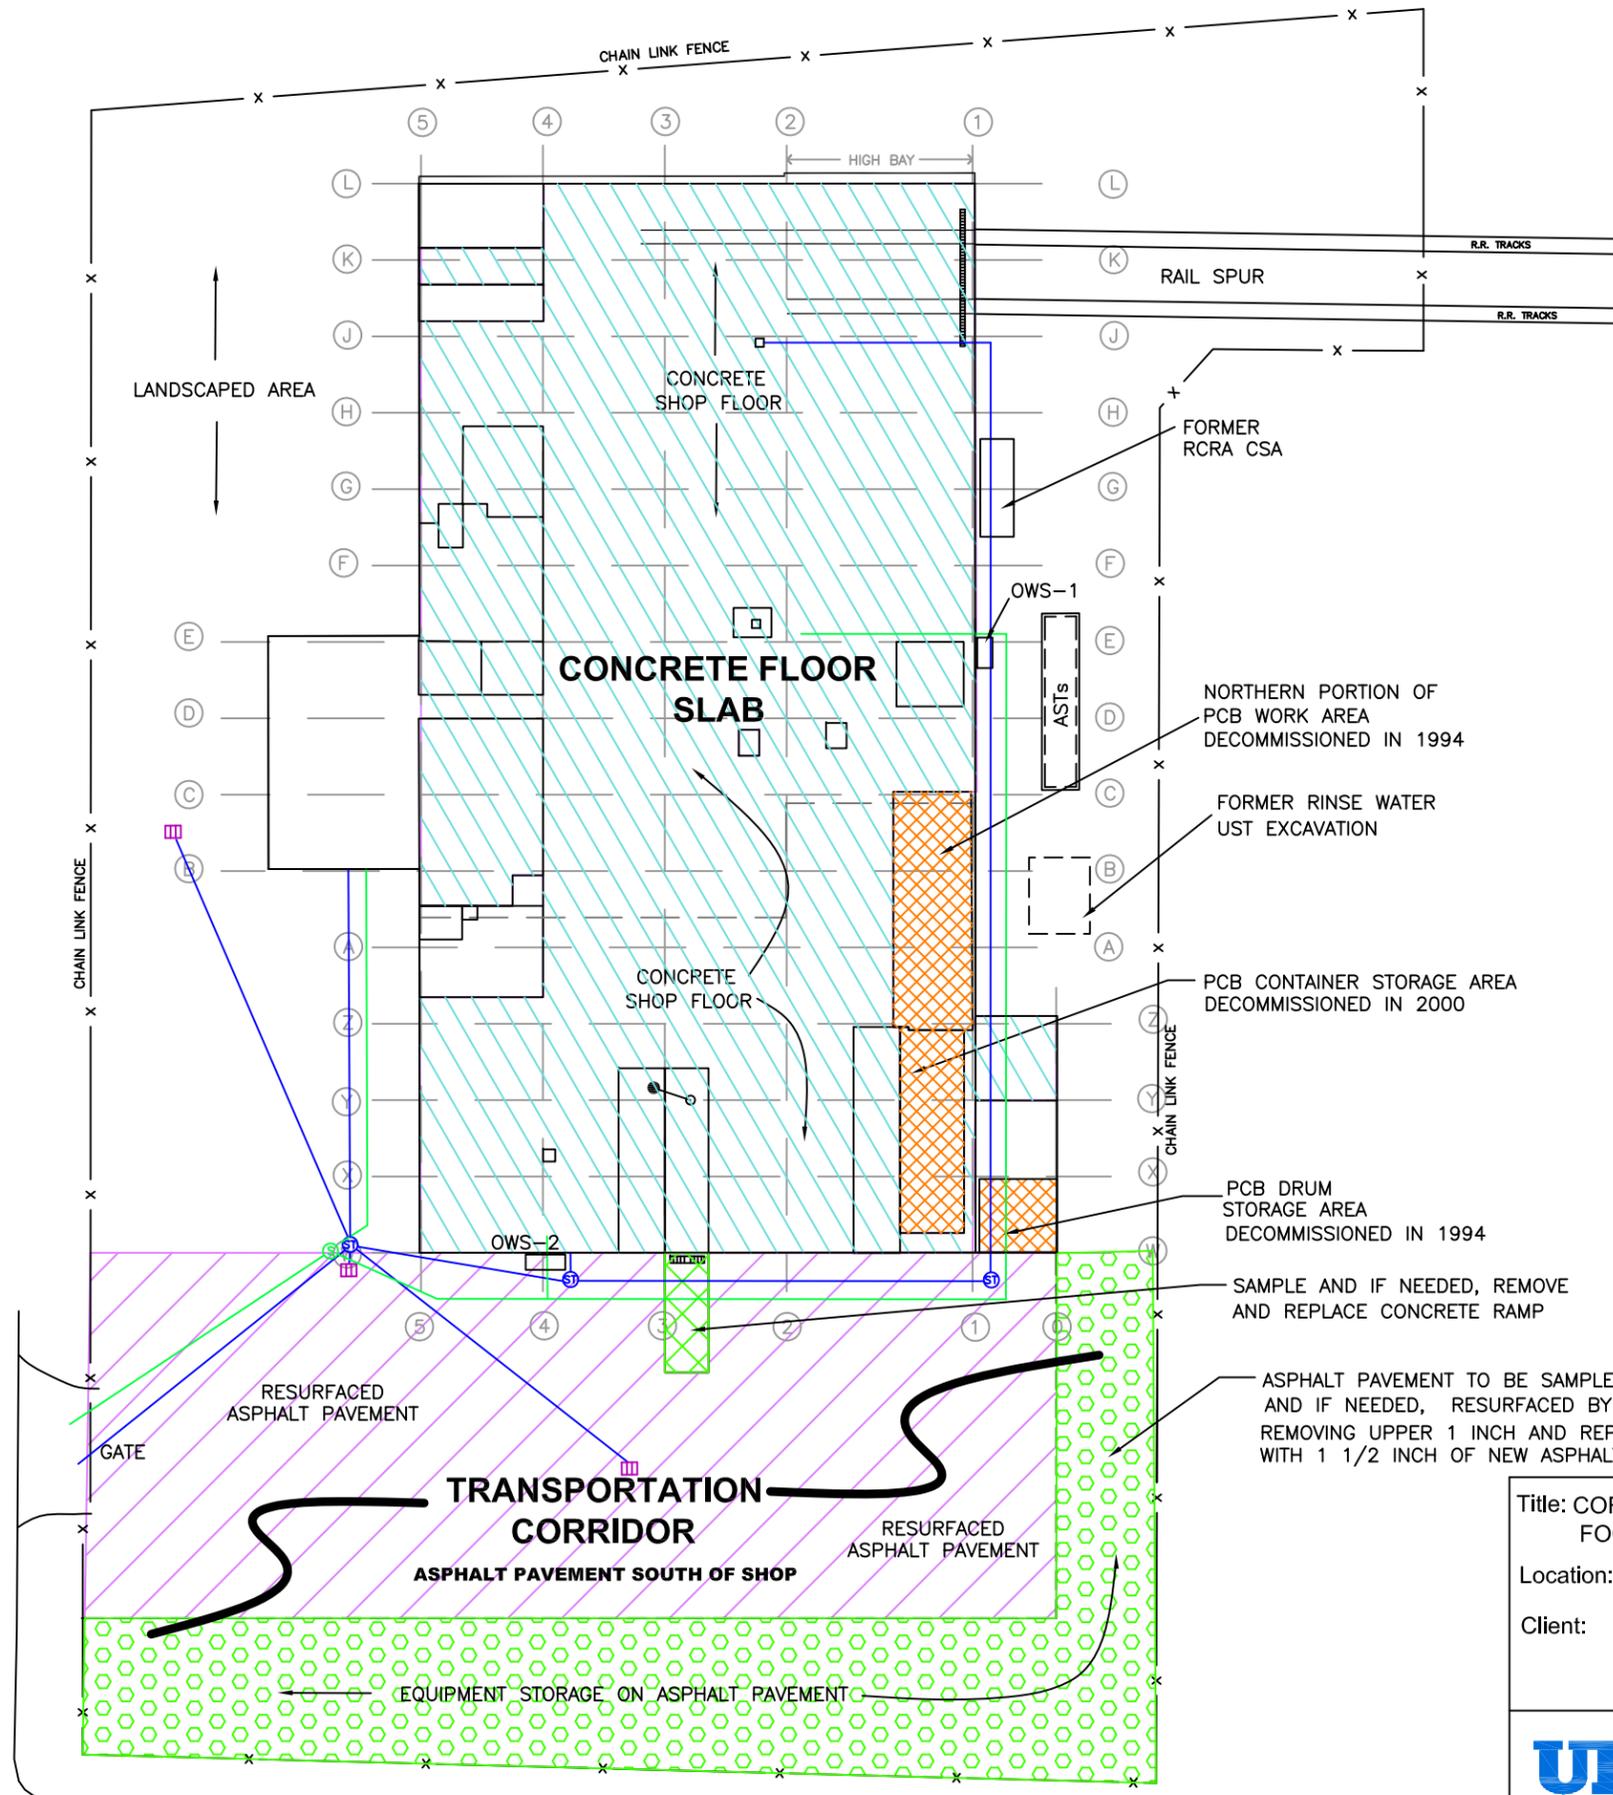
Title: CORRECTIVE MEASURES AS PROPOSED IN FOCUSED CORRECTIVE MEASURE STUDY

- ASPHALT PAVEMENT - SURFACE REMOVED AND REPLACED (2004)
-

- CONCRETE RAMP TO BE SAMPLED, AND IF NECESSARY, REMOVED AND REPLACED
-

- ASPHALT PAVEMENT TO BE SAMPLED, WHEN ACCESSIBLE, AND (IF NECESSARY) SURFACE REMOVED AND REPLACED

- Investigation and if necessary removal and replacement of the concrete truck ramp.
