2017 Site Inspection Report

Lockport City Landfill
NYSDEC Site No. 9-32-010

City of Lockport, New York
Department of Public Works

GHD | 285 Delaware Avenue Suite 500 Buffalo New York 14202
11137273 | Report No 1 | January 8, 2018

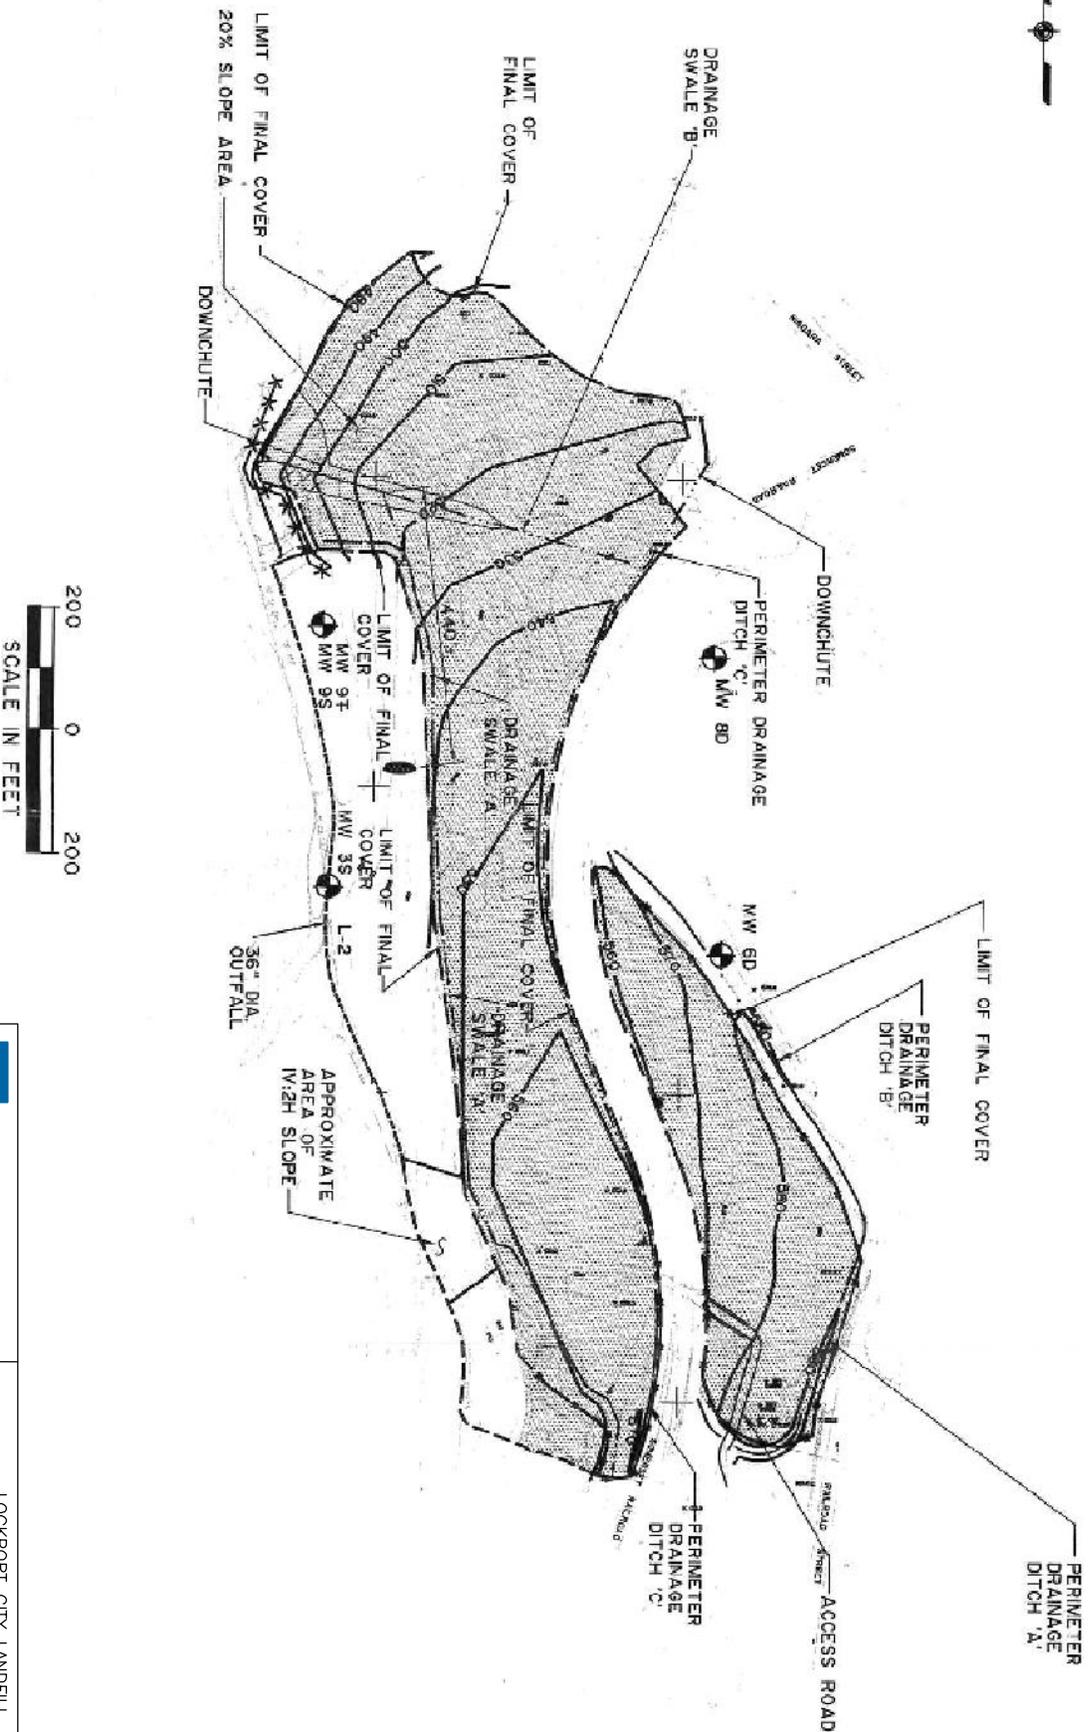
Figure 1 Site Plan

The Remedial Action Design for the Site included a Long-Term Monitoring Plan and Operation and Maintenance Plan that were approved by the New York State Department of Environmental Conservation (NYSDEC) in March 1994. The purpose of the Long-Term Monitoring Plan is to provide information to evaluate and monitor the long-term effectiveness of the remedial work. The Operation and Maintenance Plan includes site inspections and analytical testing to identify any potential problems at the landfill that are not being adequately addressed by routine maintenance, and to document the current condition of the landfill. A site plan of the Lockport City Landfill is presented on Figure 1.
