Glenn Springs Holdings, Inc.

Re: Quarterly Progress Report – Second Quarter 2021
Occidental Chemical Corporation, Buffalo Avenue Plant
NY Permit Number 9-2911-00112/00167-0
Module II – Corrective Action Requirements

In accordance with Module II of the Niagara Plant's Resource Conservation and Recovery Act (RCRA)/Part 373 Permit, the following is the quarterly data report for the period of April 1, 2021 to June 30, 2021. Table 1 is a summary of the monitoring tasks by quarter that are performed each year along with completion dates where applicable. Table 2 presents a summary of maintenance activities performed during the quarter.

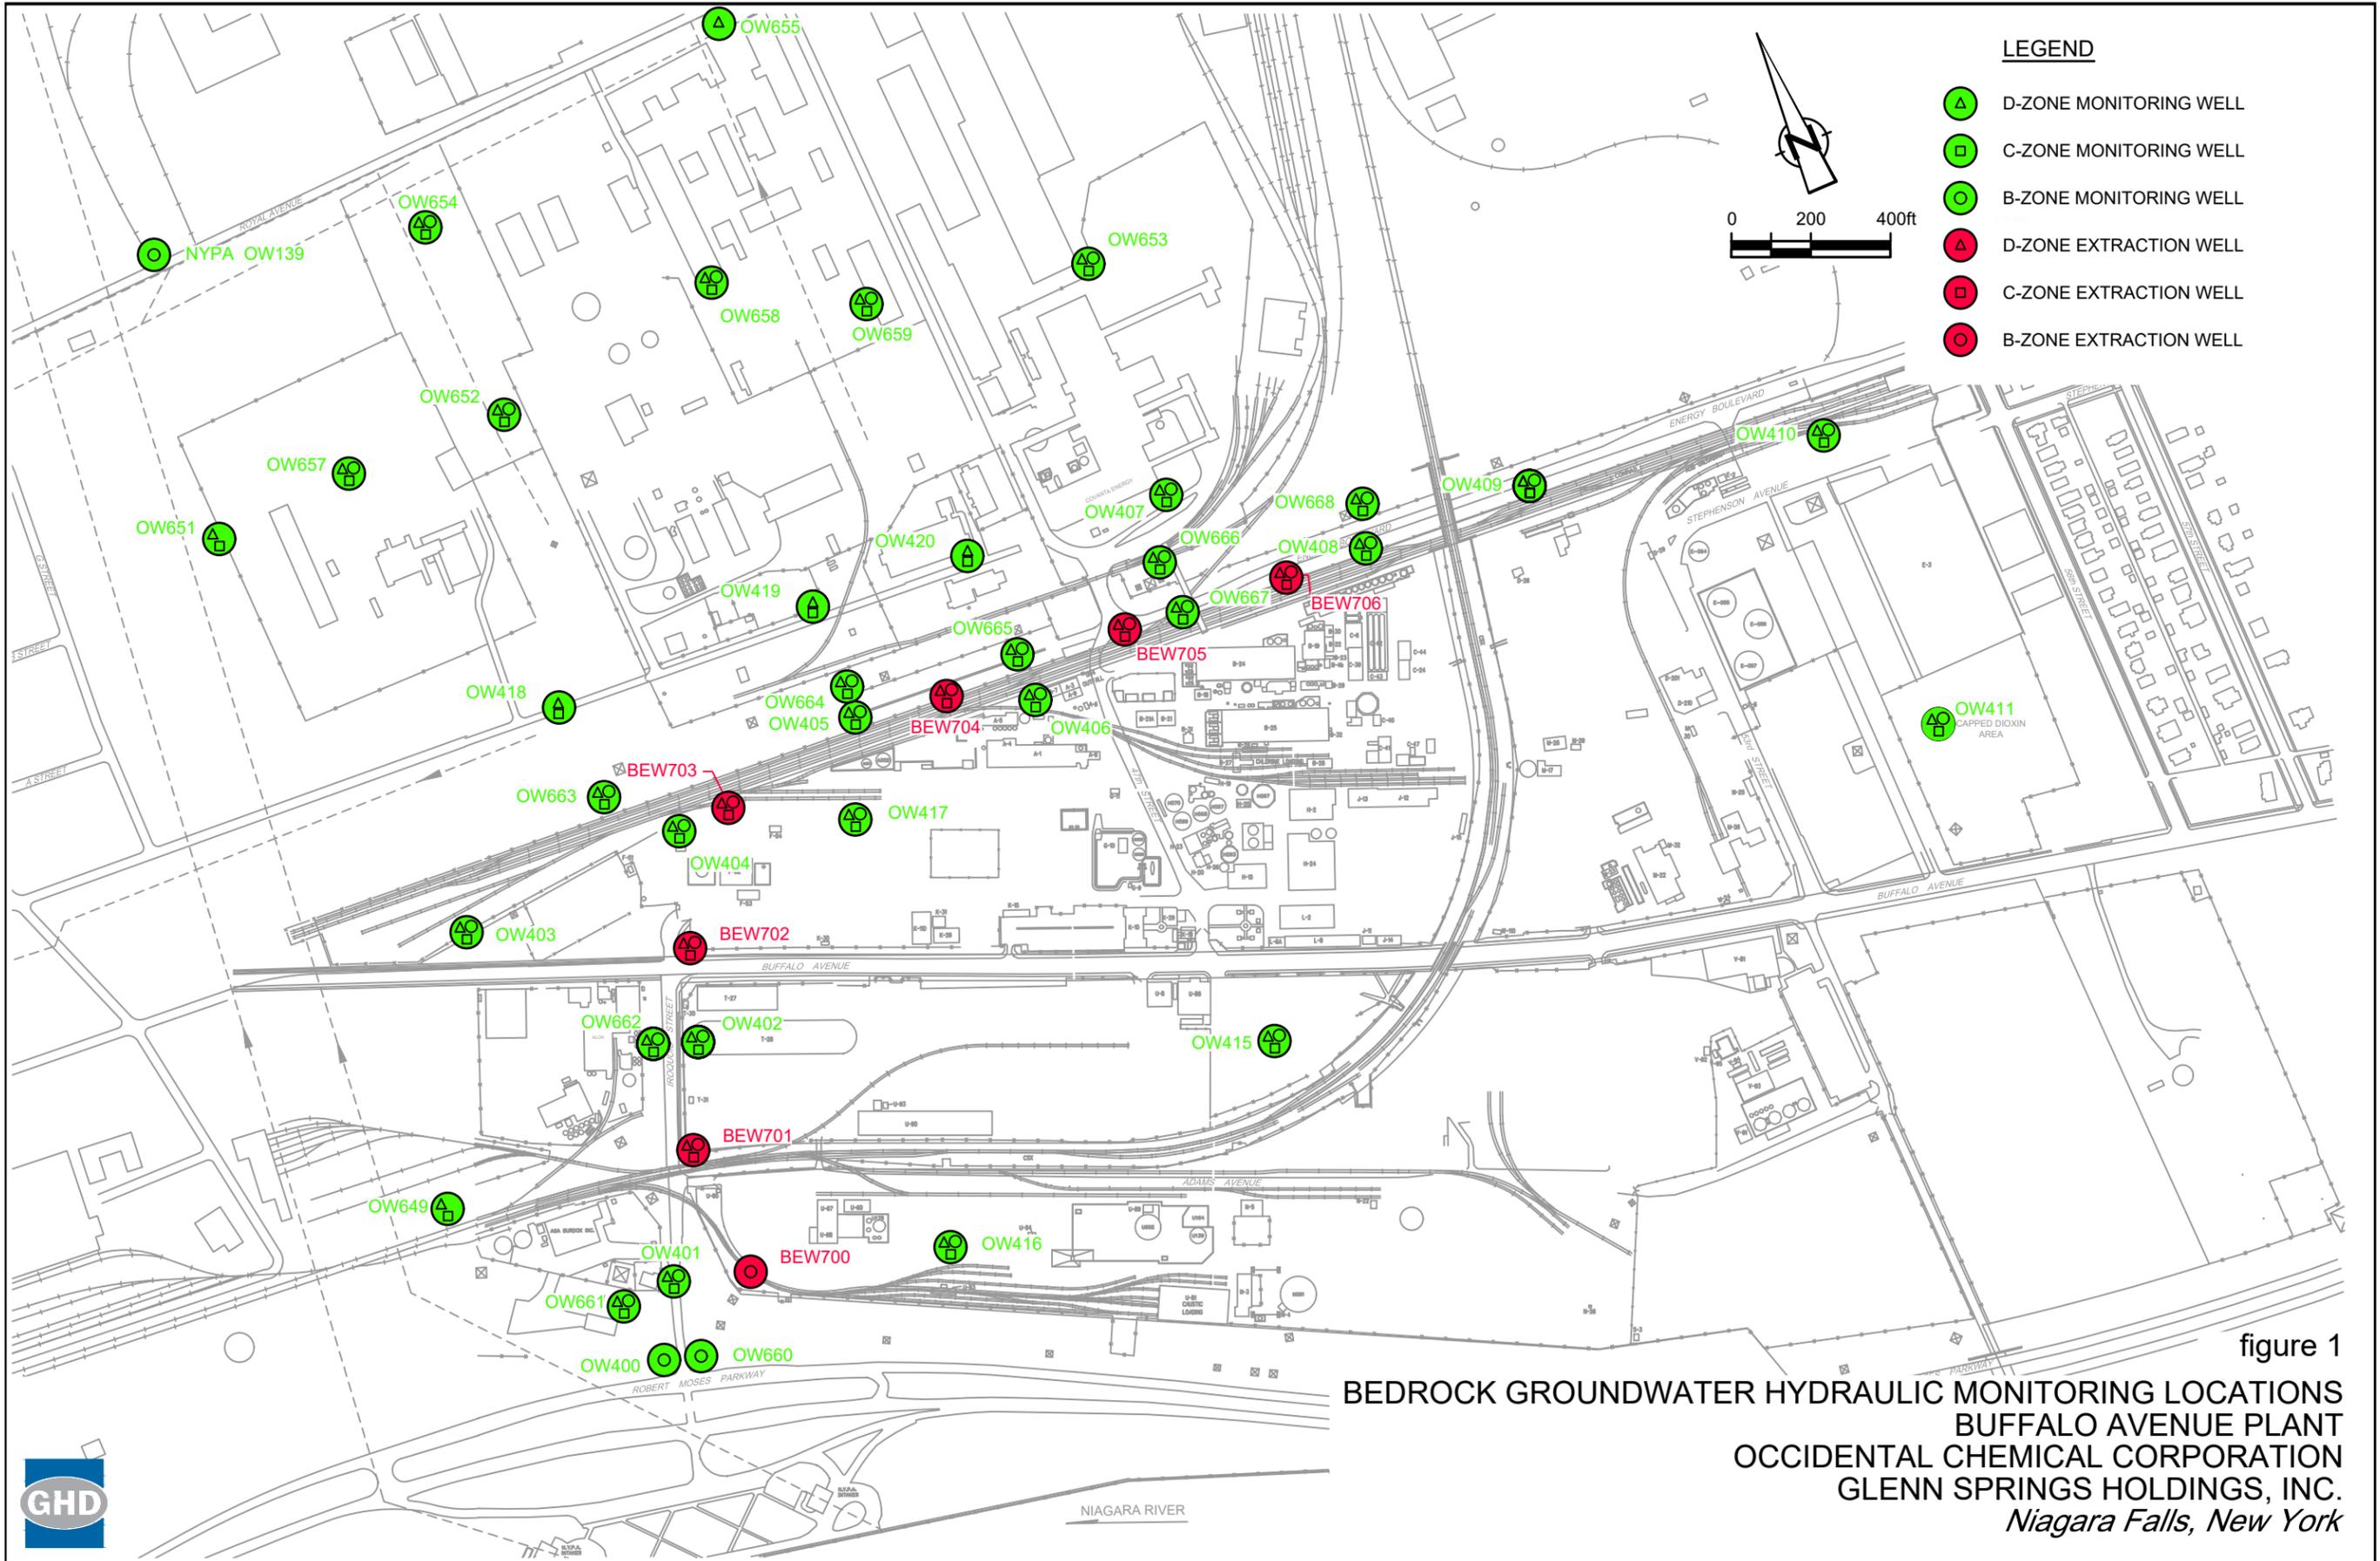
figure 1
BEDROCK GROUNDWATER HYDRAULIC MONITORING LOCATIONS
BUFFALO AVENUE PLANT
OCCIDENTAL CHEMICAL CORPORATION
GLENN SPRINGS HOLDINGS, INC.
Niagara Falls, New York

Hydraulic Monitoring Locations.....	Figure 1
Chemical Monitoring Locations.....	Figure 2
Recovery Volumes by Zone.....	Tables 3, 4, and 5
Average Monthly Flow Rate Summary	Table 6
Groundwater Elevations	Table 7
Groundwater Contours (regional containment) by Zone	Figures 3, 4, and 5

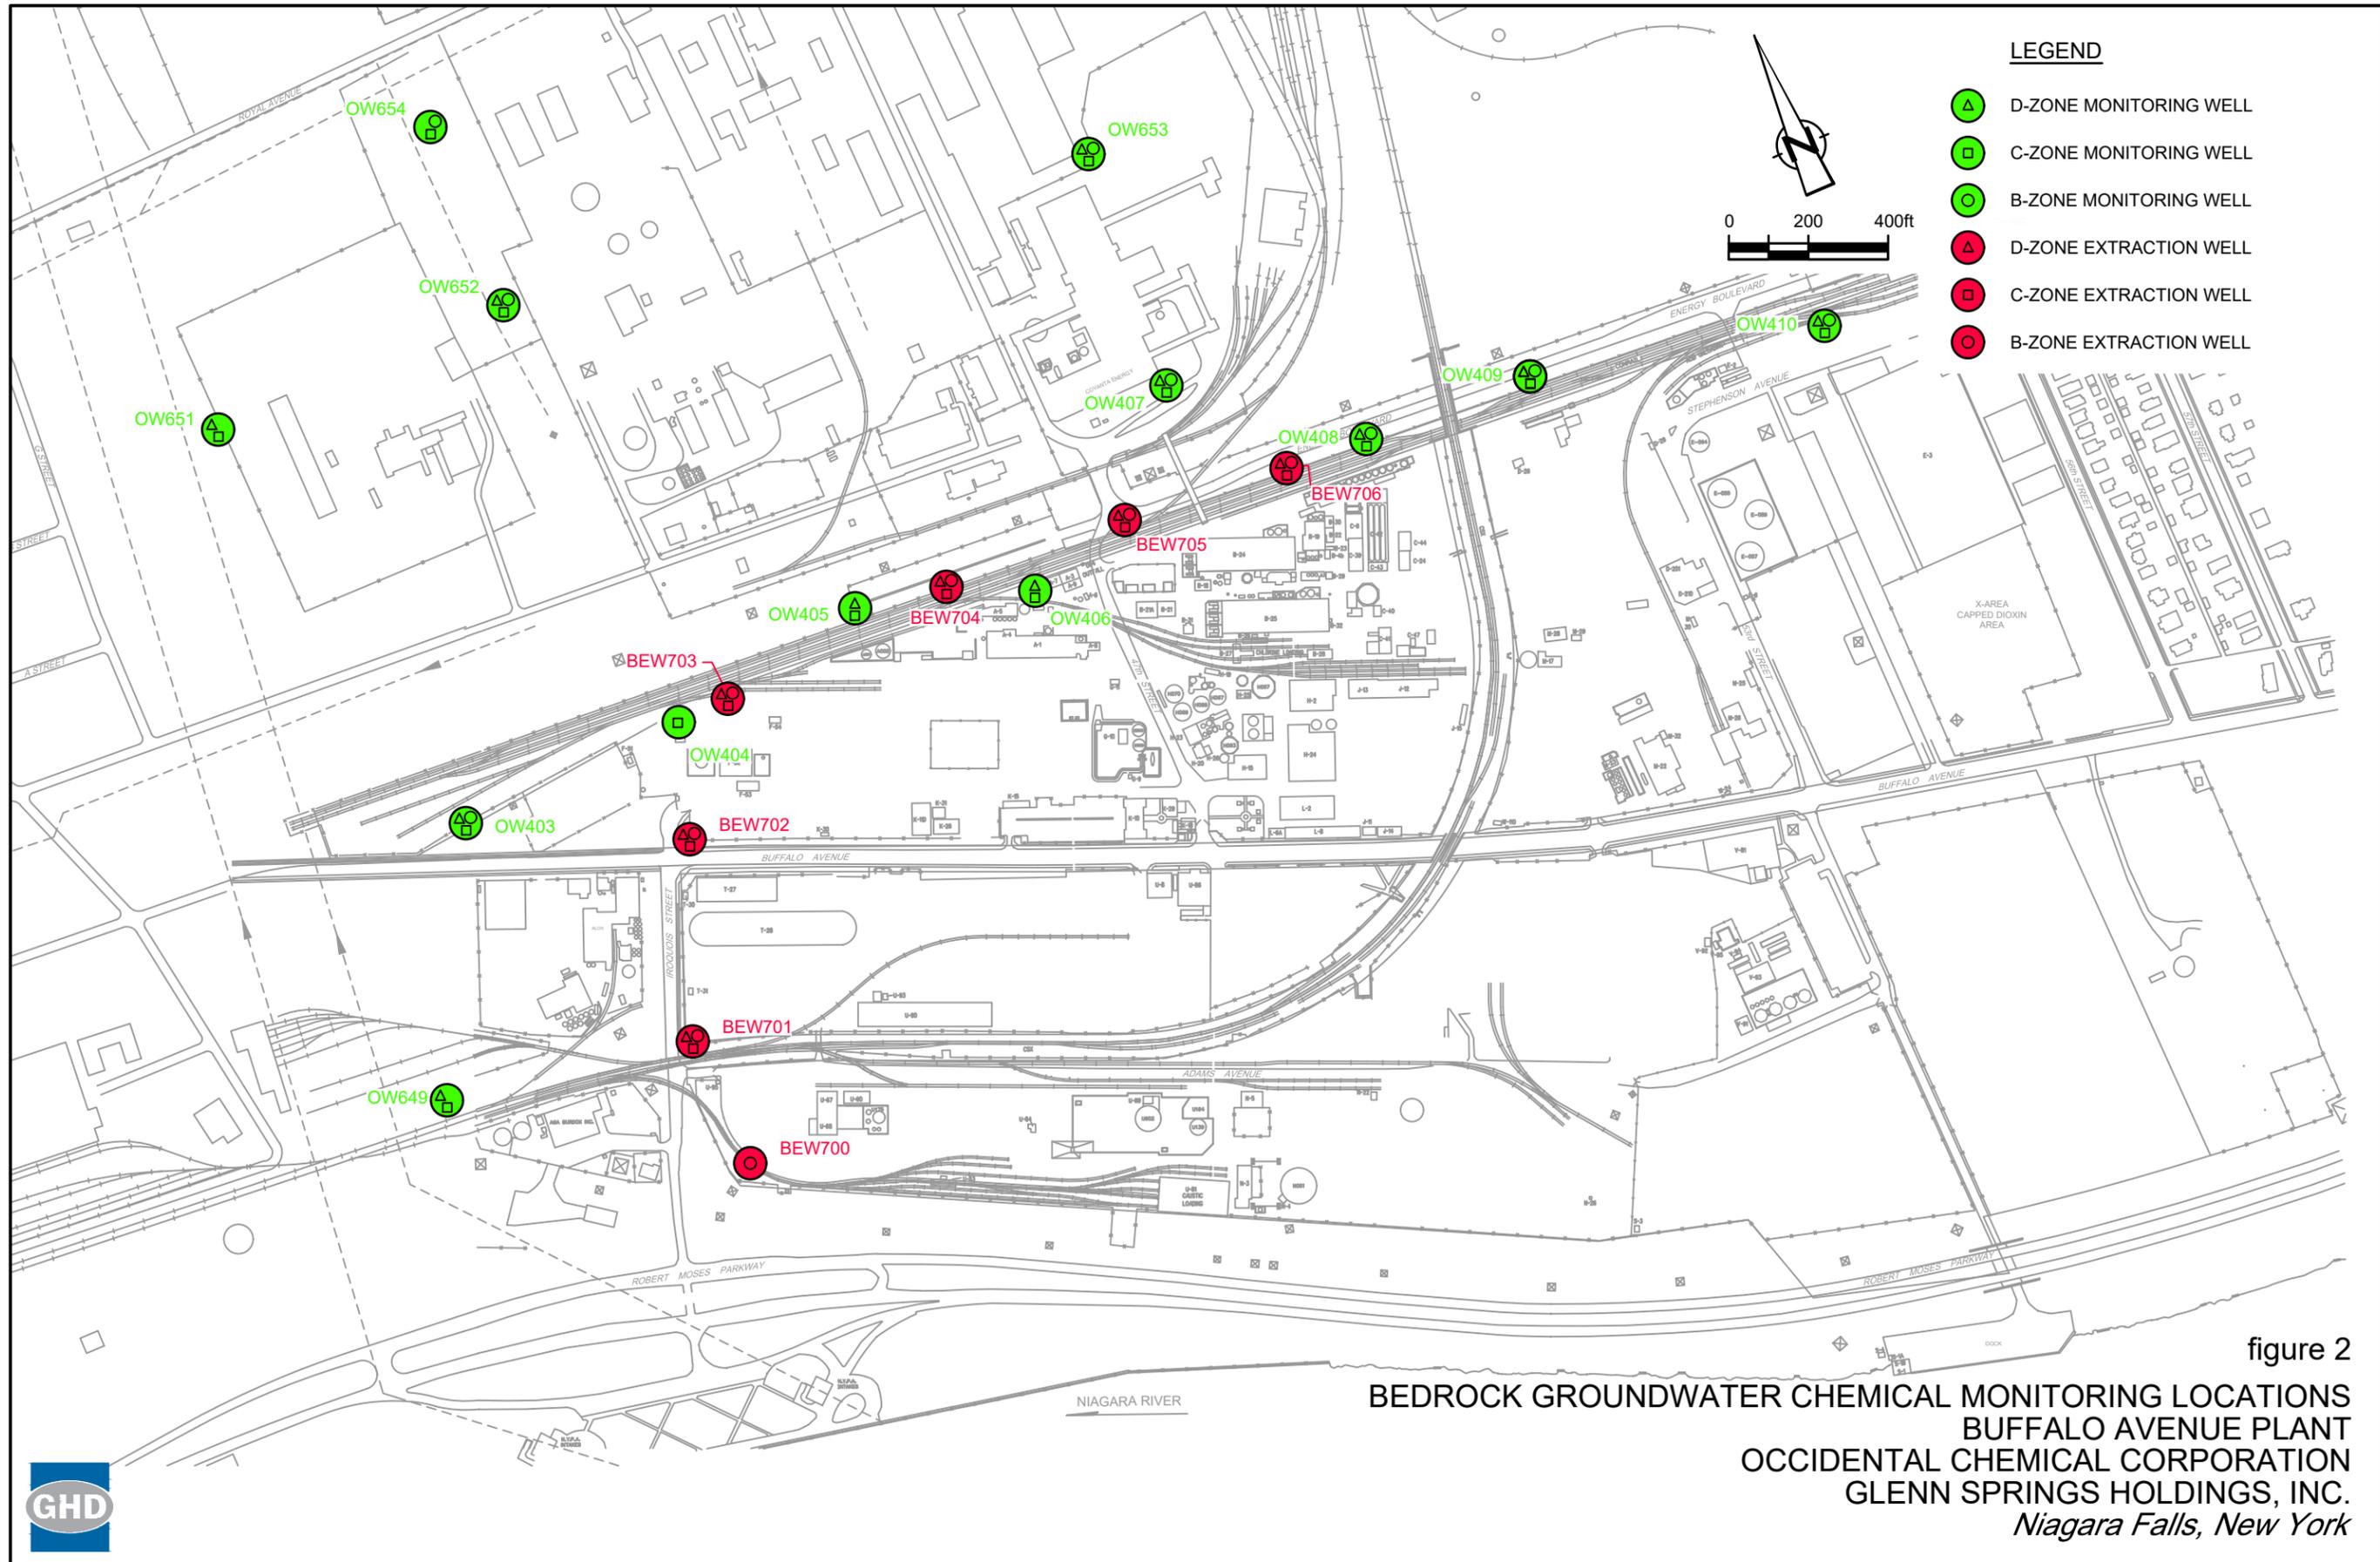
figure 2
 BEDROCK GROUNDWATER CHEMICAL MONITORING LOCATIONS
 BUFFALO AVENUE PLANT
 OCCIDENTAL CHEMICAL CORPORATION
 GLENN SPRINGS HOLDINGS, INC.
 Niagara Falls, New York

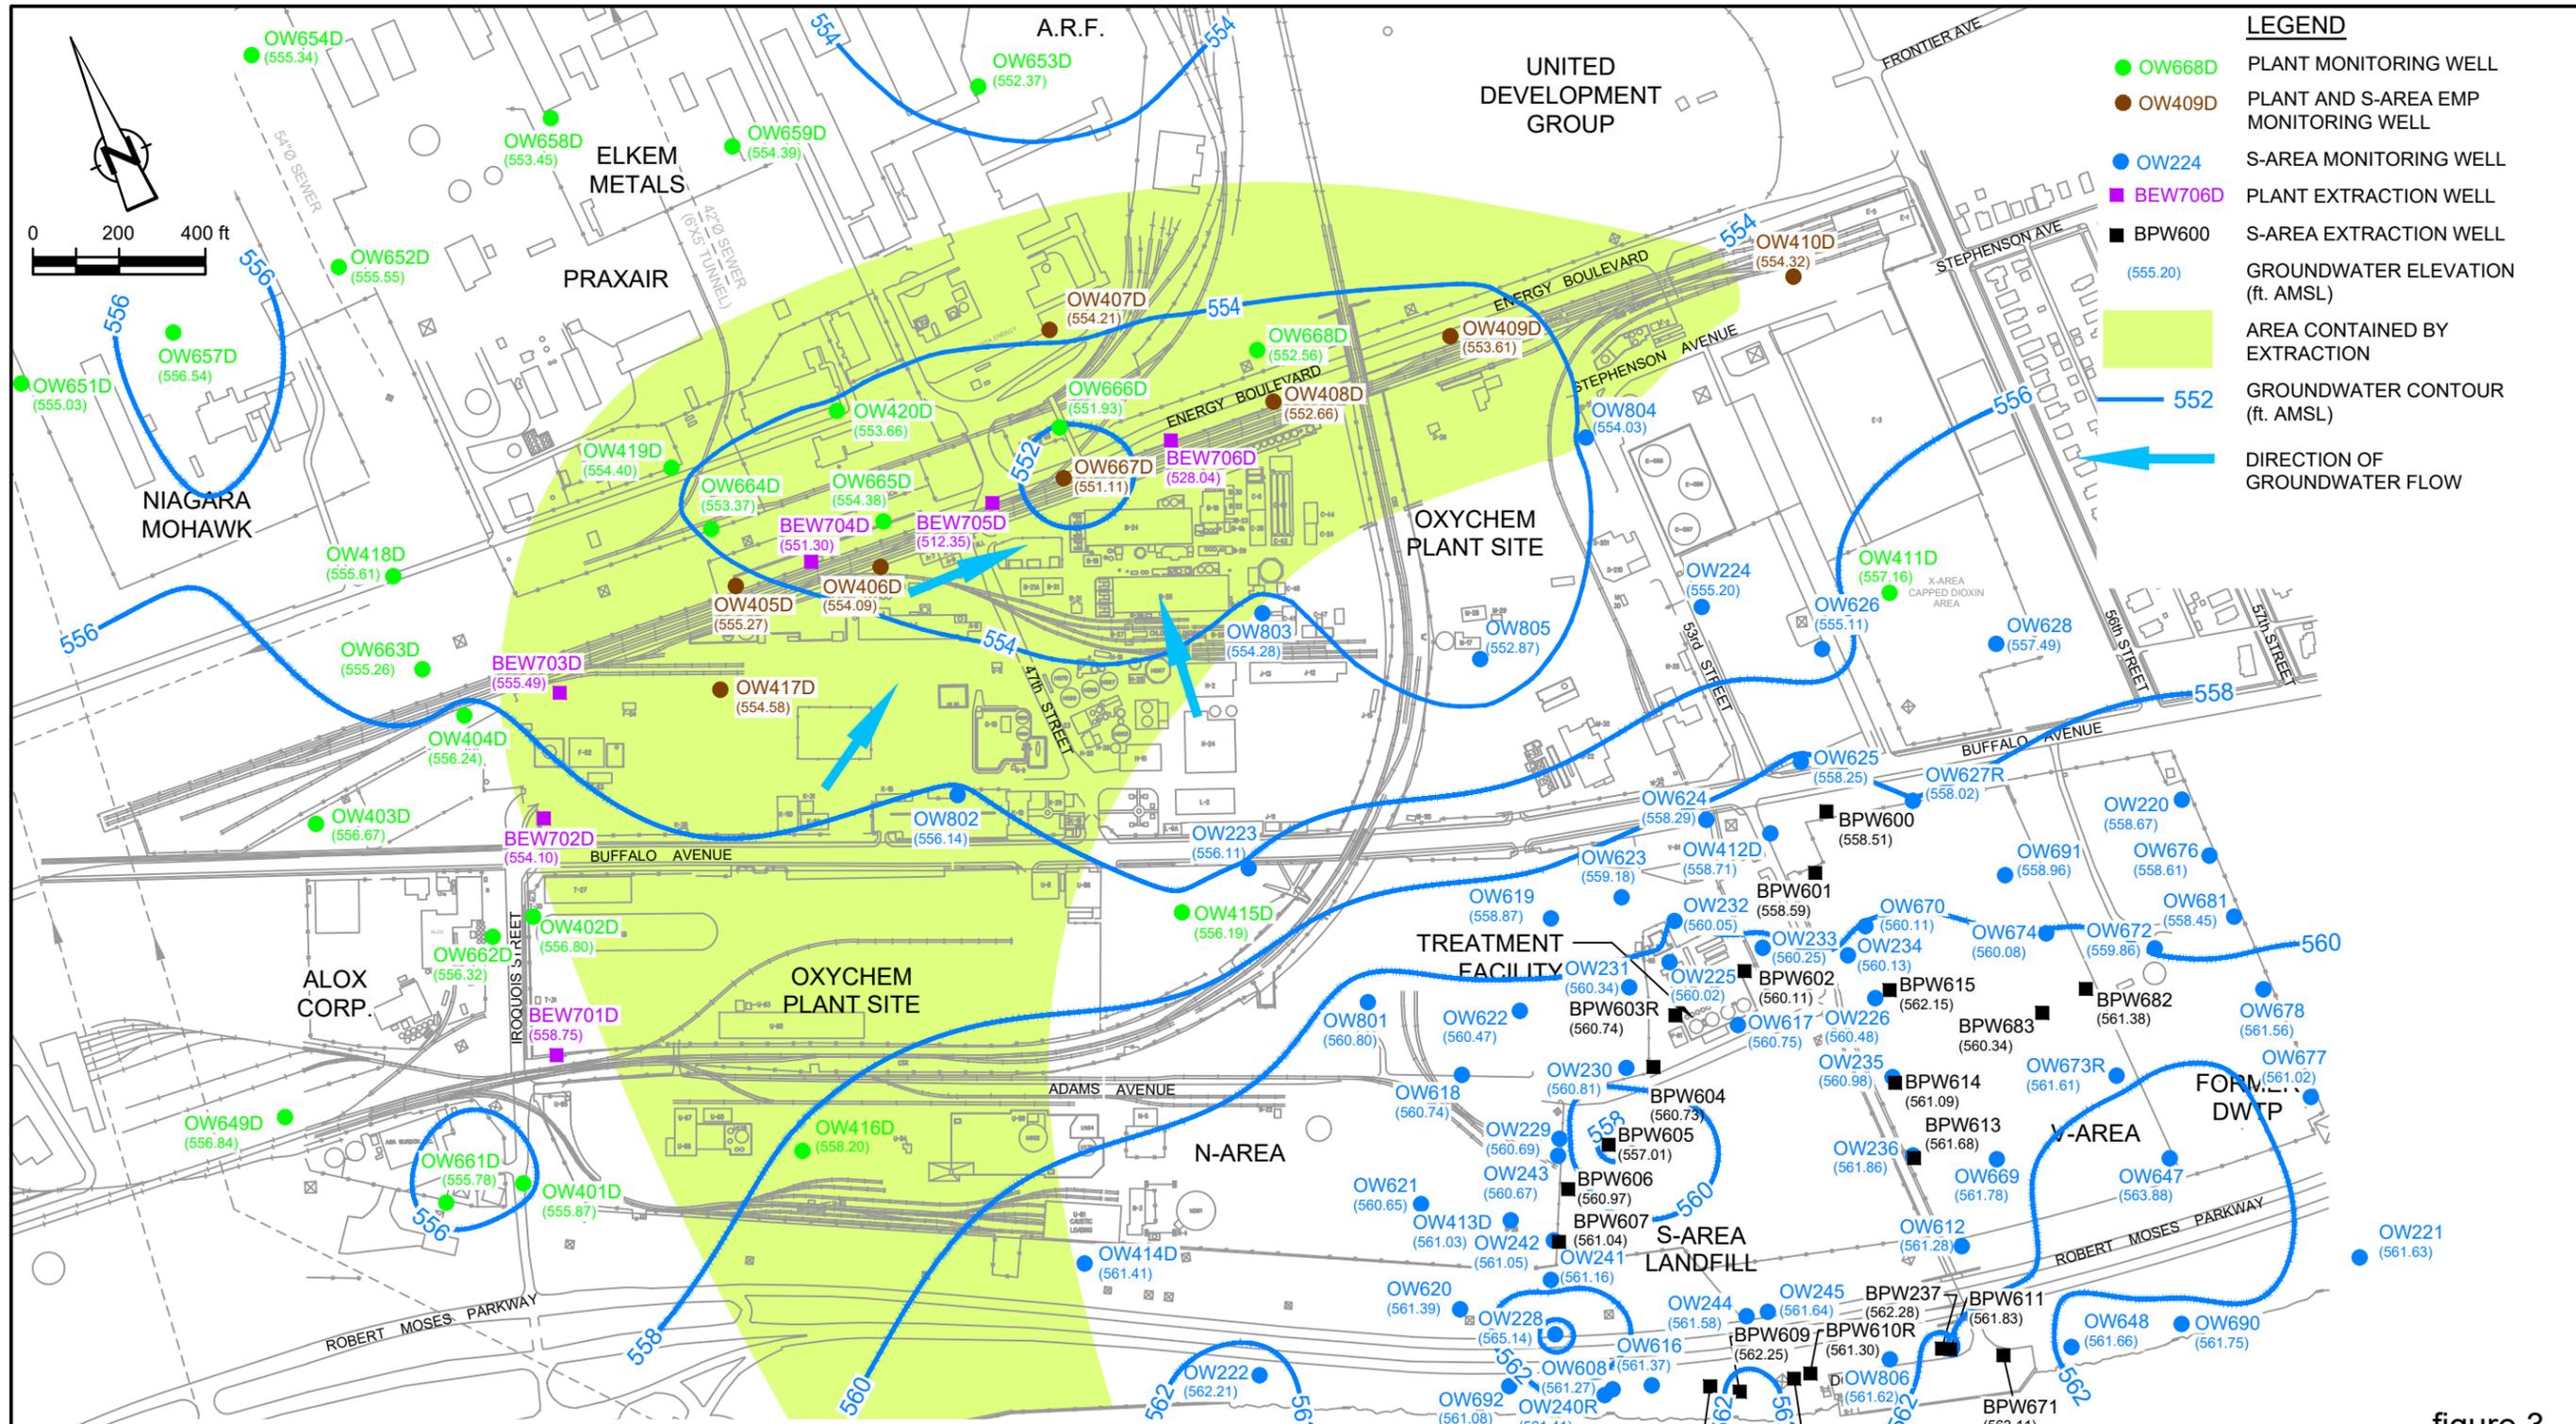
- NOTES:**
- CONTOURS REFLECT AN AVERAGE CONDITION OVER THE DATA COLLECTION PERIOD, APPROXIMATELY 4 HOURS. UNLESS OTHERWISE NOTED, CONTOURS RESPECT ALL WATER LEVEL MEASUREMENTS TO THE LEVEL OF UNCERTAINTY ASSOCIATED WITH COLLECTING LEVELS OVER A PERIOD OF SEVERAL HOURS. THAT UNCERTAINTY IS APPROXIMATELY +/-0.5 FEET FOR NYPA WINTER OPERATING CONDITIONS.
 - MEASURED ELEVATIONS FOR S-AREA PLANT EXTRACTION WELLS BEW701D-BEW706D WERE NOT USED FOR CONTOURING.

figure 3
D-ZONE BEDROCK GROUNDWATER CONTOURS
 JUNE 2, 2021
 BUFFALO AVENUE PLANT
 OCCIDENTAL CHEMICAL CORPORATION
 GLENN SPRINGS HOLDINGS, INC.
Niagara Falls, New York

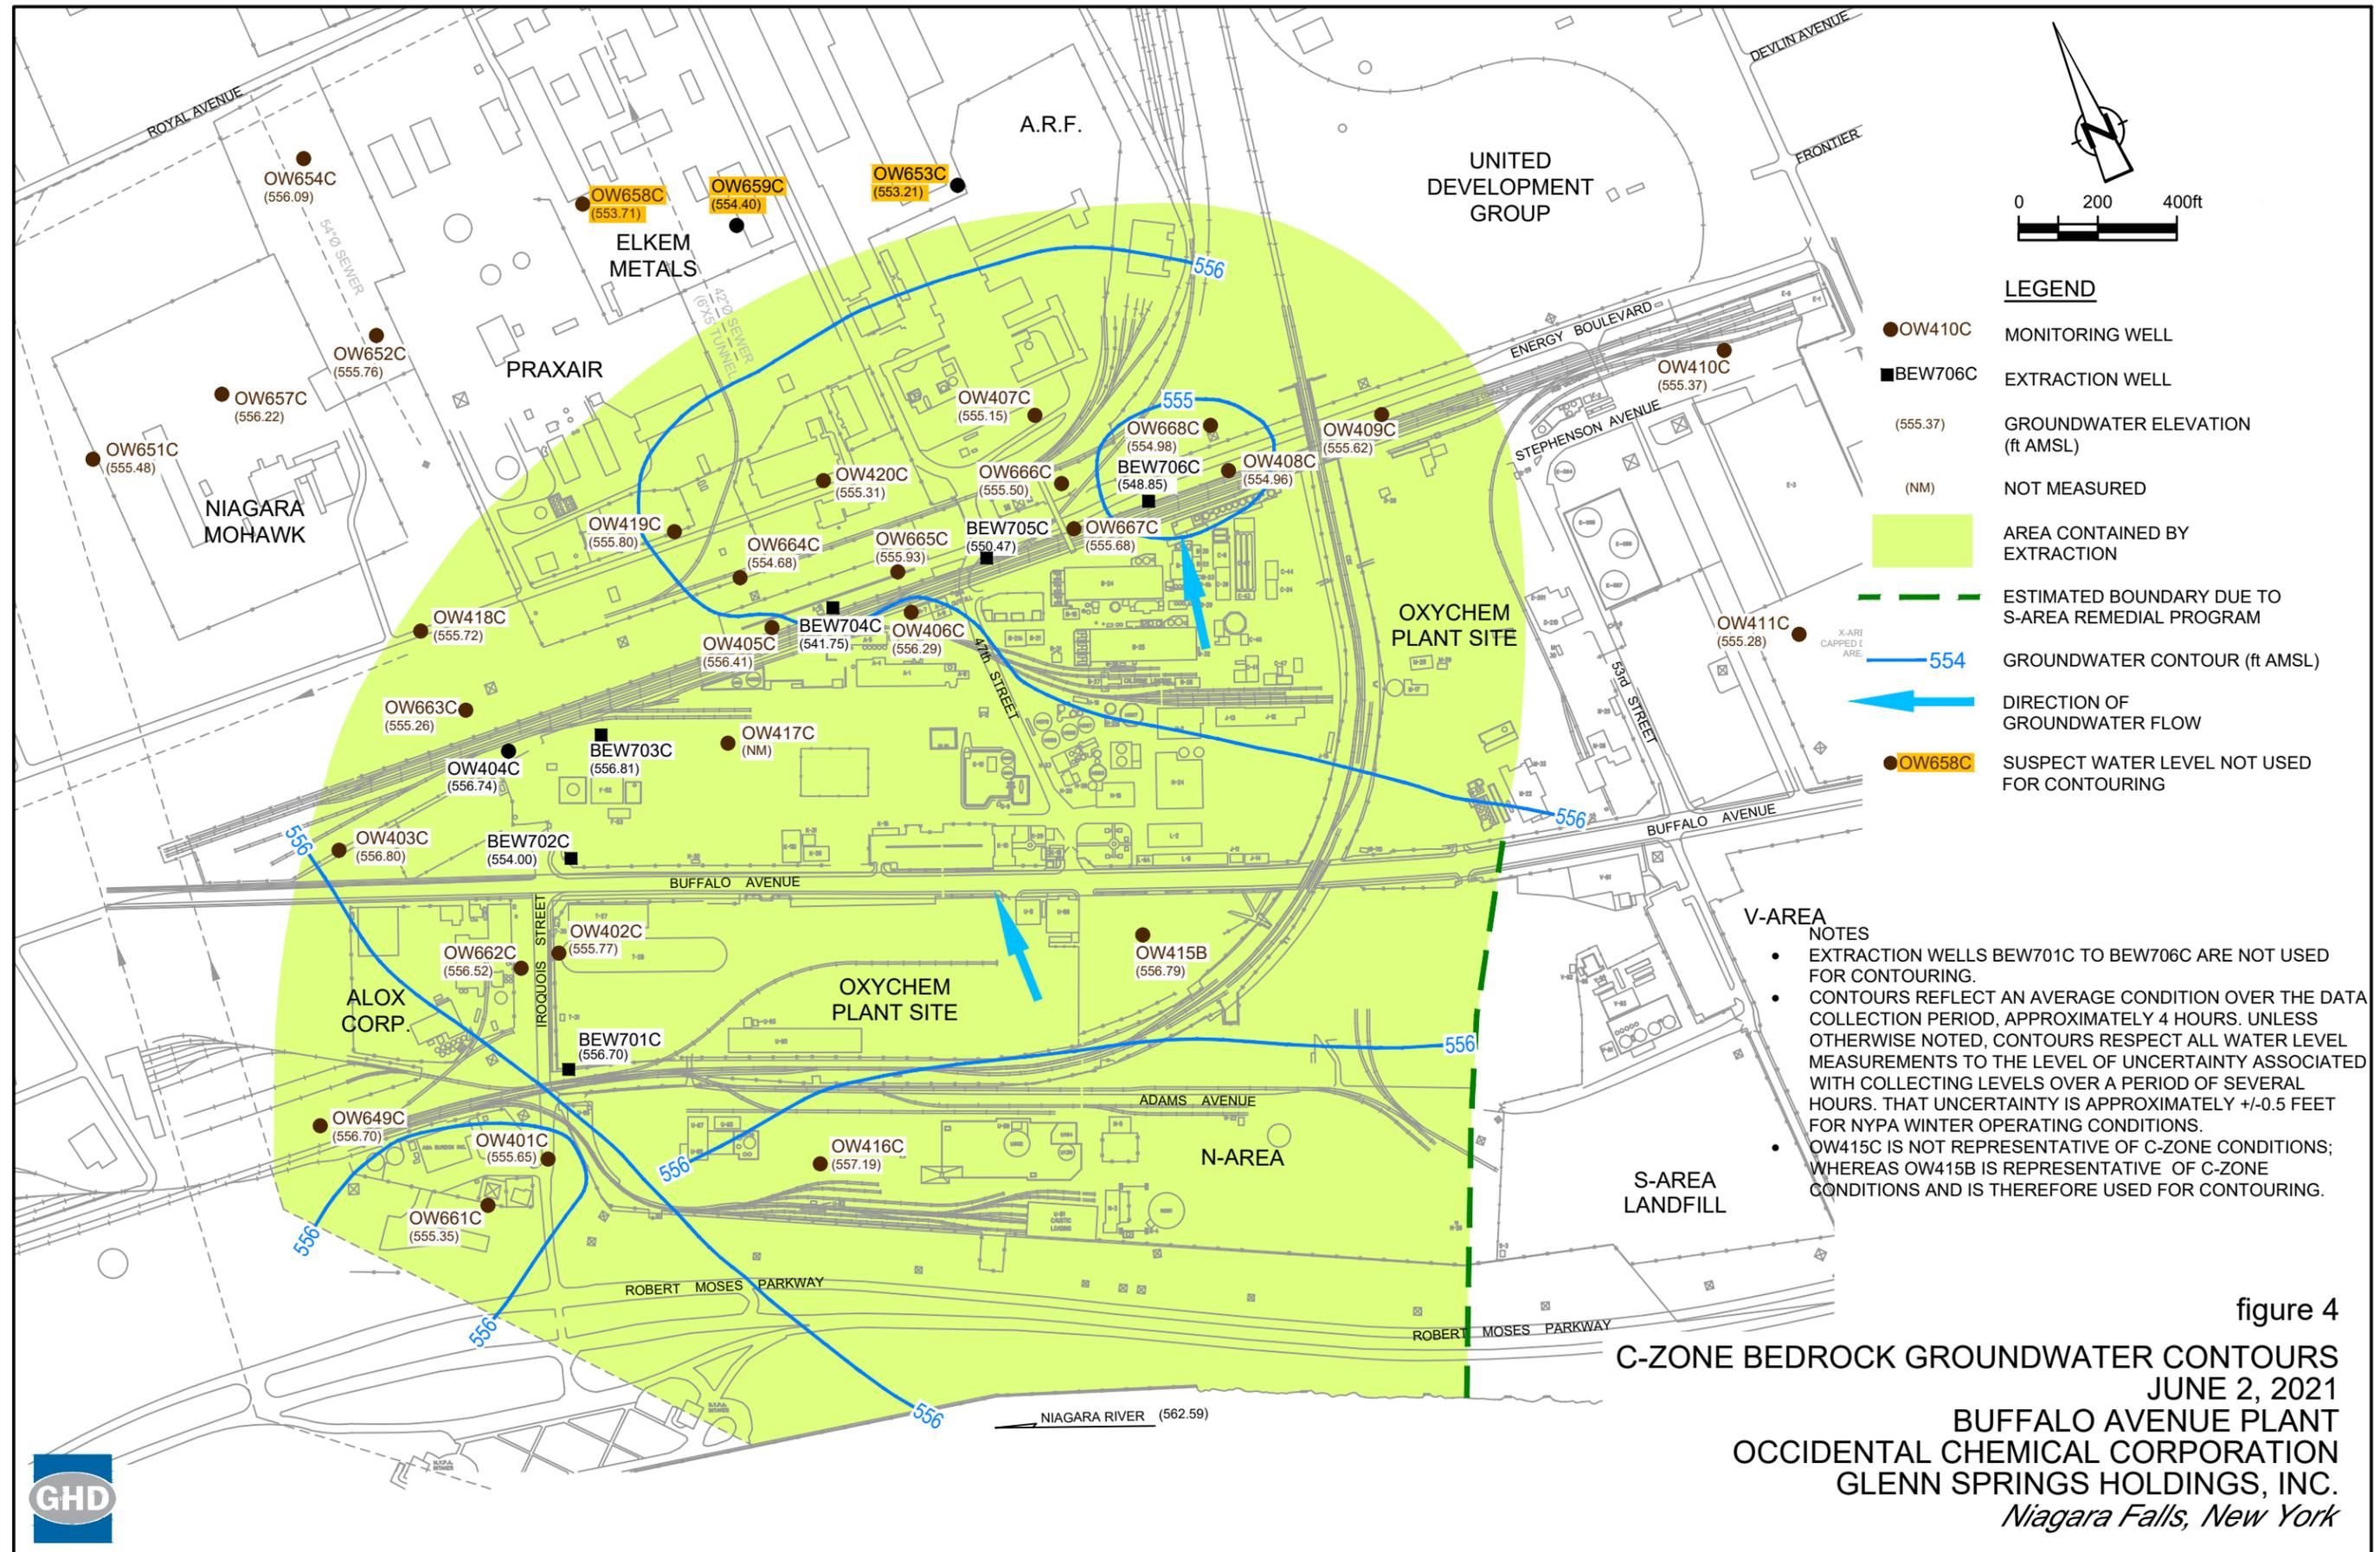
figure 4
 C-ZONE BEDROCK GROUNDWATER CONTOURS
 JUNE 2, 2021
 BUFFALO AVENUE PLANT
 OCCIDENTAL CHEMICAL CORPORATION
 GLENN SPRINGS HOLDINGS, INC.
 Niagara Falls, New York

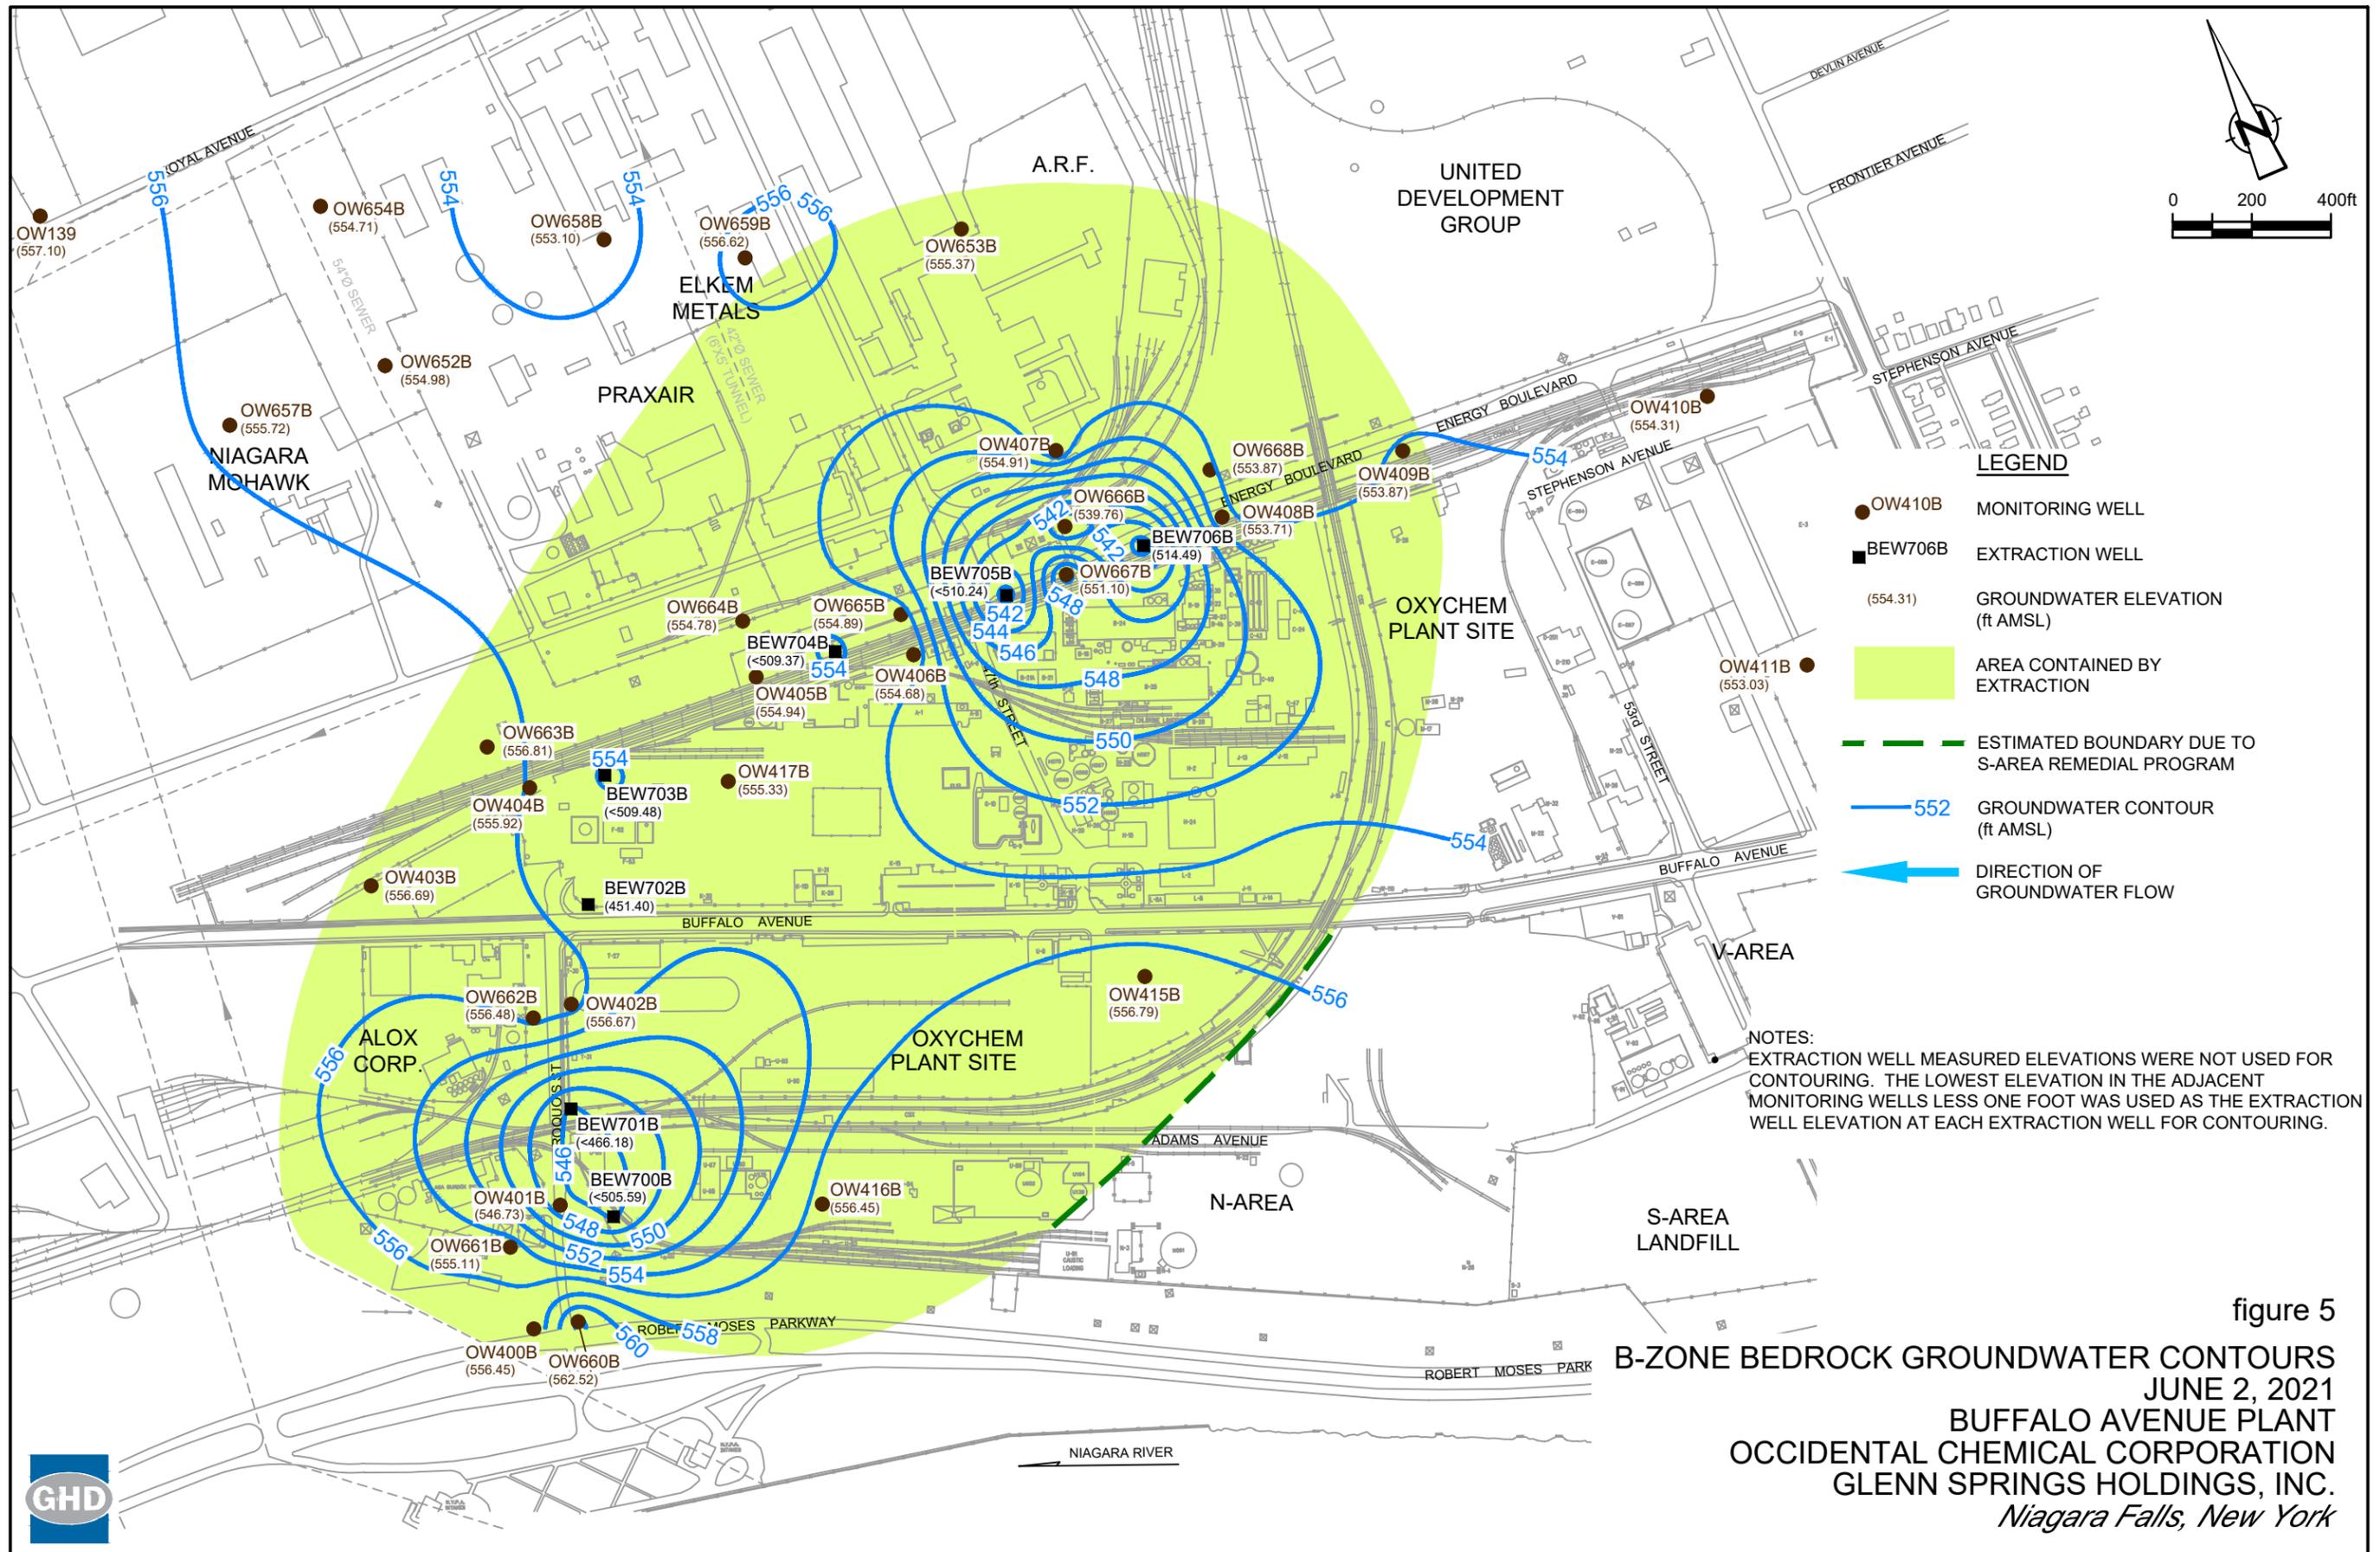
figure 5
 B-ZONE BEDROCK GROUNDWATER CONTOURS
 JUNE 2, 2021
 BUFFALO AVENUE PLANT
 OCCIDENTAL CHEMICAL CORPORATION
 GLENN SPRINGS HOLDINGS, INC.
 Niagara Falls, New York

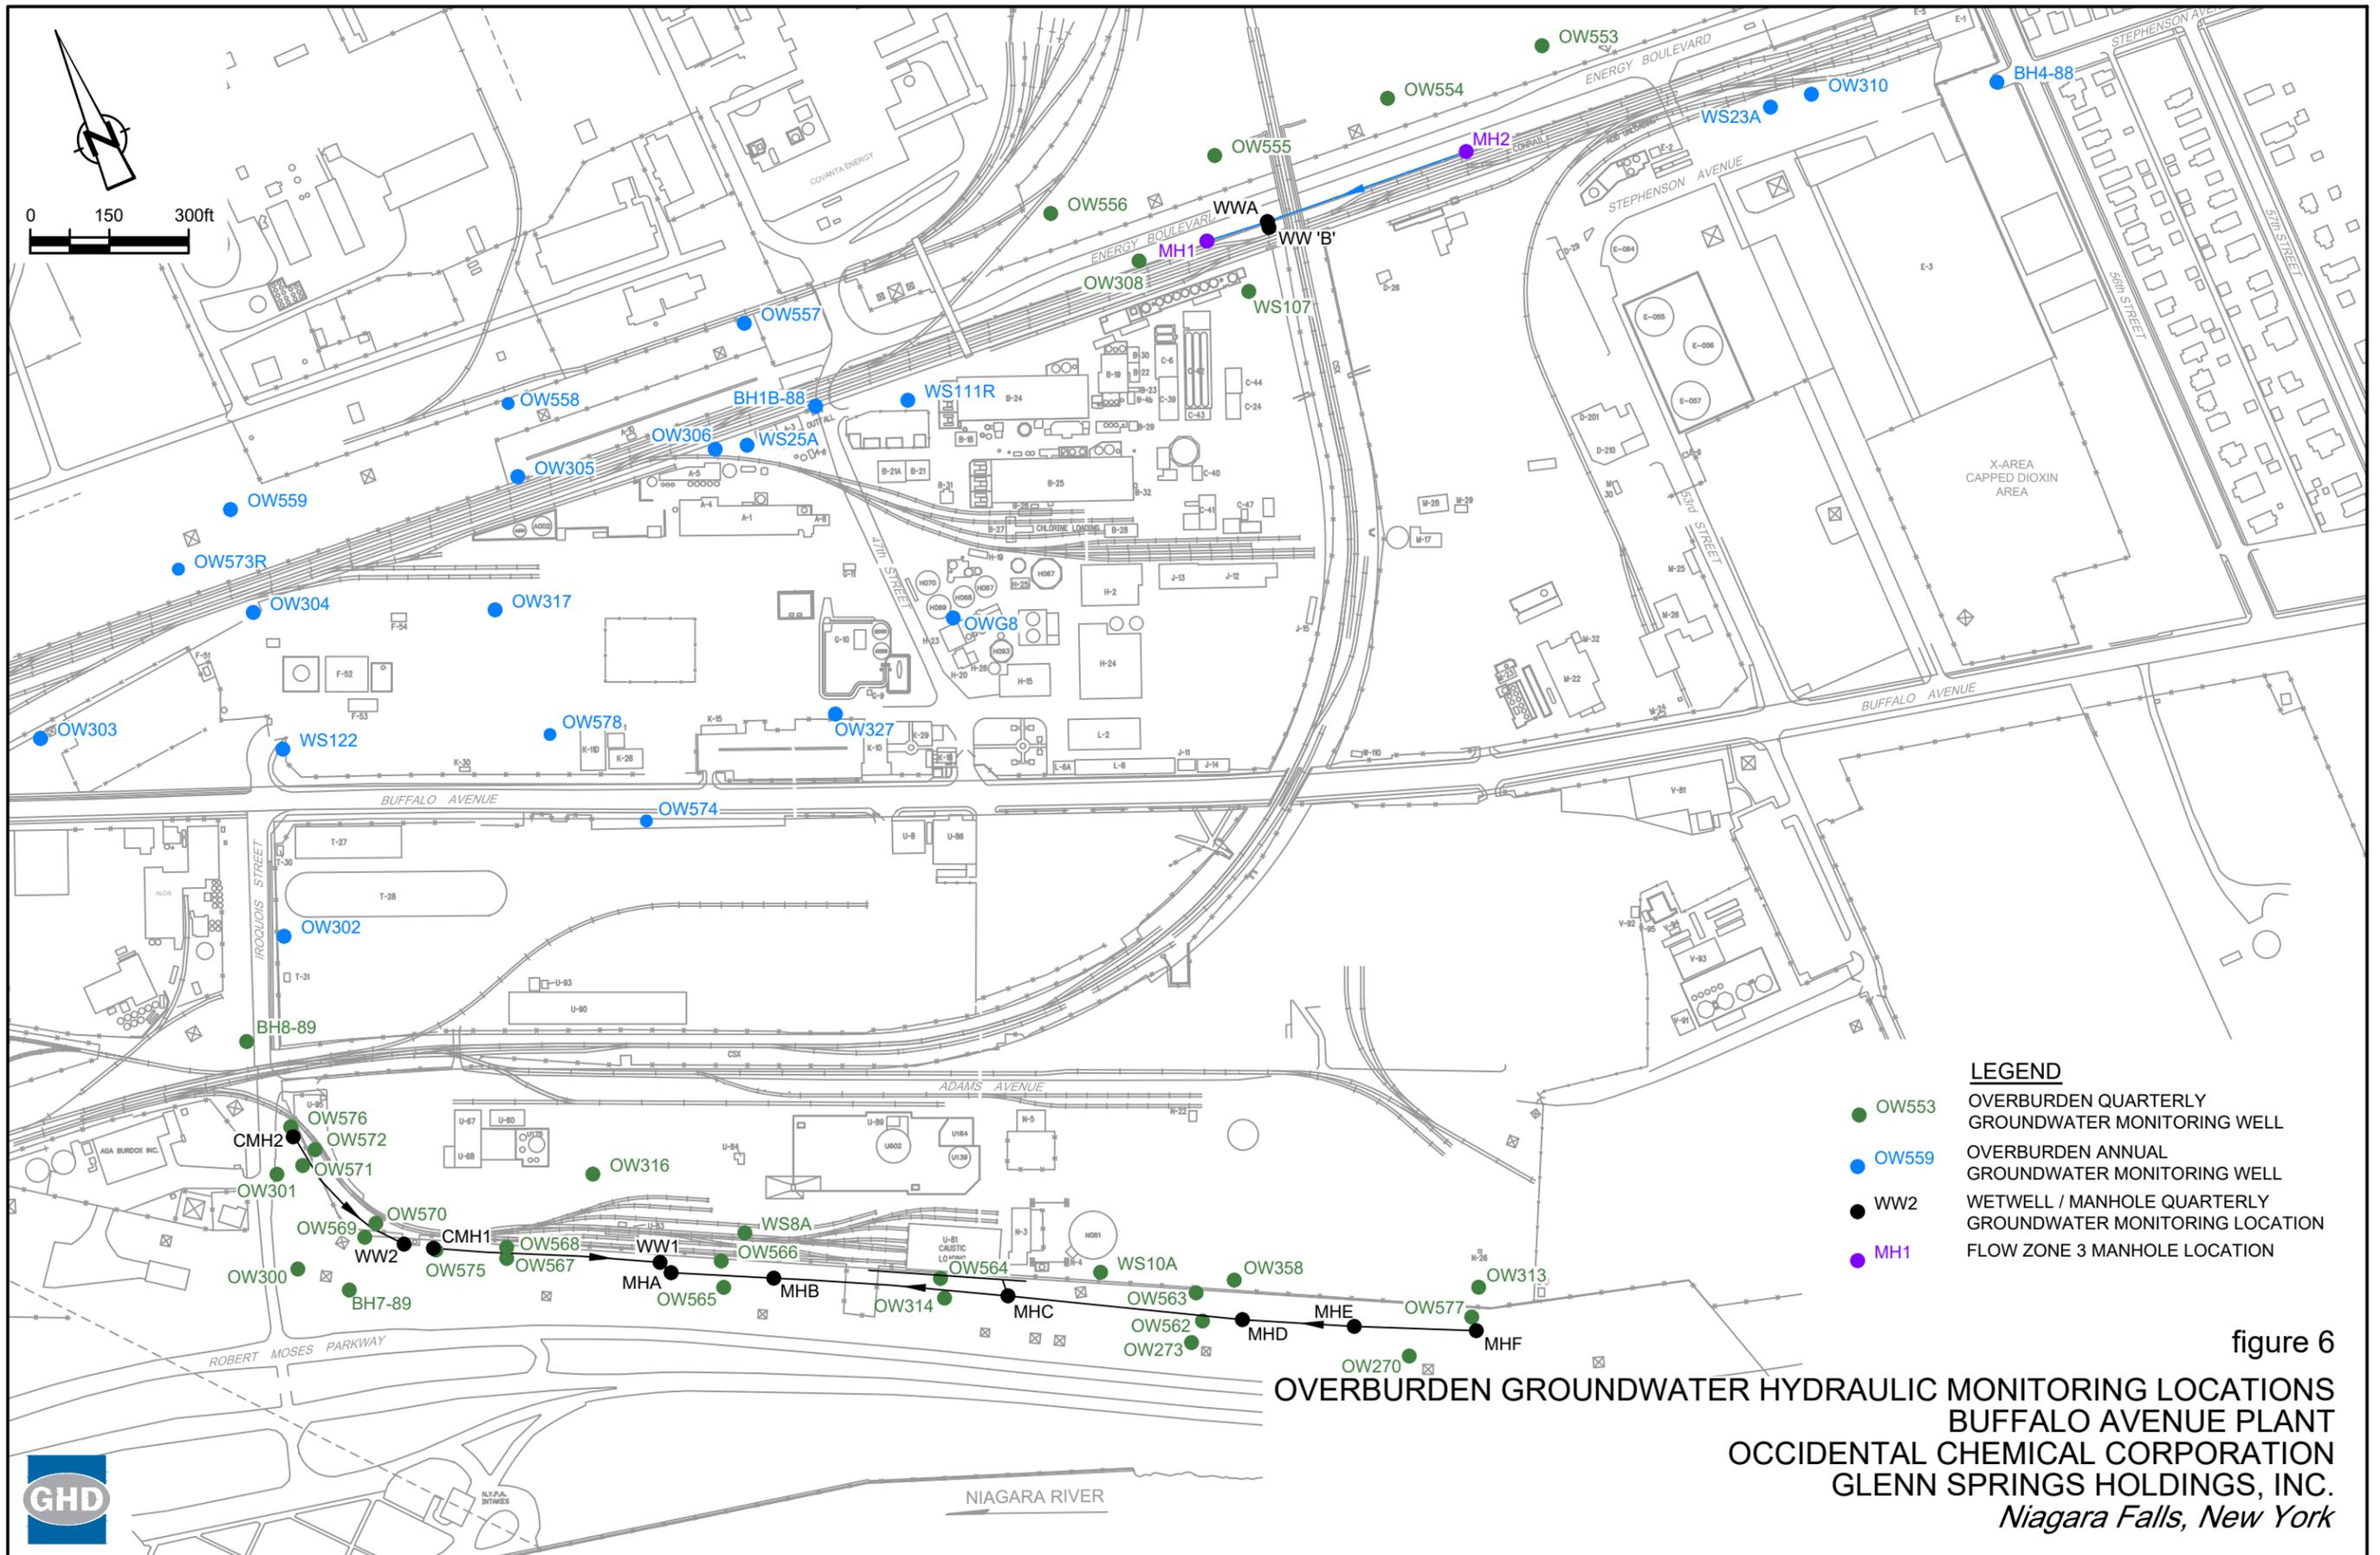
figure 6
OVERBURDEN GROUNDWATER HYDRAULIC MONITORING LOCATIONS
BUFFALO AVENUE PLANT
OCCIDENTAL CHEMICAL CORPORATION
GLENN SPRINGS HOLDINGS, INC.
Niagara Falls, New York

Hydraulic Monitoring Locations.....Figure 6
 Chemical Monitoring Locations.....Figure 7
 Weekly Flow RatesTable 8
 Average Monthly Flow Rate SummaryTable 9
 Groundwater ElevationsTable 10
 Groundwater Contours, Flow Zone 1Figure 8
 Groundwater Contours, Flow Zone 3Figure 9
