Glenn Springs Holdings, Inc.

Re: Quarterly Progress Report – Second Quarter 2021
Occidental Chemical Corporation, Buffalo Avenue Plant
NY Permit Number 9-2911-00112/00167-0
Module II – Corrective Action Requirements

In accordance with Module II of the Niagara Plant's Resource Conservation and Recovery Act (RCRA)/Part 373 Permit, the following is the quarterly data report for the period of April 1, 2021 to June 30, 2021. Table 1 is a summary of the monitoring tasks by quarter that are performed each year along with completion dates where applicable. Table 2 presents a summary of maintenance activities performed during the quarter.

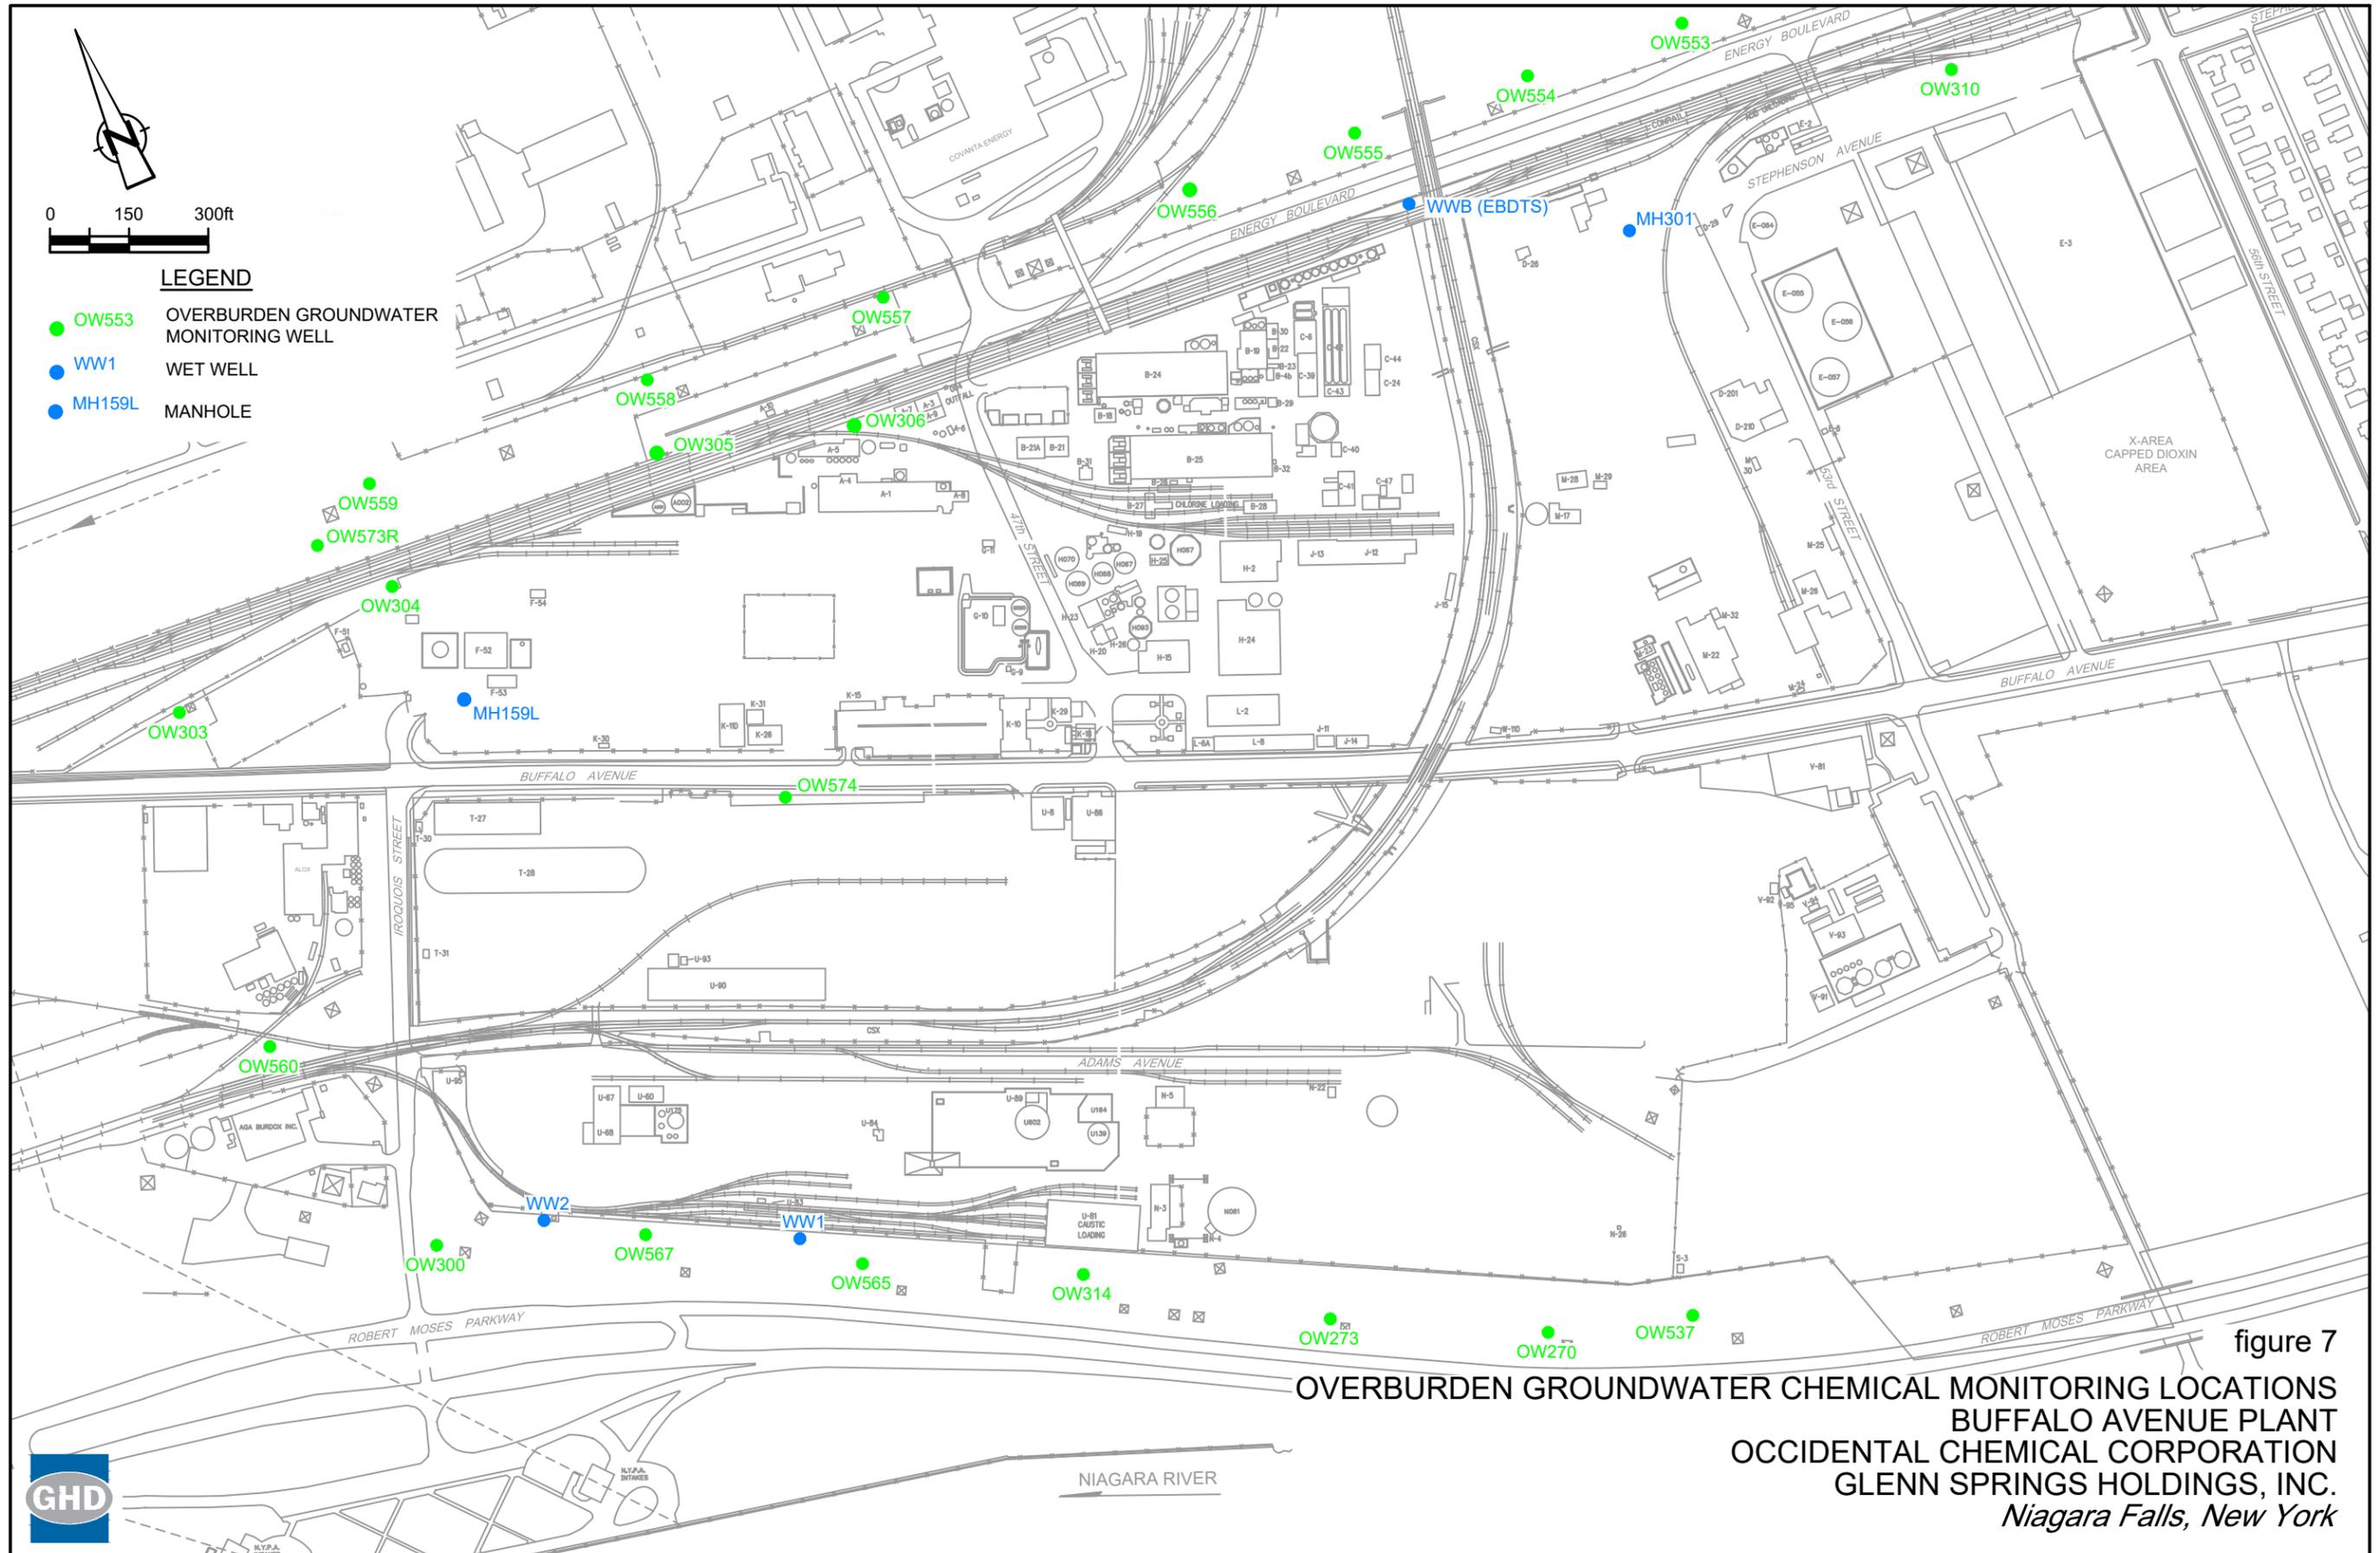
figure 7

**OVERBURDEN GROUNDWATER CHEMICAL MONITORING LOCATIONS
BUFFALO AVENUE PLANT
OCCIDENTAL CHEMICAL CORPORATION
GLENN SPRINGS HOLDINGS, INC.
Niagara Falls, New York**

Hydraulic Monitoring Locations.....Figure 6
 Chemical Monitoring Locations.....Figure 7
 Weekly Flow RatesTable 8
 Average Monthly Flow Rate SummaryTable 9
 Groundwater ElevationsTable 10
 Groundwater Contours, Flow Zone 1Figure 8
 Groundwater Contours, Flow Zone 3Figure 9

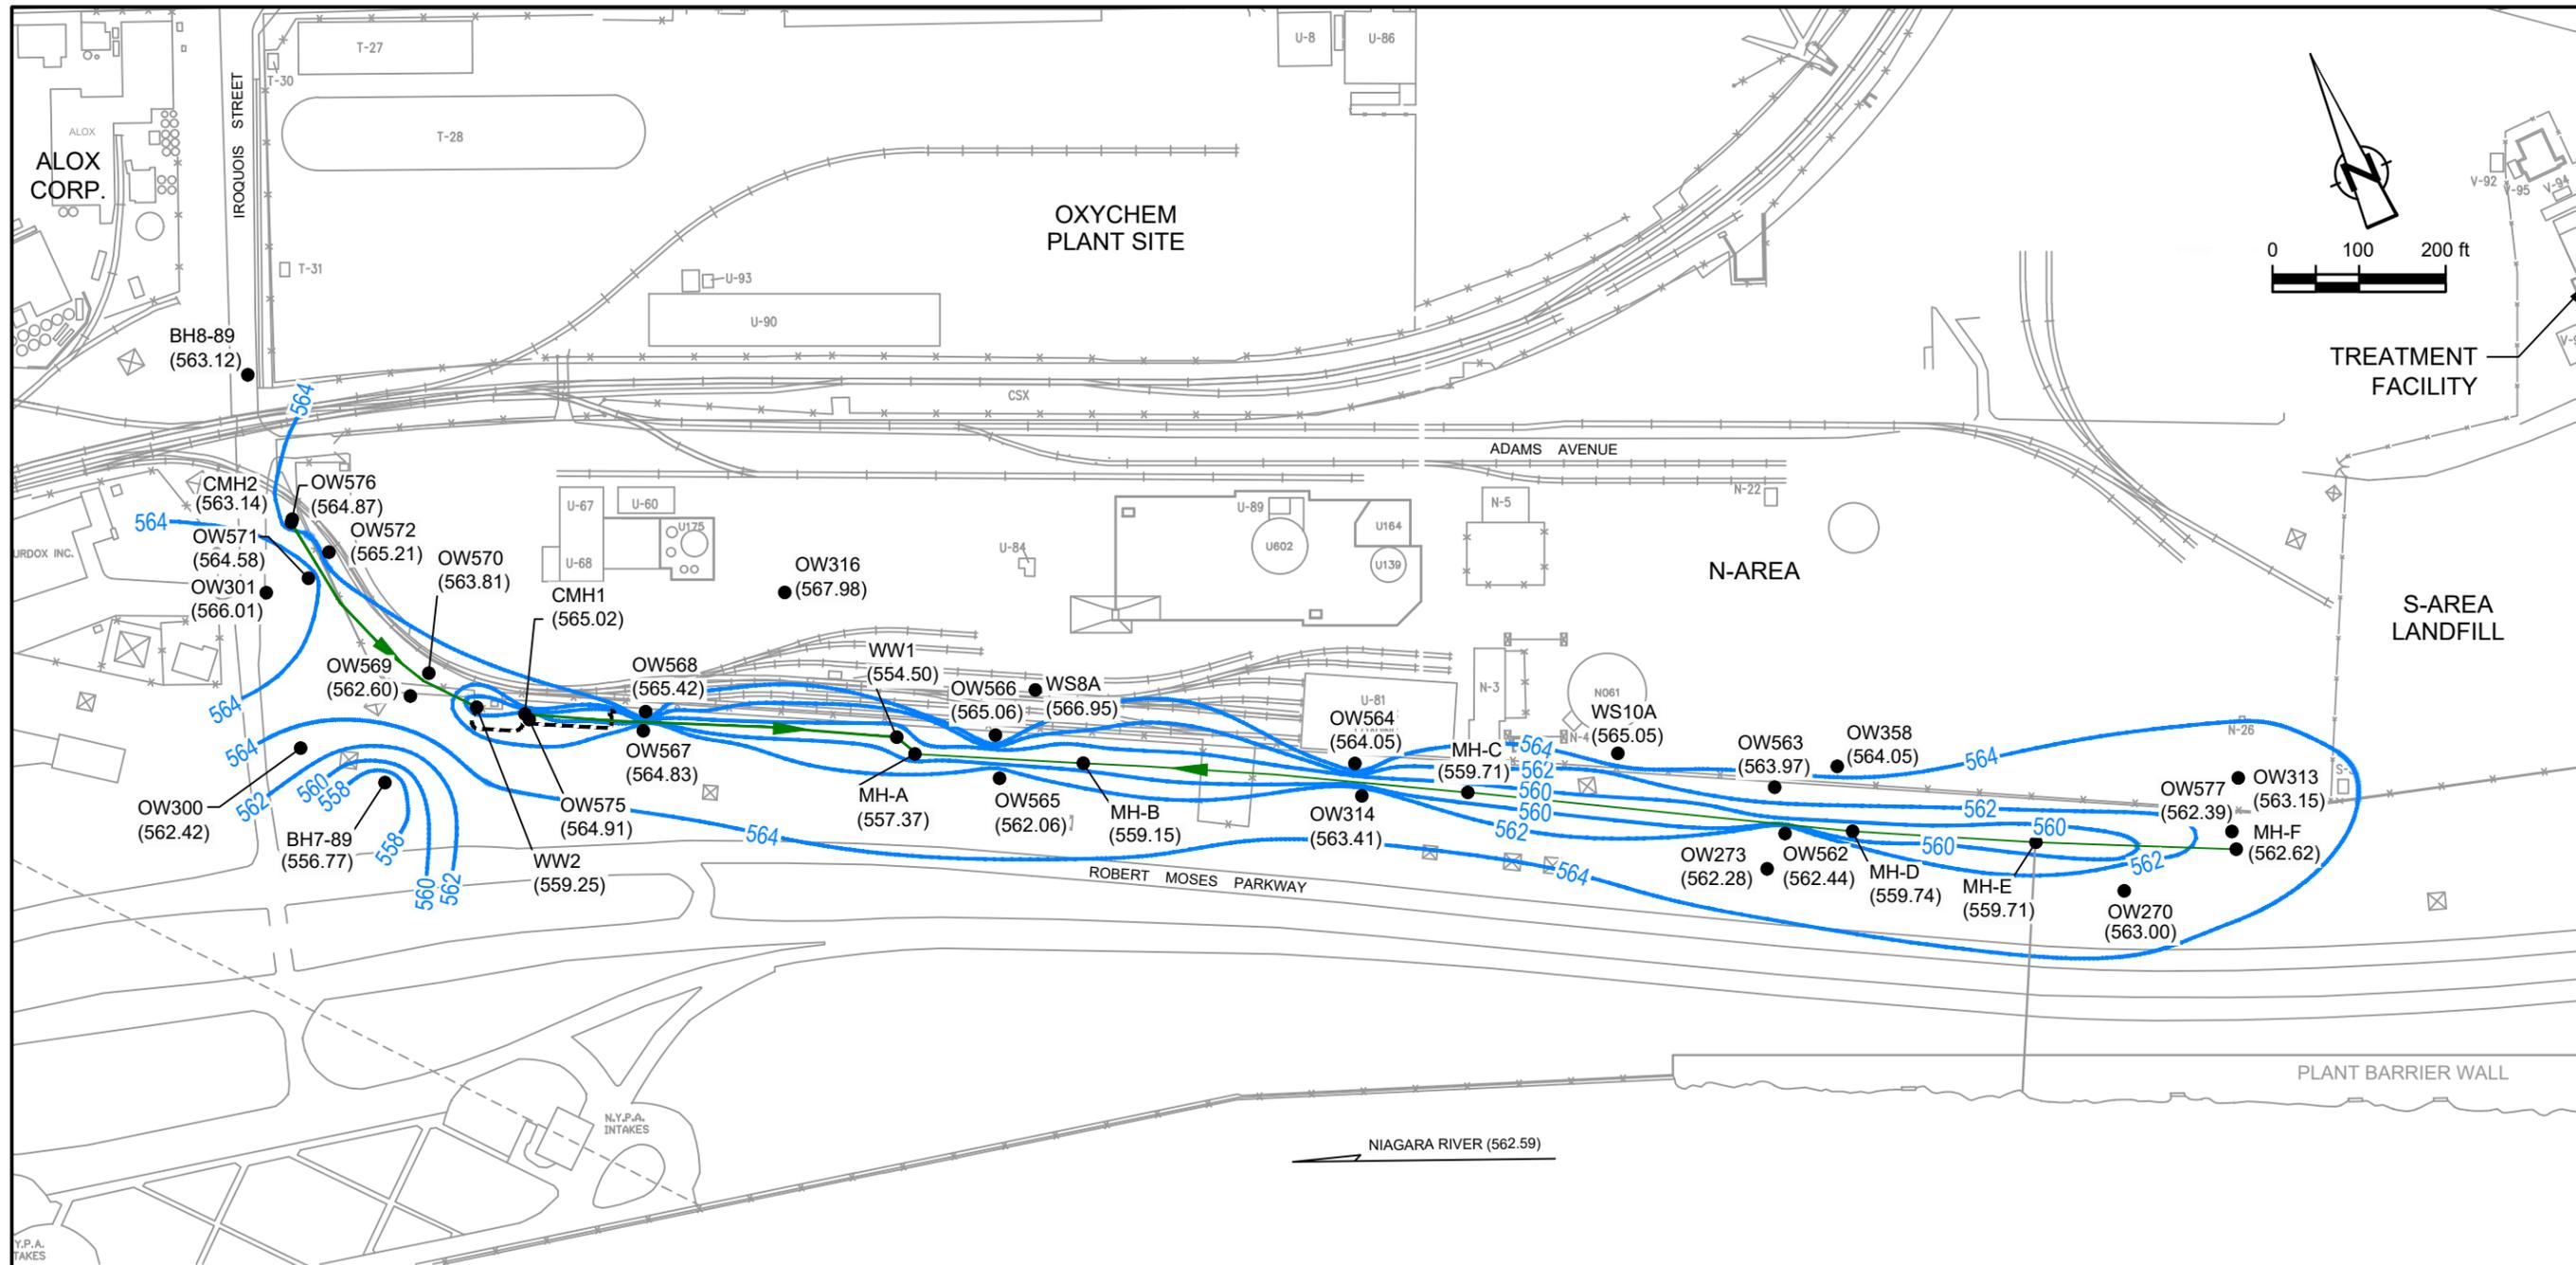
figure 8
 FLOW ZONE 1 OVERBURDEN GROUNDWATER CONTOURS
 JUNE 4, 2021
 BUFFALO AVENUE PLANT
 OCCIDENTAL CHEMICAL CORPORATION
 GLENN SPRINGS HOLDINGS, INC.
 Niagara Falls, New York

The Flow Zone 1 remedial system was operational 97.6 percent of the time for WW1 and 99.9 percent of the time for WW2 this quarter. The Flow Zone 3 remedial system (WWB of the Energy Boulevard Drain Tile System) was operational 99.9 percent of the time this quarter. Downtime occurred due to some of the issues associated with the treatment system as well as high pH at WW1, and pump replacement at WW1.

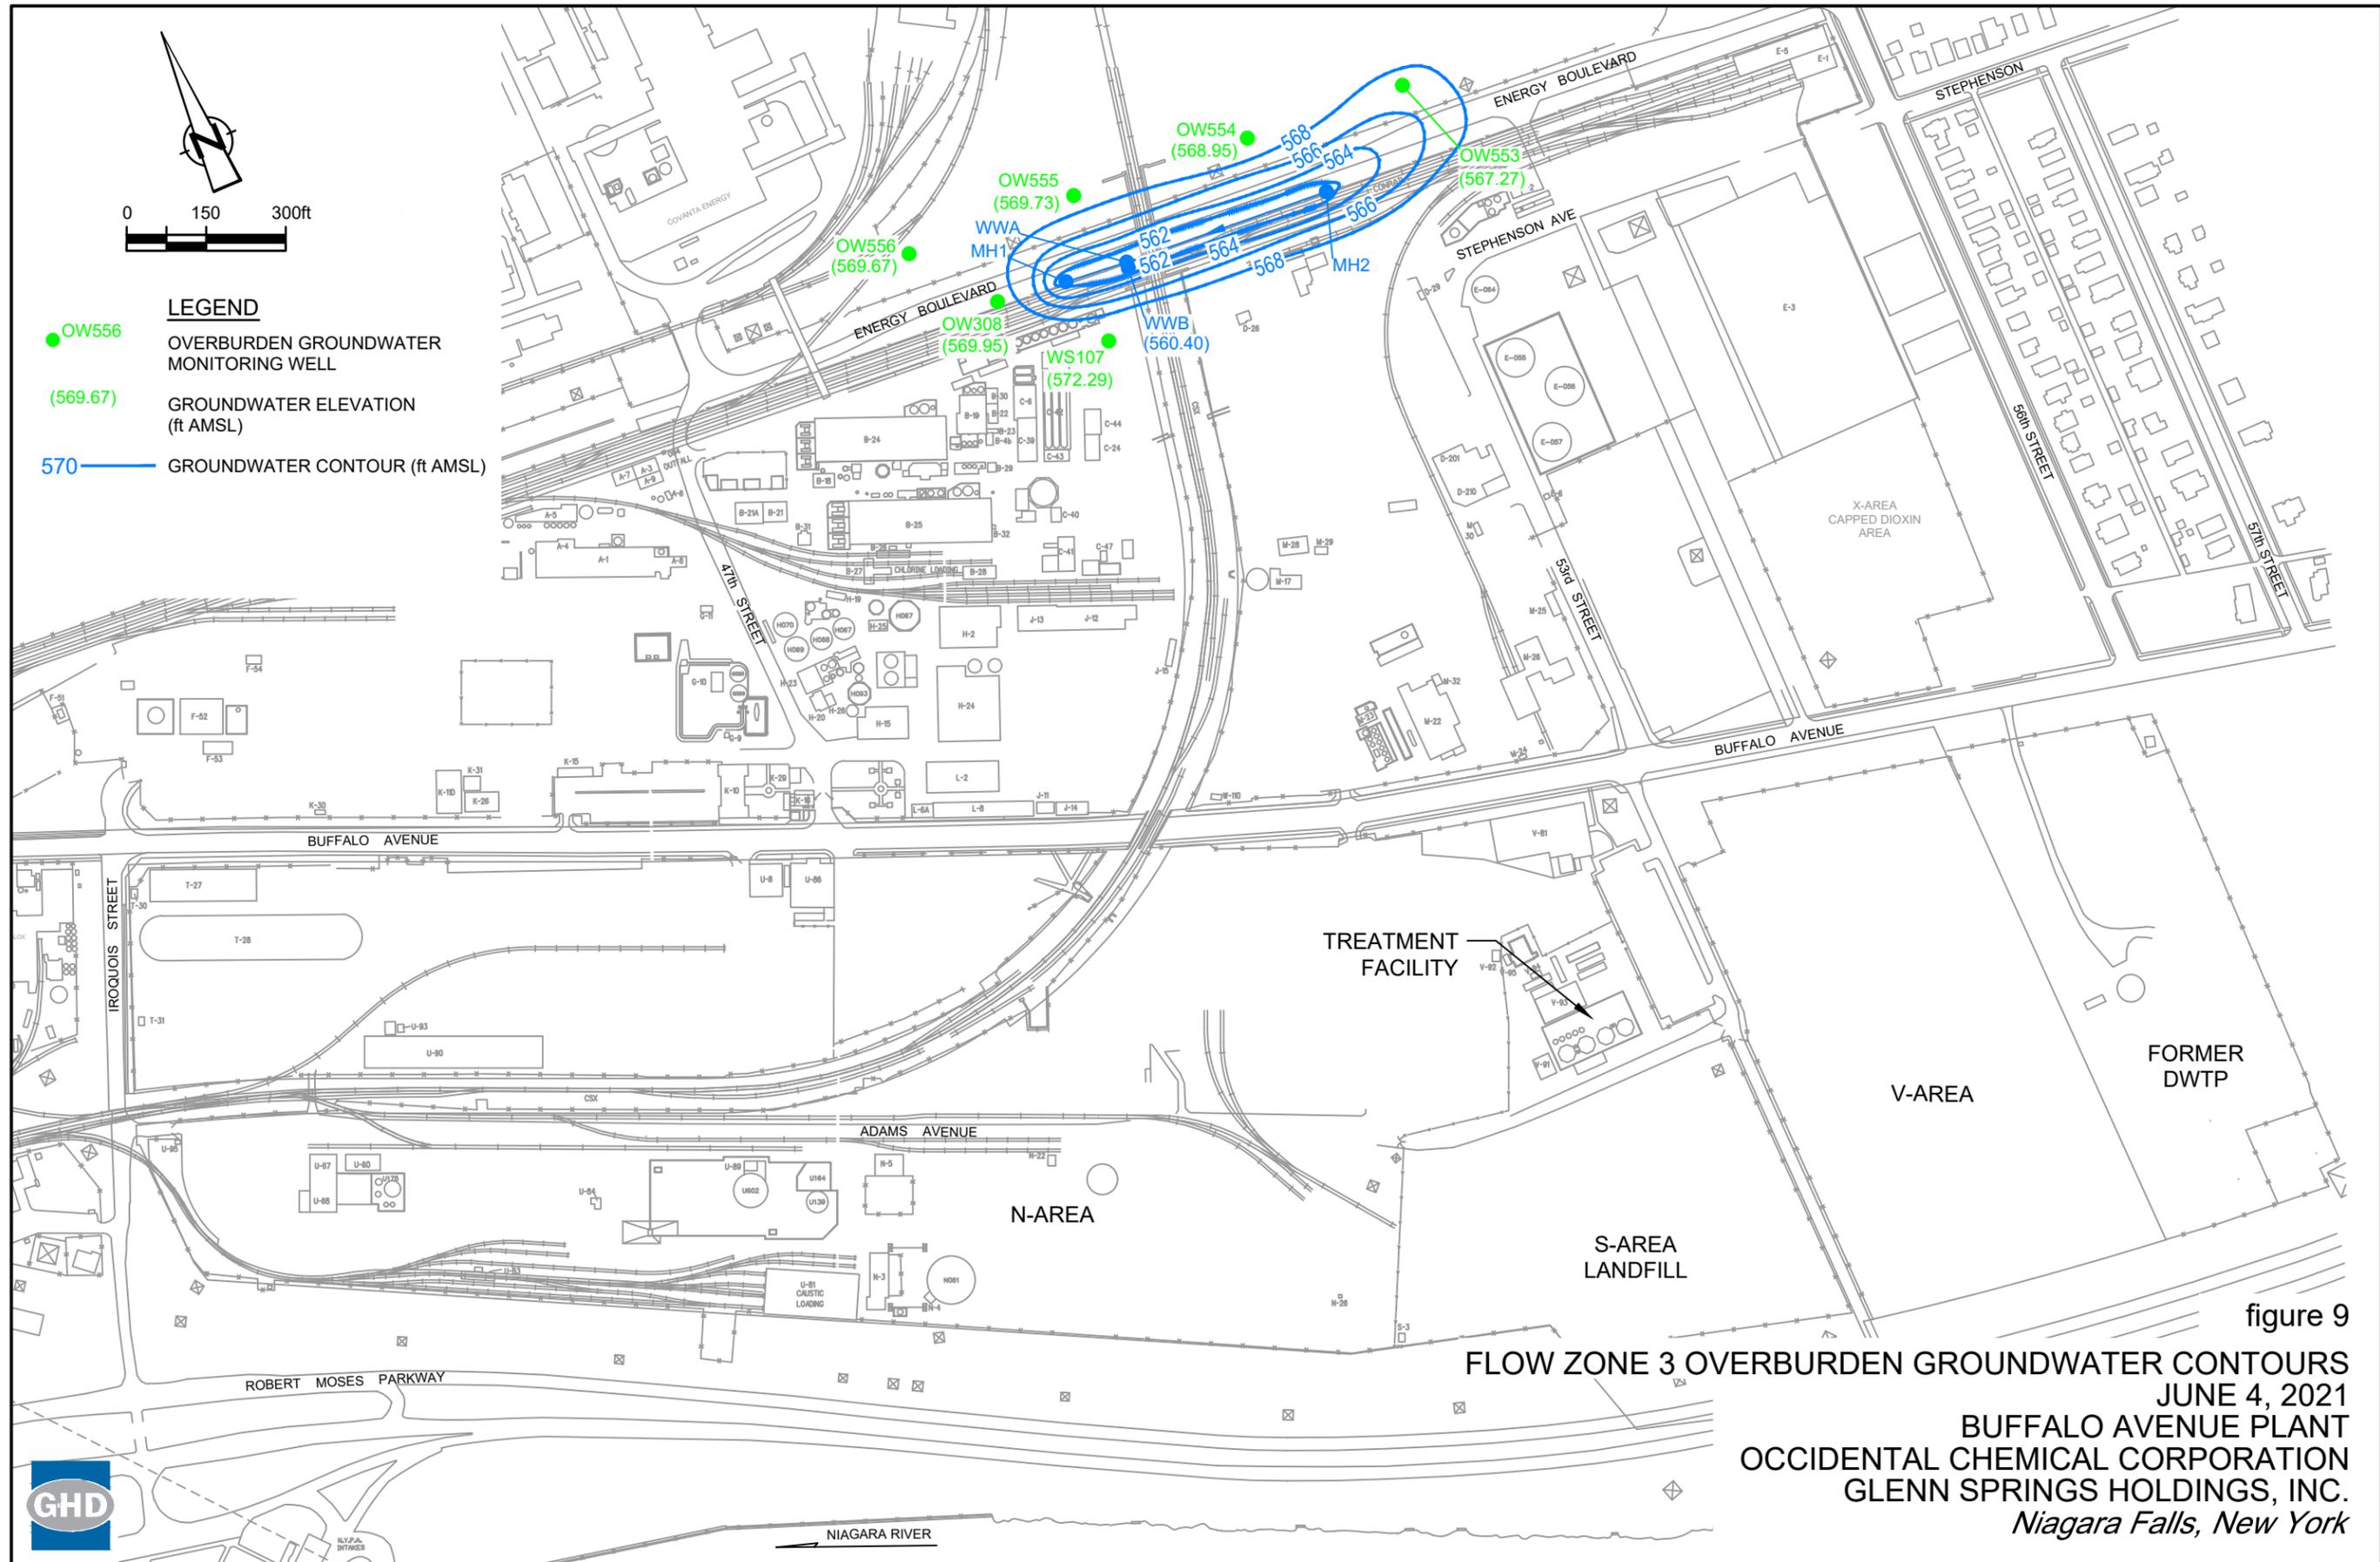
figure 9
 FLOW ZONE 3 OVERBURDEN GROUNDWATER CONTOURS
 JUNE 4, 2021
 BUFFALO AVENUE PLANT
 OCCIDENTAL CHEMICAL CORPORATION
 GLENN SPRINGS HOLDINGS, INC.
 Niagara Falls, New York

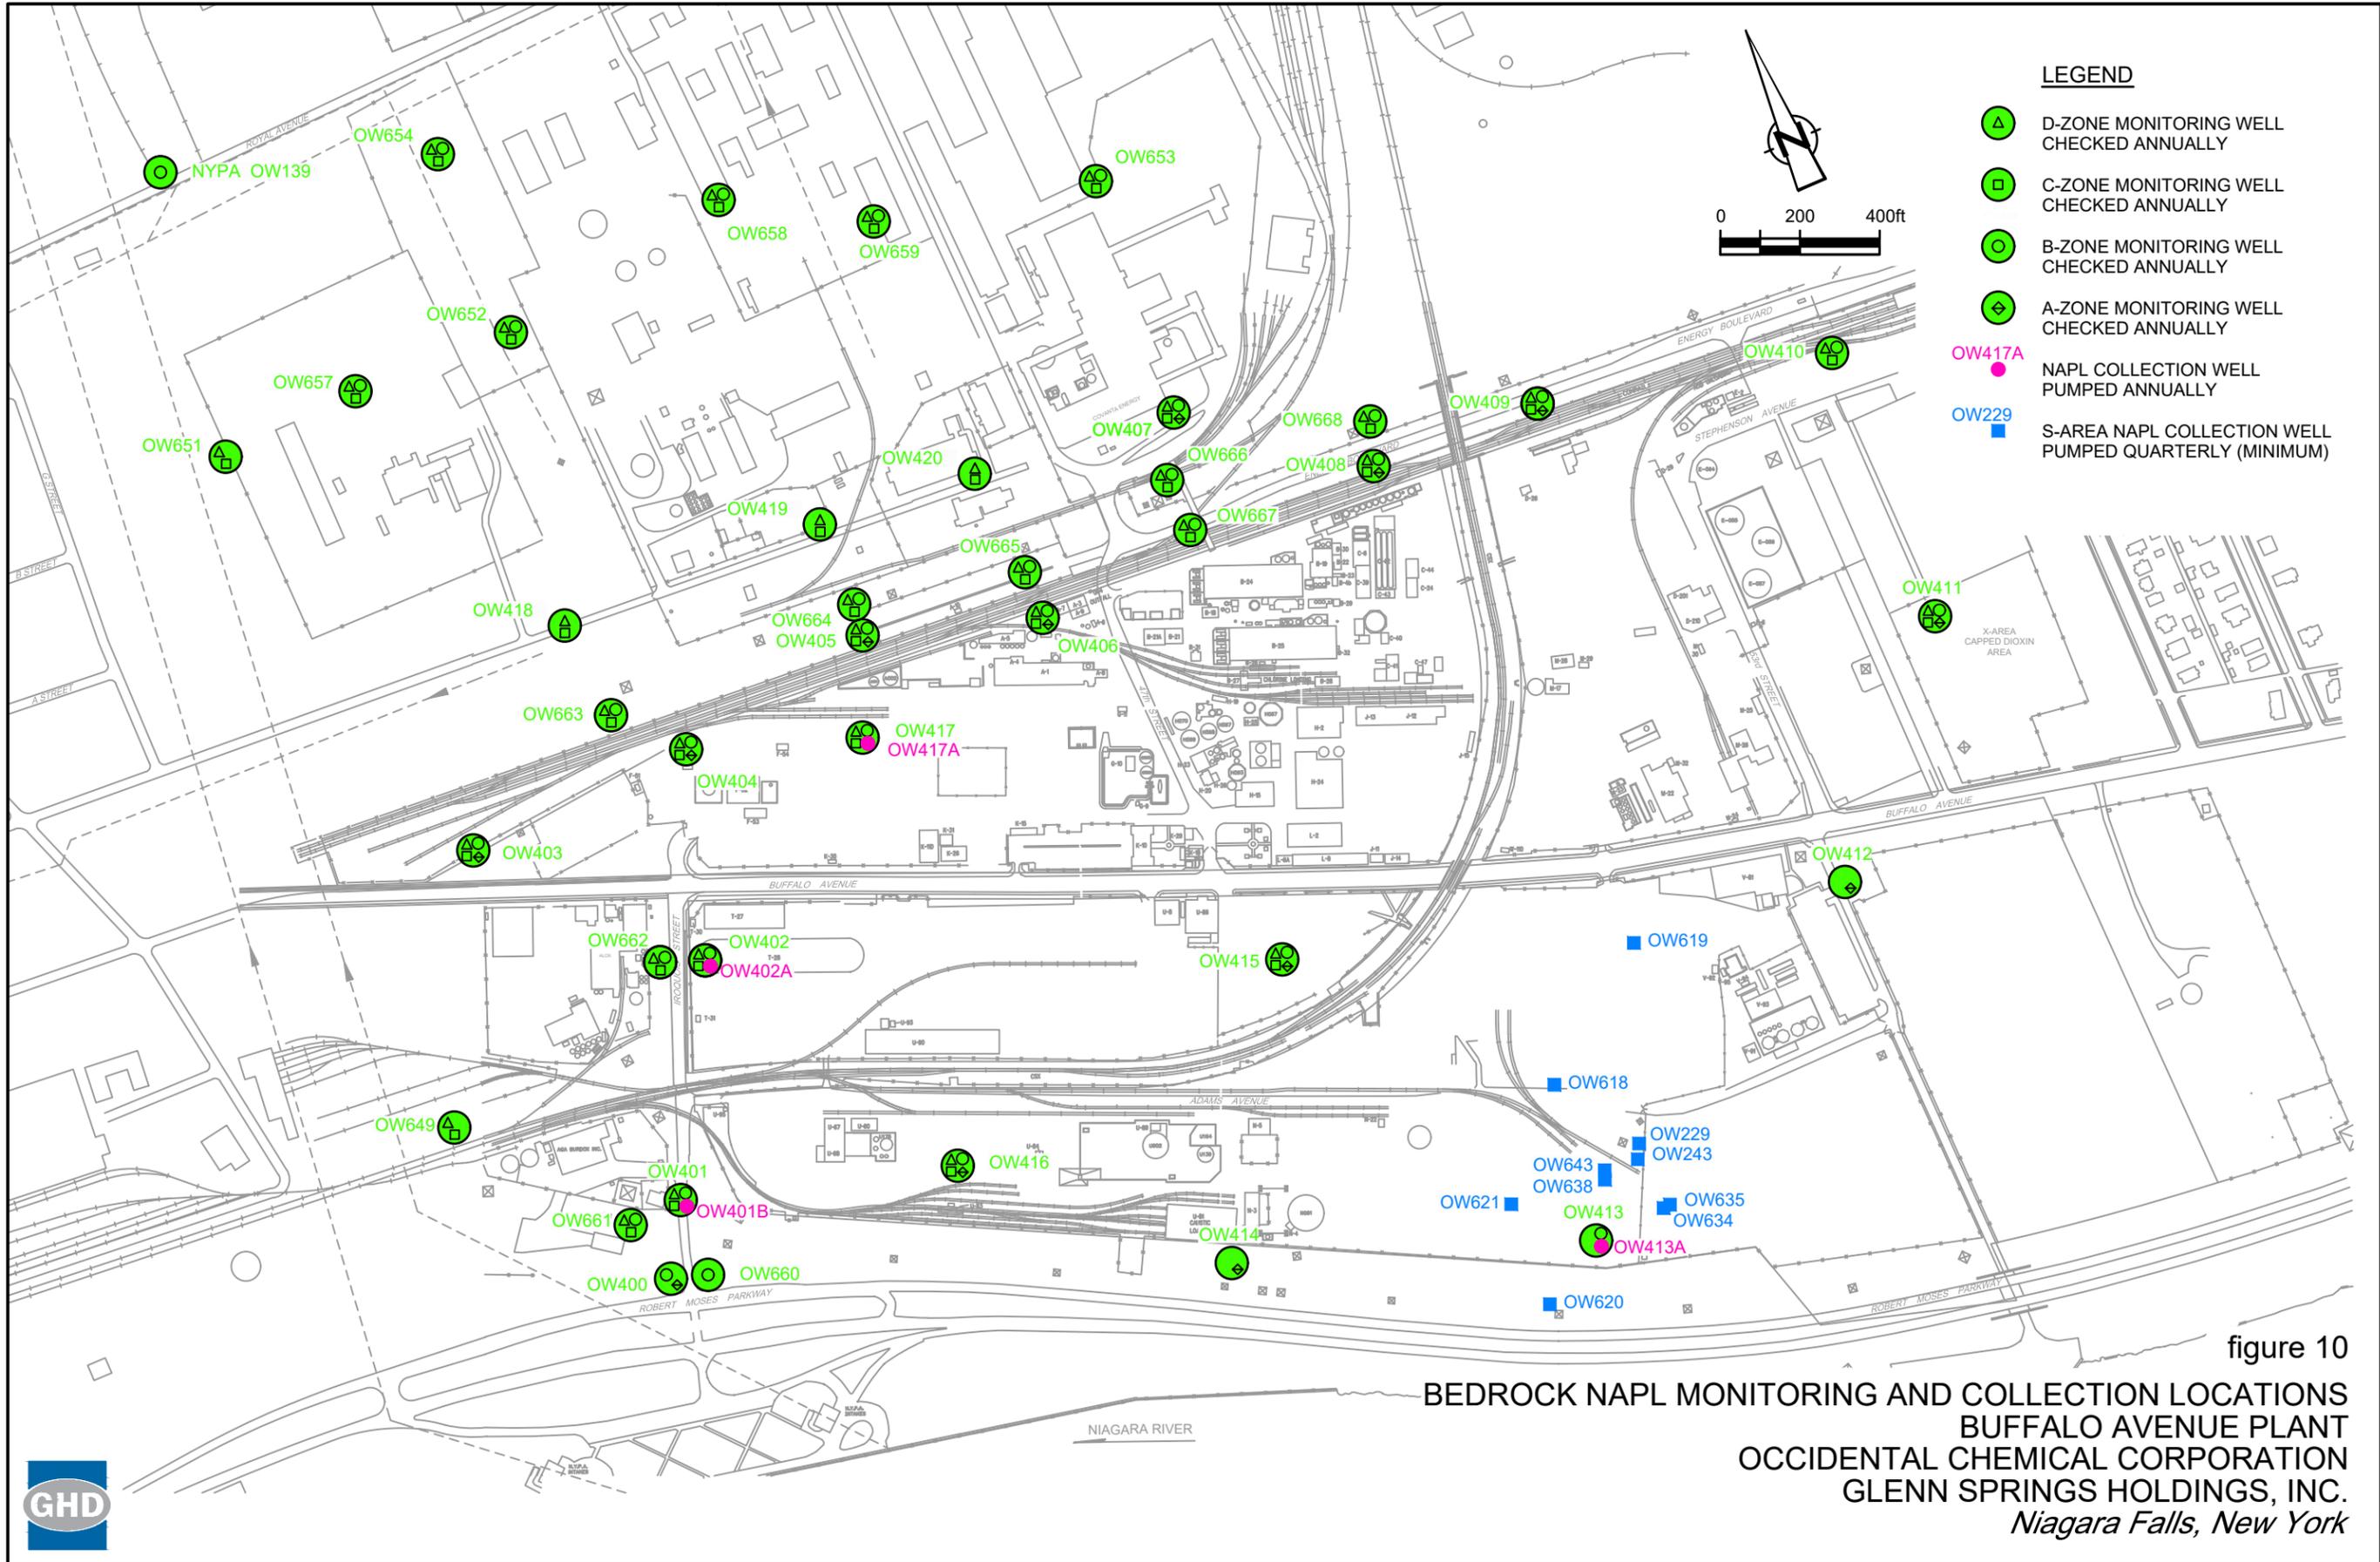
figure 10

**BEDROCK NAPL MONITORING AND COLLECTION LOCATIONS
 BUFFALO AVENUE PLANT
 OCCIDENTAL CHEMICAL CORPORATION
 GLENN SPRINGS HOLDINGS, INC.
 Niagara Falls, New York**

In accordance with the letter to the NYSDEC dated February 26, 2009, OxyChem incorporated quarterly NAPL monitoring and collection from six bedrock monitoring wells installed and monitored under the S-Area Remedial Requisite Technology Program into the Niagara Plant Corrective Action Program. Three other wells were added in accordance with the recommendations of the 2009 Annual Performance Evaluation. An additional well was added during the first quarter of 2012 in accordance with the recommendations of the 2011 Annual Performance Evaluation. These bedrock monitoring wells, designated OW229, OW243, OW618, OW619, OW620, OW621, OW634, OW635, OW638, and OW643, are located within, or immediately adjacent to, the N-Area of the Niagara Plant and contain N-Area NAPL. Quarterly NAPL checks and recovery have continued in 2021.

Bedrock NAPL Monitoring LocationsFigure 10
 Overburden NAPL Monitoring LocationsFigure 11
 Bedrock NAPL Monitoring and CollectionTable 11
 Overburden NAPL Monitoring and Collection.....Table 12
