LETTER REPORT

LINEAMENT ANALYSIS

NIAGARA FALLS ARS, SITE 3 Niagara Falls, New York

February, 1999

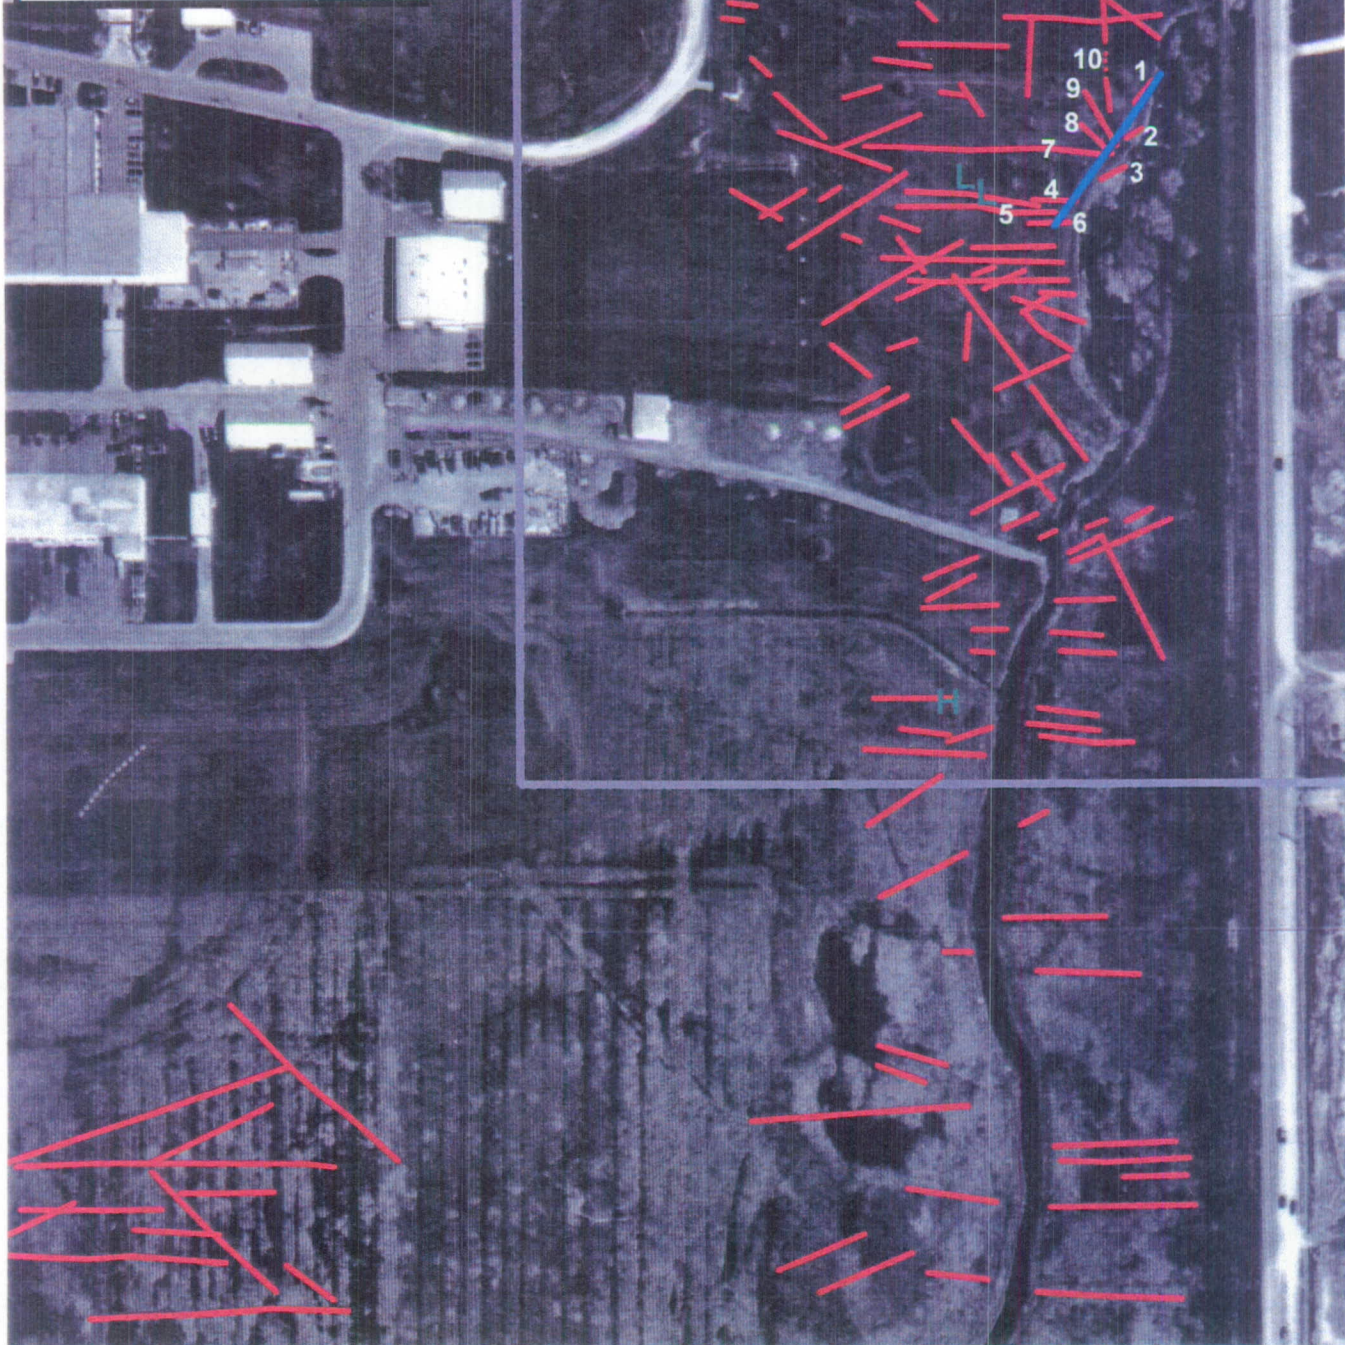
Legend

-   Surface Lineament
-   High/Low (Topographic)
-   Site Boundary
-   Proposed Trench Location
