**Re: Pre-Demolition Asbestos Inspection Services
DEC Tract 2 Project
Beech and Highland Avenues
Niagara Falls, New York**

Pre-Demolition Asbestos Inspection

**DEC Tract 2 Site
Beech and Highland Avenues
Niagara Falls, New York**

**Conditions as of
December 16, 2008**

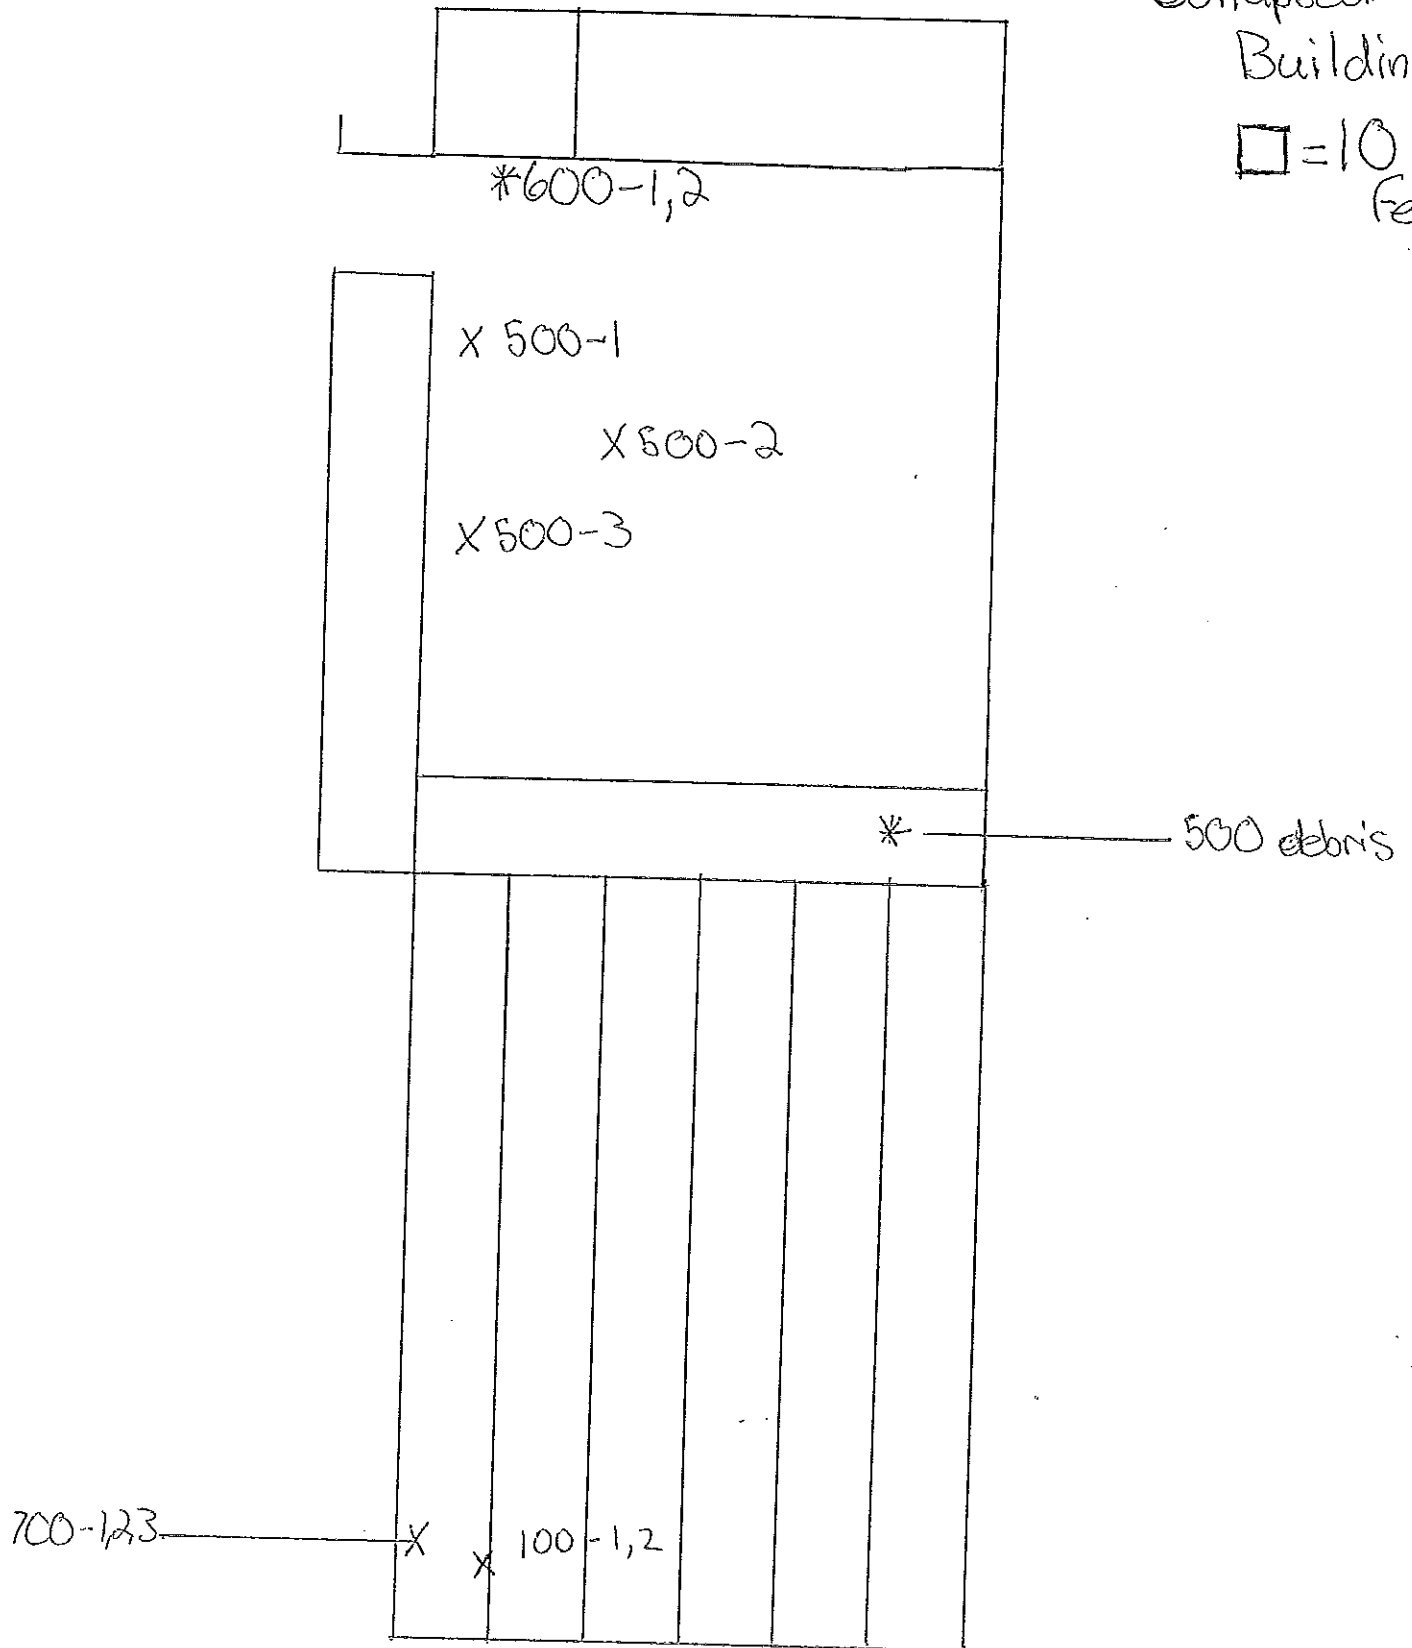
Sample location map

Collapsed Building
□ = 10 Feet

*The second component of the inspection was the remaining basements of a partially demolished structure that is situated near Beech Avenue. There exists an east and west basement connected by a corridor. A partially collapsed tunnel extends from the east wall of the west basement which contains TSI and debris. TSI which analyzed positive for asbestos exists in the basements in a severely damaged state. The entire floor of the basements is contaminated with ACM debris. At the east wall of the west basement is an electrical room constructed of transite which houses transite switch gear.
