DAILY AIR MONITORING REPORT 250 Water Street Remediation Site Manhattan, New York				04/21/22					
					Project number: 170381202					
					Page 1 of 2					
					Submitted By: Lauren Roper					Rev. No. 0
					Dust Action Level ($\mu\text{g}/\text{m}^3$)					100
VOC Action Level (ppm)					5					
Hg Action Level ($\mu\text{g}/\text{m}^3$)					1.0

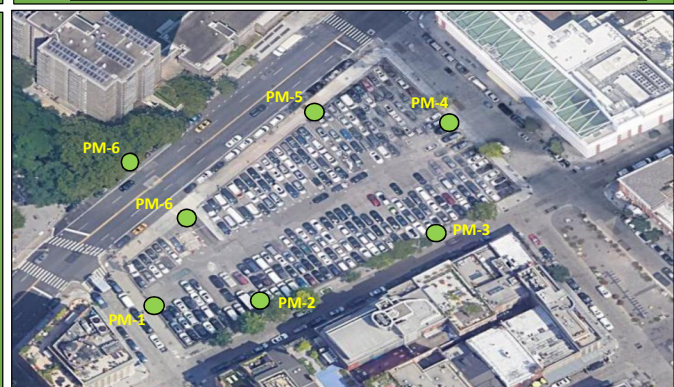
Weather Data Range for Work Day		Wind Direction	SE	Relative Humidity (%)	31.8 - 47.1	Daily Rain (in)	0.00	Readings in the summary table and graphs below are the reported downwind concentrations.
Temp (°F)	55.5 - 58.8	Wind Speed (MPH)	2.7 - 10.8	Barometer (inHg)	30.44 - 30.56

- *Mercury vapor concentrations exceeded the action level established in the CAMP from 11:03am to 11:17am at perimeter station PM-5, located along Pearl Street. The exceedances were determined to be erroneous high readings resulting from an equipment malfunction and not a result of ground-intrusive activities associated with construction activities.

- One instantaneous mercury vapor concentration causing the erroneous exceedance was recorded at 24.6 $\mu\text{g}/\text{m}^3$. Ground-intrusive activities were not ongoing at the time of the exceedance and UBS was in the process of assembling a plywood panel for the perimeter construction fencing.

- The Jerome® J405 was temporarily disconnected from the remote telemetry system to run a "warm-up" of the sensor and readings returned to background conditions. The Jerome® J405 continued to read 0.00 $\mu\text{g}/\text{m}^3$ for the remainder of the day.
